Stone Barn

337

1. Statement of Significance

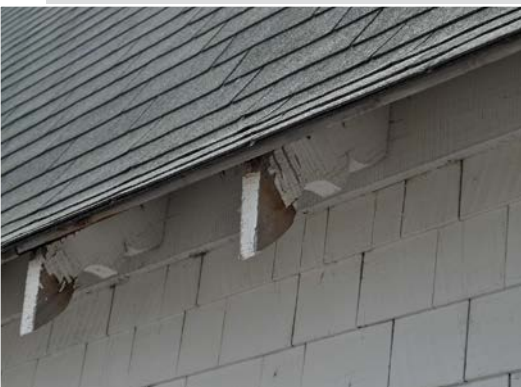
Figure 2. Top to bottom: Asphalt roof shingles have replaced the original cedar shingles, carved exposed wooden truss ends. The cedar shakes on the upper portion of the main barn have been painted white.

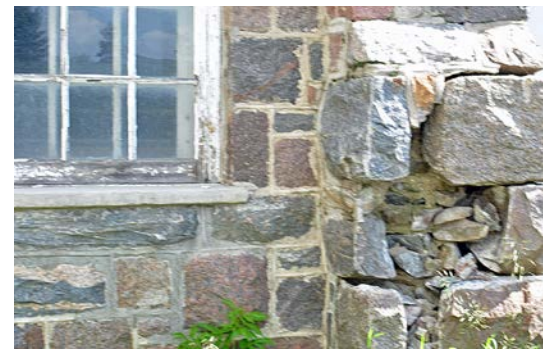
Figure 4. Ground floor walls are constructed of red and grey, rough-faced granite. Windows are framed in wood.

Windows are framed in wood and are single-glazed (Figure 4). In some places there are storm windows. Some exterior window sills feature concrete that has been replaced. A majority of the windows have retained their original glass; however, most are heavily weathered and are in poor physical condition. In a few instances the windows have been replaced or have been boarded up.

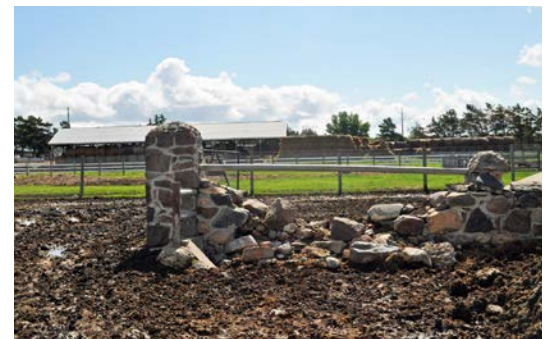
Figure 5. A portion of the stone fence which has fallen down.

The ground floor walls and piers are constructed of rough granite of varying shades of grey and red (Figure 4).^{*} A stone paddock wall in the same rough granite was added at some time after the construction of the barn. The condition of the paddock walls is poor in many places. Parts of the stone wall have crumbled and have been replaced by a more temporary fence. The stone piers on the barn are failing in several instances and were the immediate cause of the building's recent closure. The stone walls of the barn have fared somewhat better but require re-pointing. The stone retaining wall that supports the remaining ramp is in good condition and maintains its commemorative integrity. Concrete has been used to refinish the top of this ramp.

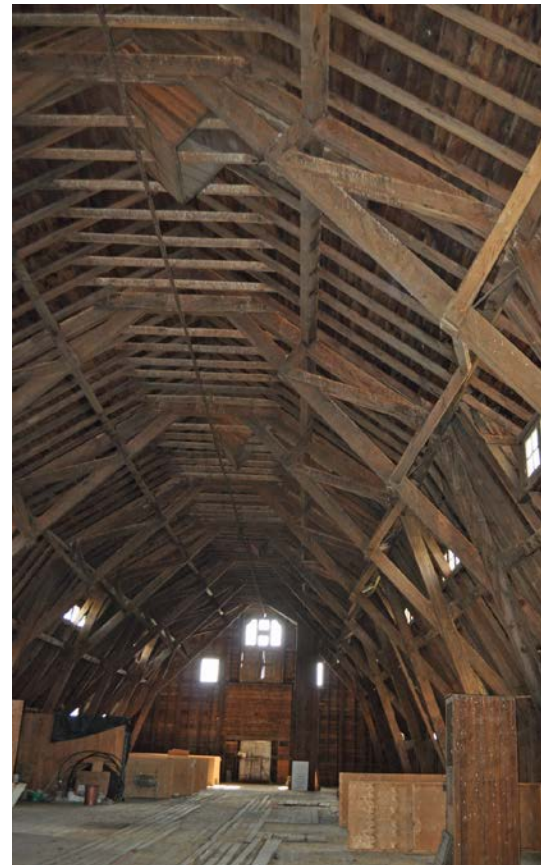
Figure 8. The loft features unfinished Douglas fir. The lower right corner shows a ventilation shaft that has been disconnected from a cupola. The opening for the cupola can be seen at the top left of the photograph.

The roof of the barn is topped by a series of prominent wooden cupolas that function to provide ventilation. On the interior, these cupolas are connected to wooden shafts that are designed to produce a stack effect and exhaust stale air from the building. These shafts reach from the centre of the roof to the floor on either side of the barn. The amount of ventilation could be controlled by opening and closing doors located on the sides of the wooden shafts. The majority of these ventilating systems are intact, although some of the cupolas have been disconnected from their shafts. Figure 8 shows one such disconnected shaft.

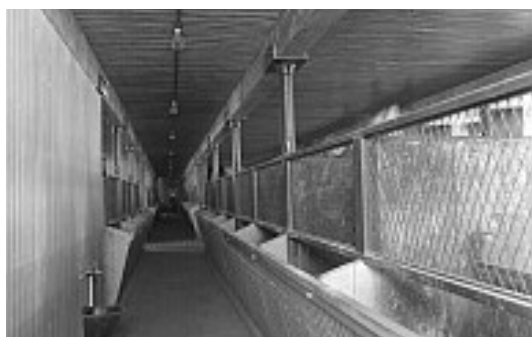
Figure 16. Interior of the horse corridor ca. 1920 with mangers on either side. The photo demonstrates how tightly configured the building was before the stalls were removed. Photo A-72, retrieved from http://scaa.sk.ca/gallery/uofs_buildings/

As a working agricultural building, the spatial configuration of the Stone Barn has necessarily changed over time. Figures 15 and 16 show how the ground floor was originally divided into livestock stalls. Originally, the west wing was configured for equestrian use and the east for cattle and sheep. Figure 16 is a view of the west wing when the stalls and feeders were in place. All of these stalls have since been removed, leaving the area a completely open space. The existing layout of the ground floor is therefore in a poor state of commemorative integrity.

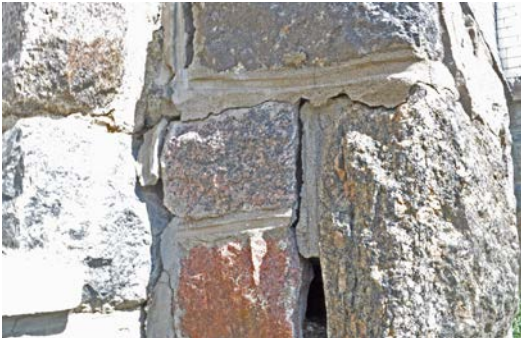
In 2010, a structural analysis of the Stone barn was carried out, which determined that degradation of the stone piers had reached a critical state. As a result, the Stone Barn was closed in September 2010. The failing structure of the Stone Barn is obviously a threat to its heritage value.

The roof of the building is composed of Douglas Fir decking, supported by a series of intricate Gambrel style bolted girder trusses, also made of Douglas Fir, shown in Figures 18 and 19. The trusses span the full width of the building, and are supported by the exterior load-bearing stone walls and pilasters. The exterior walls of the Stone Barn are constructed of granite. Stone pilasters, which thicken as they reach the ground, pick up the roof trusses (Figure 20). Figure 21 illustrates the deterioration of the stone walls.

Figure 21. Deterioration of the walls of the Stone Barn.
