Stone Barn

337

1. Statement of Significance

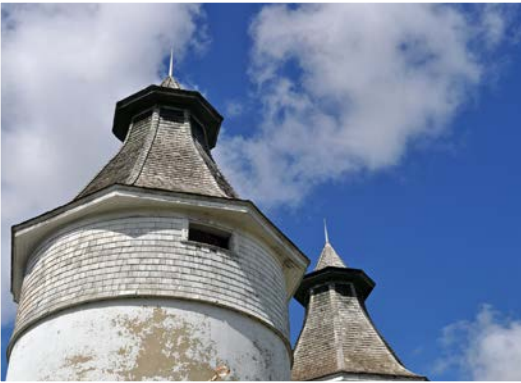
Figure 1. Concrete silos with cedar shingle roofs.

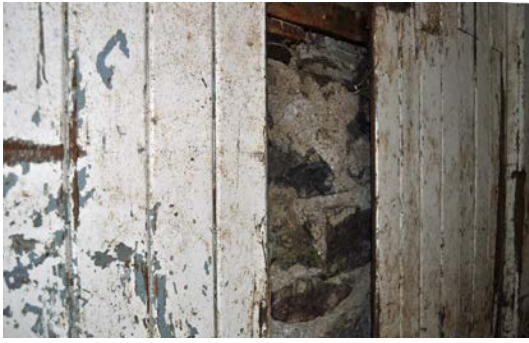
Figure 6. Interior walls clad in wooden planks.

On the interior of the building, the stone walls are clad with vertical wooden planking, painted white. Figure 6 shows this wooden sheathing covering the stone walls. Early elevations by Brown and Vallance Architects show that the building was originally conceived of as a wooden structure (Figure 7). The roof of the building is supported by a series of intricate trusses, made of Douglas fir. The trusses and decking are exposed and unpainted, and have been maintained to an excellent degree of commemorative integrity (Figure 8). These Douglas fir trusses and decking are important character-defining elements.

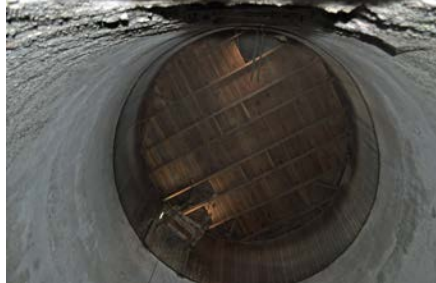
Figure 9. The interior of a silo constructed of concrete and Douglas fir

The silos are made out of cast-in-place concrete, with wooden roofs (Figure 9). Many of the original metal fixtures such as latches, hinges and pulley systems

still exist in a good state of commemorative integrity. They are all either rusted or painted but remain functional.

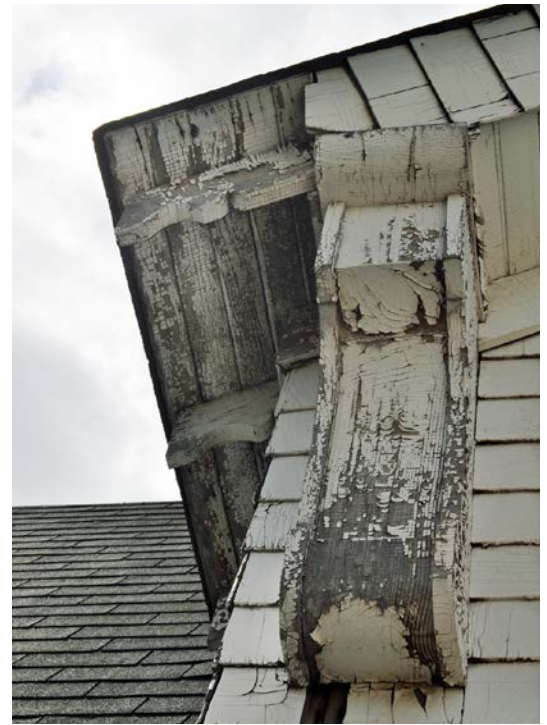
Figure 12. Carved wooden brackets flank the ramp doorway and carved wooden rafter extensions are visible under the eaves.

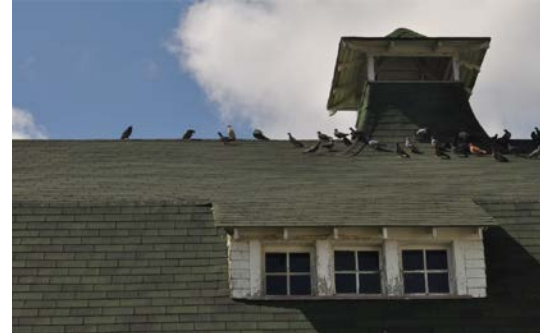
Figure 13. Cupola and dormer window.

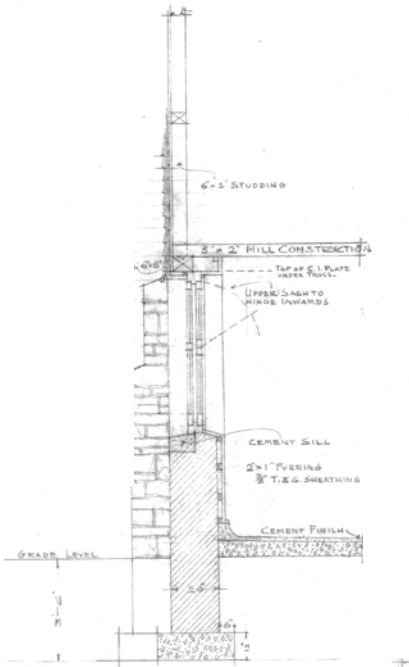
Figure 20. A wall section by Brown and Vallance Architects: Stone pilasters thicken towards the base.

The roof of the building is composed of Douglas Fir decking, supported by a series of intricate Gambrel style bolted girder trusses, also made of Douglas Fir, shown in Figures 18 and 19. The trusses span the full width of the building, and are supported by the exterior load-bearing stone walls and pilasters. The exterior walls of the Stone Barn are constructed of granite. Stone pilasters, which thicken as they reach the ground, pick up the roof trusses (Figure 20). Figure 21 illustrates the deterioration of the stone walls.

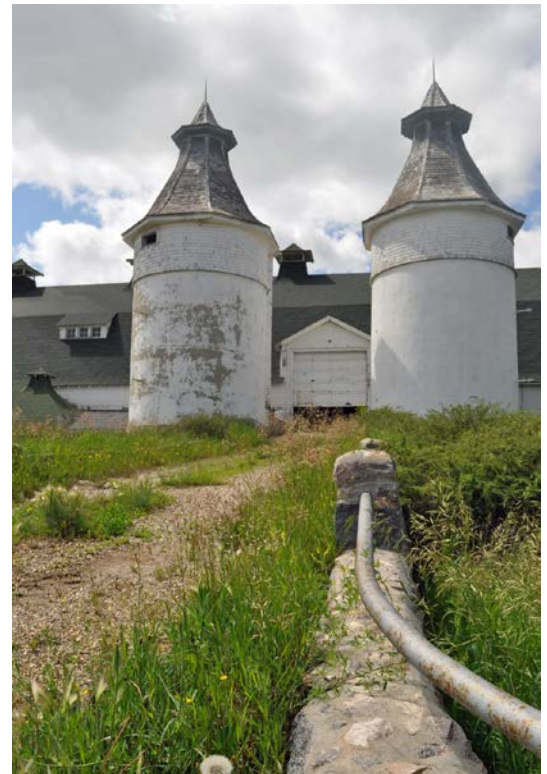
The hay loft is a remarkable, cathedral-like space; soaring to a height of about 35 feet and supported by a series of intricate wooden trusses. The hay loft is accessible from both a staircase inside the building and from an exterior ramp on the north side of the building (Figure 17). Another ramp on the west side, visible in Figure 3, has been removed.

Figure 17. The remaining ramp.

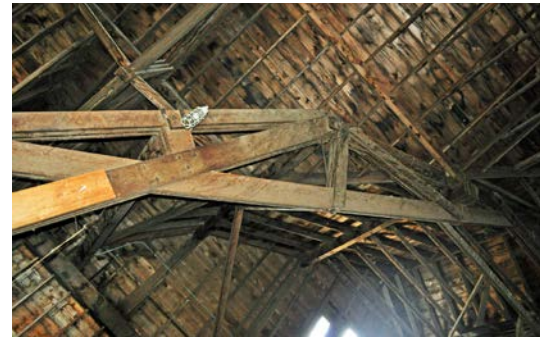
Figure 18. The structure of the barn roof.

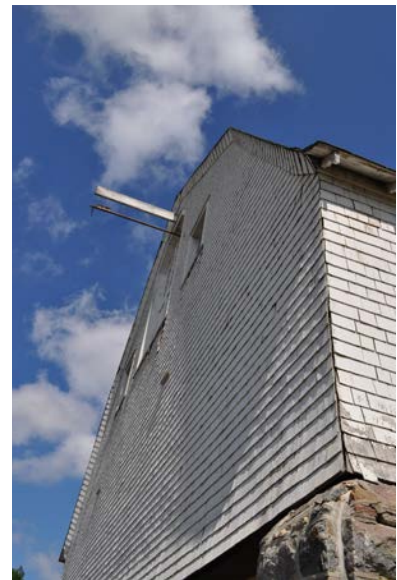
The Stone Barn also features a noteworthy system for circulating feed. A steel rail runs along the roof line of the loft and extends outside either end. Figure 24 pictures the rail system extending out from the wall above the loft door. Figure 25 shows the curving rail drawn to serve the whole loft space. At the end of each wing of the building, a loft door still exists. With hooks and pulleys, bales and feed could be hoisted from the ground outside into the hay loft, and from there could be transported around the building and lowered to the ground floor through trap doors in the loft floor. Most of the trap doors have been fastened shut or covered over with wood. Figure 26 illustrates a trap door that has not been decommissioned. The rail system remains in an excellent state of commemorative integrity.

Figure 24. The loft trolley system extends from the barn.

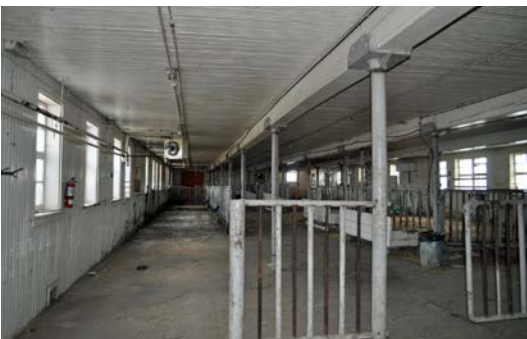
of 2" x 5" fir planks laid on edge. This floor is supported by the exterior walls, as well as by two 10" x 16" fir beams running the length of the building, which are in turn supported by steel posts (Figure 23.) In the west wing, two wooden posts can also be found.

Figure 23. Steel posts support wooden beams.
