University of Saskatchewan

Heritage Register

September 2013

Facilities Management
Division

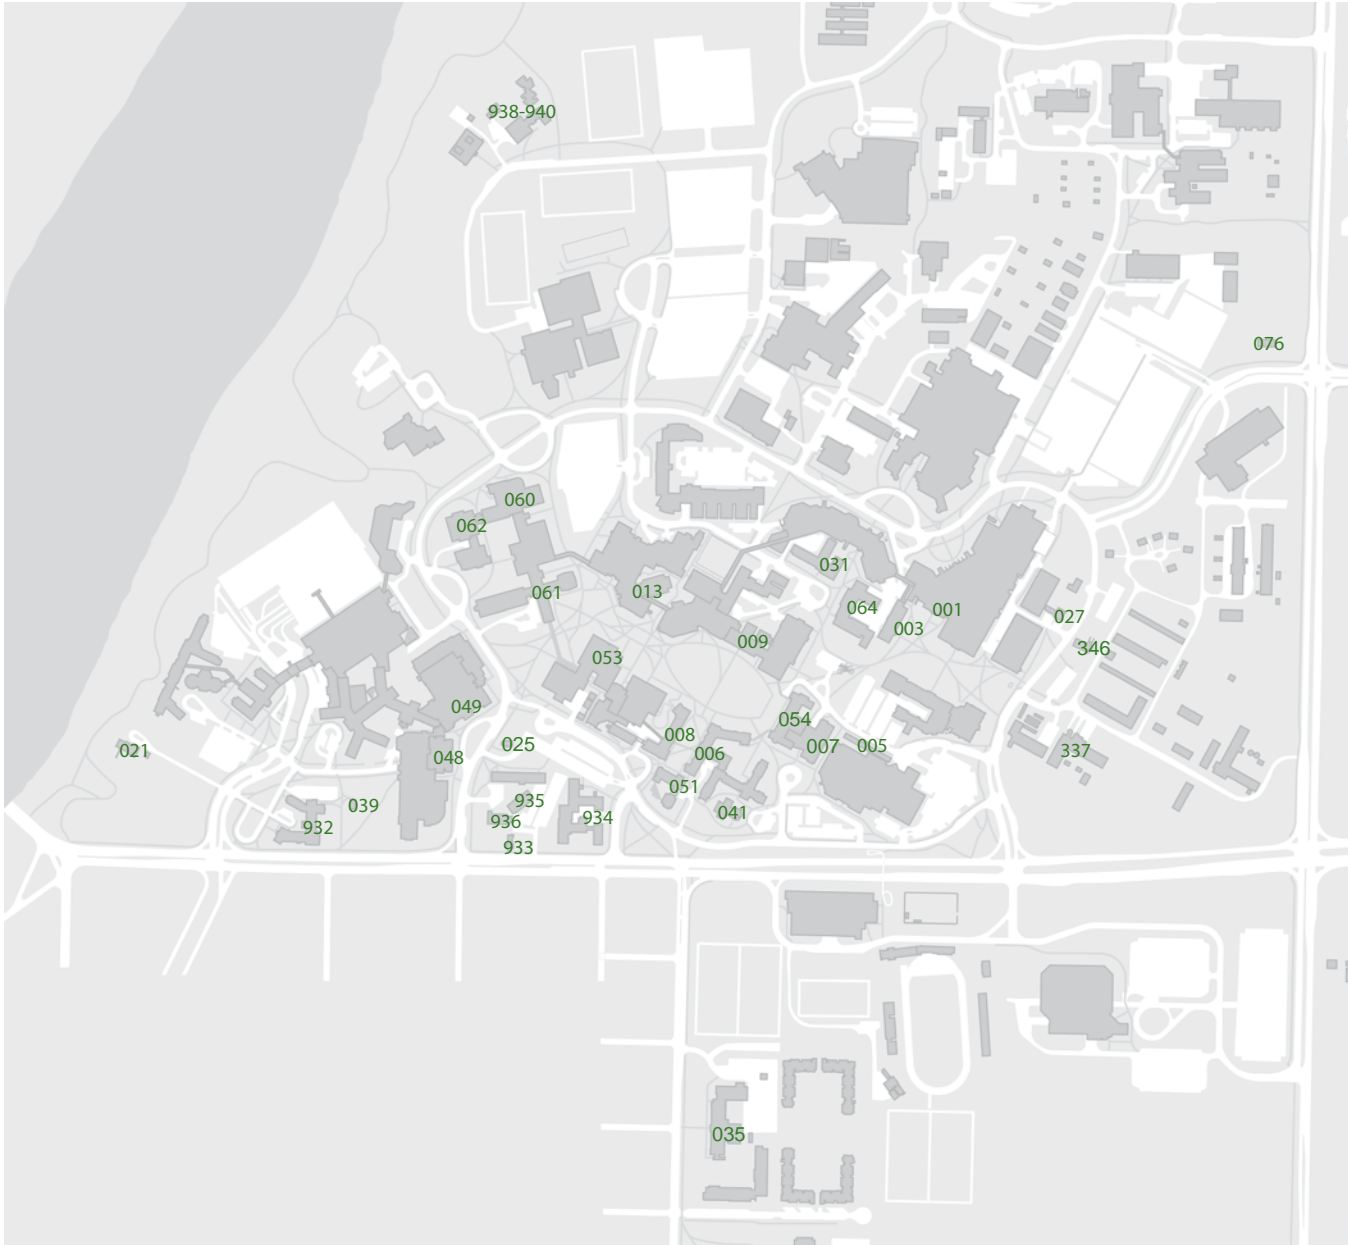
5.1 Map of Heritage Buildings at the U of S

* Ernest Linder's Studio and 'Gus' Kenderdine's Cabin located at Emma Lake Kenderdine Campus

Heritage Buildings **N** ↑

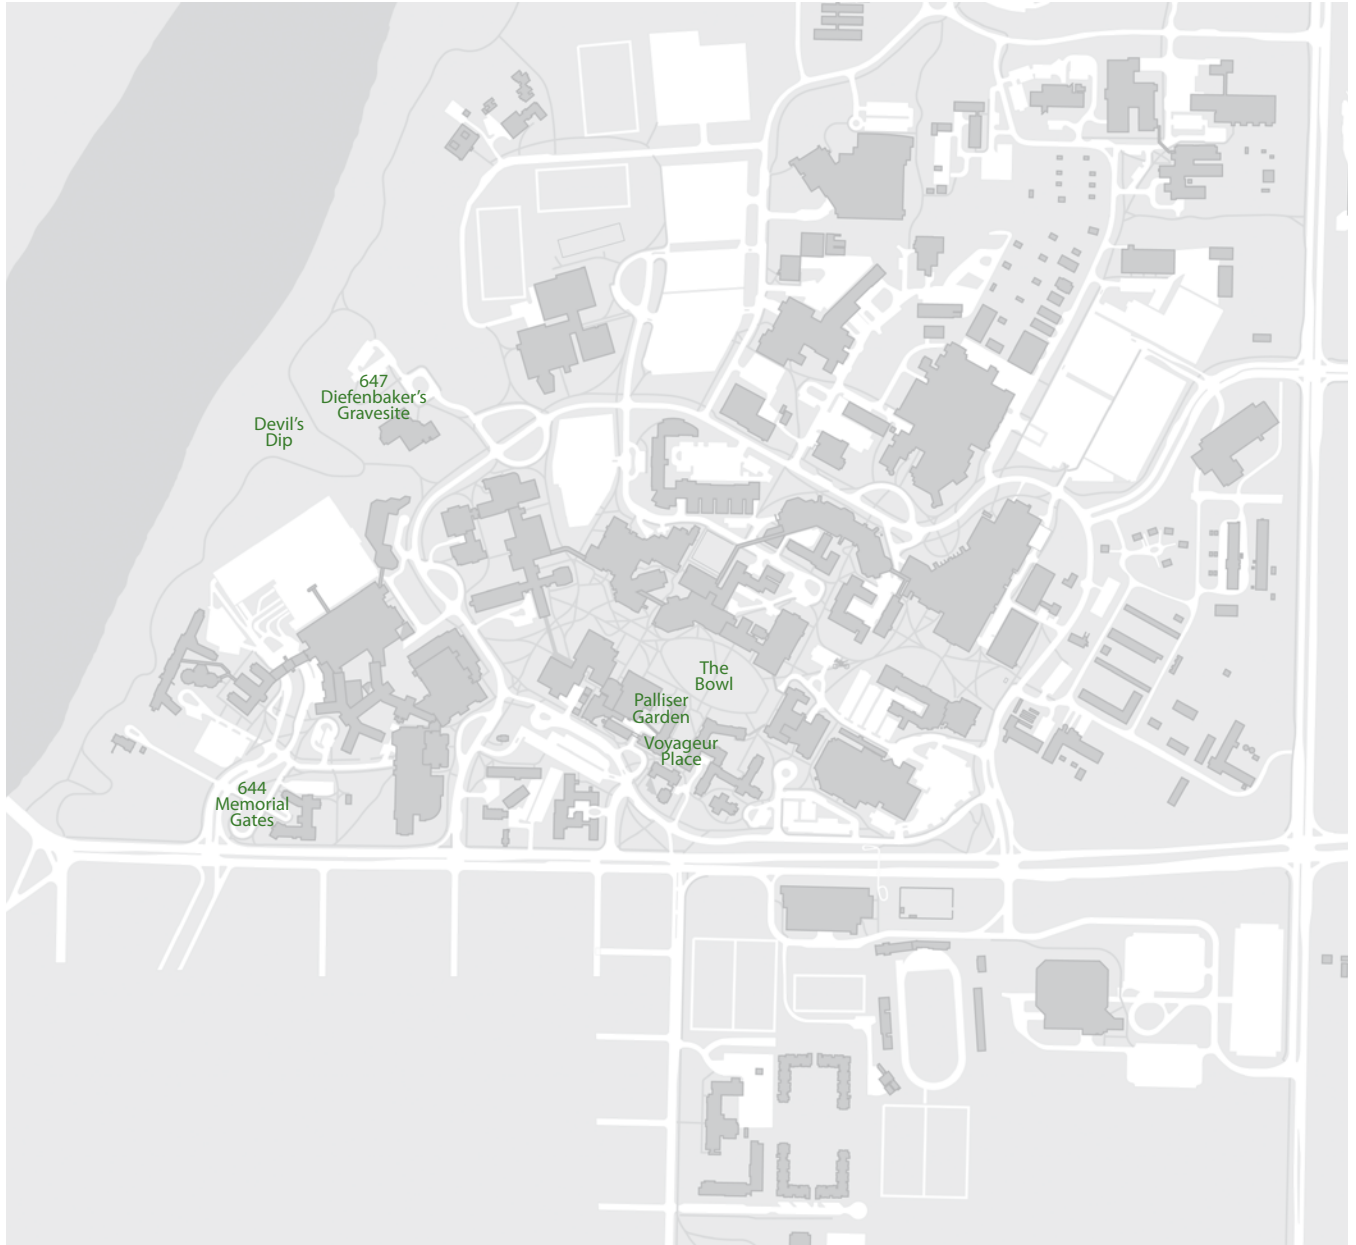
5.2 Map of Heritage Sites at the U of S

Heritage Sites **N** ↑

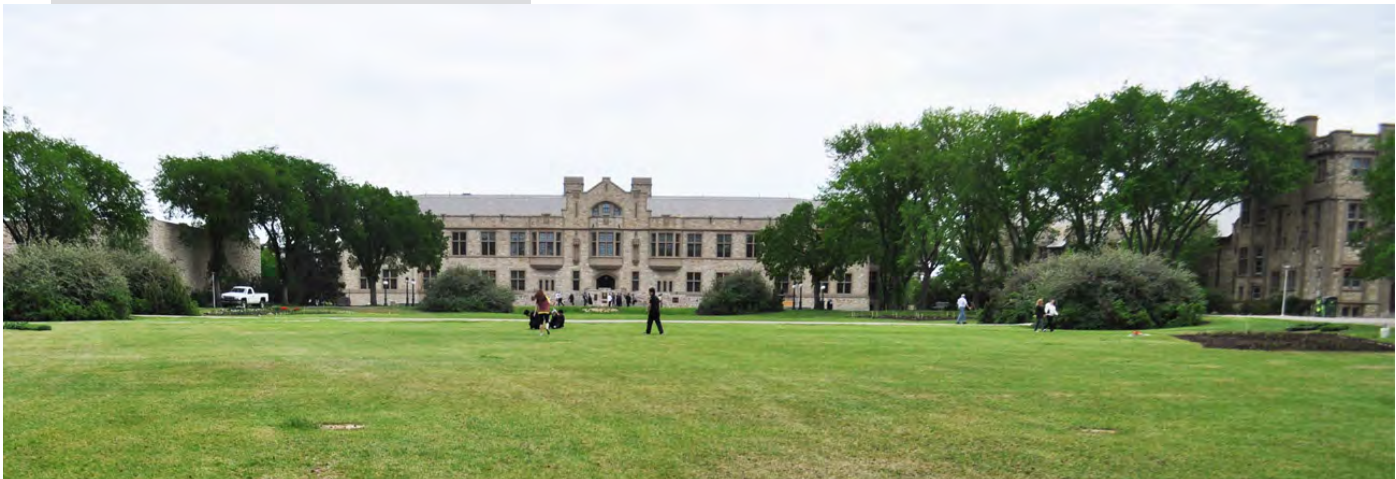
Figure 2. The Bowl: the MacKinnon Building (centre) and Saskatchewan Hall (right).

The University of Saskatchewan campus is often noted for its sense of place, its material consistency and its beauty. Its centerpiece is the ['Bowl'](#), a large outdoor courtyard that forms the heart of the campus (Figure 2). The Canadian Register of Historic Places has called the picturesque collection of stone buildings that ring this space “the finest grouping of Collegiate Gothic university buildings in Canada.”¹ But the character of the University of Saskatchewan

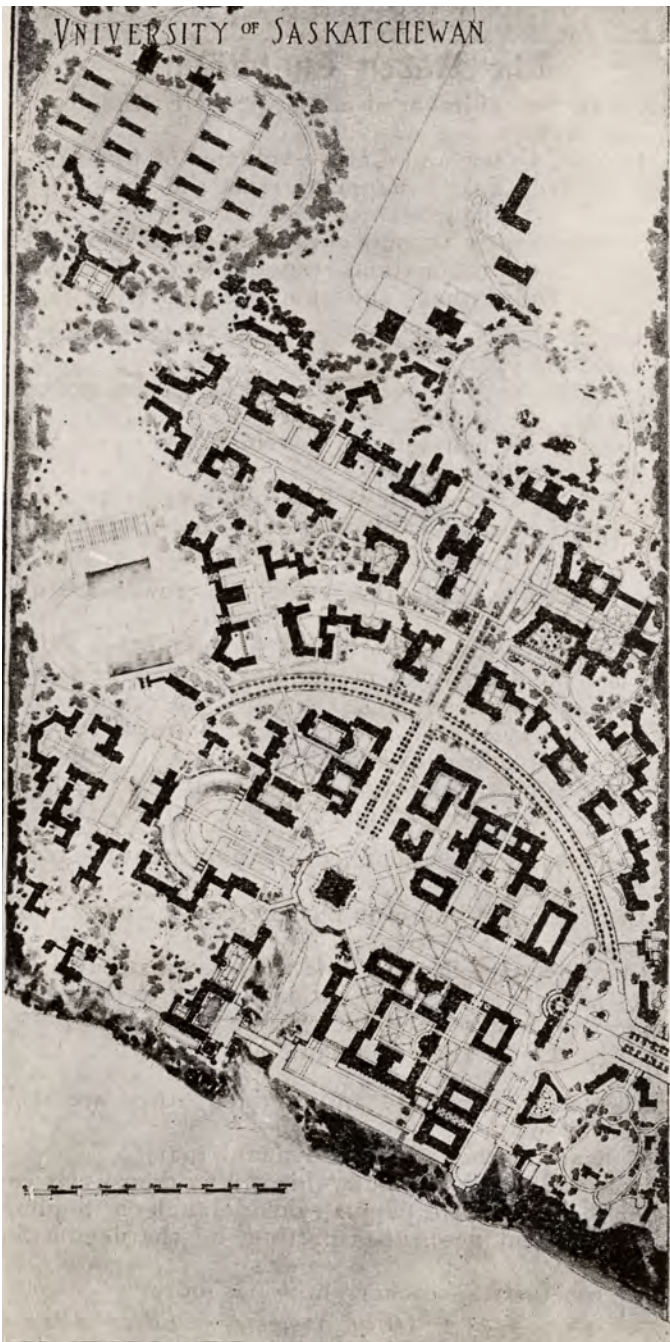
Figure 4. The 1909 Campus Plan by Brown and Vallance Architects. (Image: University of Saskatchewan Archives, A-5959).

The first phase of construction at the University of Saskatchewan occurred between 1909 and 1929. The development of the campus during this period proceeded according to a Campus Plan, created in 1909 by the architectural firm of David Brown & Hugh Vallance, of Montreal (Figure 4). Brown and Vallance also designed almost all of the buildings constructed during this period. The early architecture of the University of Saskatchewan was characterized by its traditional, Collegiate Gothic style and by the consistent use of a local dolomitic limestone, known colloquially as ‘Greystone’ (Figures 1 & 5). This first period of construction was interrupted by the stock market crash of 1929, followed by the Great Depression and the Second World War.

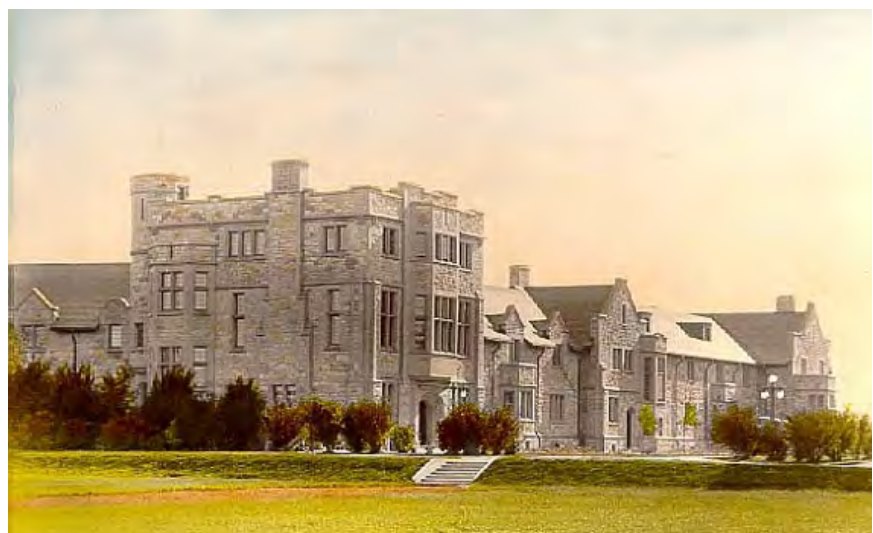
Figure 5. A rendering of Saskatchewan Hall, produced by architects Brown and Vallance. (Image: University of Saskatchewan Archives, B-389-C).

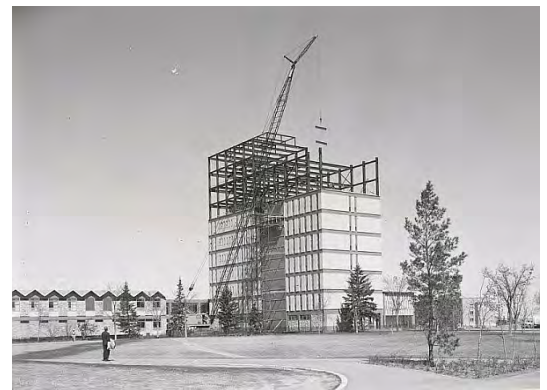
Figure 7. The addition to the Arts Tower under construction, 1964. Shore & Moffat Architects. (Image: University of Saskatchewan Archives, A-3520).

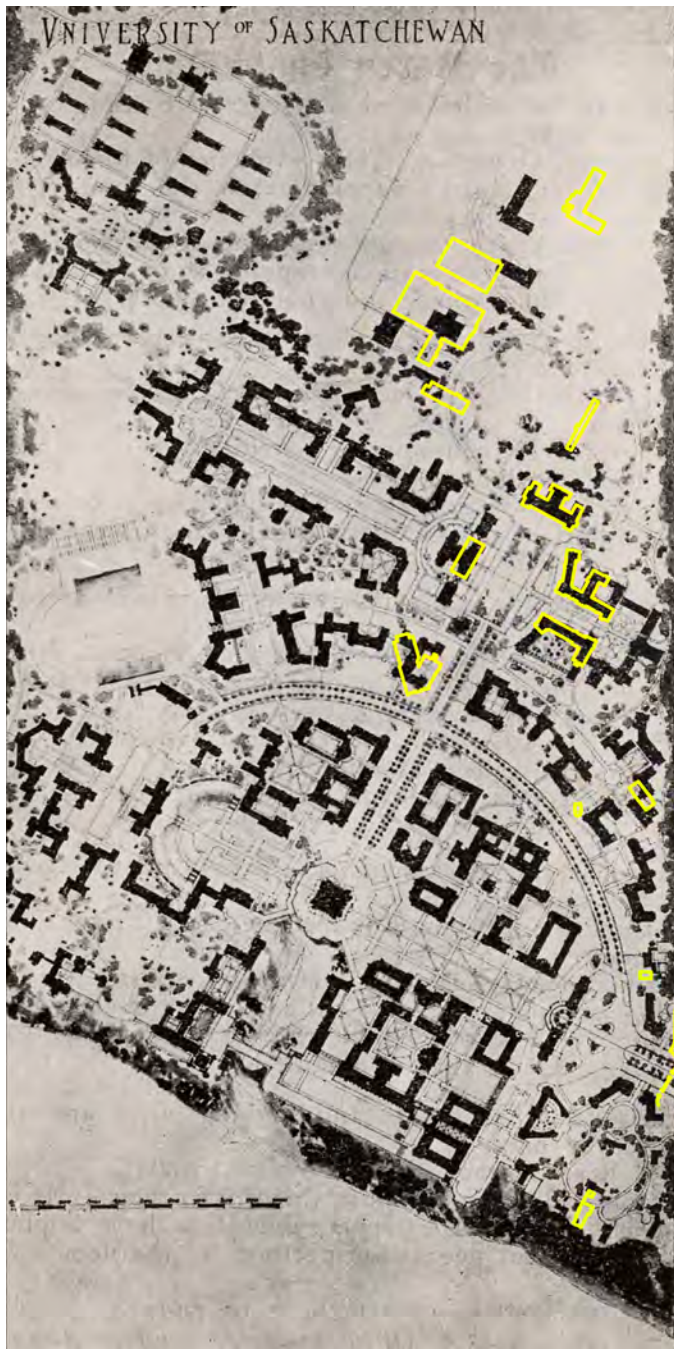
Figure 18. 1909 Master Plan, Brown & Vallance Architects. Buildings actually constructed in the period 1909-1929 are shown in yellow. (Image: University of Saskatchewan Archives & Andrew Wallace)

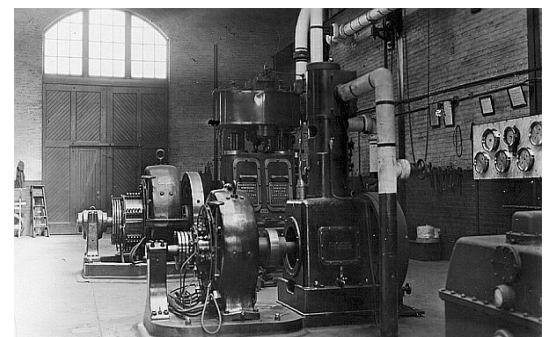
Figure 20. Central Power House, constructed 1910-12. Two steam-driven electrical generators were used to supply power to the early campus. (Image: University of Saskatchewan Archives).

The building systems of the early campus also contained many innovative features. A central power house, one of the first buildings constructed, supplied steam heat, hot water and electricity to the rest of the campus via a system of tunnels. Two coal fired boilers supplied steam and hot water, and steam-driven generators produced electricity for lighting (Figure 20).¹³

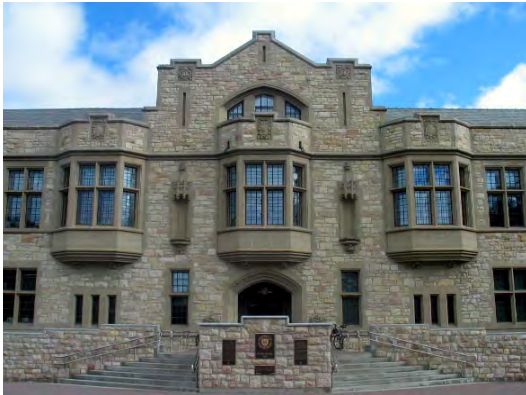
Figure 22. MacKinnon Building, Brown & Vallance Architects, 1910-13. (Image: FMD).

The MacKinnon Building features most of the elements associated with the gothic revival styles. Consider, for example, the central bay of the MacKinnon Building in comparison to the Angel Inn, a medieval building featured in Pugin's book *Contrasts* (Figures 21 & 22). Both buildings are symmetrical in composition, with the main entrance forming the central element in the design. Both entrances are recessed within a shallow pointed arch; the use of the arch, particularly the pointed or gothic arch, is a typical feature of the gothic styles. Statuary niches flank the entrances in both cases. Both elevations feature a row of three bay or oriel windows.

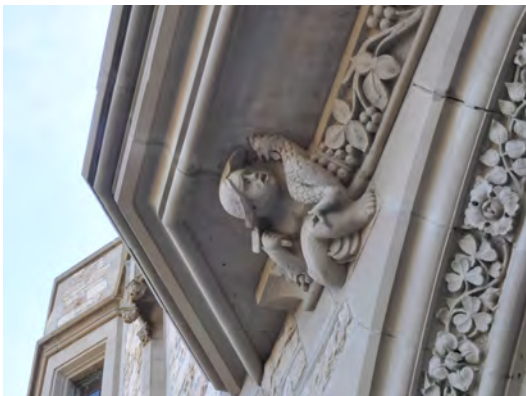
Figure 23. Carved stone gargoyle, MacKinnon Building. (Image: FMD).

Carved stone ornamentation is another common feature of the Collegiate Gothic style. Walter Murray, the university's first president, requested the depiction of local fauna, such as gophers, ducks, and prairie chickens, in the carved stonework of the MacKinnon Building. Unfortunately, the eastern Canadian stone masons brought in to carry out this work were unfamiliar with these animals. They literally carved their frustrations in stone; one gargoyle, representing a mason, is shown struggling with a prairie chicken (Figure 23). Some of the depictions of Saskatchewan creatures, such as the gopher, are inaccurately rendered. Other more standard decorative motifs include acorns, oak leaves and ivy.

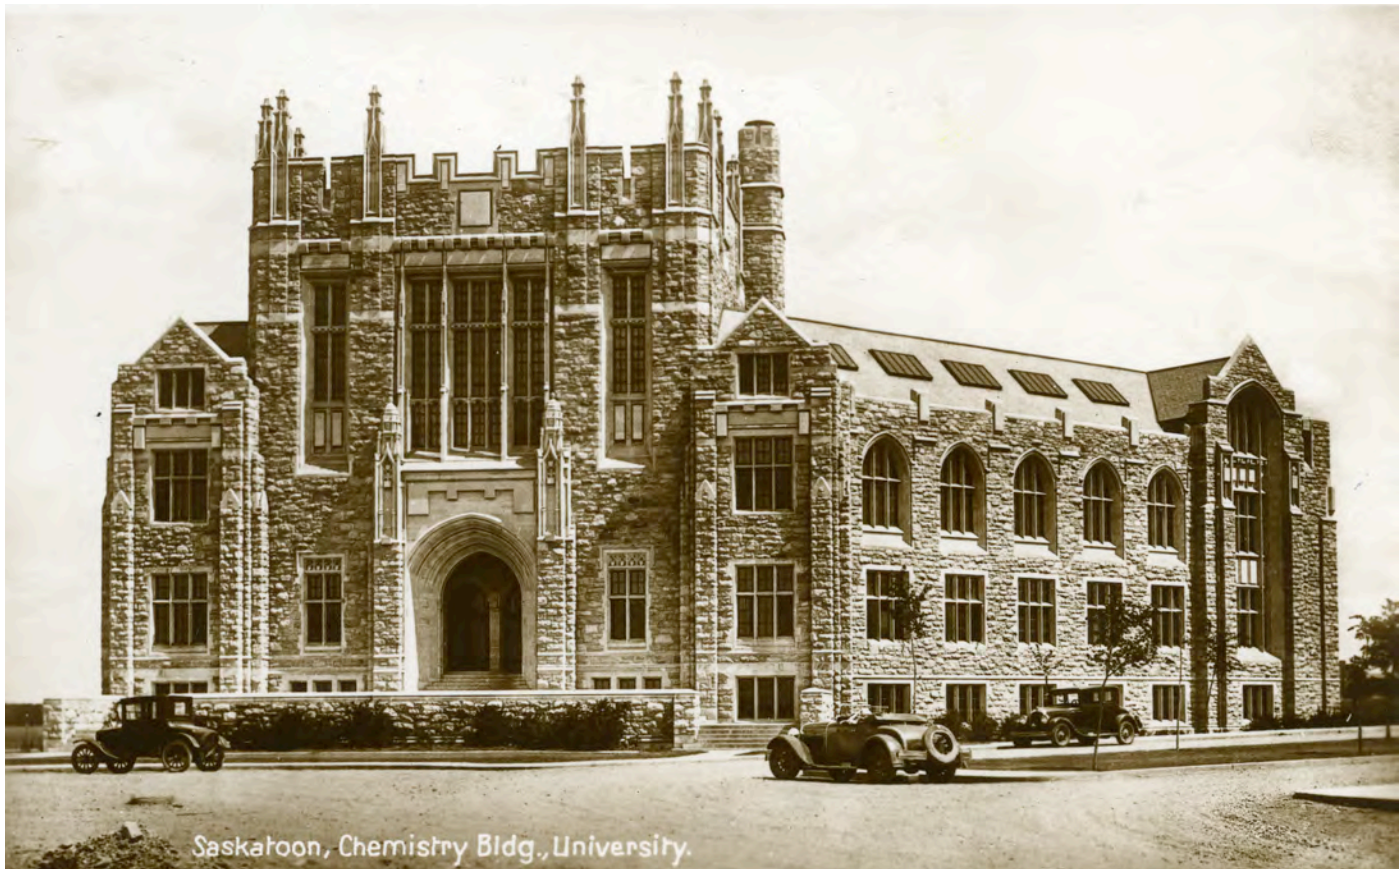
Figure 25. The Thorvaldson Building, 1924. (Image: University of Saskatchewan Archives, A-3923).

In its form and detail, the Thorvaldson Building also illustrates the European and ecclesiastical roots of the Collegiate Gothic style better than any other building at the University of Saskatchewan. Compare, for example, the Thorvaldson Building (Figure 25) to the chapel of King's College Cambridge (Figure 26). The imposing scale of the Thorvaldson Building, its verticality, the character of its grand entrance, and its stylistic references to architectural elements such as flying buttresses, spires, and church portals make clear reference to this and other precedents in European Christian architecture.

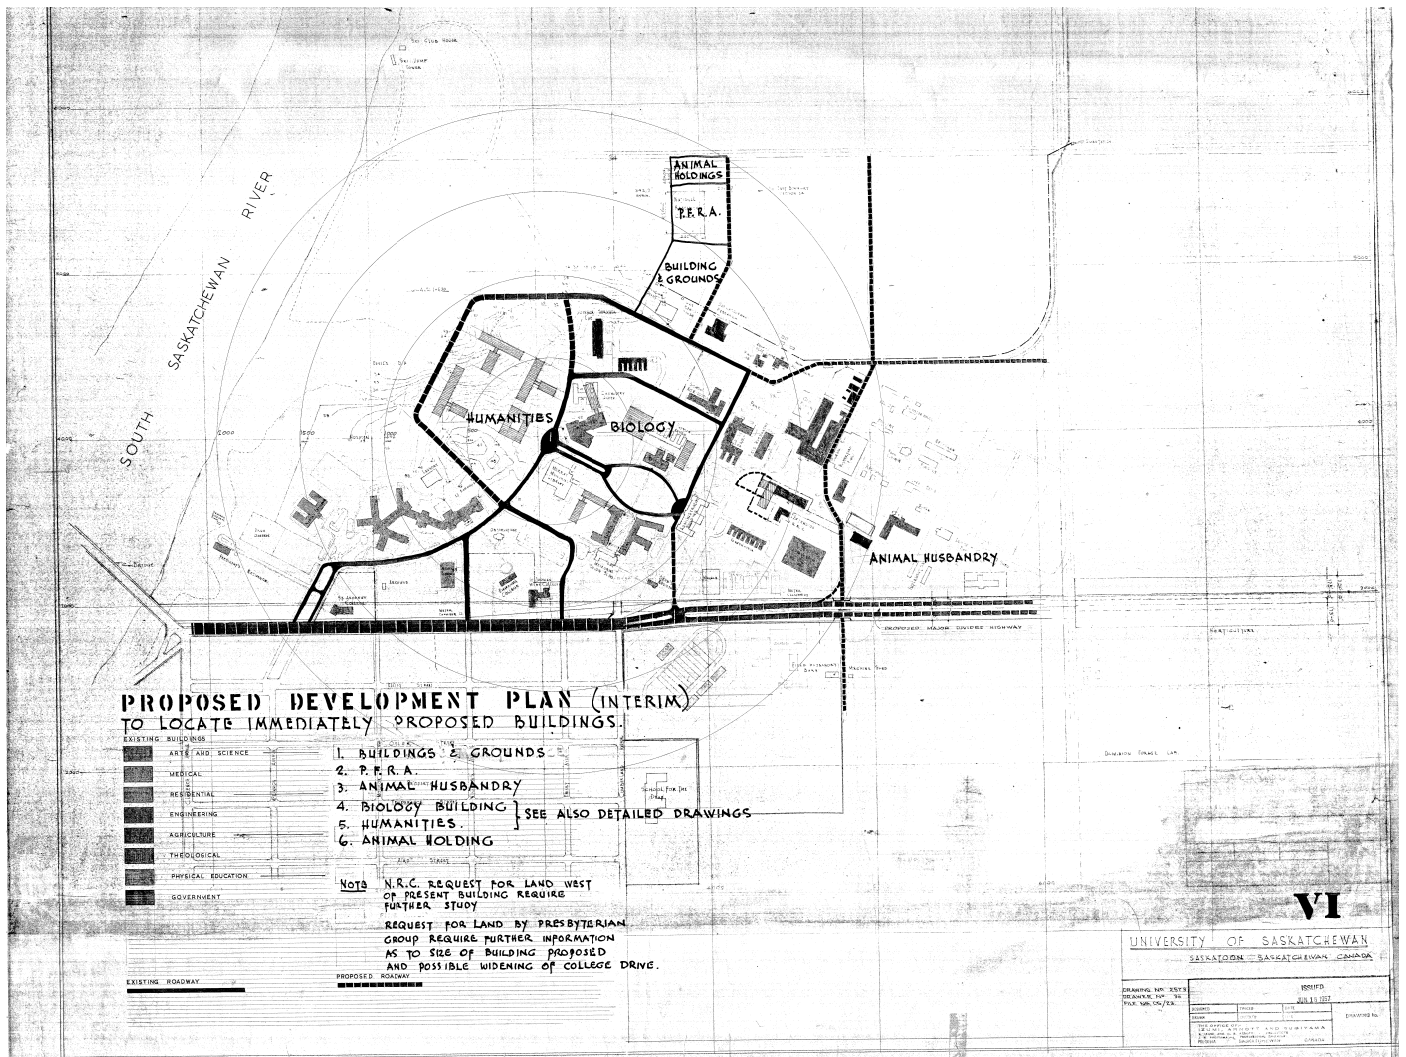
Figure 28. Campus Plan, 1957, Izumi, Arnott & Sugiyama Architects. (Image: University of Saskatchewan Archives, CG-23-T).

Between 1954 and 1957, the architectural firm of Izumi, Arnott & Sugiyama was engaged by the University to carry out a series of planning studies (Figure 28). This work was intended to address the issue of increasing traffic congestion, to suggest locations for a number of new buildings and to provide direction for the future growth of the campus. The adoption of Izumi's plan essentially marks the abandonment of the 1909 Plan. The new plan involved the construction of a ring-road intended to provide vehicular access around the perimeter of the campus, and thereby to separate the campus into pedestrian and vehicular areas. This road was constructed, and is now called Campus Drive. Locations were proposed for several new buildings, including a Humanities complex, a Biology building and some new residence halls. Finally, the plan proposed the division of the campus into a series of functional zones: Arts, Sciences, Medical, Agricultural and Residential. All of these proposals were implemented in some form over the course of the next decade.

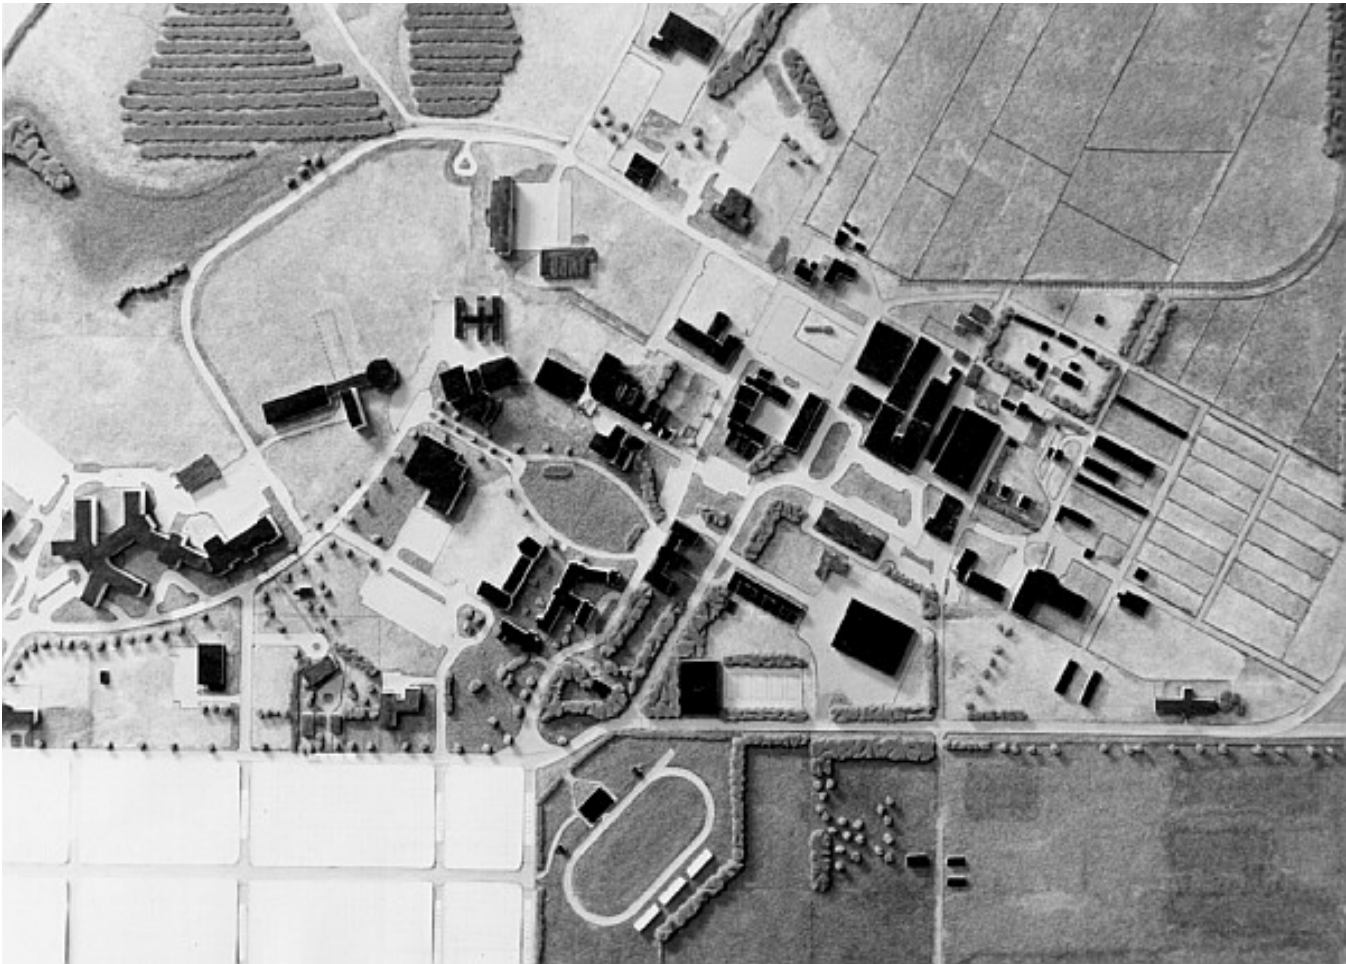
Figure 29. Model of the campus in 1961. (Image: University of Saskatchewan Archives).

A photograph of a model of the campus in 1961 illustrates the effects of Izumi's recommendations (Figure 29). The construction of Campus Drive and the location of the Arts Tower effectively terminated the Bowl and cut off future development of the campus core from the river. The more direct relationship of the campus to the river implied by the 1909 Plan was altered by this new approach.

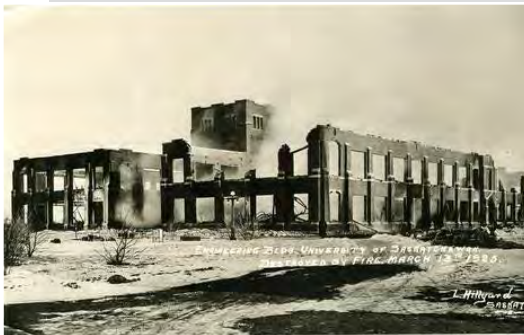
Figure 1. The ruin of the Engineering Building after the fire of 1925. The photograph is dated March 13, 1925. Photo A-364, retrieved from <http://sain.scaa.sk.ca/items/index.php/engineering-building-fire;rad>.

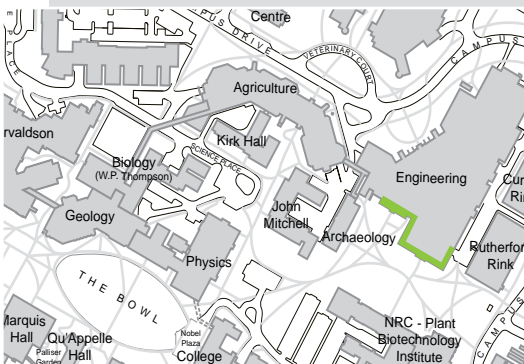
Figure 2. A plan view showing the location of the surviving portion of the 1925 Engineering Building in relation to the current building. The area shaded in green is discussed in this report.

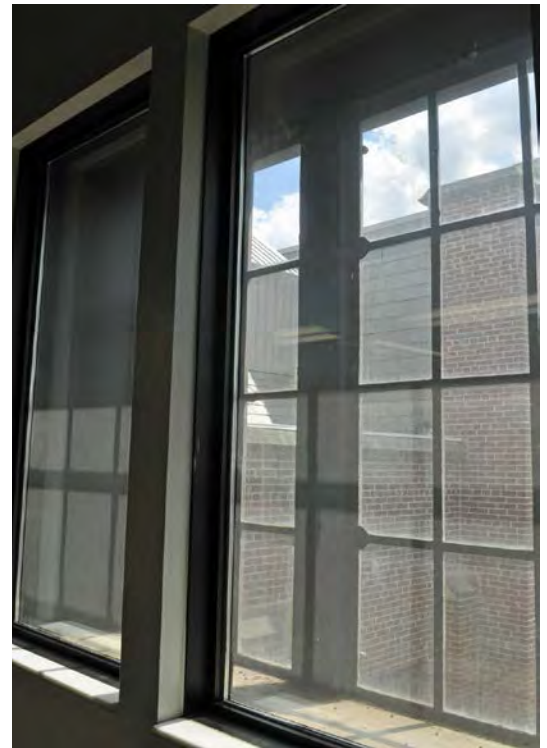
Figure 4. New aluminum framed double glazed windows have been fitted over the interior of the original windows.

The exterior walls feature extensive glazing, consisting of single-glazed windows in rolled steel frames. The window frames are original to the 1925 reconstruction, and are in excellent condition. They have been covered on the interior by double-glazed aluminum-framed inserts, to improve their thermal performance (Figure 3). The exterior brick walls and steel-framed windows on the southern portion of the building are important heritage elements with excellent commemorative integrity.

Window sills, decorative string courses and crenellation are all built in Indiana limestone (Figure 4). (For further information on building stones used at the U of S, refer to [‘Appendix: Stone.’](#)) The roofing materials - slate tile with copper flashings - are character-defining elements that link the Engineering Building to other campus buildings. Flat roofs, not visible from the exterior of the building, were originally roofed with tar and gravel, which has since been replaced with a membrane roofing system (Figure 5). Windows were framed in rolled steel with steel hardware. The threshold to the southwest entrance to the building is granite, another material characteristic of early University of Saskatchewan buildings.

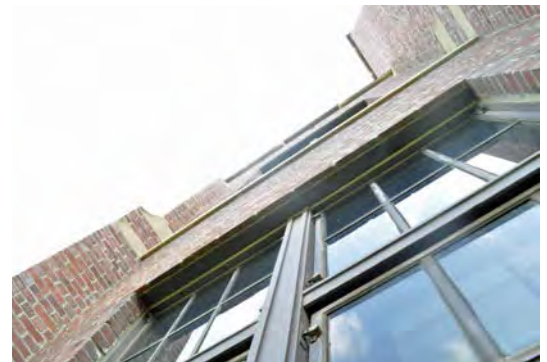
Figure 5. Brick and sandstone walls. Painted steel window frames.

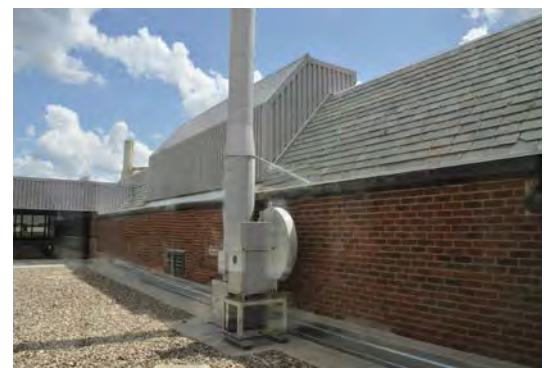
Figure 6. Roof materials: slate tiles for sloped portions and membrane roofing for flat portions.

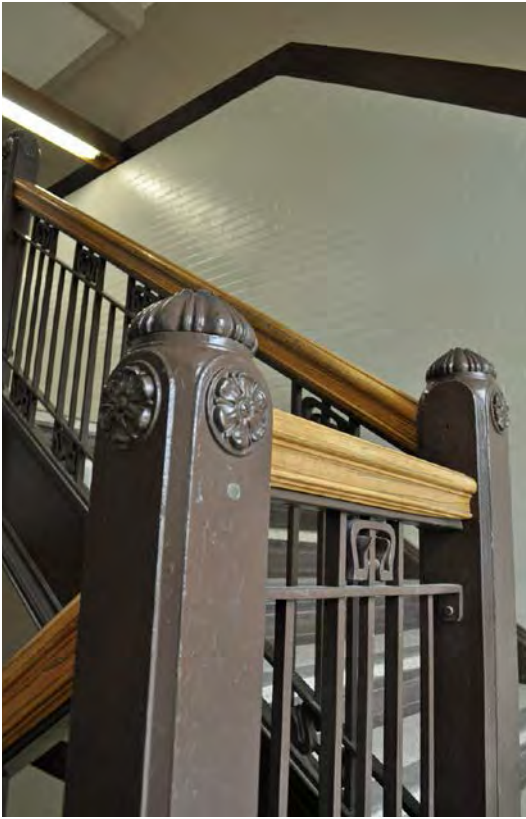
Figure 7. A decorated interior staircase with oak banisters, steel and iron balustrades, terrazo treads and steel risers.

The staircase shown in Figure 7 is one of the few character-defining elements dating from the reconstruction of 1925. This staircase features oak banisters and a balustrade of steel and iron. These materials are seen on staircases in numerous early university buildings and are important character-defining elements. The staircase itself is in a reasonably good state of commemorative integrity with few modifications. Treads, which were originally slate, have been replaced by terrazzo. However, the original stairwell is largely obscured by paint, coatings and replacement materials. Figure 8 shows the 1925 drawings of the staircase.

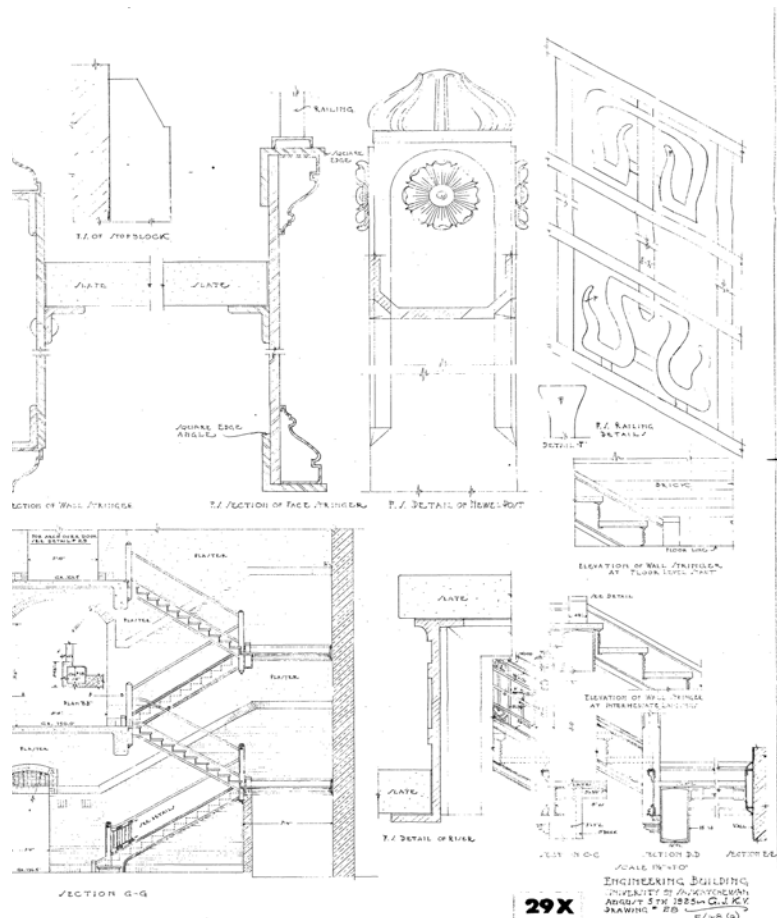
Figure 8. A drawing of the staircase details for the 1925 reconstruction of the Engineering Building. Retrieved from Facilities Management Division Asset System Records, File E-108-T.

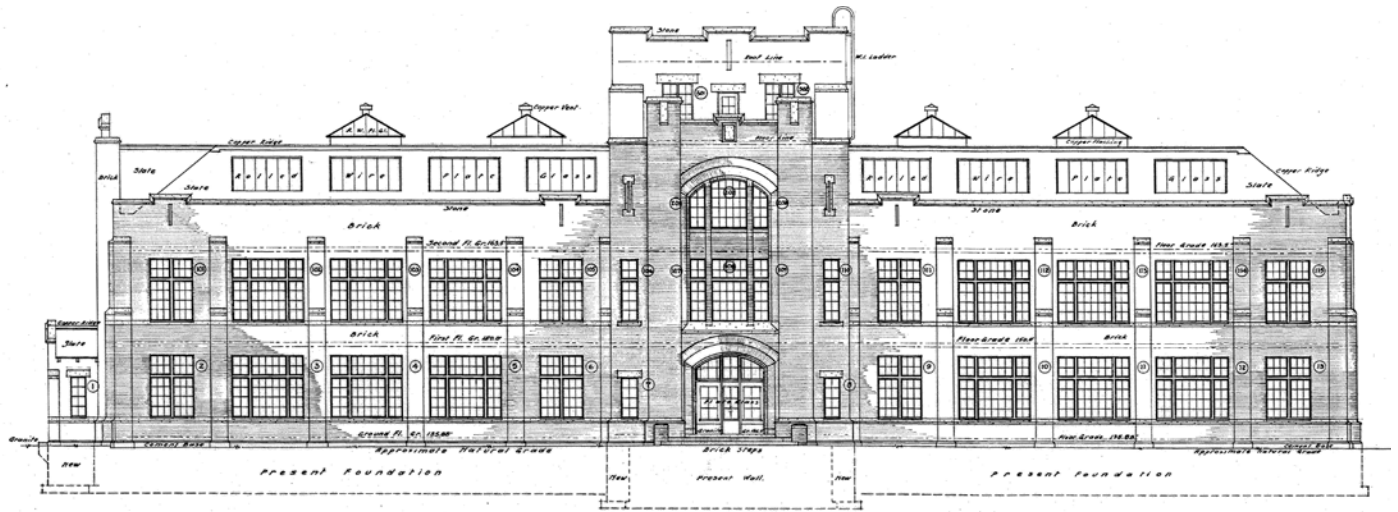
Figure 9. South elevation of the 1925 Engineering Building. Retrieved from Facilities Management Division Asset Record System, File E-5-T.

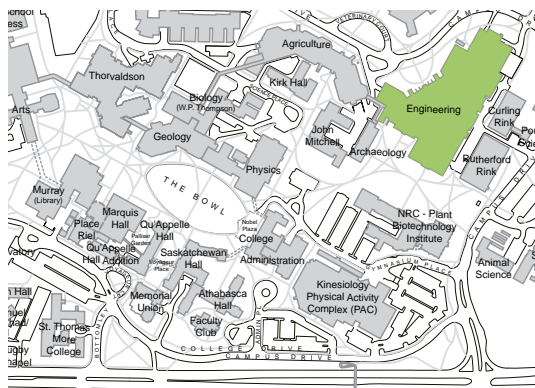
Figure 12. The current form and location of the Engineering Building in plan are indicated in green on this contemporary campus map.

Through all of these works, the scale has been limited to three floors; however, the original shape of the building has been subsumed by the additions. Figure 11 shows the current form of the Engineering building in plan. Aside from their effect on the original form, the additions are beyond the scope of this report.

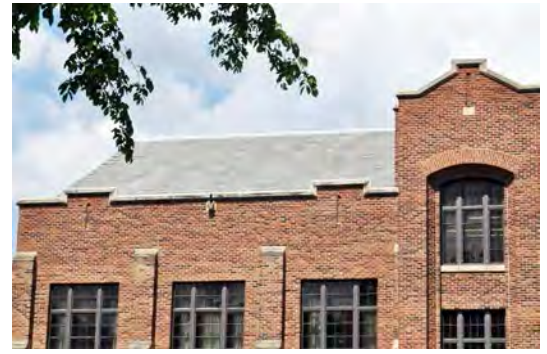
Figure 13. The Collegiate Gothic elements of the Engineering Building include: arches, crenellation, slate tile roofing, embellished drainage spouts and decorative archer slots.

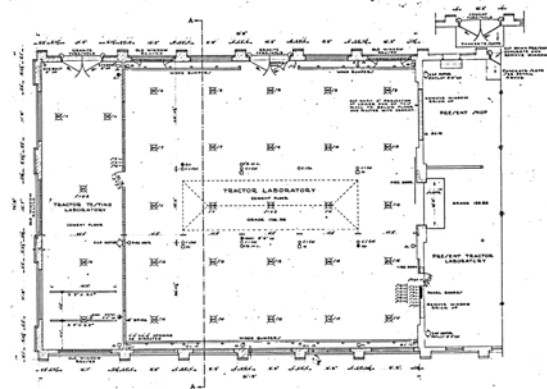
Figure 15. Plans for the extension of the tractor lab in 1940. Retrieved from Facilities Management Division Asset Record System, File E-55-T.

The Engineering Building was originally designed to hold machinery and plant science exhibits for classes, among other functions. It was therefore characterized by a large, open floor plan with rooms substantial enough to hold the large equipment of the period. In 1913, a 72' by 122' addition was constructed, including a test lab for building materials, a civil engineering lecture room, a classroom, a farm mechanics workroom and a third floor for the study of farm machinery. In 1917 the building was again extended to house a tractor lab. Figure 15 shows the floor plan for this extension.

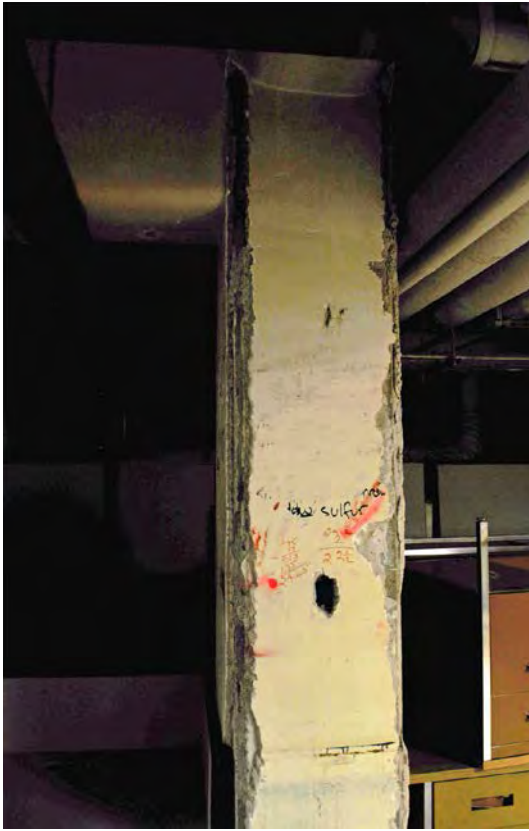
Figure 17. The concrete foundation and footings that withstood the fire of 1925 were reused in the reconstruction of the Engineering Building.

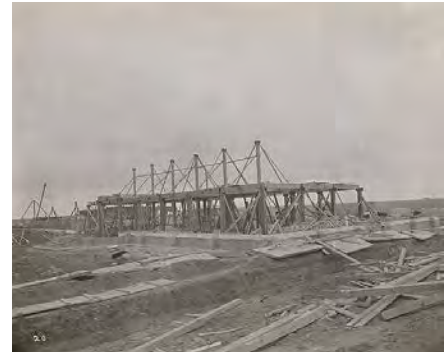
Figure 16. A photograph of the construction of the Engineering Building in 1910. Photo A-328, retrieved from http://scaa.sk.ca/gallery/uofs_buildings/

The original Engineering Building was supported by a wooden post and beam structure. Figure 16 shows this structural system being erected. When the building was reconstructed in 1925, the wooden structure was replaced with a steel frame. Below grade a concrete foundation supported the building. The concrete footings survived the 1925 fire and were reused in the reconstruction. These surviving foundations are a character-defining element of heritage significance. Figure 17 illustrates an original concrete column located in the basement of the building. In both their 1912 and 1925 iterations, the exterior walls of the building were load bearing structural elements.

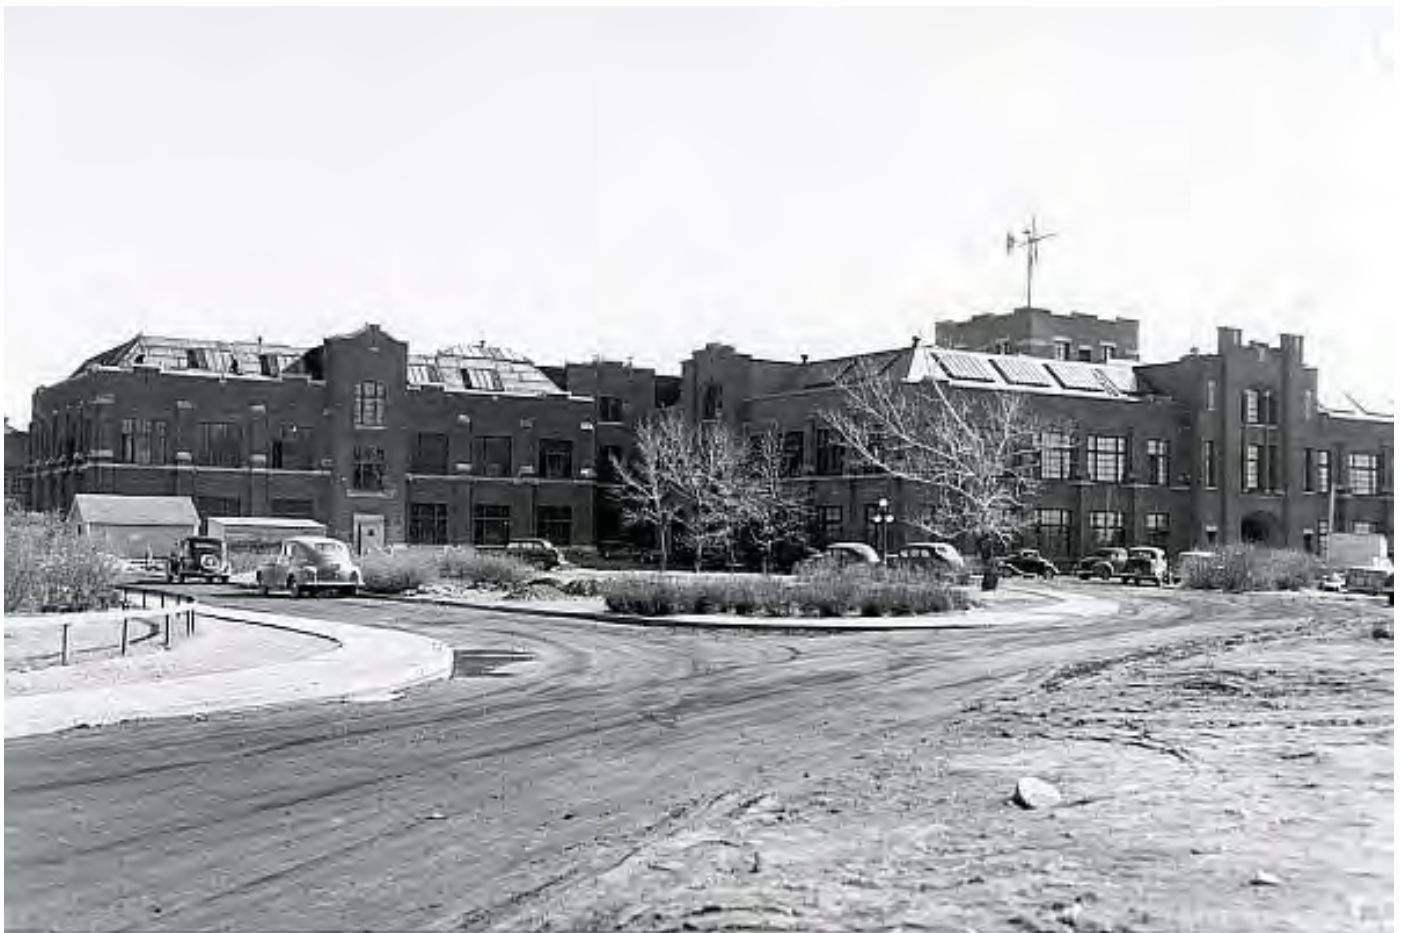
Figure 20. The 'old portion' of the Engineering Building that survived the fire. Photo A-4914 retrieved from http://scaa.sk.ca/gallery/uofs_buildings/

A portion of the original building survived the fire due to its unusual construction. The ceramics lab was built to withstand the heat of the kilns. A fire-proof kiln door and walls lined with fire brick helped to stop this room from succumbing to the fire. The ceramics curriculum was discontinued in the 1950's and the ceramics lab no longer exists. Figure 20 shows the parts of the building that survived the fire.

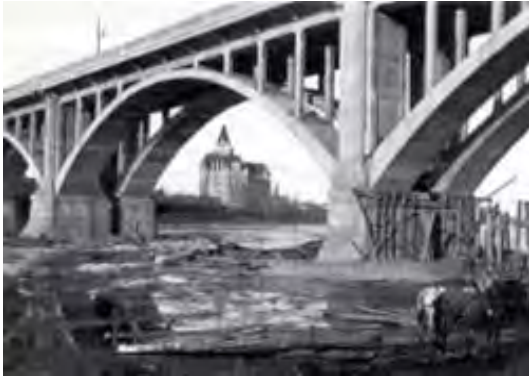
Figure 21. Saskatoon's Broadway Bridge (originally known as the 'Engineers Bridge' under construction in December, 1932. The bridge is a product of early University of Saskatchewan engineering faculty and graduates. Retrieved from http://scaa.usask.ca/gallery/uofs_events/articles/1932.php

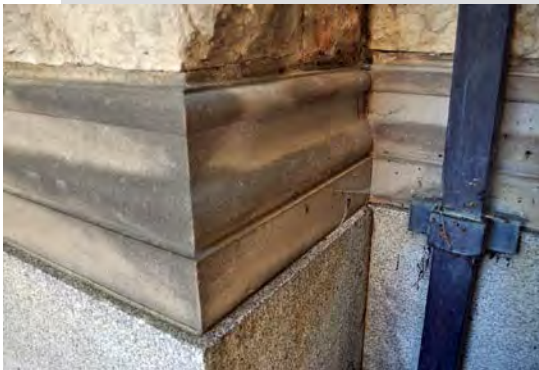
Figure 1. Top to Bottom: 'greystone', Indiana limestone, granite. A copper drainage pipe is pictured to the right.

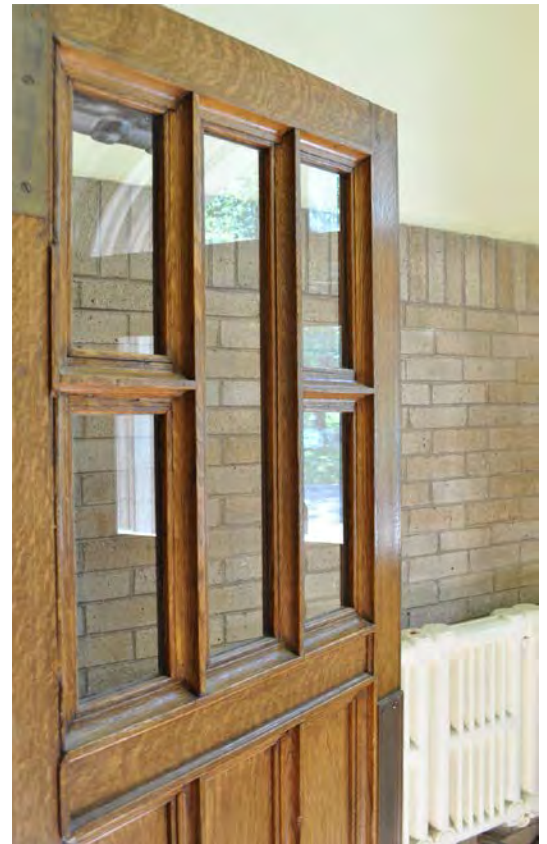
Figure 3. Quartersawn oak vestibule door with glazed panels. Brick and plaster clad wall, cast iron radiator.

The original exterior and vestibule doors at the two main entrances were constructed of quartersawn oak with glass panels (Figure 3). The vestibule doors and both sets of door frames and transoms remain, but the exterior doors have been replaced with new doors which do not match the original design. Interior doors are typically of stained douglas fir, and feature wood-framed glass transoms. The original door and transom glass has a distinctive striated texture (Figure 4). On the ground floor, the door transoms are set into brick arches.

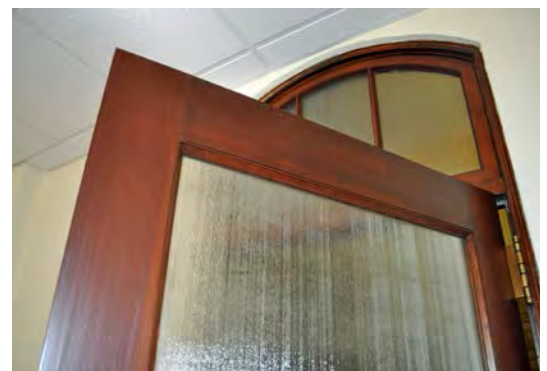
Figure 4. Textured door and transom glazing.

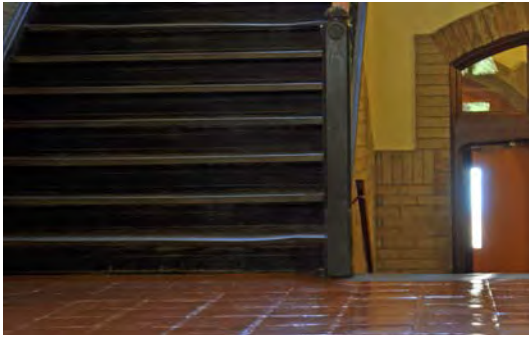
Figure 5. Black slate stair treads and painted clay tile flooring.

The entrance vestibules feature red clay tile flooring. This material is also found in the hallways adjacent to the stairs; however, in these locations it has been painted. Stair treads and landings are of black slate, a character-defining element distinct from the slate used in other U of S buildings of this period, which is typically green in colour. The slate stair treads are worn from decades of use (Figure 5). The stairs have painted steel and cast iron balustrades and stringers, with oak handrails. Cast iron can also be found throughout the building in the form of painted radiators.

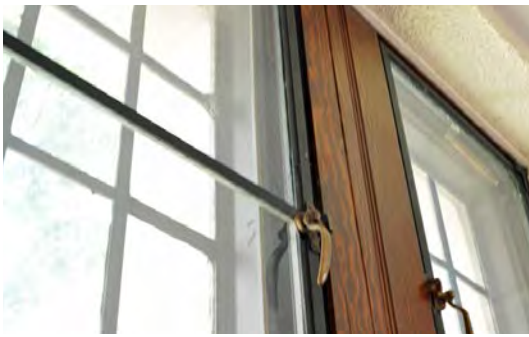
Figure 6. Steel framed windows, wood casings and brass hardware.

The interior walls of the building are clad in a combination of brick and plaster as shown in Figure 6. All outside walls have an interior surface of brick that has been heavily painted. Interior walls are finished in plaster which ranges in condition from very poor to good. The floor of the building is painted concrete in some areas and or vinyl composition tiles in others. As Figure 7 illustrates, the ceiling is clad in painted wood paneling between exposed painted wooden beams. Interior doors are also made from wood which has been painted (Figures 5 and 9). A 1920 photograph shows that the wooden elements were painted by that time. Most of the windows have steel security bars (Figure 9), which are a recent addition. Heat is supplied via cast iron radiators, which are original.

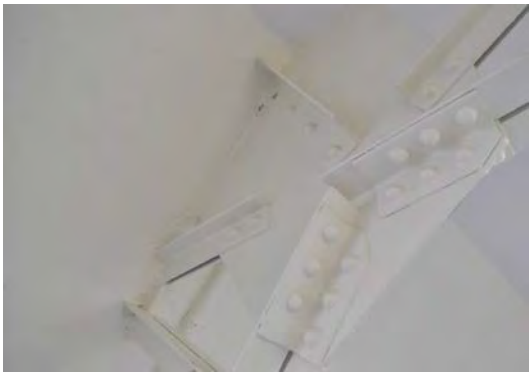
Figure 7. Exposed structural steel.

The attic and basement are both treated as ancillary spaces, with more utilitarian finish materials. On both levels flooring consists of painted concrete. The walls are plaster or painted brick, the ceilings are generally a rough-textured plaster, and in some instances have been concealed with dropped tile. In the attic, only a few original wooden doors exist; the rest are pressed steel doors of no heritage significance. Some of the skylights have been replaced, others have had their wooden frames painted obscuring the original material. A character-defining material of the attic is the steel forming the exposed trusses shown in Figure 7. (See section 2.6).
