University of Saskatchewan

Heritage Register

September 2013

Facilities Management
Division

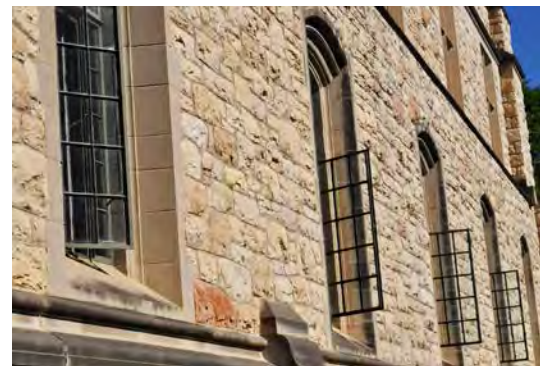
Figure 10. Arched ground floor windows and string courses.

The architectural style of the Archaeology Building is Collegiate Gothic. As shown in Figure 10, the ground level of the building features limestone door and window surrounds in the form of both pointed and standard arches. The four corners of the building are marked with prominent stone buttresses and quoined stonework. Cut stone string courses decorate the stone walls at the window sill levels. Narrow limestone archer slots adorn the low parapet roofline. All of these features are character-defining elements.

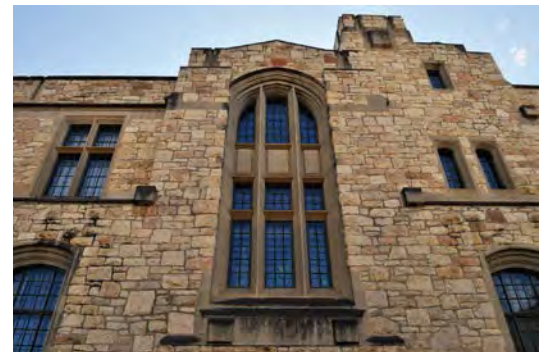
Figure 11. The west facade: archer slots line the parapet roof, a tower rises to the right of a double height Gothic window.

The building's most commanding façade is illustrated in Figure 11, although it is now somewhat obscured by later construction. On this west face, the location of the main staircase is expressed with a prominent double-height window with a pointed arch and mid height spandrels. This window and an adjacent decorative element referencing a Norman tower, both form part of an asymmetrically composed elevation, and are important character-defining elements. The central staircase offers a view out of this window from each of its landings as shown in Figure 12. On the interior, the arch of this window is framed in a shallow vault.

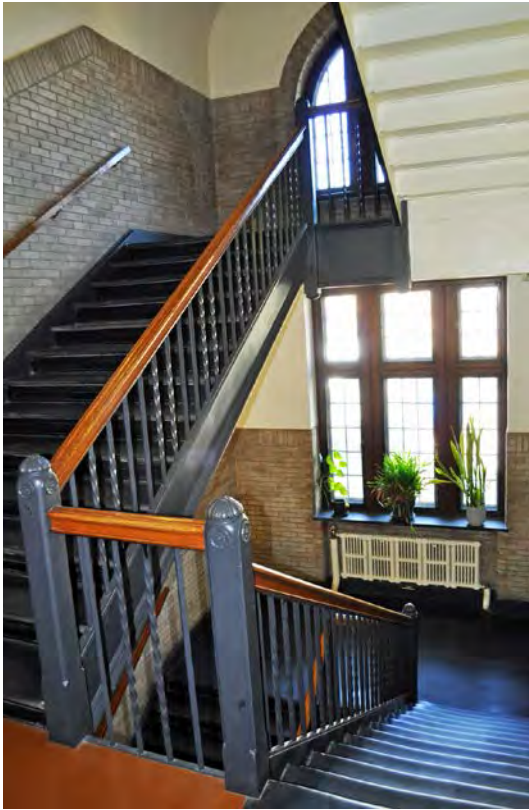
Figure 12. The main staircase.

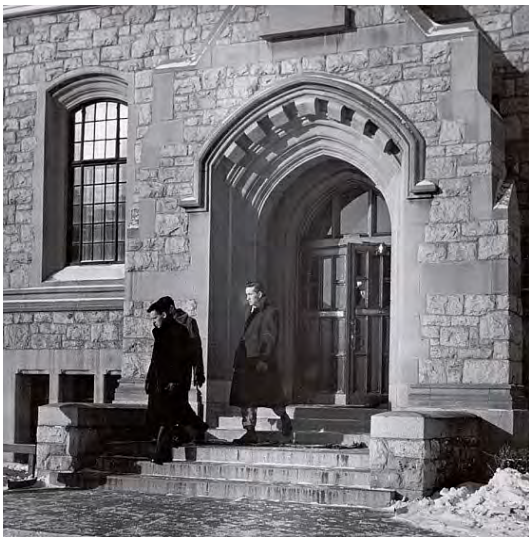
Figure 14. Unadorned stone blocks above the west entrance where cut stone ornamentation was originally intended. Photo taken ca. 1960. Photo A-288, retrieved from http://scaa.sk.ca/gallery/uofs_buildings/

On both lengths of its façade, the Archaeology Building features blank stone blocks around its entrances. These blocks were originally intended to be decorated with cut stone ornamentation. Shields and reliefs were also intended for the blank spandrels or stone panels that accompany the windows. These finishing touches were never carried out and the stone 'blanks' are now character-defining elements in their own right. Figure 13 shows the architect's original specifications for carved stone decoration around the west entrance, and the incomplete work is illustrated in Figure 14.

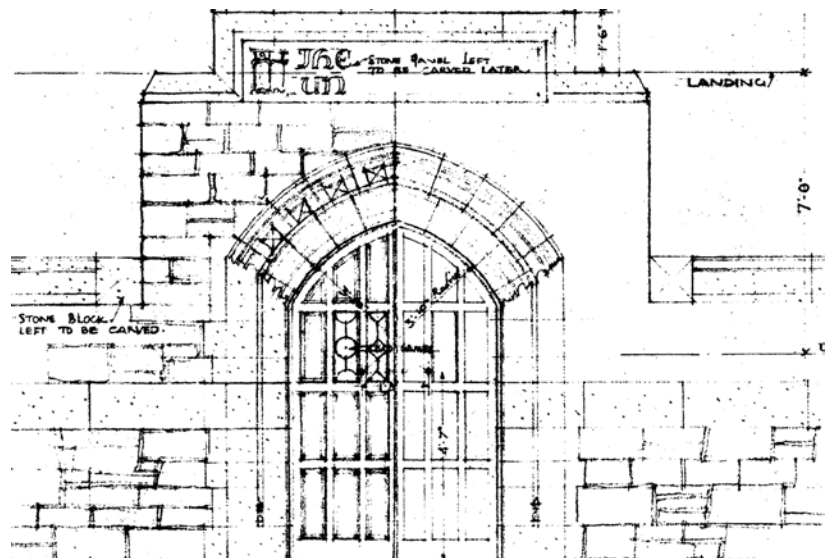
Figure 13. Elevation of the west entrance. Retrieved from Facilities Management Division Asset Record System, File CB-21-T.

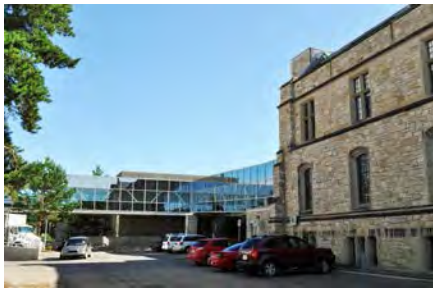
Figure 19. The west side of the building faces onto a parking lot and loading dock.

Originally constructed as the Field Husbandry Building, the Archaeology Building does not appear on the 1909 Campus Plan, but was located immediately to the west of the original [Engineering Building](#). It appears to have been placed with the intention of defining the western end of the courtyard that is now known as the 'Engineering Bowl'. As Figure 18 shows, it is orientated in a linear fashion along a roughly north-south axis, with entrances from the east and west. Notably, the building's more active west façade now faces onto a parking lot and loading area, somewhat compromising its commemorative integrity (Figure 19). At the time of its construction, this elevation addressed an area of open fields.

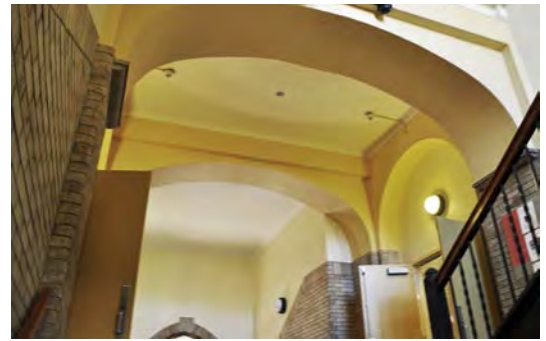
Figure 15. Four arches crown the space at the foot of the main stair.

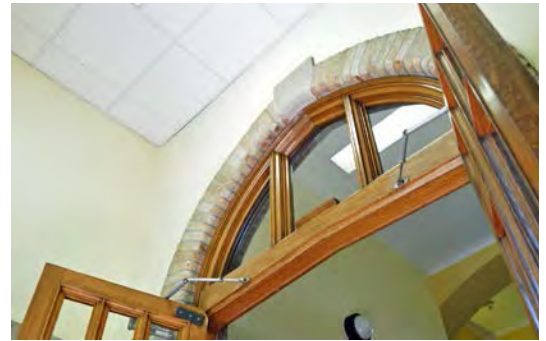
Figure 16. Transom in the form of a pointed arch, inset into a brick arch, with keystone.

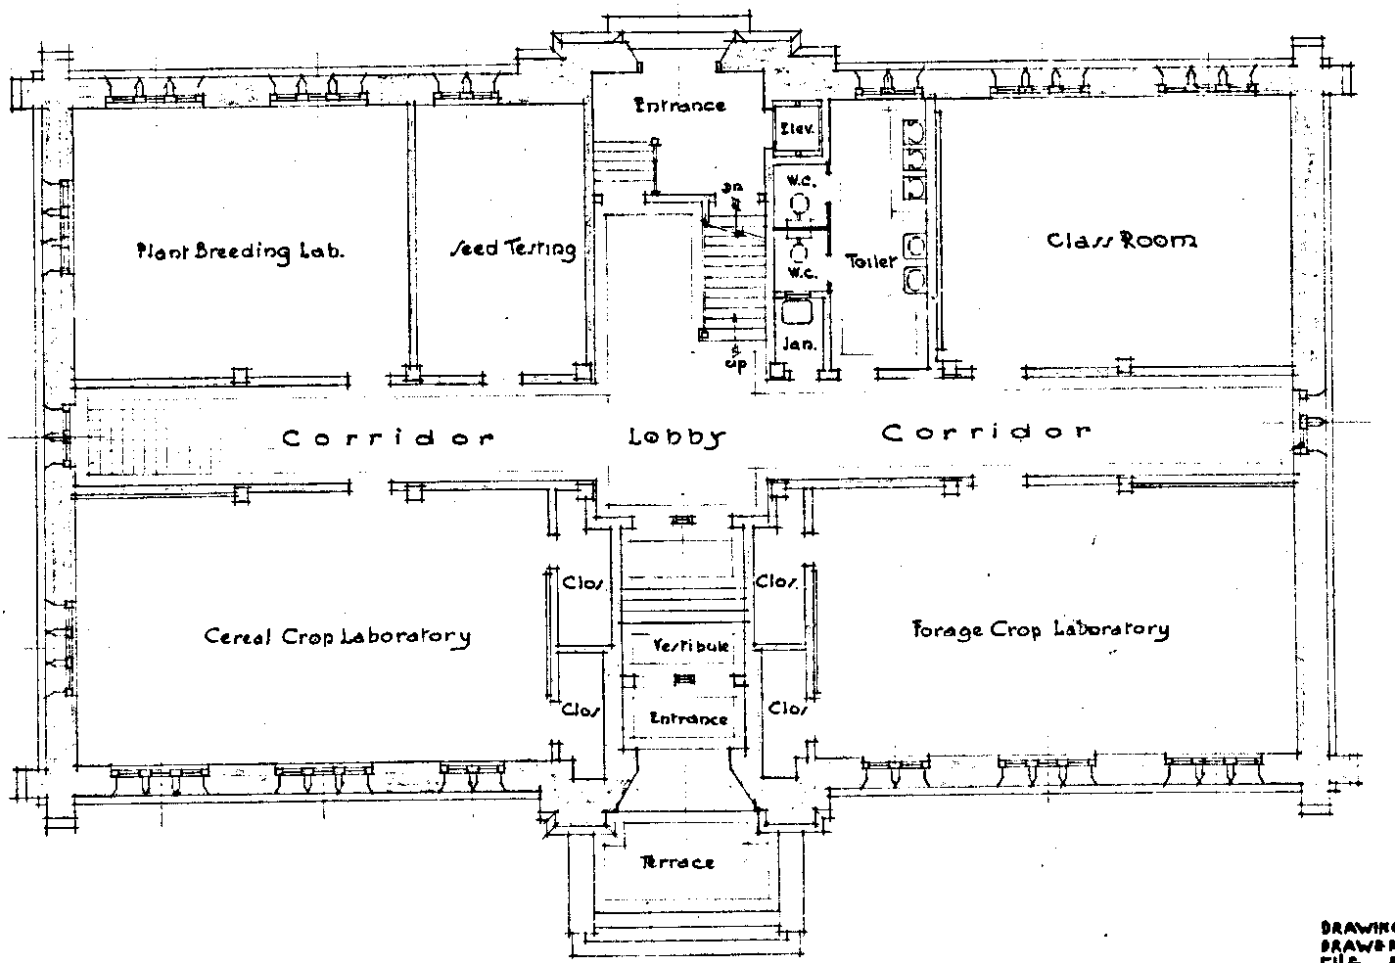
Figure 20. The ground floor plan of the original Field Husbandry (now Archaeology) Building. Retrieved from Facilities Management Division Asset Record System, File CB-15-T.

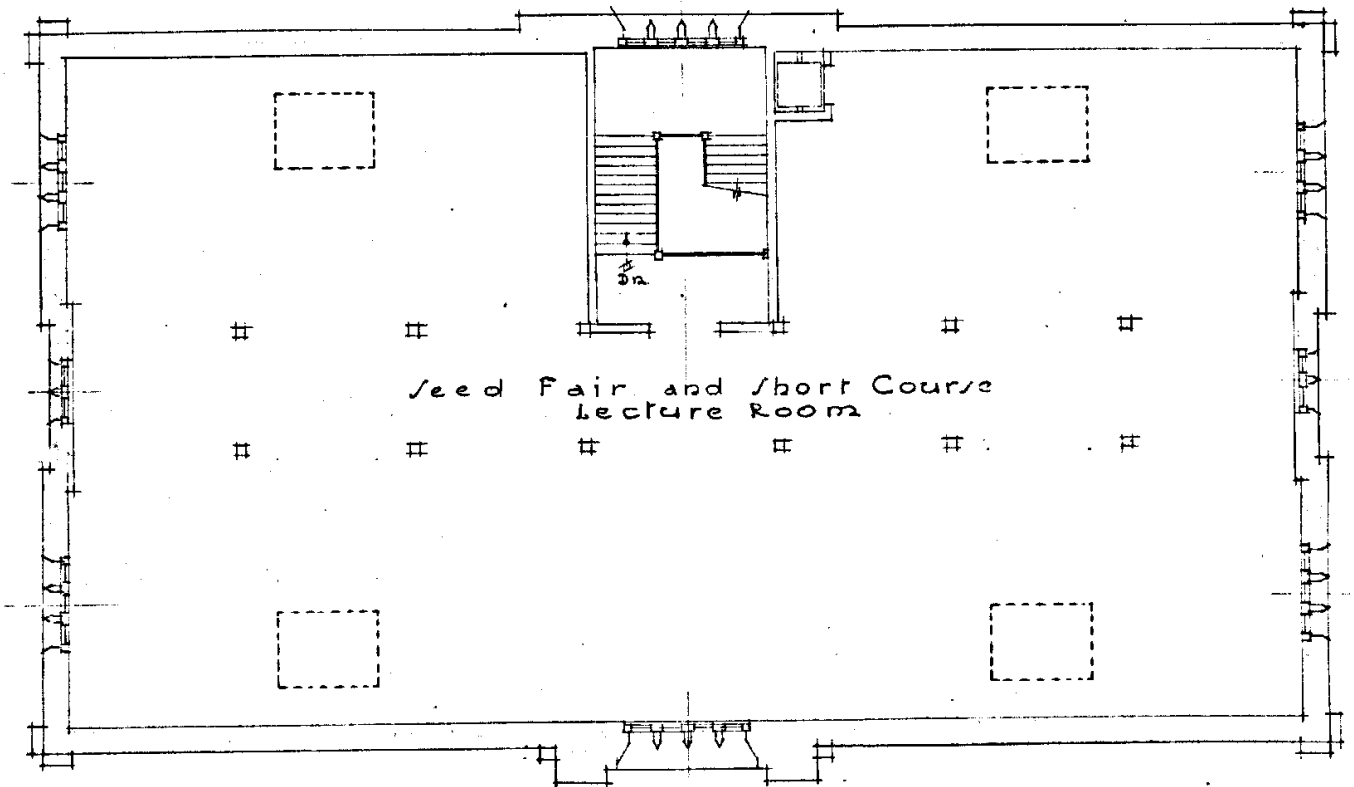
Figure 21. The attic floor plan of the original Field Husbandry (now Archaeology) Building. Retrieved from Facilities Management Division Asset Record System, File CB-17-T.

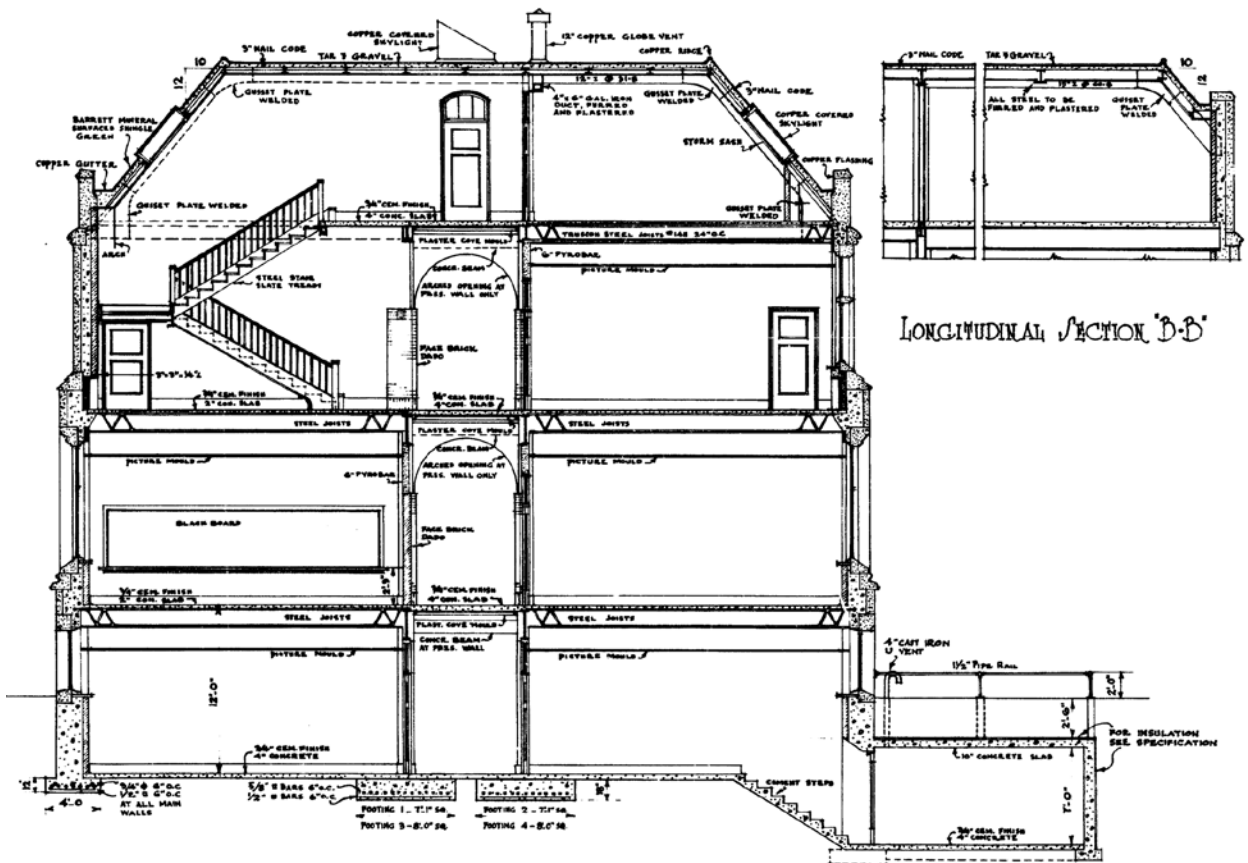
Figure 22. Section through the Field Husbandry (now Archaeology) Building. Retrieved from Facilities Management Division Asset Record System, File CB-51-T.

The general spatial configuration of the Archaeology Building is typical of the configuration of other academic buildings built on campus prior to the Second World War. On the ground and first floors, it features a simple floor plan with central double loaded corridors providing access to a series of discreet rooms - offices, classrooms and laboratories - on either side. Figure 20 shows the original layout of the ground floor. Notably, a small elevator was provided for and is visible in the drawings. The shaft still exists, but the elevator is no longer in use. (See Section 2.6 Systems). The original layout on these floors has been generally maintained. The original plans show the basement and attic as having open floor plans, as is shown in Figure 21. Both floors have since been divided into separate rooms, albeit to different degrees. The basement has been arranged around a double loaded corridor. The attic has also been divided into separate rooms; however, a large open area has been maintained. Figure 22 shows the shape of the attic in section.

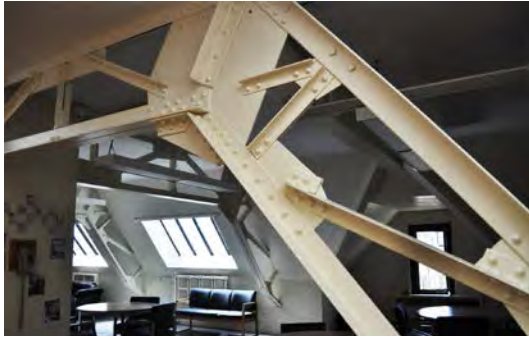
Figure 24. Arched steel truss in the attic.

- exposed arched steel roof trusses
- shaft for original elevator

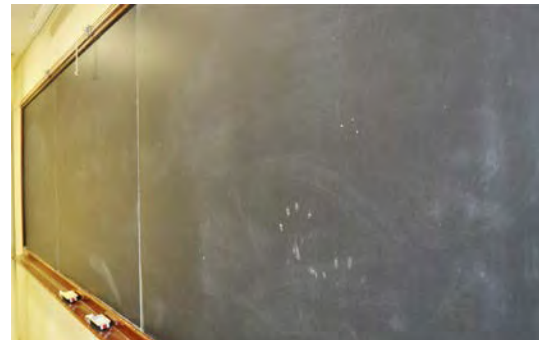
Figure 27. Slate chalkboard in oak frame.

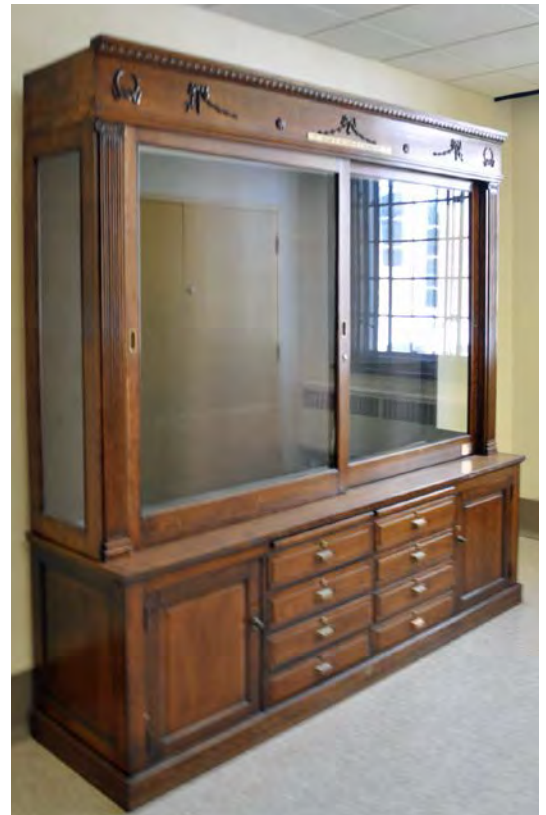
Figure 28. Oak cabinets found in the Archaeology Building.

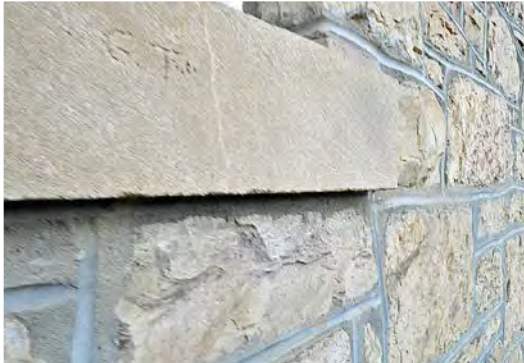
Figure 1. A window sill of Indiana limestone set into a 'greystone' wall.

The exterior of the remaining Horticulture Building is finished in fieldstone or 'greystone' (Figure 1). Its windows are single-glazed, with removable storms and insect screens. Windows and doors are all framed in painted wood (Figure 2). Window sills are made from Indiana limestone, also visible in Figure 1. (For further information on building stones used at the U of S, refer to [Appendix: Stone](#).)

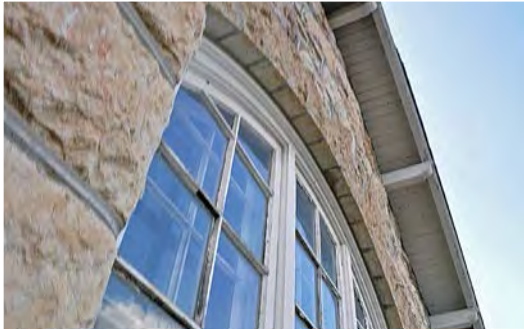
Figure 2. Wood-framed windows in a greystone wall, and exposed rafter ends.

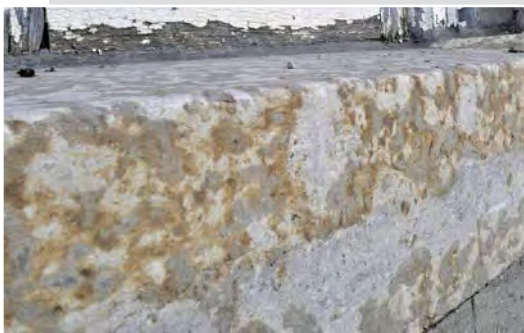
Figure 3. A Tyndall stone threshold.

Two metal doors on the west side were later additions. Some of the thresholds under doorways are made from Tyndall stone, as well as two newer lintels on the west façade (Figure 3). The original doorways between the Header Houses and the greenhouses are now filled with exposed concrete block. The hardware on both the interior and exterior of the building is brass which has been painted in some cases and left exposed in others. Asphalt roof shingles, painted wood trim with lead flashing complete the building envelope.

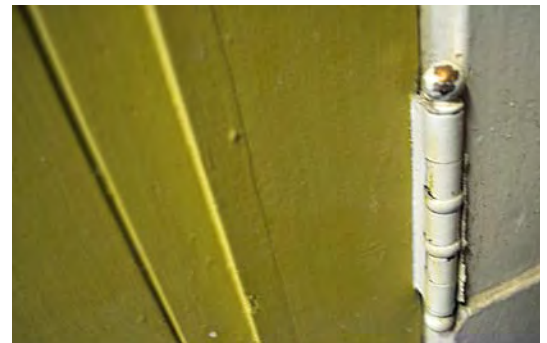
Figure 5. A brass hinge on a wooden door, both of which have been painted.

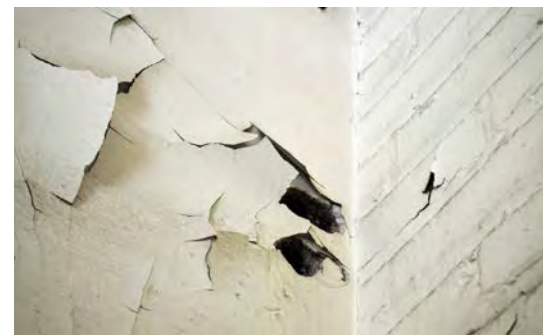
Figure 6. L to R: a plaster wall and a brick wall, both painted.

The interior walls of the building are clad in a combination of brick and plaster as shown in Figure 6. All outside walls have an interior surface of brick that has been heavily painted. Interior walls are finished in plaster which ranges in condition from very poor to good. The floor of the building is painted concrete in some areas and or vinyl composition tiles in others. As Figure 7 illustrates, the ceiling is clad in painted wood paneling between exposed painted wooden beams. Interior doors are also made from wood which has been painted (Figures 5 and 9). A 1920 photograph shows that the wooden elements were painted by that time. Most of the windows have steel security bars (Figure 9), which are a recent addition. Heat is supplied via cast iron radiators, which are original.

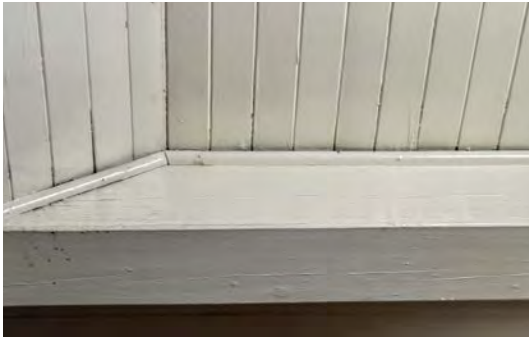
Figure 7. A wooden beam and wood paneling, both painted.

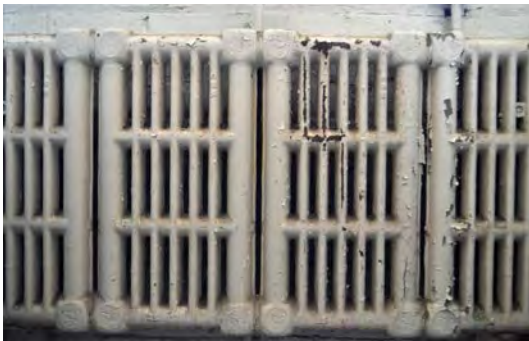
Figure 8. A cast iron radiator.

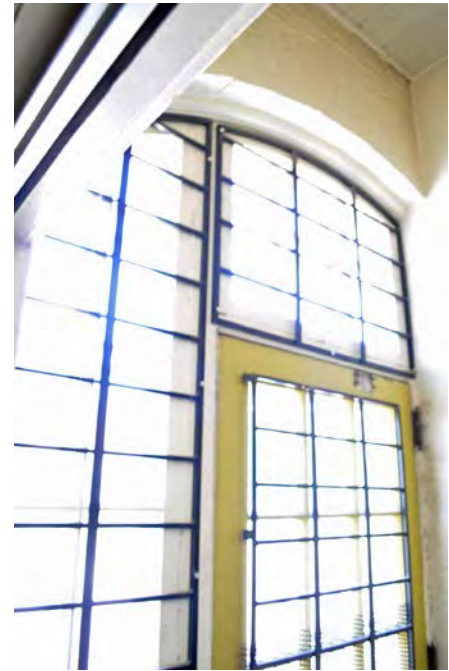
Figure 9. Steel bars have been retrofitted over the interior side of the windows.

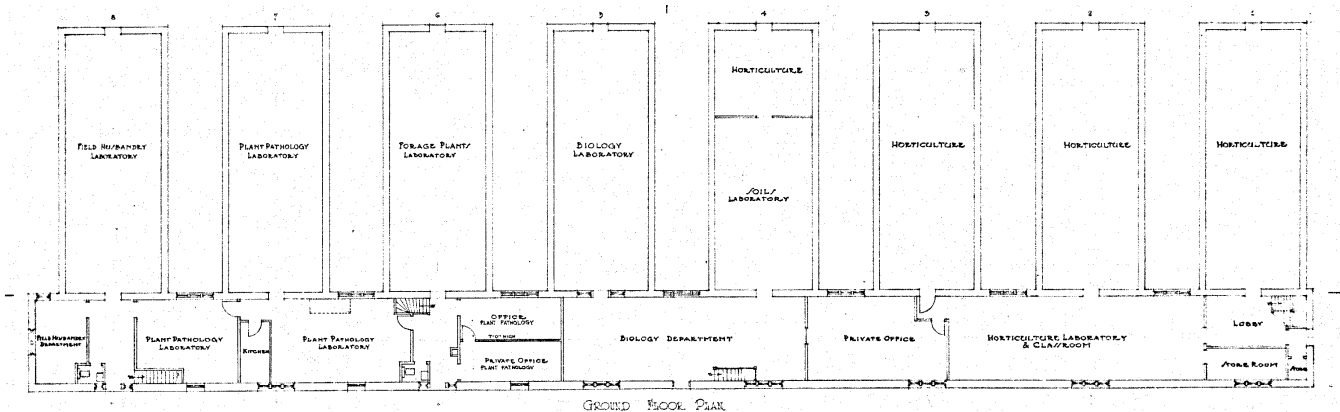
Figure 10. Plan of the Horticulture Building with its green houses attached. The 'Header Houses' along the bottom of the plan are all that remain. The plan is oriented with north facing down. Retrieved from Facilities Management Division Asset Record System, File HG-15-T.

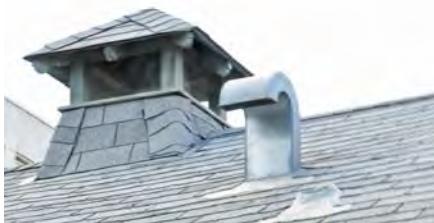
Figure 14. One of two cupolas on the roof of the Horticulture Building.

are a characteristic of the Arts & Crafts style. Several of the windows and doors are set into arched openings (Figure 12). Greystone quoins frame the building's corners and constitute another character-defining element. The eaves are ornamented with shaped wooden rafter extensions (Figure 13). Two cupolas protrude from the roof, providing attic ventilation as well as decoration (Figure 14).

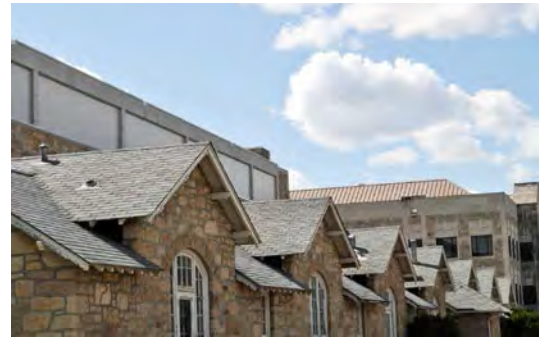
Figure 11. The gable ends of the dormers give the Header Houses the appearance of a row of buildings.

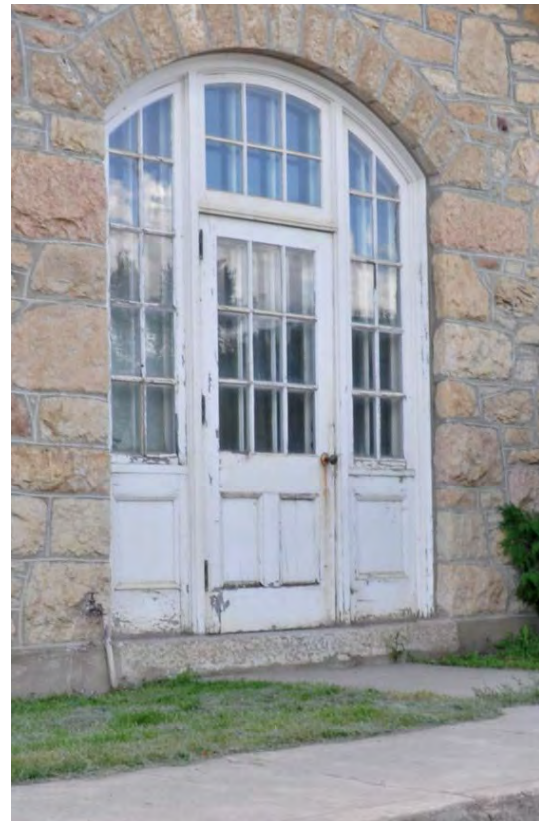
Figure 12. An arched doorway with arched transom and side lites.

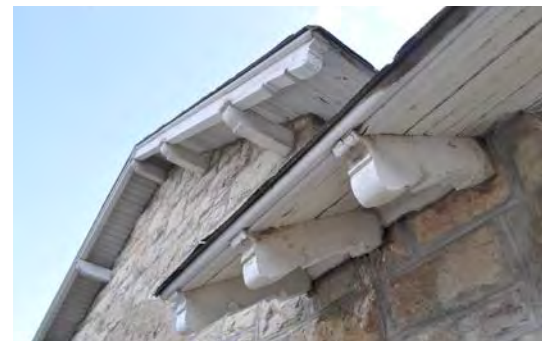
Figure 13. Exposed wooden rafter ends.

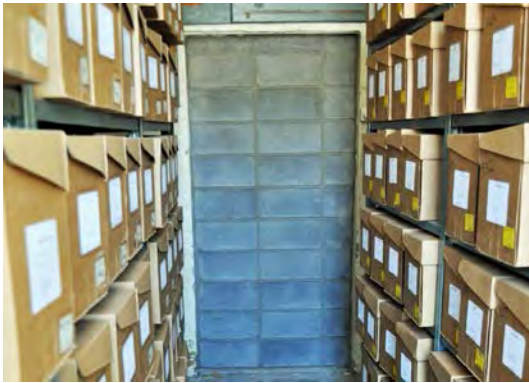
Figure 16. Concrete block fills the openings on the south side.

The south side of the building no longer features any openings. With the demolition of the green houses and subsequent construction of the Kinesiology Building, all of the south-facing openings were filled in with concrete block (Figure 16).

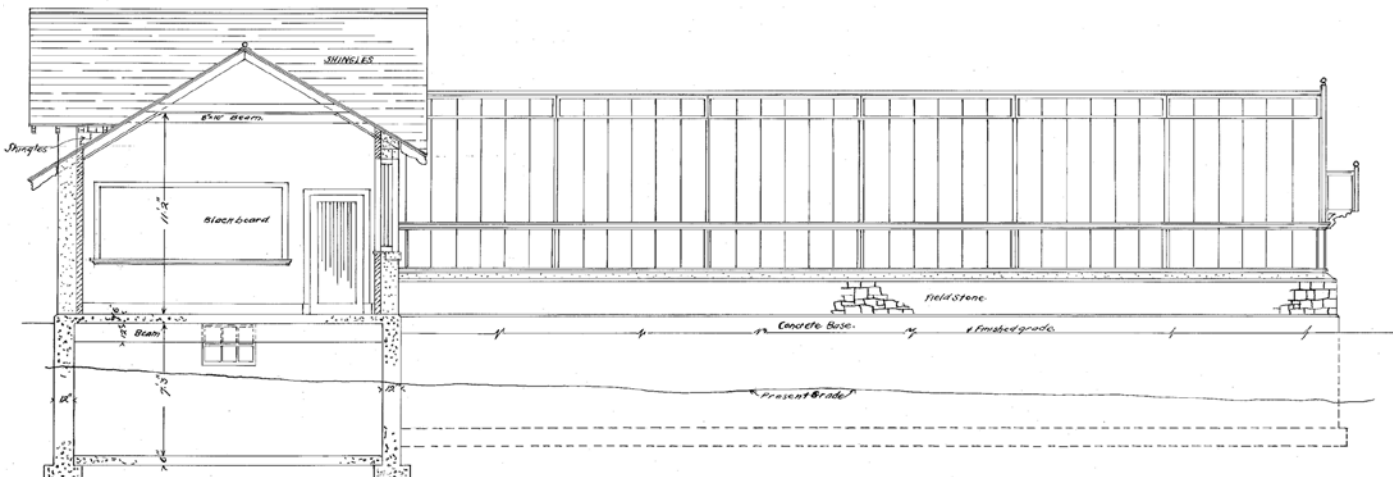
Figure 17. Cross section. Retrieved from Facilities Management Division Asset Record System, File HG-19-T.

The narrow floor plate of the Horticulture Building allows its roof to be supported by a series of simple trussed rafters, which are concealed on the inside of the building by wood paneling, but are visible on the exterior as exposed rafter ends. Wooden beams supporting the rafters of the large dormers are visible on the interior. The foundations and basement walls are cast-in-place concrete. Concrete beams support the ground floor concrete floor. No interior columns are required. The exterior walls are of load-bearing stone and brick masonry. Figure 17 provides a cross section of the building.

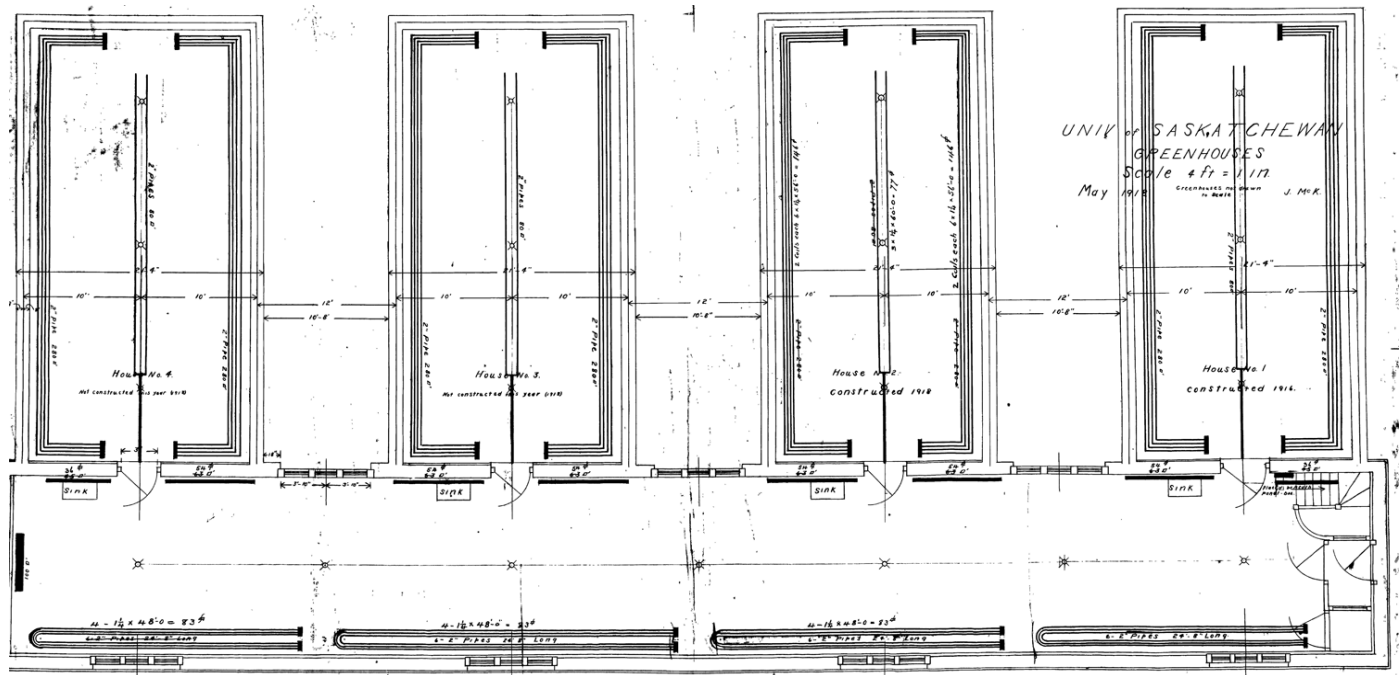
Figure 18. Floor plan showing heating pipes in the greenhouses and header houses. Retrieved from Facilities Management Division Asset Record System, File HG-1-T.

The Horticulture Building was provisioned with radiant heating pipes which ran around the perimeter of each greenhouse. The greenhouses and their piping systems were demolished; however, the same provision was made, on a smaller scale, in the Header Houses. Some of these pipes still exist and can be found along the base of the exterior walls. Figures 18 & 19 show this system of pipes.

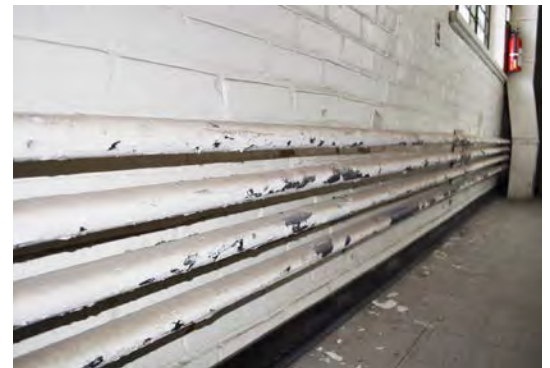
Figure 19. Radiant heating pipes still visible in the Horticulture Building.

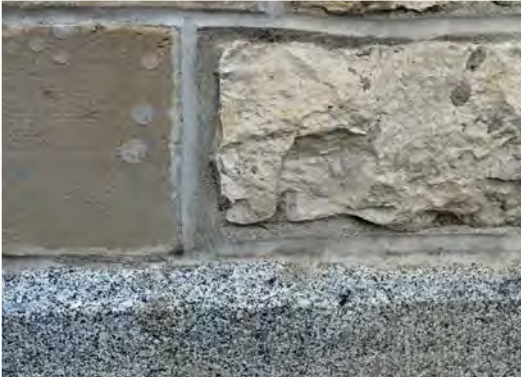
Figure 1. Cut sandstone and rough-faced 'greystone' over a granite base course.

The characteristic combination of ‘greystone’ and sandstone forms the exterior of Saskatchewan Hall. The principle material is rough-faced greystone, while cut sandstone is used for quoins, grotesques, crenellation, door and window surrounds. At the entrances, granite forms a base course and stairs. Figure 1 illustrates these materials. (For further information on building stones used at the U of S, refer to [‘Appendix: Stone.’](#))

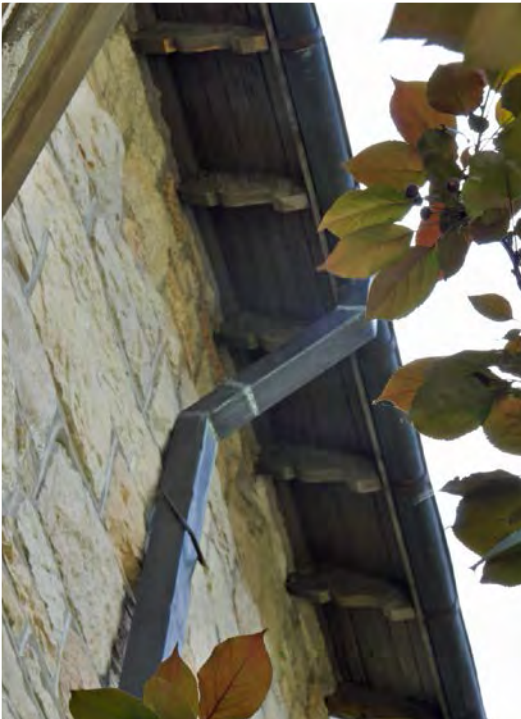
Figure 2. Copper drainage gutter and exposed wooden rafter ends.

The roof of Saskatchewan Hall is clad in slate, with copper eaves troughs. At the eaves, exposed wooden rafter ends provide decoration. Figure 2 illustrates the eaves detailing, and Figure 4 illustrates the slate roof tiles. The exterior doors are oak with glass lites. These are not original, but were made using the doors of [Qu’Appelle Hall](#) as a reference.

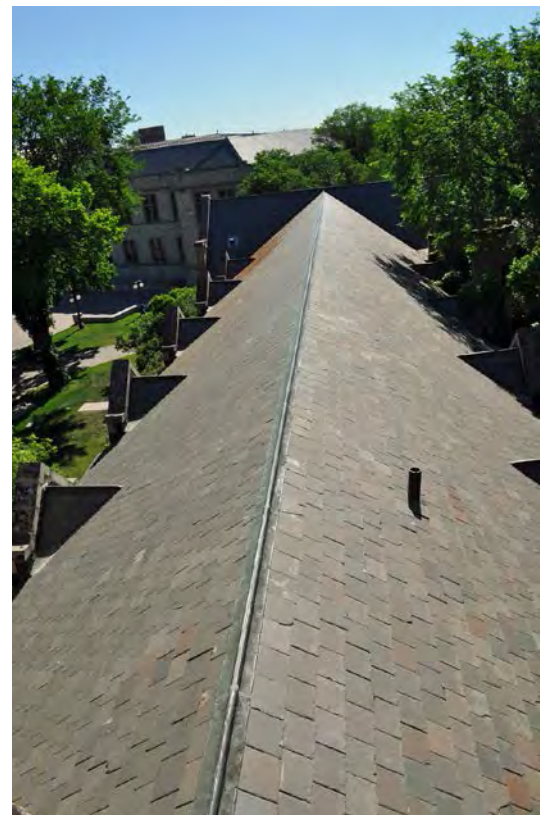
Figure 4. Slate roof tiles.

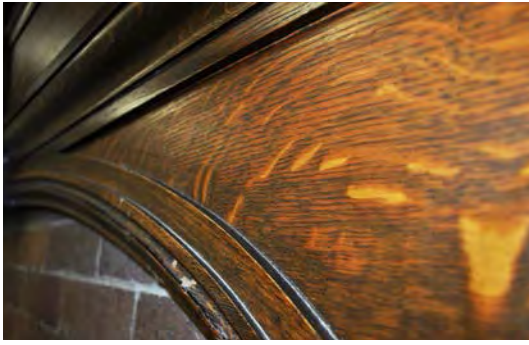
Figure 5. Quarter sawn oak on a fireplace mantle.

Interior millwork features, such as fireplace mantles, door and window trim are constructed of stained quarter sawn oak as shown in Figure 5. Wooden picture moldings inside the residence rooms have been painted. The stained oak door surrounds of the residential rooms have been well maintained; however, over time as certain pieces experience wear and damage, replacements have been made. In the corridors, some original oak doors have been replaced with steel doors and frames, as a fire protective measure. A few original oak doors remain to ancillary spaces such as the stairwell to the roof or attic crawl spaces. Figure 6 illustrates an example.

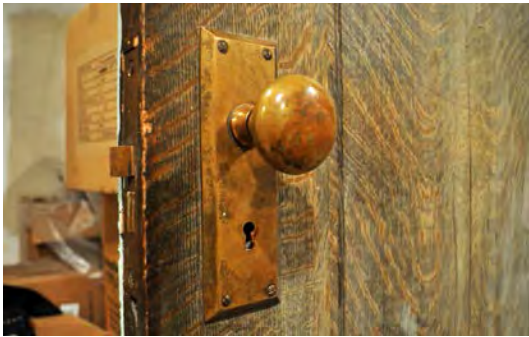
Figure 6. An oak door with brass hardware.

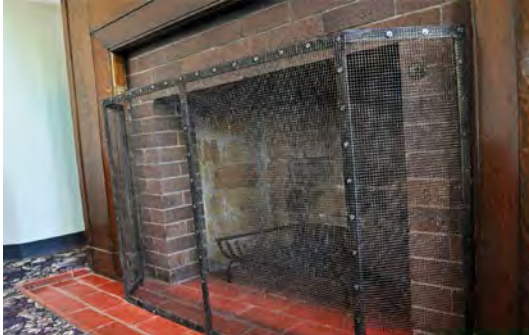
Figure 7. Oak, brick and red clay terracotta floor tile frame a fireplace.

In the second floor lounge, two brick fire places with oak surrounds and red terracotta tile hearths stand facing each other (Figure 7). Between them is an oak window seat, shown in Figure 8, set into the niche of an oriel window. The main floor features a much larger and more central fireplace. At least two other fireplaces in the south end of the building have been hidden under more recent wall finishes. Their general locations are apparent from the chimneys extending through the roof.

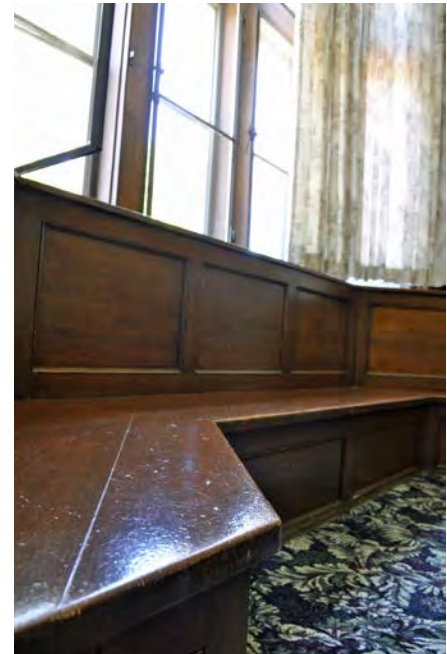
Figure 8. An oak window seat.

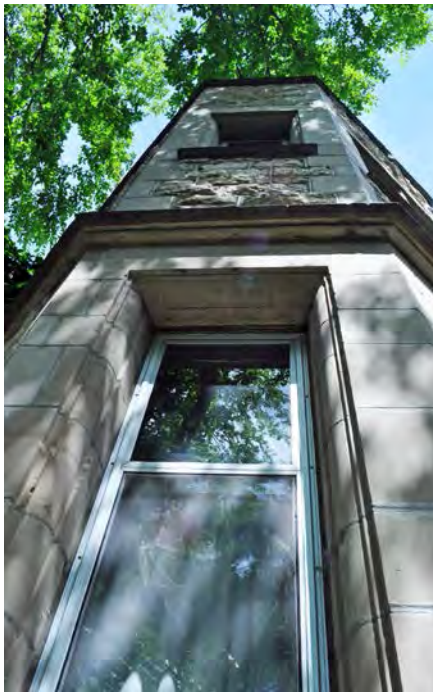
Also original are the oak surrounds of many of the windows. Set into these oak surrounds are single-paned steel framed sash windows. Much of the original glass is still intact, as is the original brass hardware. In most instances, aluminum storm windows have been fitted over the original windows, as shown in Figure 9. In a few cases, the original steel-framed exterior insect screens are intact. (See Figure 10). Overall, the windows of this building have excellent commemorative integrity.

Figure 9. Aluminum framed storm windows with sliding screens have been added to the exterior.

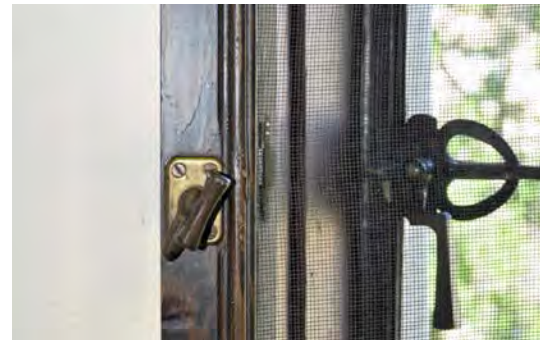
Figure 10. A window with both screen and exterior glass intact.

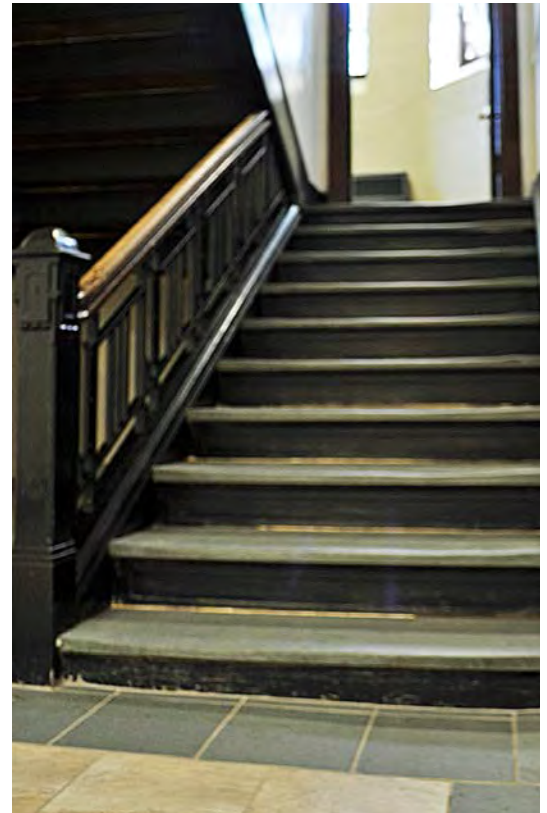
The staircases also retain excellent commemorative integrity. They are made in the same form and style as the staircases that typify other early University of Saskatchewan buildings such as the [MacKinnon Building](#) and the [Physics Building](#). Slate treads and landings are complemented by a steel and iron balustrade and stringers finished in black paint.

The steel and iron balustrade features subtle decorative details and oak hand rails. Staircases designed in this style are a unifying feature of University of Saskatchewan interiors; most staircases in early university buildings are designed in the style described here.

Figure 11. A staircase featuring slate treads, steel and iron balustrade and oak handrail.

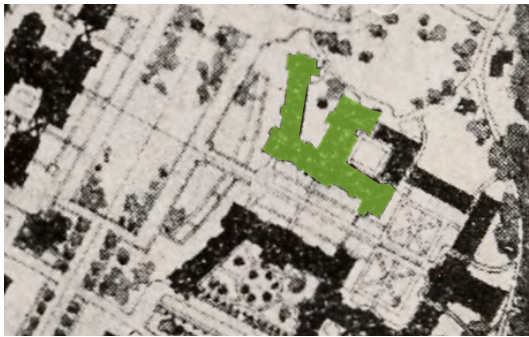
Figure 14. The form of Saskatchewan Hall in plan is indicated in green. Its shape provides for the framing of outdoor spaces. North is to the left.

The form of Saskatchewan Hall is important to the early Campus Plan set out by Brown and Vallance Architects. In plan, the building is shaped as a capital letter F, as illustrated in Figure 14. This shape forms exterior courtyards which were a primary goal of the 1909 campus plan. This master plan was as much a landscape plan as it was an architectural vision, and it conceived the university grounds as a series of interconnected courtyards formed by their adjacent buildings. The courtyards vary in scale from the grandeur of 'The Bowl' to the intimacy of the smaller courtyards behind Saskatchewan Hall. The form of Saskatchewan Hall was intended by the 1909 plan to define the shape, scale and character of The Bowl and the other outdoor courtyards such as Voyageur Place. The scale of Saskatchewan Hall is consistent with the other buildings that enclose The Bowl. At a height of three stories above ground, Saskatchewan Hall is well proportioned to the pedestrian activity that takes place around it. The landscaped courtyards around the university's early buildings still retain their character and are in and of themselves important character-defining elements.

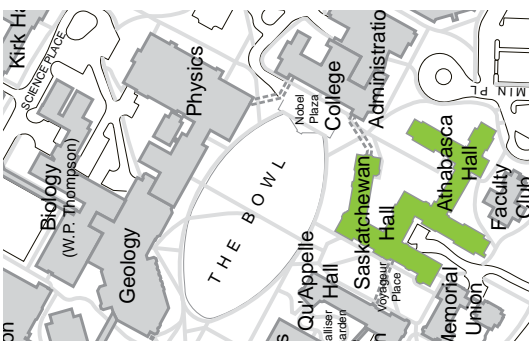
Figure 15. The form of Saskatchewan Hall with Athabasca Hall added to it is indicated in green on this contemporary campus map.

No deletions have been made to the form of Saskatchewan Hall, but Athabasca Hall was added to it in 1964. Figure 15 illustrates how this has extended the building footprint south and east. Despite the addition, the original form of the building is still easily discerned.

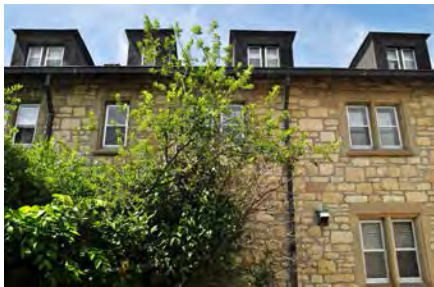
Figure 17. Dormer windows.

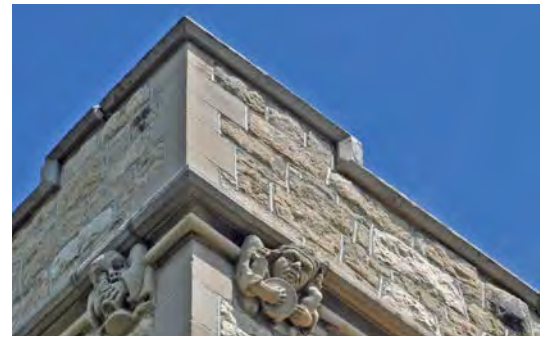
Numerous character-defining elements of the Collegiate Gothic are to be found on the building's exterior. The north and west-facing facades are the most ornamented, owing to their frontage onto The Bowl and Voyageur Place (Figures 13 & 16). The roof of Saskatchewan Hall is clad in slate tile; a material common to many Collegiate Gothic buildings at the university. Punctuating the roof is a series of dormer windows shown in Figure 17. Below the crenellated parapets that make up the roof line, a number of gothic grotesques populate the exterior. Both of these character-defining elements are visible in Figure 18. The grotesques are particular to this building, and portray aspects of student life. The figures are carved holding tennis rackets, microscopes and musical instruments. Shown in Figure 19, around the northwest entrance to the building, the arched stone entry is embellished with reliefs featuring flora and fauna such as a gophers and grape vines. A shield depicts a stylized key. The carved grotesques and reliefs all exist in excellent commemorative condition. Their contribution to the style of the building and the subject matter they portray make them important character-defining elements.

Figure 18. Crenellated parapets define the roofline. Two grotesques are shown, one using a microscope and the other playing a drum.

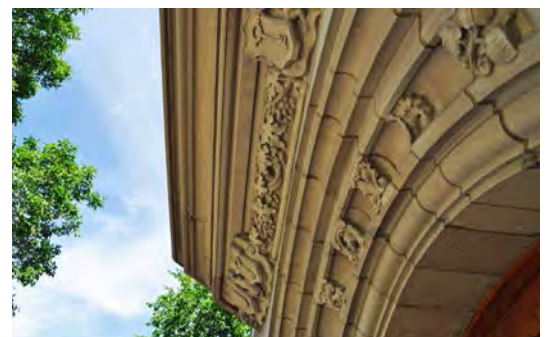
Figure 19. The arch framing the main entry is embellished with stone reliefs and heraldry.

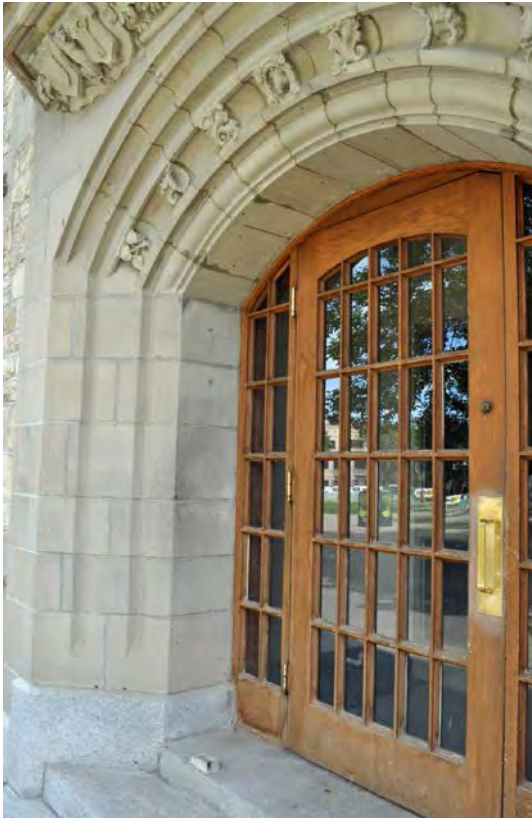
Figure 22. An arched entry.

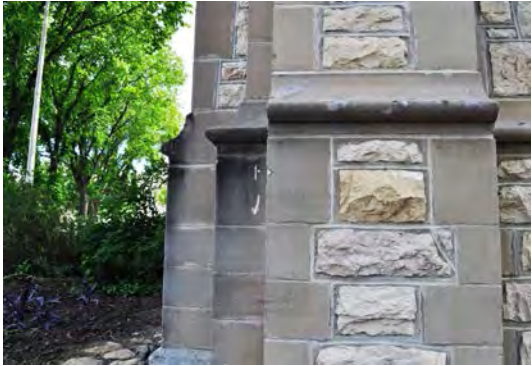
Figure 23. String courses and quoining.

Above the northwest entrance, an oriel window overlooks Voyager Place. (Figure 20). The oriel window is accompanied by a series of bay windows on both the north and west elevations. (Figure 21). Sandstone quoins, ornamented drainage spouts and narrow archer slits contribute to the Collegiate Gothic architectural style of the building. Carved stone arches surround the two west entrances (Figure 22). String courses, as illustrated in Figure 23, are used to accommodate the thickening of the exterior stone towards the base of the building, while adding a decorative element. Many windows also feature sandstone arches. On the north façade, a turret reaches from the ground floor to the roof, further defining the neo-gothic style of the building (Figure 24).

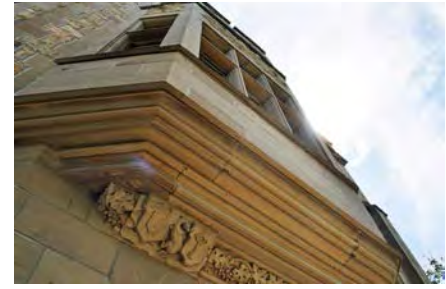
Figure 20. Oriel window.

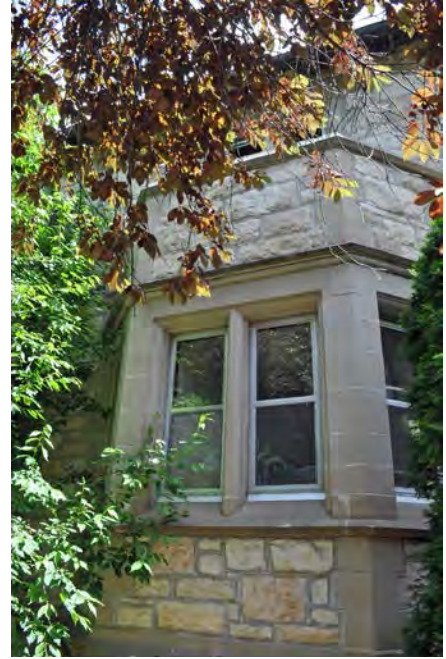
Figure 21. A bay window with a false balcony.

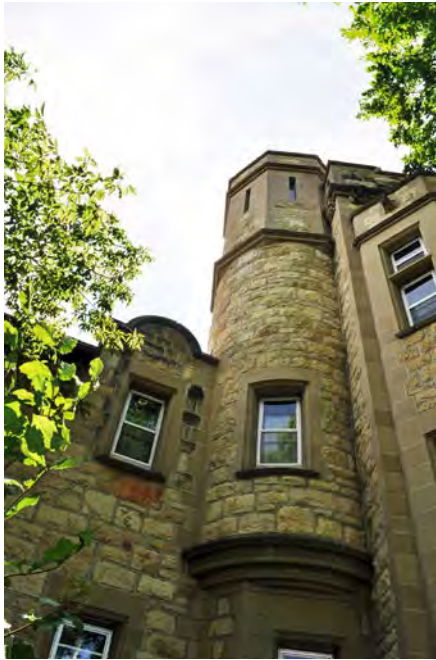
Figure 24. A turret on the north side of Saskatchewan Hall.

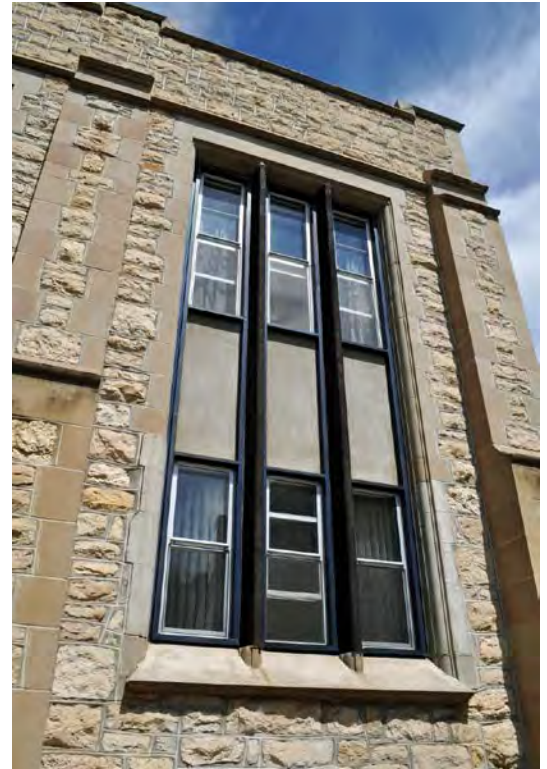
Notably, many of the windows on the building's east facing walls are less ornamented than those on other elevations. Only a few windows on these facades have bays, balconies or oriels. This differentiation orientates the building toward the more public outdoor spaces of [The Bowl](#) and [Voyageur Place](#). As Figure 25 shows, the windows appear in sets of nine with large surface areas to maximize light penetration. With renovations, some of these windows have been replaced. The dining room used to feature a double-height vaulted ceiling. Renovations converted this grand space into two floors. To conceal the addition of the floor the three middle windows were covered in each set.

Figure 25. Understated windows on the east side of Saskatchewan Hall.

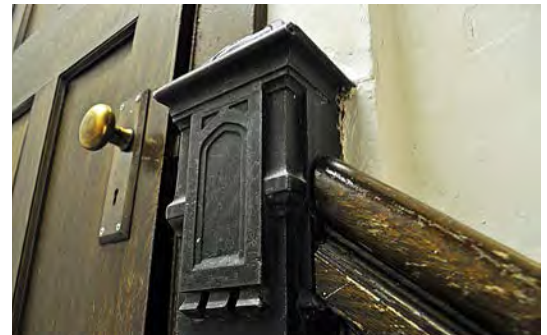
Figure 26. A detail found on all staircases in Saskatchewan Hall.

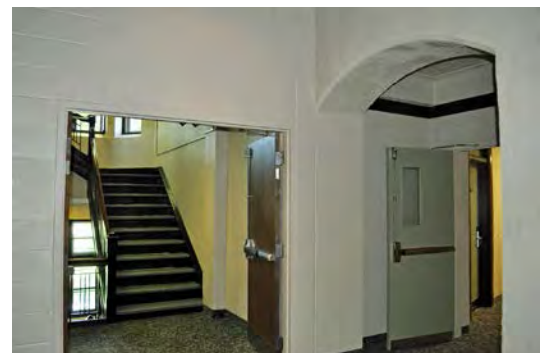
The interior of Saskatchewan Hall has varying levels of commemorative integrity with respect to architectural style. The ground floor has been much more compromised than the upper stories. On the upper floors, some of the original plaster work, and most original fireplaces, stairwells and window seats have been maintained to an excellent standard of commemorative integrity. However, in general, the preservation of historical character-defining elements in this building has been inconsistent. Figure 27 illustrates an example of this inconsistency.

Figure 27. L to R: A newer doorway, without arch, compared with an original arched doorway.
