University of Saskatchewan

Heritage Register

September 2013

Facilities Management
Division

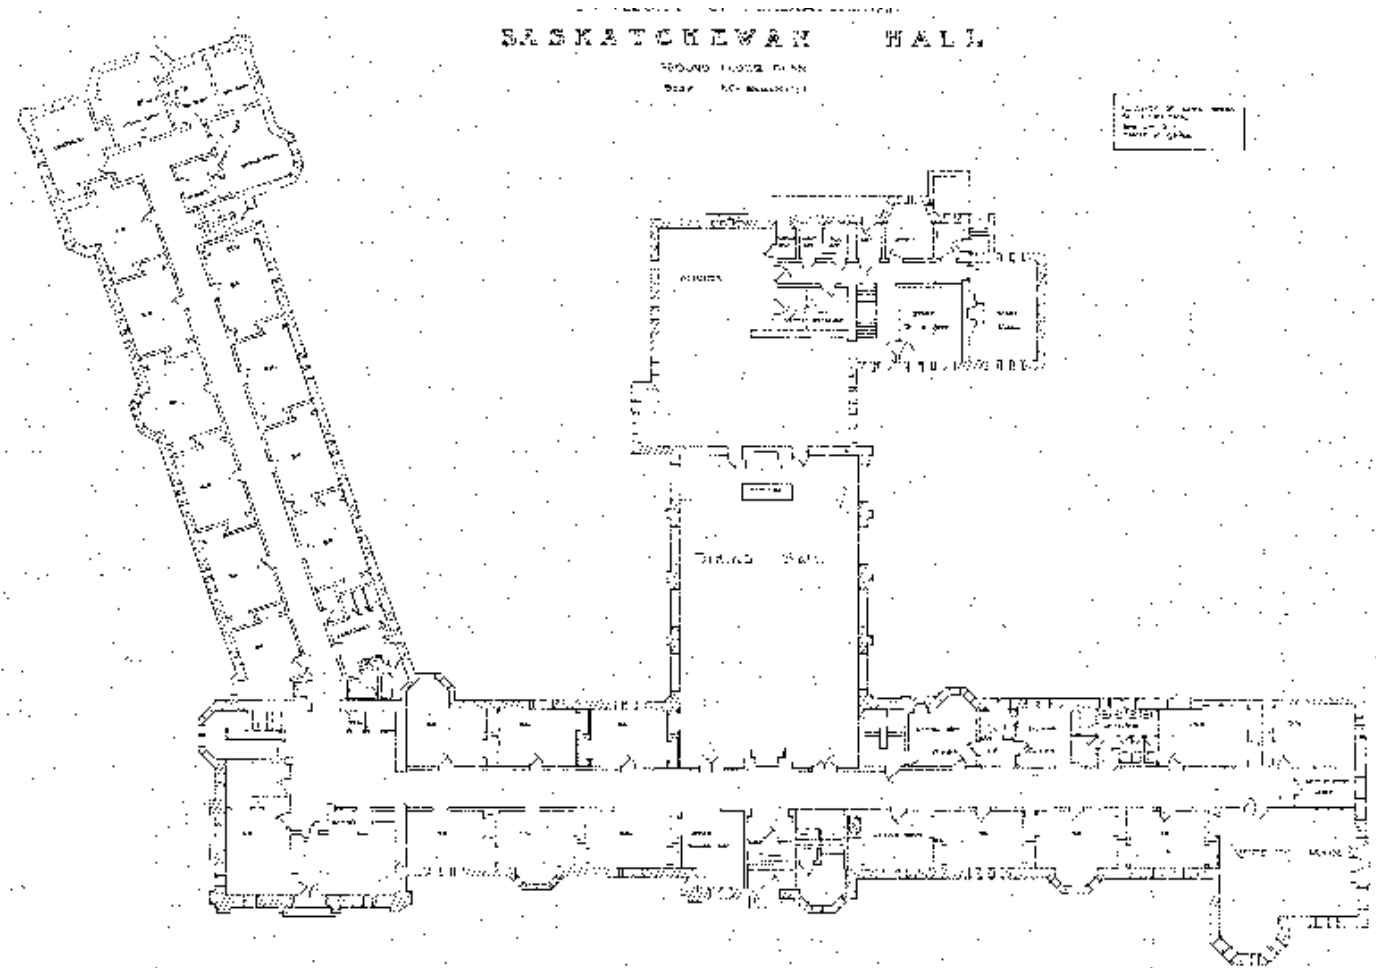
Figure 29. The ground floor plan of Saskatchewan Hall ca. 1947. Uses have changed, however the double loaded corridor layout has been maintained. The dining room and kitchen spaces have been converted into office space. Retrieved from Facilities Management Division Asset Record System, File SH-8-T.

The general arrangement of Saskatchewan Hall is a series of narrow wings, with spaces arrayed off a double-loaded corridor. The floor plan is illustrated in Figure 29. This arrangement is typical of multi-unit residential construction, where all living spaces require access to windows. Narrow floor plates allow the greatest possible penetration of natural light into interior spaces. Even stairwells featured large bays of windows to allow for maximum light penetration. Figure 30 illustrates this feature.

been maintained and is illustrated in Figure 29. The dining hall was the exception to this general cellular arrangement, but has since been compromised both in plan and section. The dining hall was located in the central wing running east-west. Originally two stories in height, the dining hall wing featured a high coffered ceiling. A series of windows on either side created an expansive, light-filled space. A large fireplace was located centrally on the west wall of this grand room. Figure 31 shows the original use of the space and its open configuration. Renovations in the 1950's saw the height of the room completely altered with the addition of another floor over the dining space to provide a gymnasium. This fundamentally altered the nature of the space, dividing it vertically into two lower spaces. Figure 32 shows the gymnasium that was added over the dining hall.

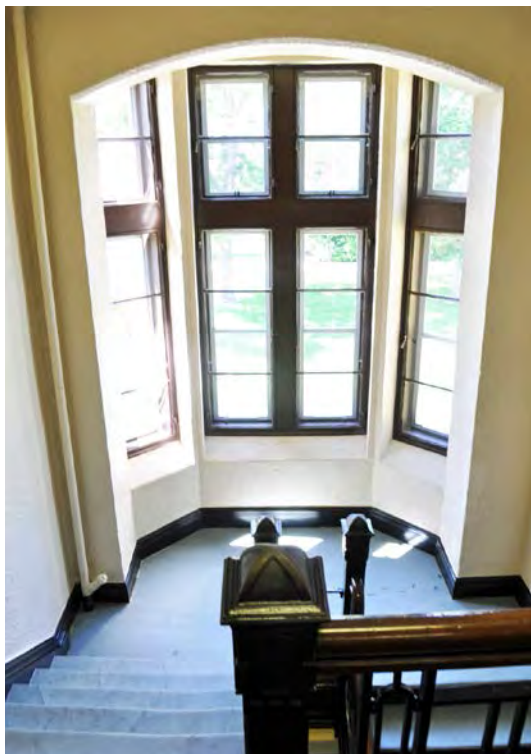
Figure 30. Bay windows act as lightwells for the building. Arches are a common stylistic characteristic.

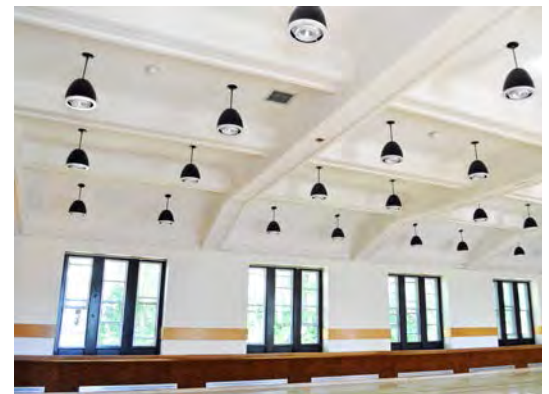
Figure 32. The gymnasium in Saskatchewan Hall. The roof and windows pictured here used to overlook the dining hall.

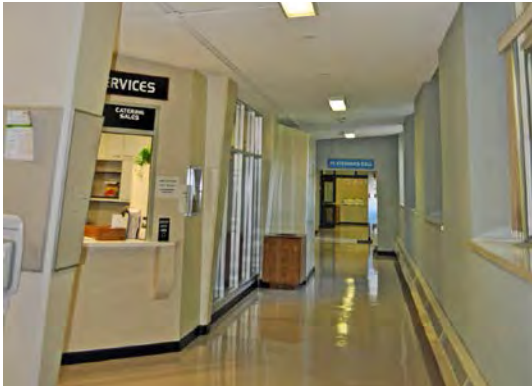
Figure 33. The current layout of the space originally used as a dining room. Few stylistic elements remain.

The space of the former Dining Hall has also been made more linear, by its division into a number of administrative offices arranged along a single loaded corridor. Athabasca Hall, added in 1964, is accessed through this corridor, reinforcing the conversion of the space from a gathering place to a circulation route. Figure 33 shows this reconfiguration of the former Dining Hall. For decades, the grand hearth of the Dining Hall was lost behind furred out walls. In 2010, the fireplace was rediscovered during a renovation. Although no longer functional, its material characteristics and architectural style are well maintained and in an excellent state of commemorative integrity. Figure 34 shows the hearth. Other chimneys protruding from the roof perhaps give a clue to several other hidden hearths within the building.

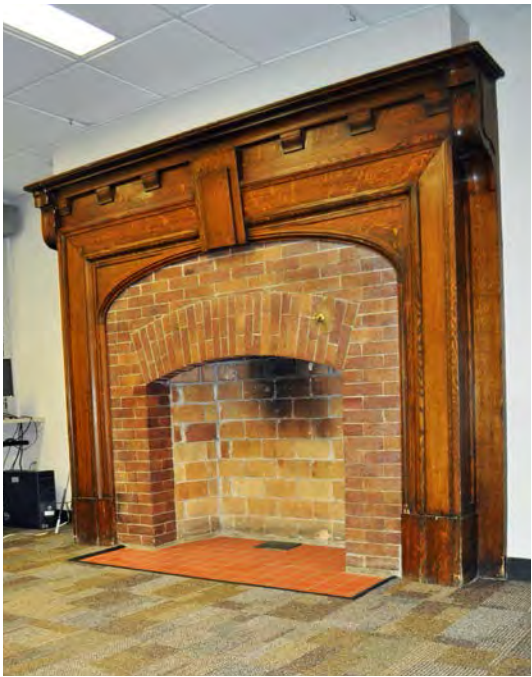
Figure 34. The dining room hearth, now located in an administrative office.

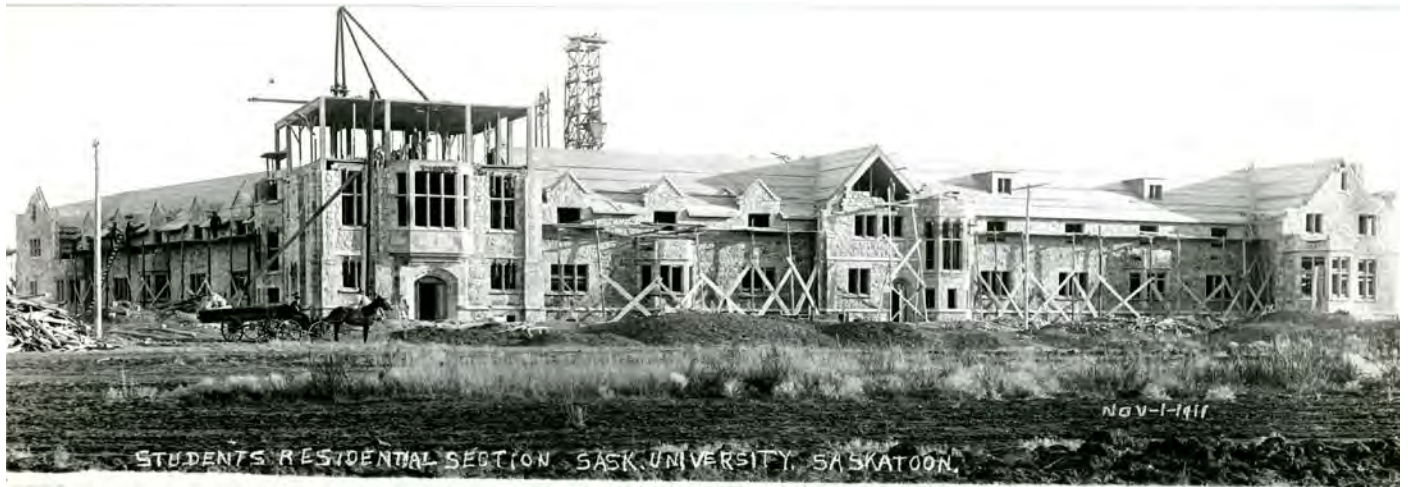
Figure 35. Saskatchewan Hall under construction, November 1, 1911. Photo A-786, retrieved from University of Saskatchewan Archives.

The original structure of Saskatchewan Hall consists of cast-in place concrete slabs supported by concrete beams and columns. The roof rafters are wooden, and are supported by the concrete frame. The exterior walls of Saskatchewan Hall are of stone, supported on concrete foundation walls and footings. At the exterior stone walls, the concrete structure is buried within the masonry construction and is not visible, but is evident in photographs taken during construction. On the interior, a pair of concrete beams runs on either side of the central corridors, parallel to the exterior walls. This early concrete structure proved problematic, and in 1971, an extensive rehabilitation project was undertaken to reinforce it. Excessive deflection in the concrete beams was addressed by the addition of steel supporting columns at the midspan of each structural bay. An additional structural concrete slab was poured over top of the existing one both to strengthen it and to level the floors, which had sagged due to structural deflection. The exterior stone walls, although not intended as load-bearing, have likely assumed a supporting function, given the deflection visible in the interior concrete beams.

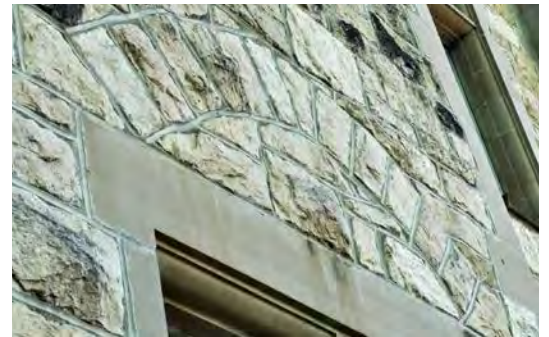
Figure 36. A stone relieving arch helps to support the wall over a window.

A notable structural feature is the relieving arch visible in Figure 36, supporting a stone chimney over a window overlooking the Bowl.

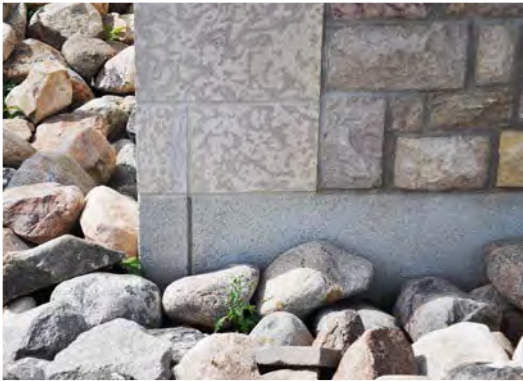
Figure 1. Tyndall stone and greystone above a precast concrete base.

The exterior materials of the Administration Building are in keeping with those of the [MacKinnon Building](#) to which it is an addition. 'Greystone,' which has come to characterize the University of Saskatchewan campus, is the primary exterior material. Greystone is complemented by cut Tyndall stone. Precast concrete panels form a base for the exterior walls. (For further information on building stones used at the U of S, refer to ['Appendix: Stone.'](#)) All three of these materials are illustrated in Figure 1 and are in excellent commemorative condition. Glazing is modern in its materiality, featuring double-glazing and aluminum frames.

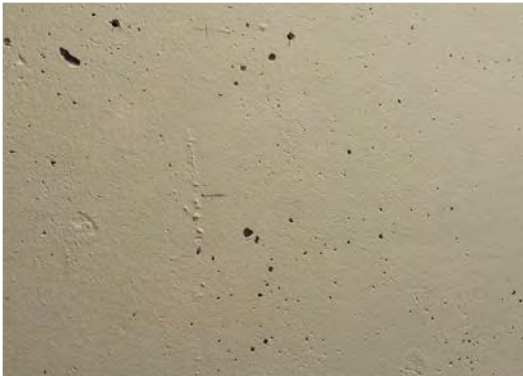
Figure 2. Painted concrete wall.

Painted exposed concrete is a primary element on the interior of the building and a character-defining material (Figure 2). Concrete columns are also left exposed throughout the building. The main stair features a balustrade made of concrete. The concrete is often accompanied by grey tile which appears on window sills, around the bases of columns and as a cap on the concrete balustrade (Figure 3). Doors in the building are either oak (Figure 5) or painted steel. Door hardware has a brass finish, also shown in Figure 5. Painted steel is used for handrails and balustrades (Figure 6).

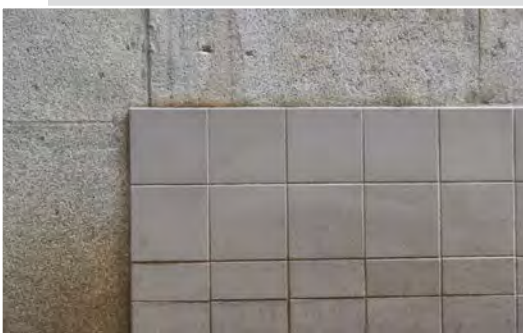
Figure 3. Grey ceramic tile.

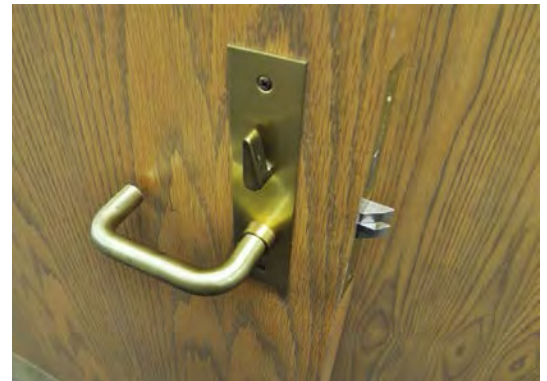
Figure 5. Brass-finish door handle.

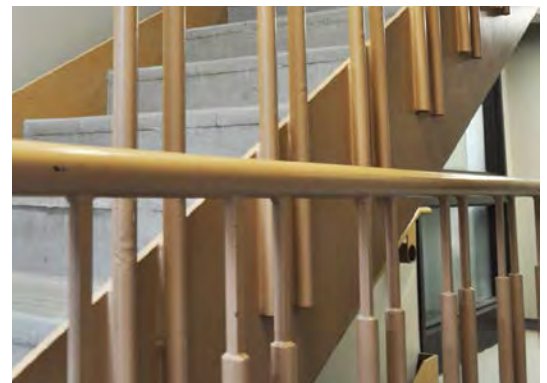
Figure 6. Painted steel balustrade.

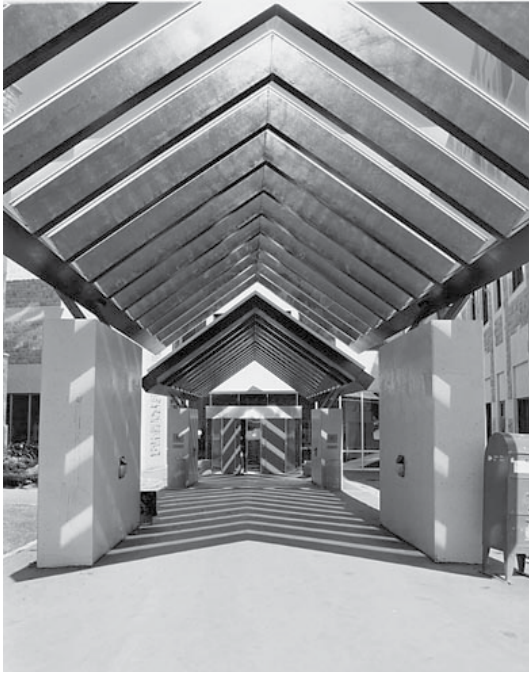
Figure 7. Triangular entrance canopy, now demolished. Photo A-7071, retrieved from http://scaa.usask.ca/gallery/uofs_events/articles/1956.php

As it was originally constructed, the entrance to the Administration Building was set back to form an exterior courtyard between it and the [MacKinnon Building](#). The courtyard was bisected by a walkway, covered in a triangular canopy, leading to the main entrance (Figure 7 & 15). In 1997, a large, triple height atrium was added to the north side of the building, enclosing the courtyard. A new paved forecourt with low stone walls was added to the north of the new addition.

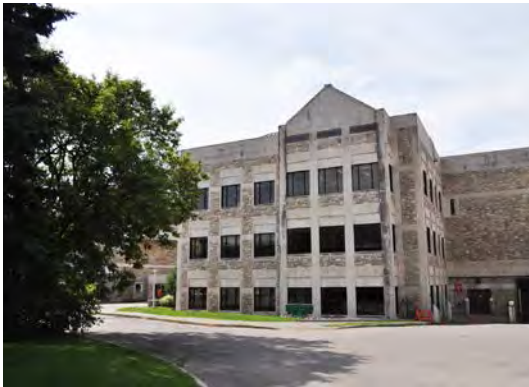
Figure 8. Abstracted references to Collegiate Gothic forms.

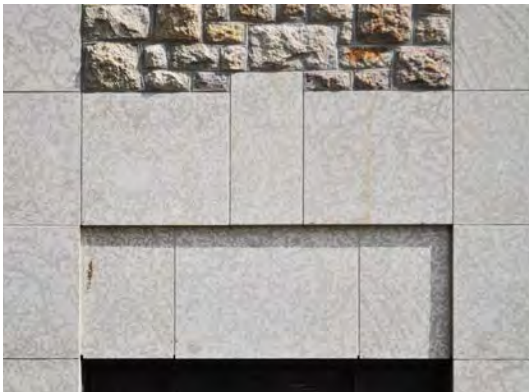
Figure 9. Reference to keystones in the stonework above the windows.

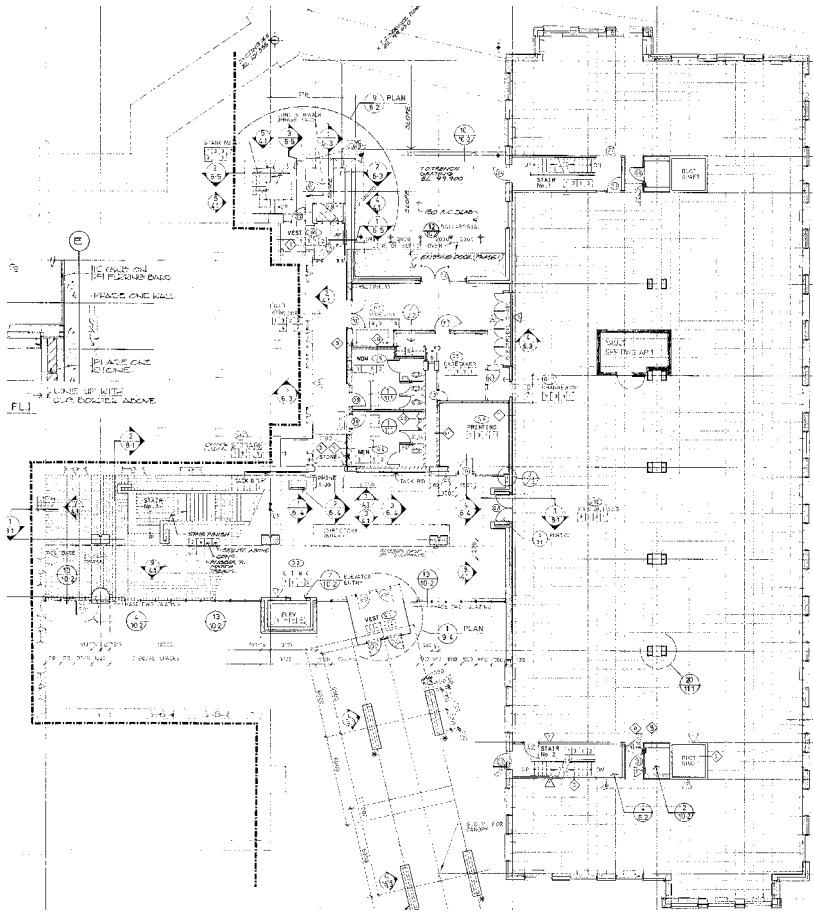
Figure 12. Original ground floor plan of the Administration Building. Retrieved from Facilities Management Division Asset Record System, File AB-671-AB.

The Administration Building is a three-storey office building, each floor similar in layout. An east wing contains flexible office space (Figure 12), later fit out with demountable walls. The open plan of the office wing has allowed for its reconfiguration many times since the building's construction. The central wing connects the building back to the [MacKinnon Building](#), and houses the entrance lobby, a grand staircase, as well as services such as washrooms, storage, receiving and mechanical rooms. The building links to the MacKinnon Building on all three of its levels.

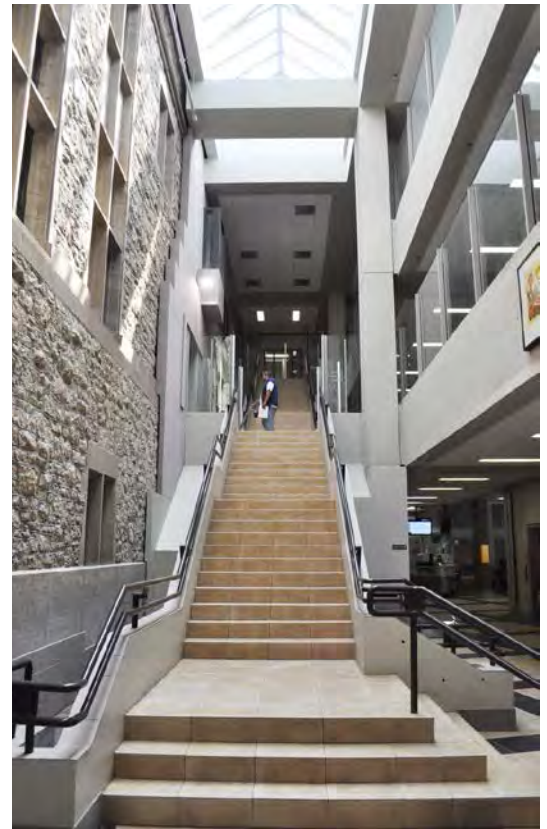
Figure 13. Central stair in the atrium.

The three levels of the Administration Building are connected vertically by a central stair, located in a glazed atrium space (Figure 13). The atrium is built up against the former exterior wall of Convocation Hall, part of the MacKinnon Building, such that the old stone wall now forms an interior feature of the Administration Building. This strategy is repeated at many other locations throughout the building (Figure 14).

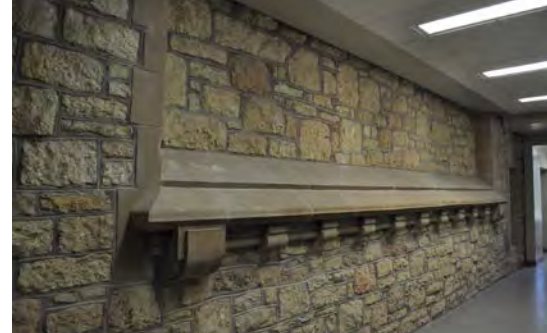
Figure 14. Exterior wall of the MacKinnon Building enclosed in the Administration Building.

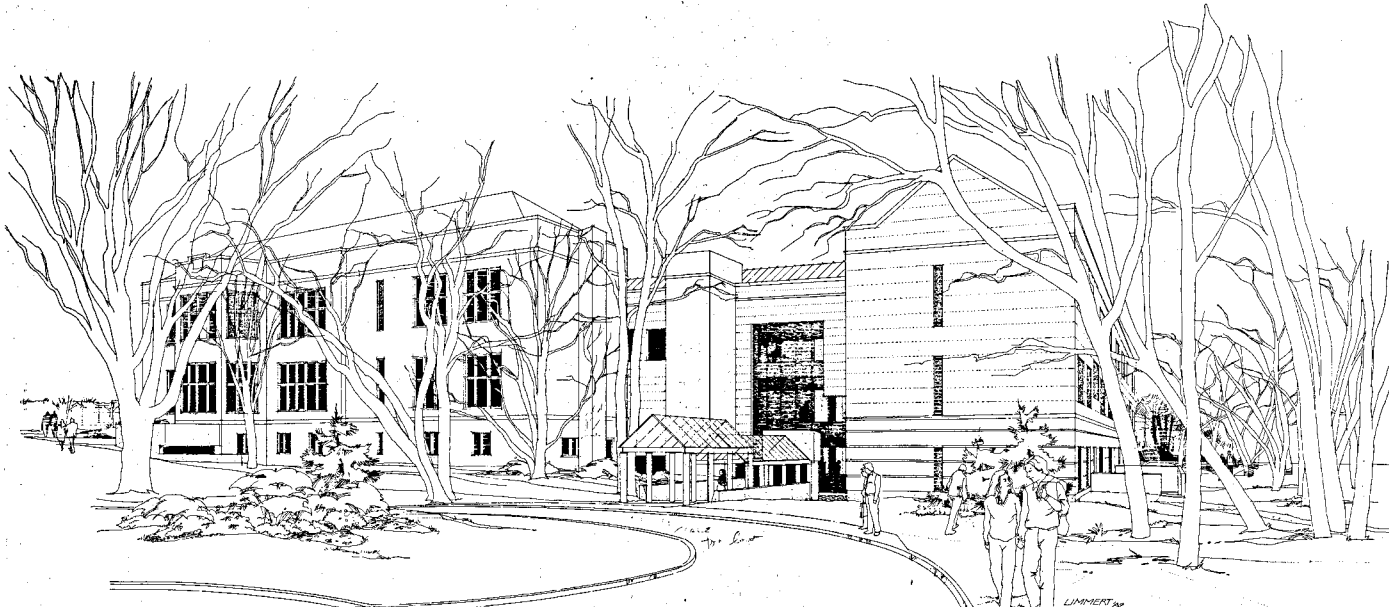
Figure 15. A perspective drawing of the 'arrival court.' A small outdoor courtyard was located to the left of the entrance canopy. Retrieved from Facilities Management Division Asset Record System, File AB-671-AB.

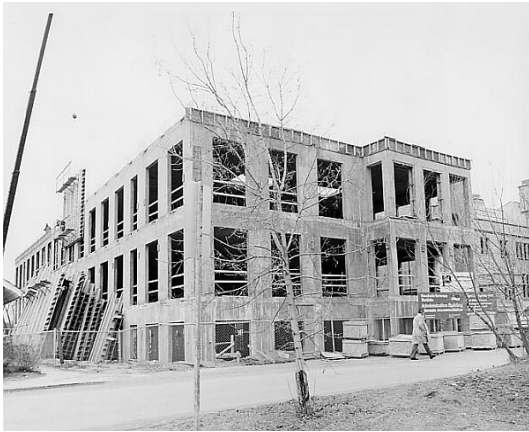
Figure 16. The Administration Building during construction. The concrete walls are visible. Photo A-7037, retrieved from http://scaa.usask.ca/gallery/uofs_events/articles/1956.php

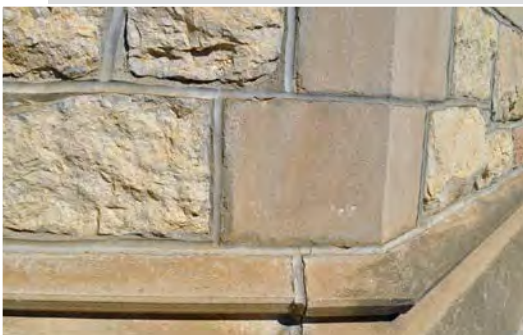
Figure 1. Indiana limestone trim on a 'greystone' wall.

Qu'Appelle Hall closely followed the first wave of construction at the university, and was designed with a similar palette of materials to those of the [MacKinnon Building](#) and [Saskatchewan Hall](#). The primary exterior material is rough-faced 'greystone'. Cut stone trim and ornamentation is in Indiana Limestone (Figure 1), a subtle change from the MacKinnon Building and Saskatchewan Hall, where sandstone was used for this purpose. Granite was used for exterior staircases (Figure 2), although a concrete ramp has been poured over the granite stairs at the north-east entrance. Granite was also used as a base course for the exterior walls. (For further information on building stones used at the U of S, refer to ['Appendix: Stone.'](#))

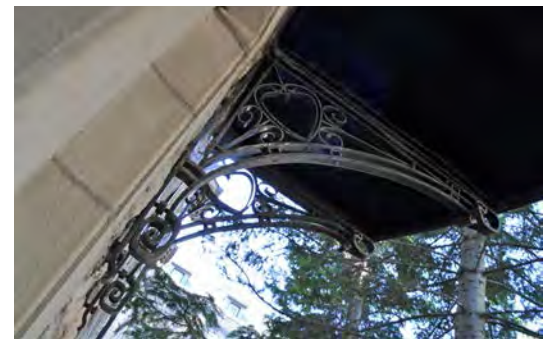
Figure 4. Steel brackets supporting a balcony on the west side of Qu'Appelle Hall.

Exterior doors on Qu'Appelle Hall are made of oak with inset glass. Other materials include slate roof tiles, copper drainage hardware and exposed wooden rafter ends. On the west façade, a series of ornate painted steel balconies distinguish the building from its predecessors (Figure 4). All of the original exterior materials are character-defining elements.

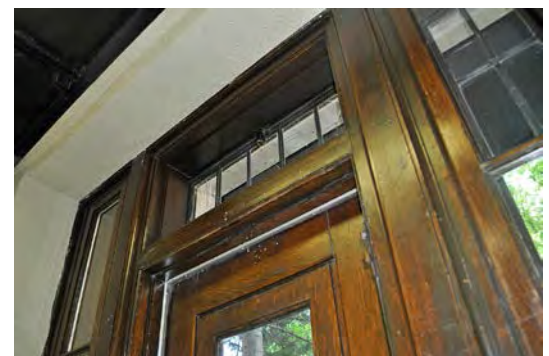
Figure 5. Oak window and door surrounds, steel framed sidelites.

Oak is a primary interior material, used for doors, door transoms, windows, door and window trim, stair handrails, fireplace surrounds and decorative trim. Stair balustrades are constructed of steel and iron (Figures 5 & 6). Door and window hardware is brass. Originally the interior doors featured glazed transoms. These have all been replaced with a metal panel save for a few doors in the basement and exterior (Figure 5). Windows are single-glazed and framed in oak. The original storm windows have been replaced by permanently affixed aluminum framed storm windows with screens (Figure 7). The original oak features are character-defining elements.

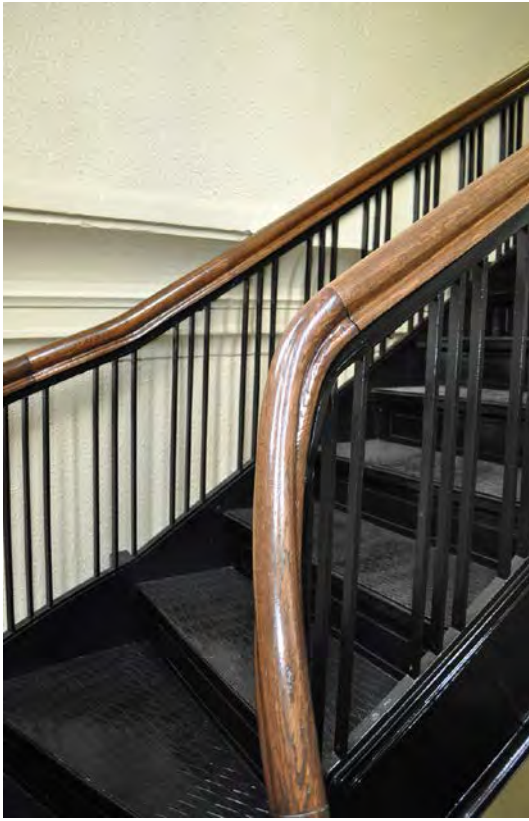
Figure 6. The uppermost staircase: iron treads, stringers and balustrade, oak banister.

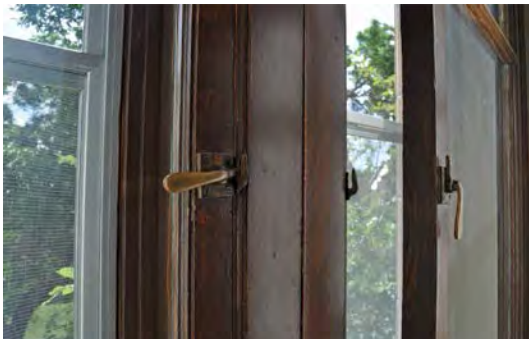
Figure 7. L to R: aluminum framed window, oak window surround, brass hardware, original wooden framed glazing.

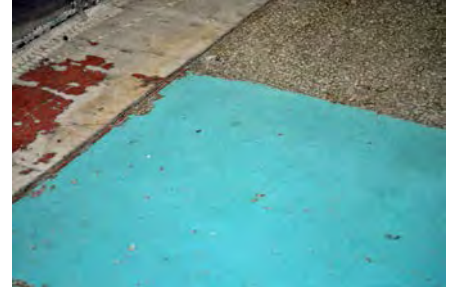
Figure 8. Marble and terrazzo located around the former pool. Both show evidence of having been painted.

Although rarely used in other early University of Saskatchewan buildings, marble is employed quite heavily in Qu'Appelle Hall. Stair treads and landings and window sills are typically made of marble. A few marble baseboards remain. Marble is also found in combination with terrazzo as a flooring material in the basement. As Figure 8 illustrates, the former pool deck was finished in marble and terrazzo. The marble is white in colour and is generally in good condition, however, some of the marble landings have cracked. Some of the marble has been replaced by a locally available green marble that is also found in Saskatchewan Hall (Figure 9).

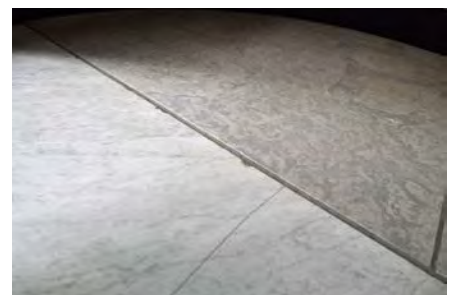
Figure 9. L to R: cracked original white marble, green replacement marble.

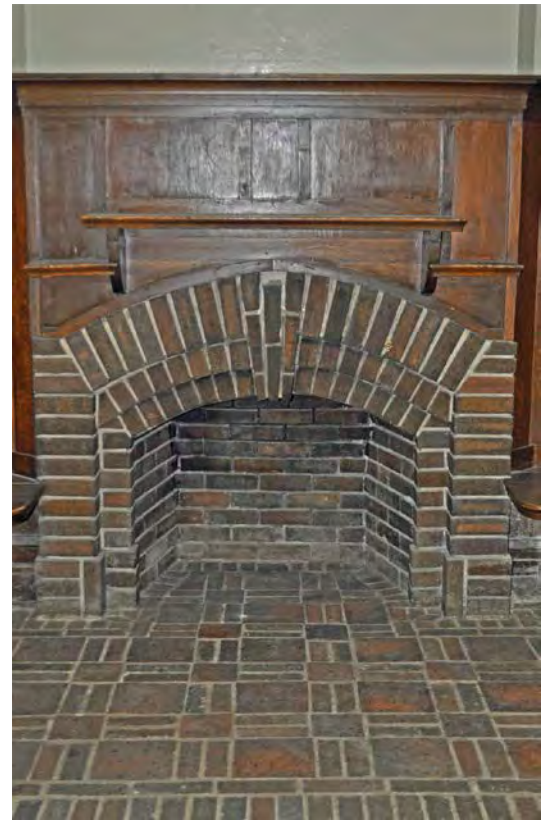
Figure 10. Oak mantelpiece and brick hearth.

Qu'Appelle Hall has three fireplaces that are visible and several others have been concealed within walls. As Figure 10 shows, these feature oak surrounds and brick hearths. The fireplaces are character-defining elements.

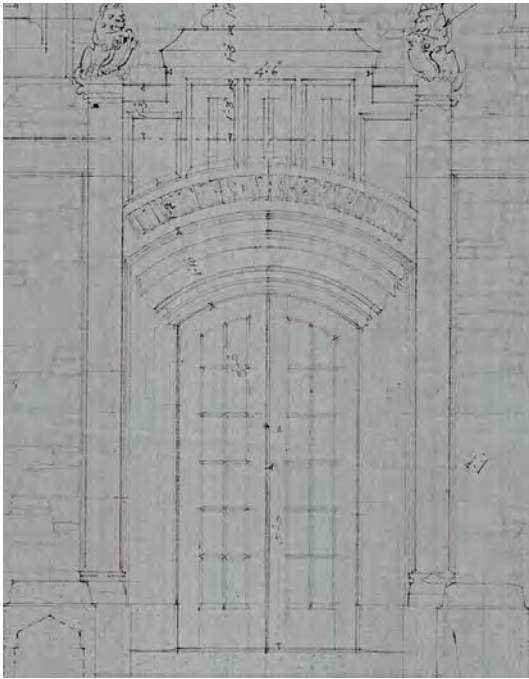
Figure 13. Plans for Qu'Appelle Hall: cut stone reliefs and statuary. Retrieved from Facilities Management Division Asset Record System, File Q-3-T.

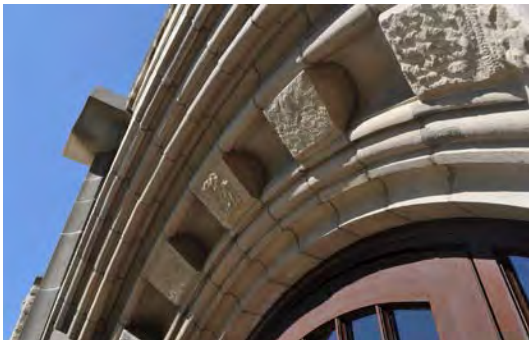
Figure 14. Stone blanks above an entrance, intended for carved decoration.

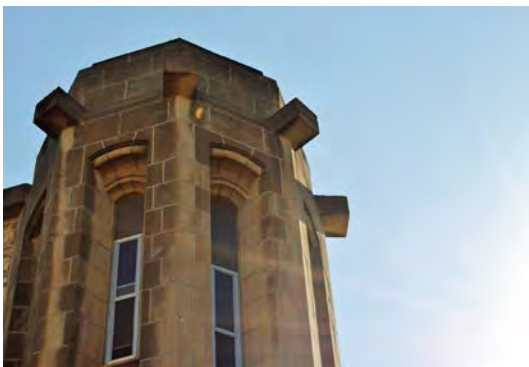
Figure 15. A turret with limestone protrusions and narrow archer style windows.

Qu'Appelle Hall is an excellent example of Collegiate Gothic architecture, despite its incomplete ornamentation. Its elevations are playful, asymmetrical compositions featuring gabled walls, projecting oriel windows, pointed arches, turrets and towers. Gabled dormer windows punctuate the roof line. On the south elevation, tall arched windows adorned with limestone tracery indicate the former location of a dining hall. The south-west and north-west corners of the building are marked by turrets, with narrow archer-style windows, containing circular stairs (Figure 15). Stone piers between the tall windows on the southern façade reference those of gothic churches (Figure 16). Indiana limestone string courses punctuate the façade on all sides of the building. On the west façade facing [Palliser Garden](#), arched door and window openings and ornate painted steel balconies overlook the courtyard (Figure 17).

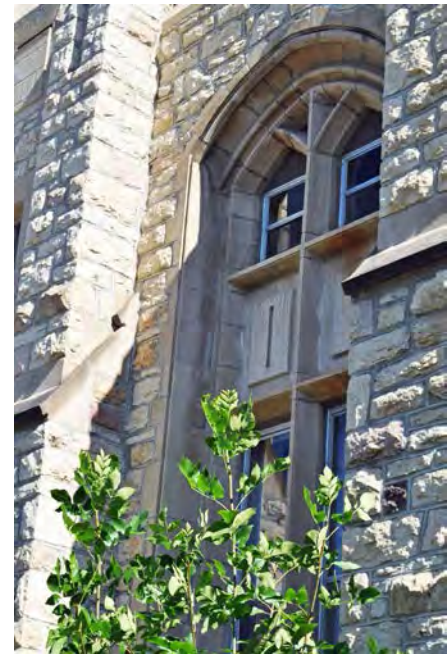
Figure 16. A gothic arched window with tracery and spandrels.

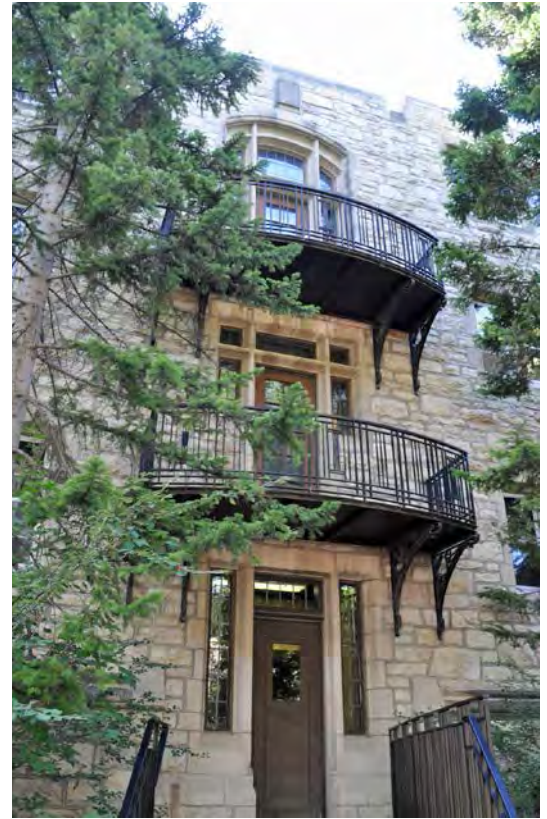
Figure 17. Ornate steel balconies on the western face of the building.

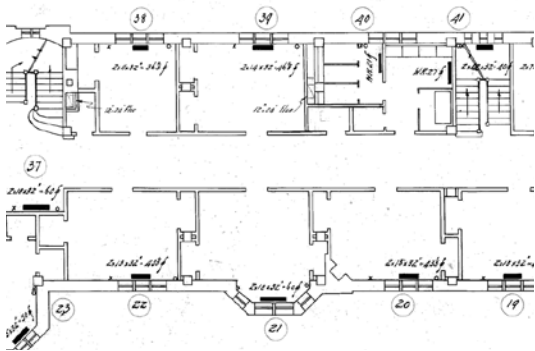
Figure 19. A portion of the original ground floor plan. North is to the right. Retrieved from Facilities Management Division Asset Record System, File Q-17-T.

Most of Qu'Appelle Hall is organized as a series of residential rooms arranged along double loaded corridors (Figure 19), except for the south wing, which originally accommodated larger spaces such as a dining hall on the ground floor and a swimming pool in the basement.

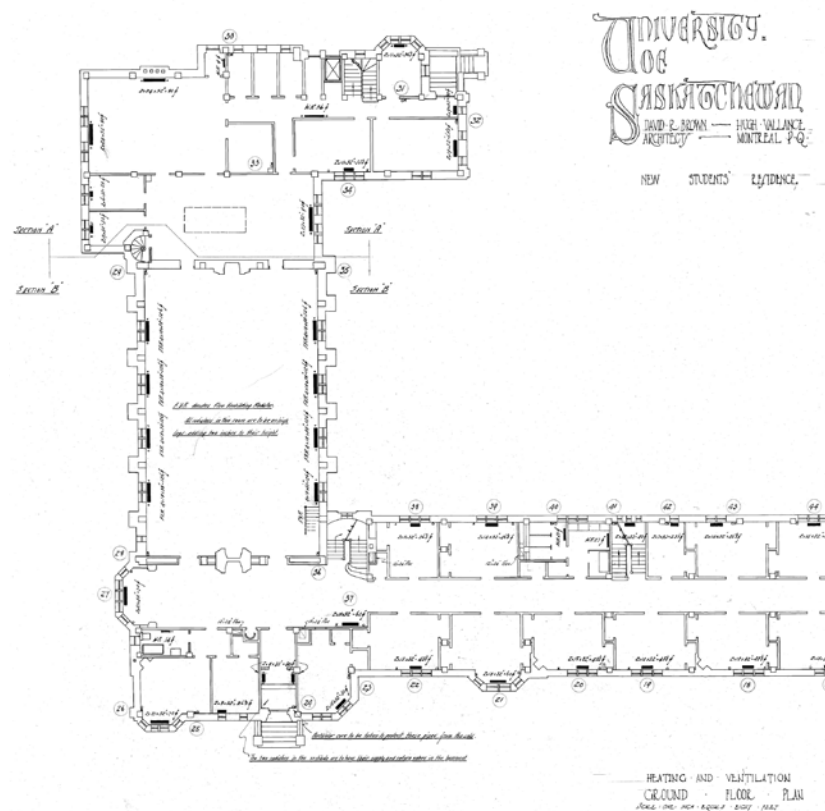
Figure 21. The original layout of the south end of the ground floor. The large open space was a dining room with two fireplaces. North is to the right. Retrieved from Facilities Management Division Asset Record System, File Q-17-T.

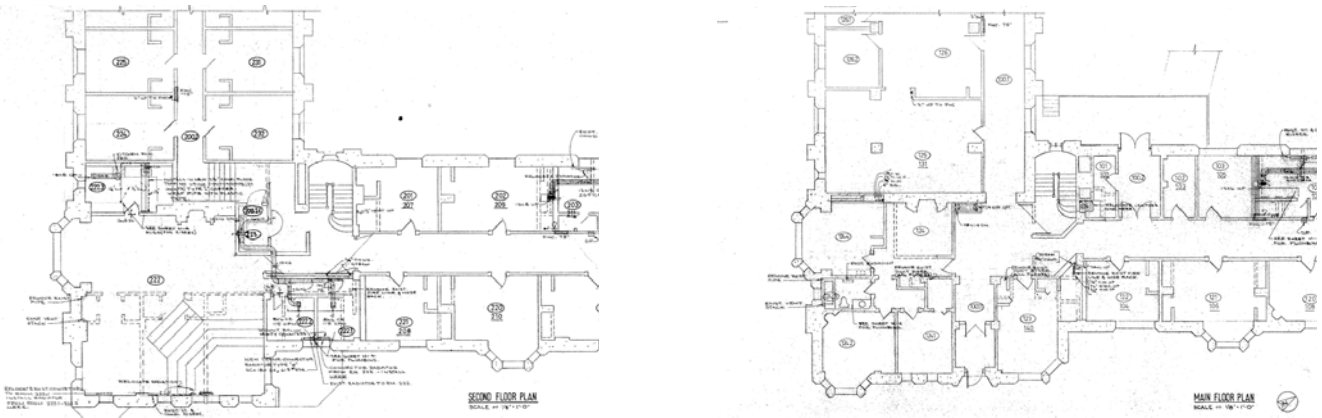
Figure 22. 1972 renovations to the south wing. L to R: the second floor plan, the main floor plan. North is to the right. Retrieved from Facilities Management Division Asset Record System, File Q-271-AB.

The second floor of the south wing was once the open space above the dining hall. This wing has been renovated by the insertion of a floor plate, and is now known as 'Church,' owing to the gothic arched windows of its rooms. A comparison of Figures 22 and 23 demonstrate the changes made to this portion of the building.

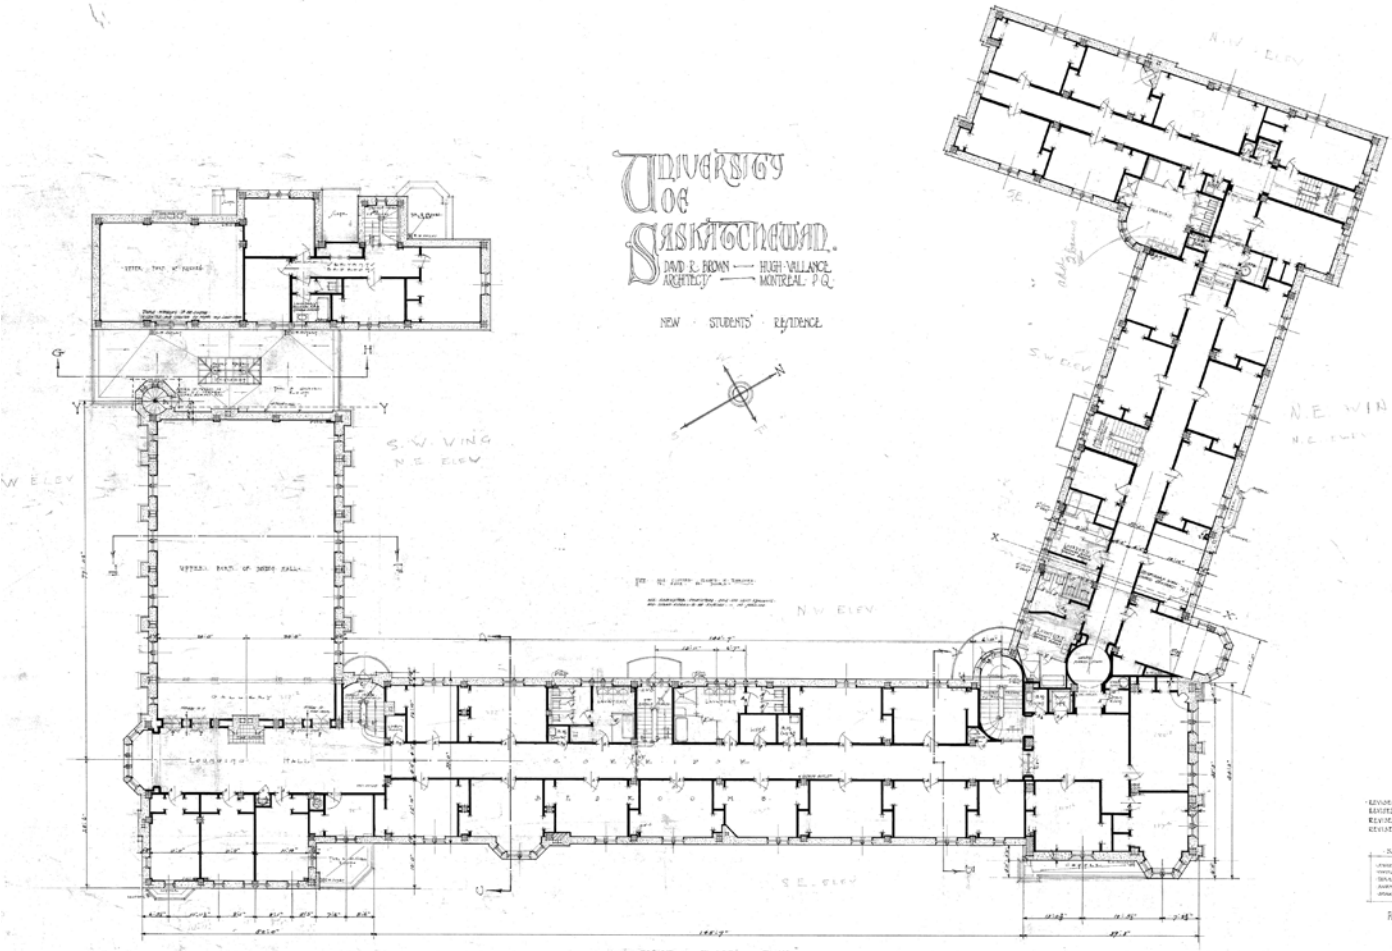
Figure 23. The original second floor plan shows an open space above a dining area and a lounge hall. North is to the right. Retrieved from Facilities Management Division Asset Record System, File Q-30-T.

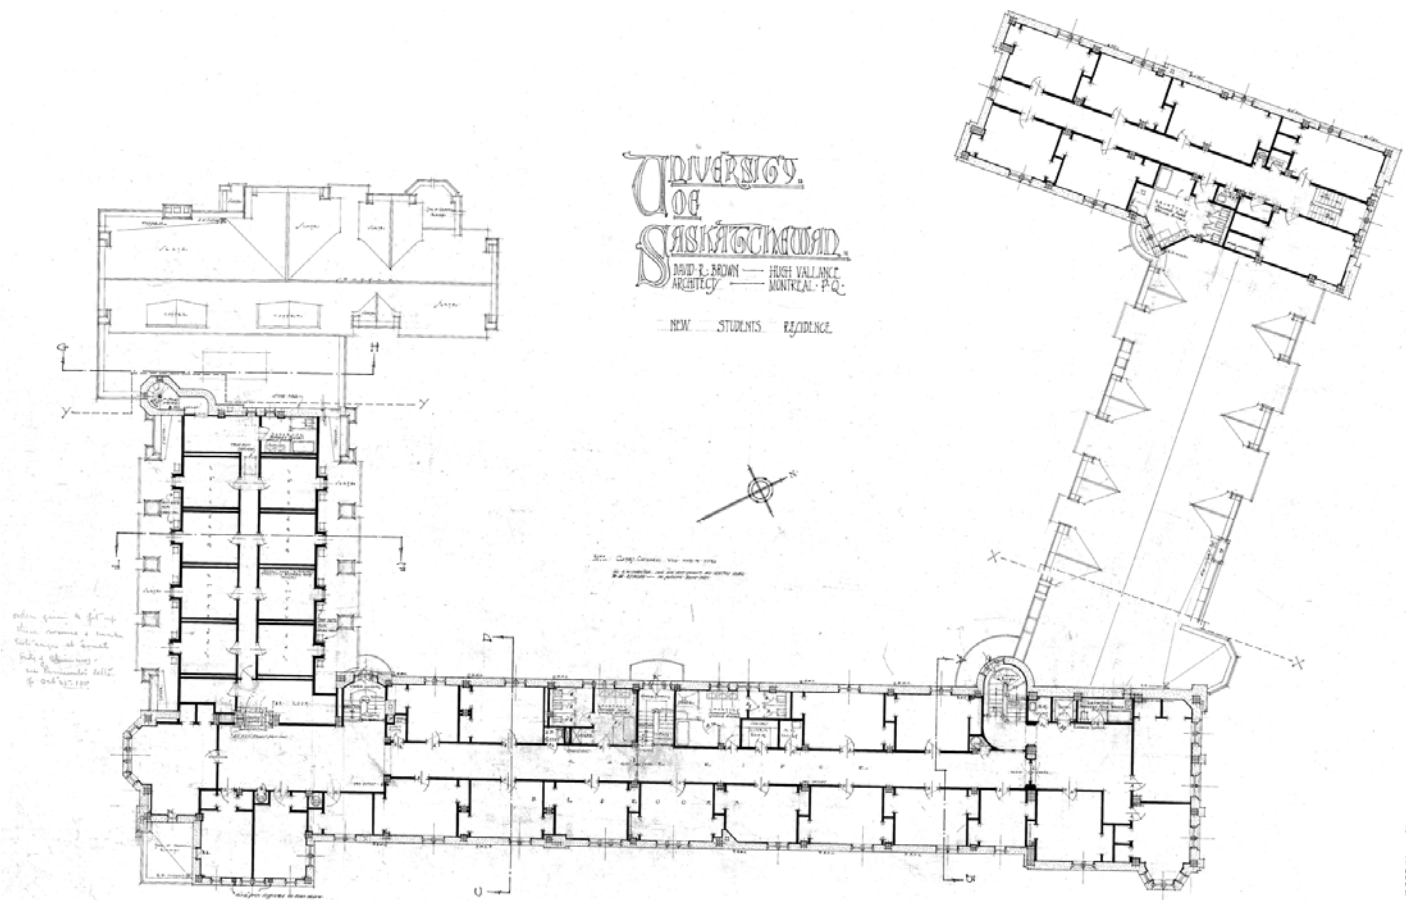
Figure 26. Original third floor plan. 'The rafters' are in the upper left (south west) corner, accessible here only by the turret staircase. North is to the right. Retrieved from Facilities Management Division Asset Record System, File Q-29-T.

The third floor of the south wing has become known as 'The Rafters.' The rooms here are named for their high, slanted ceilings that take the shape of the roof directly above. These rooms look out of the dormer windows that puncture the roofline of the south wing. Formerly, these rooms were accessible only by a spiral staircase in the turret on the building's south west corner. This spiral staircase was removed as part of renovations in 1972, and the 'Rafters' are now reached by new stairs added at either end of the hall.

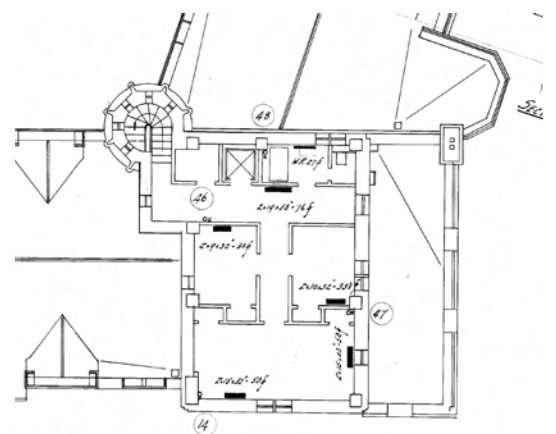
Figure 27. 'The Tower' as it was originally configured. It has since been divided into residence rooms. Retrieved from Facilities Management Division Asset Record System, File Q-14-T.

The fourth floor of Qu'Appelle Hall is known as the 'Tower,' and is no longer used because it is served by only one staircase, and therefore does not conform to the current fire code. This area consists of a suite of four rooms in the north east corner of the building.

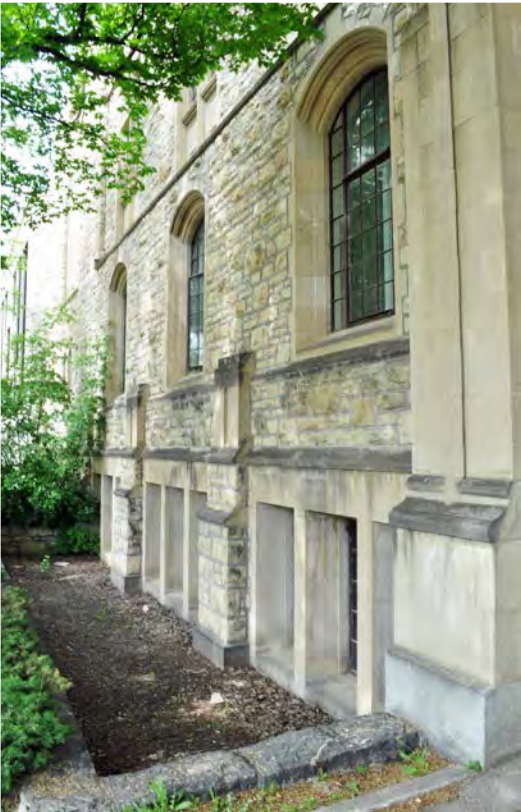
Figure 1. Materials of the Physics Building: greystone complemented by Indiana limestone with a granite base.

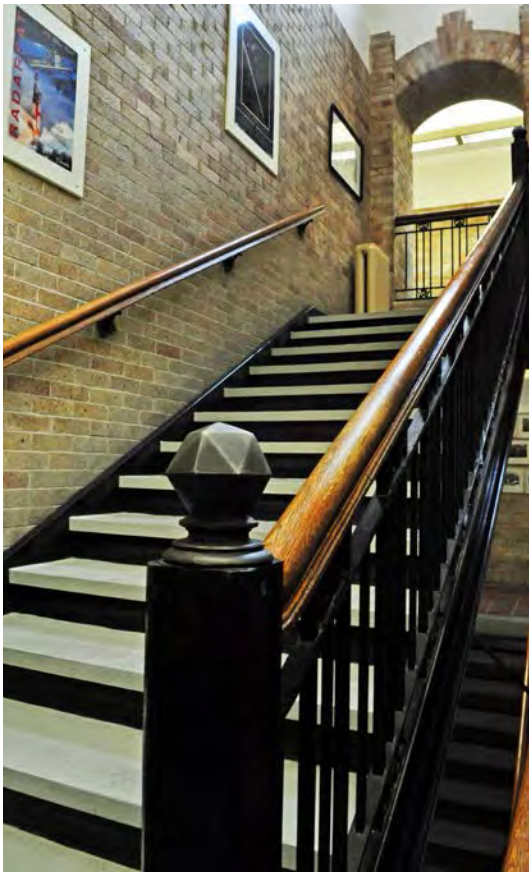
Figure 4. Main staircase: steel and iron balustrade and stringers, oak banister. The concrete treads are not original.

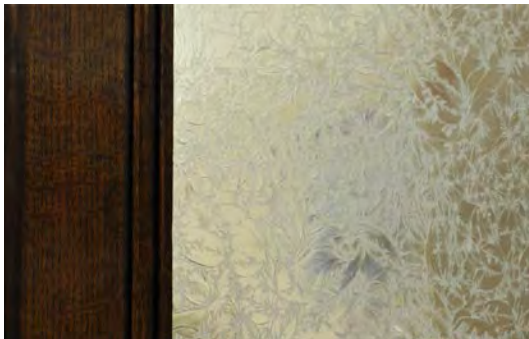
Figure 5. Patterned glazing in a quarter sawn oak door.

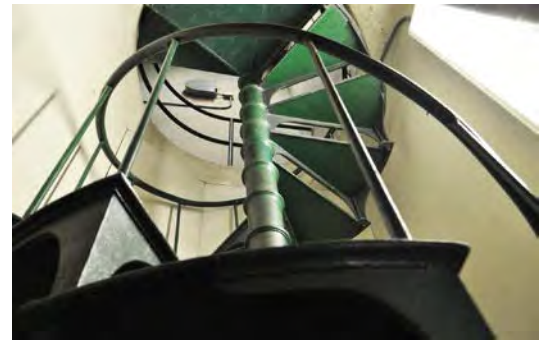
Figure 8. Steel and iron staircase.

The main staircase in the Physics Building shares many characteristics with other early University of Saskatchewan buildings, such as the MacKinnon Building: slate treads, and oak handrails supported by steel and iron balusters (Figure 4). The commemorative integrity of the staircase is diminished by the fact that the treads between the ground and first floor have been replaced with concrete. The remaining original slate treads in the Physics Building were replaced with matching slate in 2012. Two secondary staircases also exist in the building: a narrow flight of stairs leading from the Second Floor to the Attic level and roof, and an interconnecting spiral stair between the Second storey and the Attic. Both of these secondary staircases are constructed of iron and steel (Figure 8).

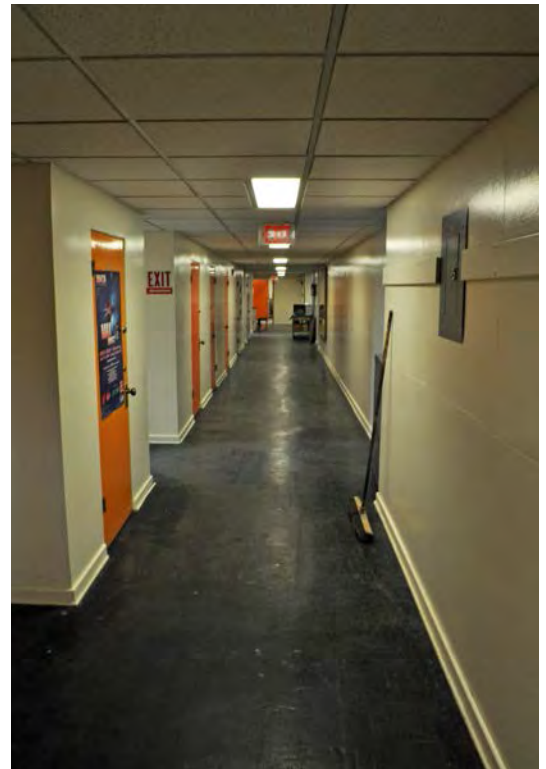
Figure 9. Attic corridor.

The third floor or attic features a material set completely different from the rest of the building. Shown in Figure 9, the walls appear to be made of painted wood as well as the doors. The floor is painted concrete and the original ceiling has been covered by a suspended acoustic tile system. Steel roof trusses, which form part of the roof structure, are also partially exposed in the attic level (Figure 10). (See Section 2.6 Systems).

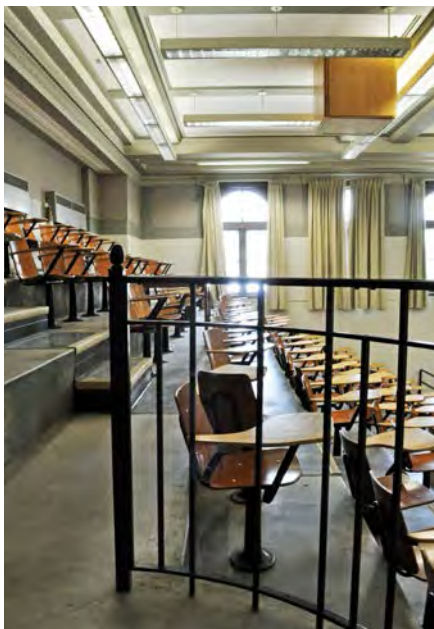
Figure 11. Lecture theatre: steel and iron balustrade and desk mounts, original windows and concrete risers.

The lecture theatre (Figure 11) is a character-defining element, but many of its material finishes have been altered over time. The concrete risers and wooden tablet-arm chairs are original. The painted wood ceiling, painted wood wall panelling and acoustic panels on the walls and ceilings were the product of later renovations. The brick walls have also been painted. The original oak and slate chalkboard, although worn, has not been refinished. The original steel and iron balustrade is pictured in Figure 11. Overall, this room has a high level of commemorative integrity.

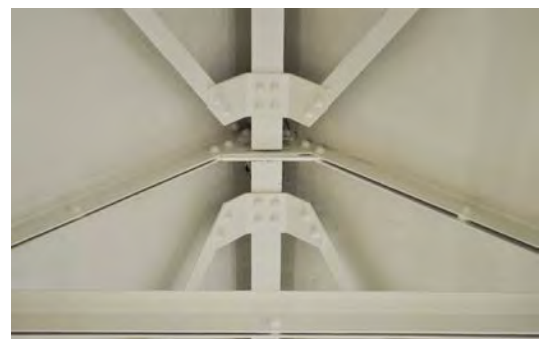
Figure 10. Steel truss.

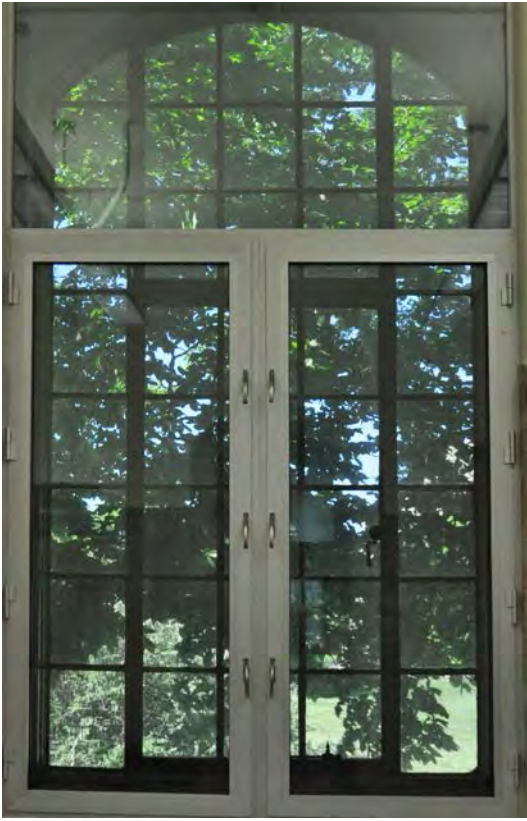
Figure 12. Modern aluminum framed secondary glazing over the interior of the original windows.
