University of Saskatchewan

Heritage Register

September 2013

Facilities Management
Division

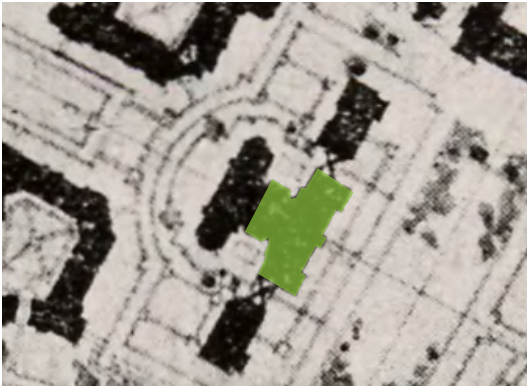
Figure 13. Plan view of the Physics Building. The original built portion is indicated in green. North is to the left.

The Physics Building is a T-shaped building in plan, laid out with its primary axis parallel to the central axis of [The Bowl](#). Its secondary axis is laid out perpendicular to the first, aligned with the centre of The Bowl and protruding to the north of the building. The architects intended for the Physics Building to eventually take the shape of an H, with two hallways joined by lecture theatres at the centre. Figure 13 illustrates the original plan, and the form of the building as constructed in 1921.

The form of the Physics Building has been added to over time. Figure 14 shows the original form. For a plan view of the original form refer to Figure 13. In 1948 the Betatron Building was built as a one storey addition accessible through the basement of the Physics Building. The Betatron Addition featured thickened concrete walls to contain the gamma rays being researched there. This addition also featured a small concrete chamber for gamma rays to be shot into and measured. The thickened walls of the chamber are shown in Figure 15. Between 1966 and 1967, an addition to the Physics Building was constructed to the south-east.

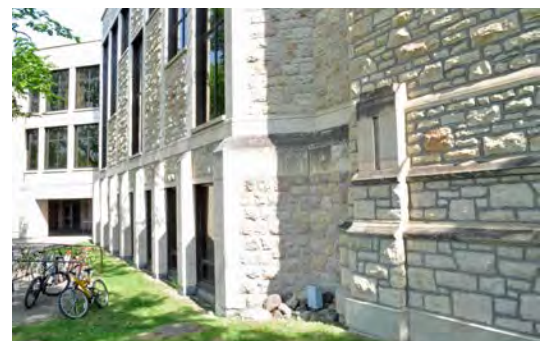
Figure 17. L to R: the facades of the Geology and Physics Buildings.

A similar modification was made to the building's form on the north-west where a link to the Geology Building has joined the two buildings, as seen in Figure 17.

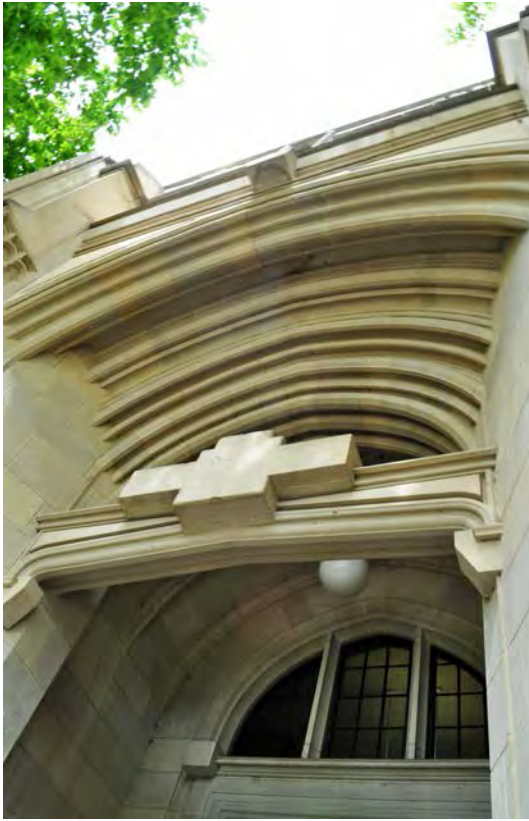
Figure 18. A recessed, vaulted entryway with pointed arches is a Collegiate Gothic character-defining element. Other typical Collegiate Gothic decorative elements, such as grotesques, heraldry and reliefs are absent.

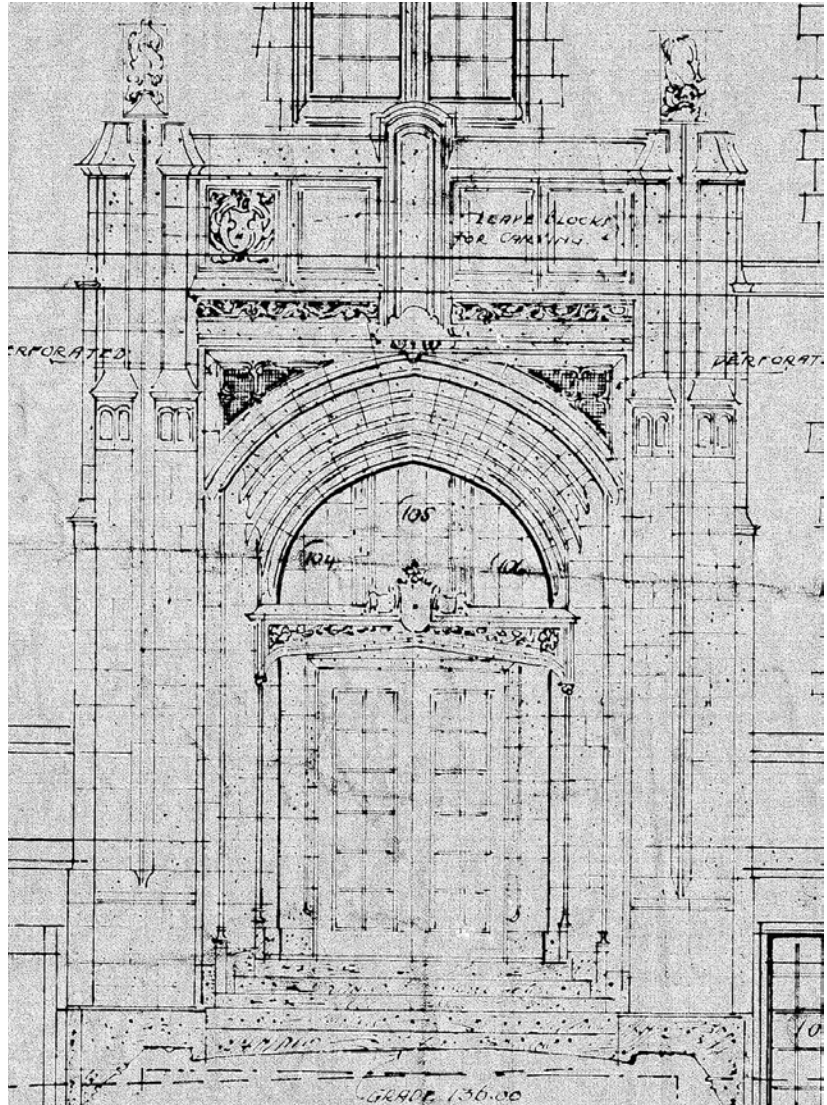
Figure 19. A drawing specifying ornamentation around the main entry. Retrieved from Facilities Management Division Asset Record System, File P-6-T.

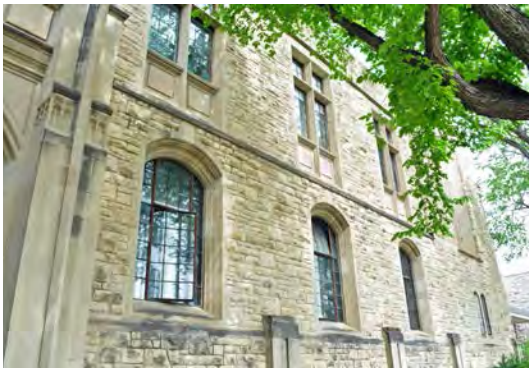
Figure 20. Arched windows, stone piers and spandrels.

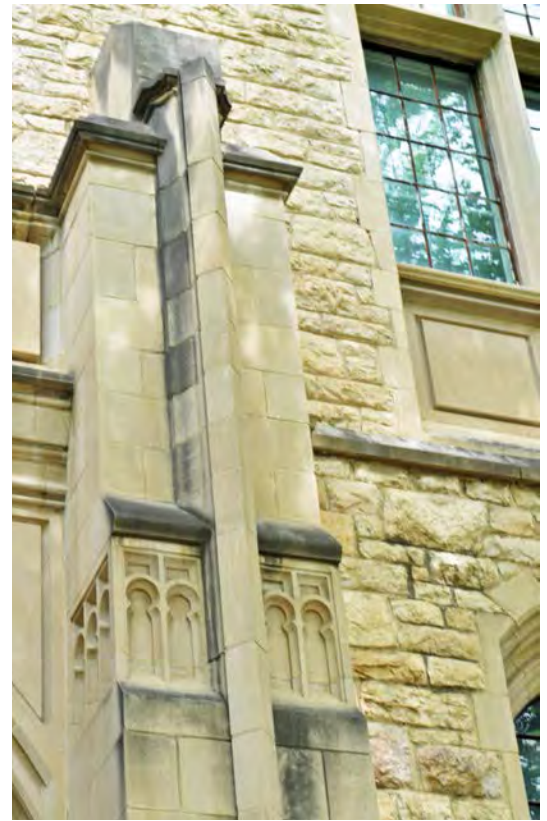
Figure 21. Horseshoe arch reliefs decorate either side of the main entry.

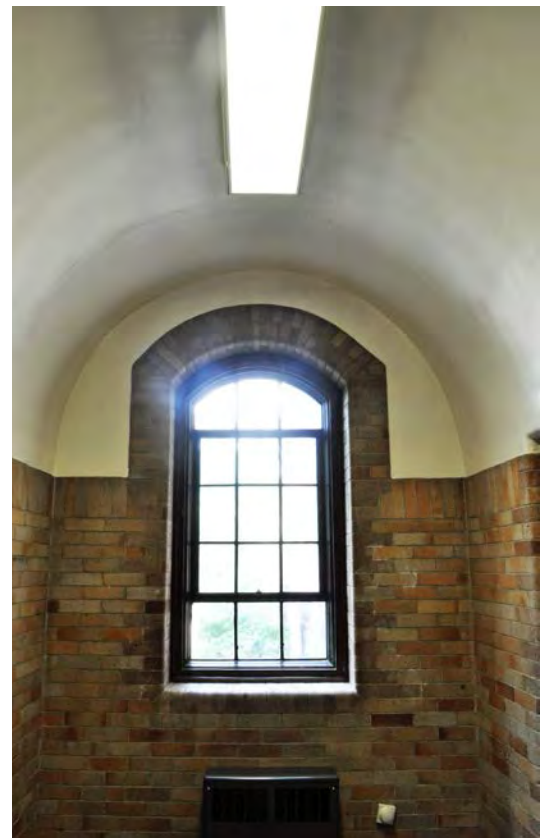
Figure 22. A vaulted ceiling and brick wainscoting.

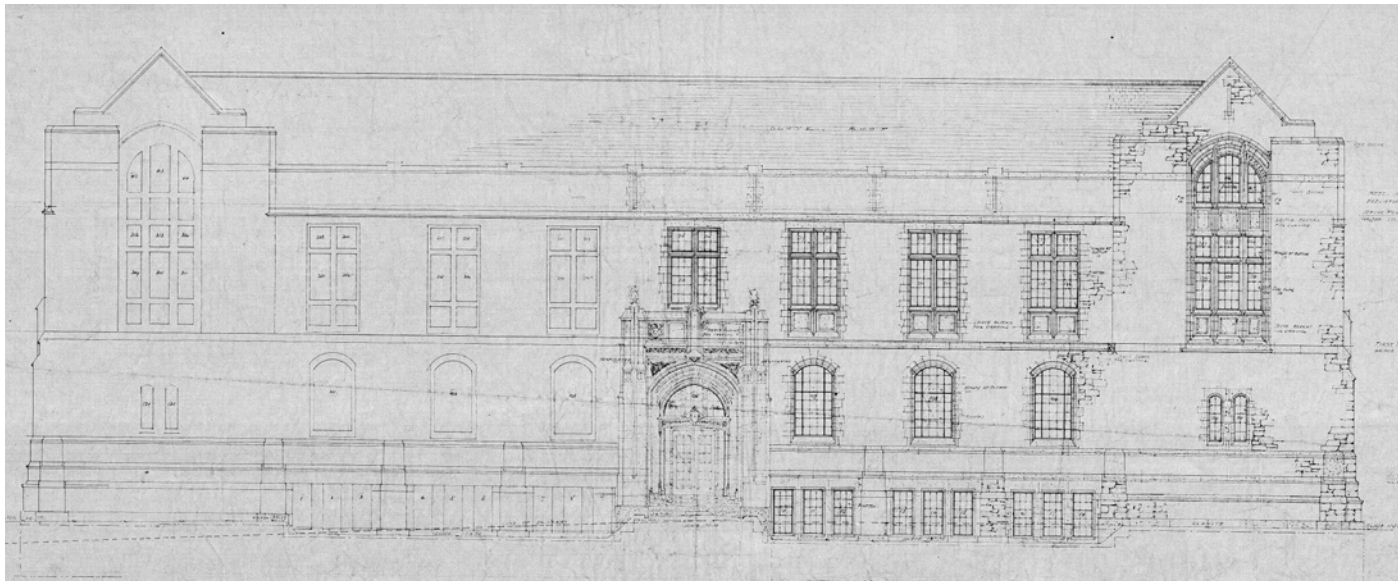
Figure 23. A 1917 elevation of the Physics Building. Retrieved from Facilities Management Division Asset Record System, File P-6-T.

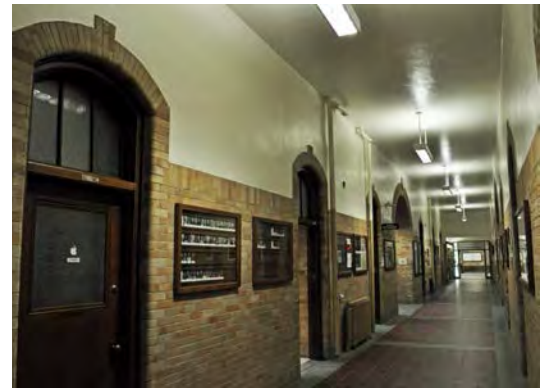
Collegiate Gothic elements are continued inside the building. The entrance vestibule features brick walls and arches, and a second set of oak doors, with an arched wooden transom. In the corridors, a brick wainscoting is extended to form brick archways around door openings (Figure 25). The doors also feature arched transoms. Many of the interior windows share this arched shape. Many secondary hallways feature vaulted ceilings and arched entries. Figure 22 shows some of these interior elements. The attic contains heritage value in the large arched windows of the two end bays, which are set at floor height and nearly reach the ceiling (Figure 30).

Figure 25. The main corridor of the Physics building relies on electric light.

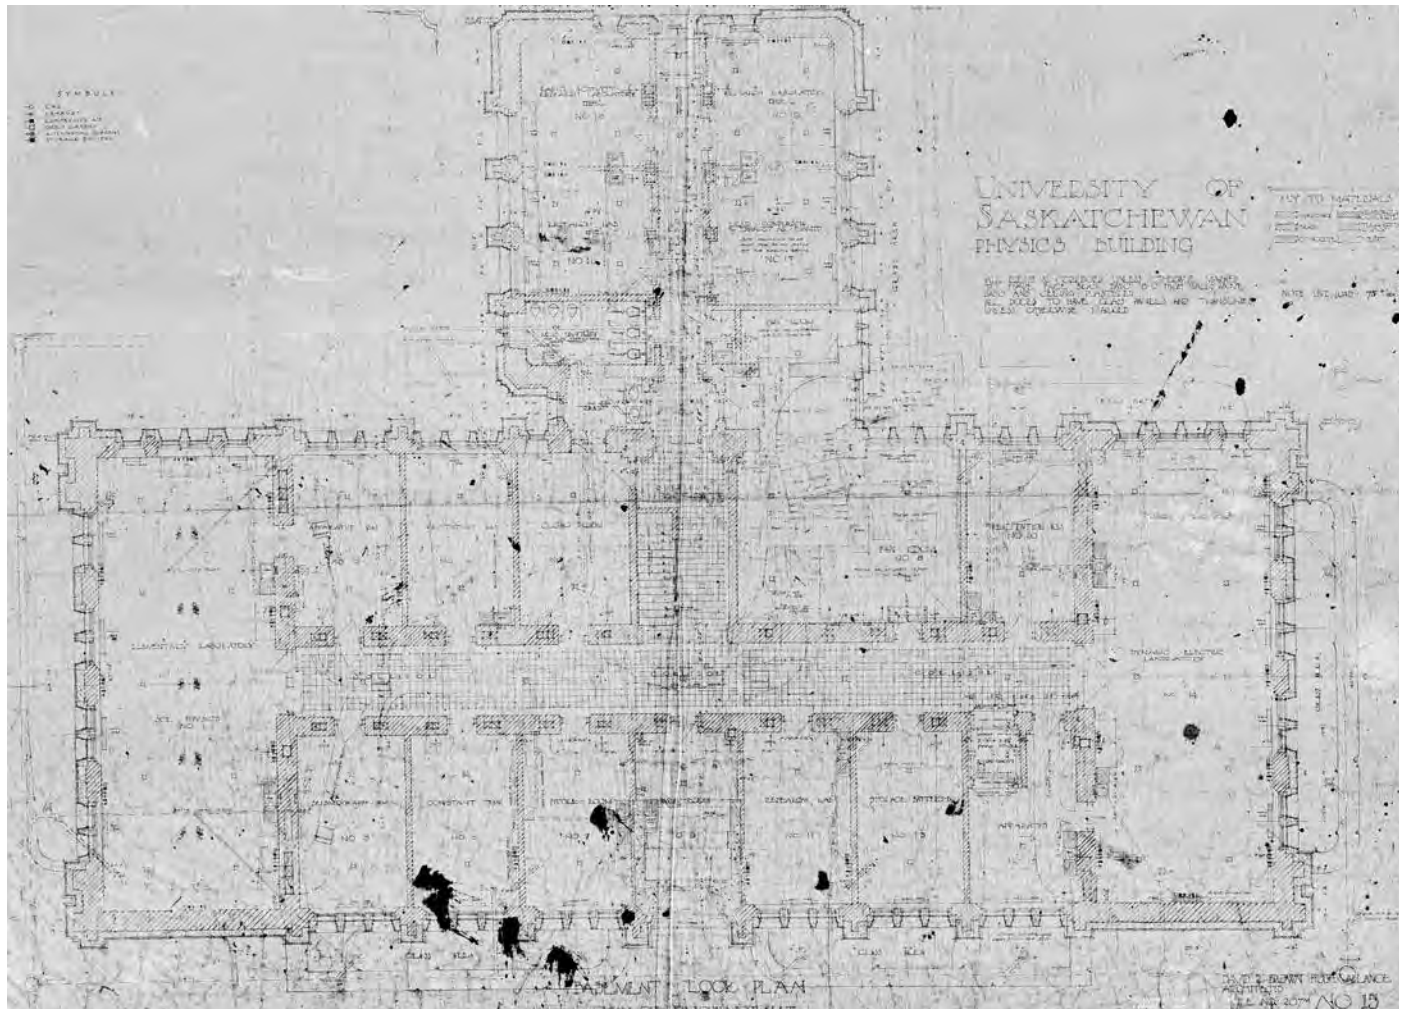
As discussed earlier, the Physics Building is T-shaped in plan. The longer bar form, which sits parallel to the central axis of The Bowl, was arranged on each of the basement, first and second floors as a series of rooms arrayed along a double-loaded corridor (Figure 26). These rooms contained laboratories, classrooms and offices. The second volume of the building, which extends from its north side, contained the larger space of the lecture theatre, which spans between the first and second floors.

The basement's spatial configuration has been changed in a similar fashion. Figure 26 shows its original layout. The east portion of the basement has been reconfigured to connect to the basement of the Physics Addition. The large lab that Figure 26 shows at the end of the basement corridor has become an extension of the hallway. Figure 27 shows this change. The west end of the basement has not been extended.

Figure 26. A 1917 basement floor plan shows labs at either end of the main corridor. Retrieved from Facilities Management Division Asset Record system, File P-10-T.

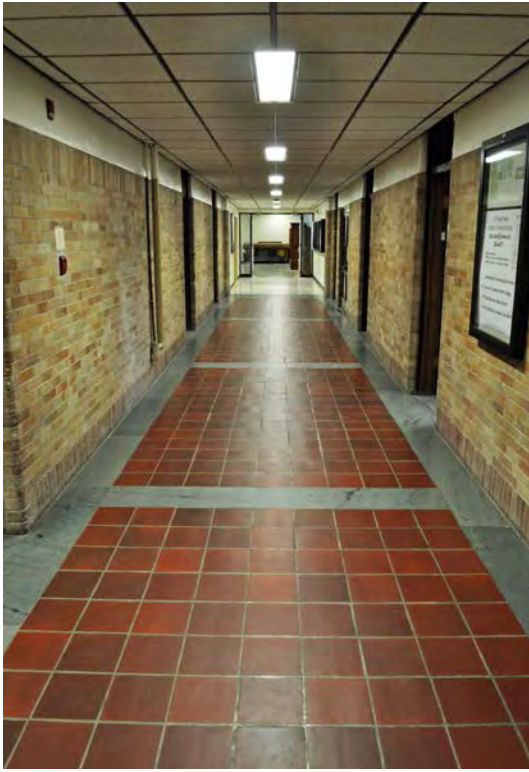
Figure 27. The main corridor features brick walls, terra cotta and slate floor tiles. A suspended ceiling tile system has obscured some of the transom windows above the doors.

The application of suspended ceiling tiles in the basement has reduced the height of these spaces. The ceiling in the northern portion of the building has not been covered. Where the dropped ceiling has been installed, some transoms have been partially obscured. Fluorescent lighting has been installed within the suspended ceiling tile system and now provides the majority of the light in the corridors.

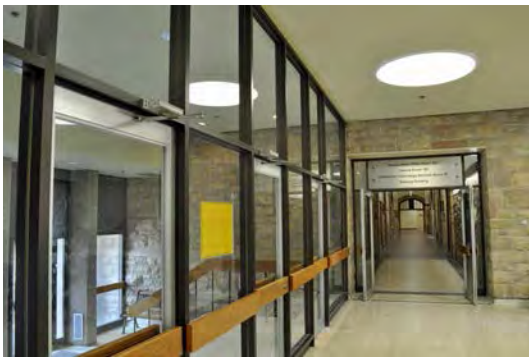
Figure 28. Lobby of the Physics Addition.

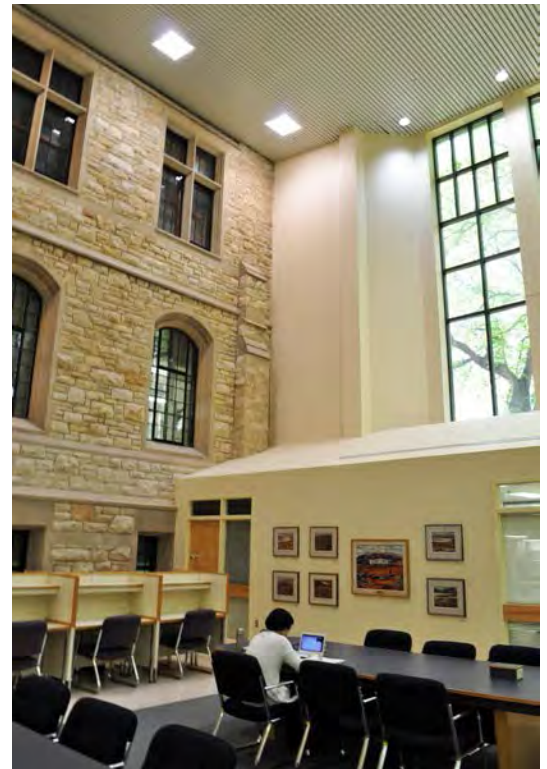
Figure 29. The west wall of the Physics Building now makes up part of the interior of the Geology Building.

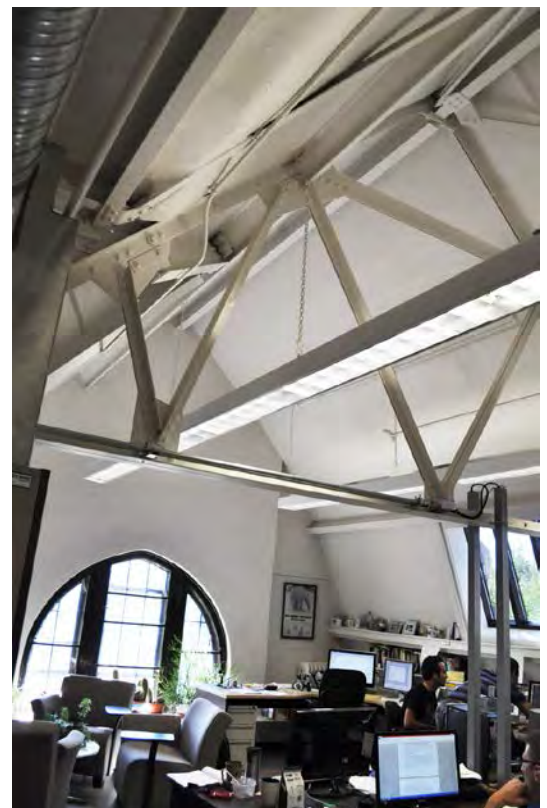
The rooms in the attic space are also filled with daylight, owing to the large skylights and arched windows there. The skylights are original features, which retain their character and are useful in lighting offices, equipment rooms and labs. These skylights are important in defining the light and airy character of the attic. The exposure of the steel truss system, the high ceilings and sloped walls of the attic are all elements integral to the quality of this space (Figure 30).

The roof structure over the laboratory wing in the Physics Building consists of a sloped concrete slab with embedded steel I beam purlins on a system of steel trusses. Steel columns and a steel truss system support the roof structure as shown in Figure 30. The truss system spans the width of the roof and continues along the slanted walls created by the slope of the roof. The walls that have been added in the attic now conceal the steel column supports shown in Figure 30. The steel truss remains visible in the attic. The roof structure over the lecture theatre is a cast-in-place concrete slab with embedded steel I beam purlins.

Figure 30. Attic: large gothic arched window, exposed truss and high sloped ceiling.

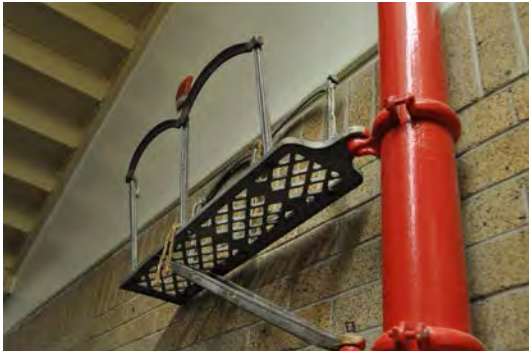
Figure 33. Fire hose carrier.

The building also still carries remnants of more common systems at the time. For example, fire hose carriers can still be found attached to some of the stand pipes (Figure 33). Also, as the building was constructed for use in scientific education and experimentation, many of the windows and transoms were equipped with hinged valance boxes (Figure 34). The valances were presumably provided to house dark blinds for controlling light levels in the labs. Some windows still have built-in chases and provisions for tying down the blinds. The hinged valances remain, but no blinds are known to still exist.

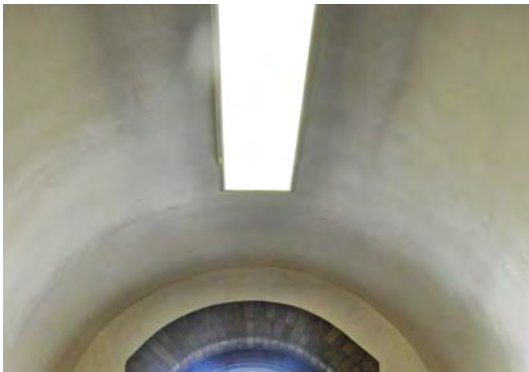
Figure 34. Hinged oak valance.

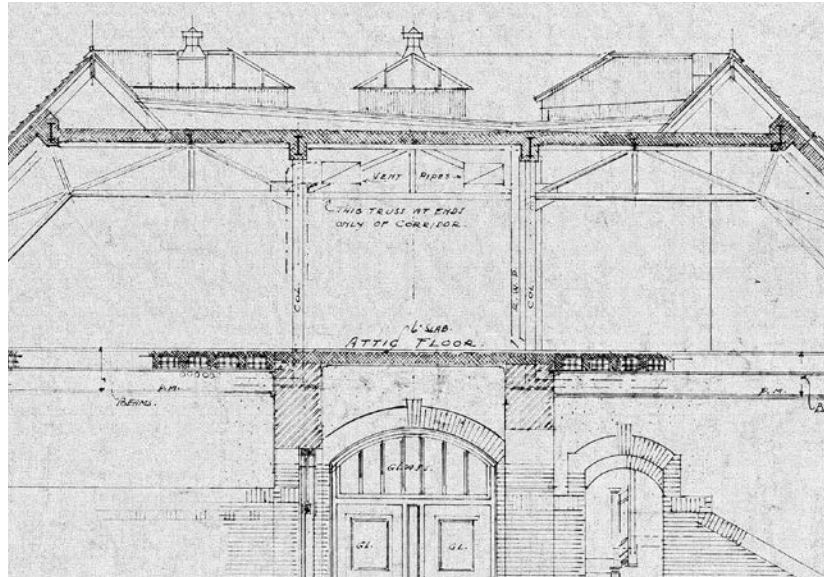
Figure 31. A 1917 section shows the roof structure of the Physics Building. Retrieved from Facilities Management Division Asset Record System, File P-2-T.

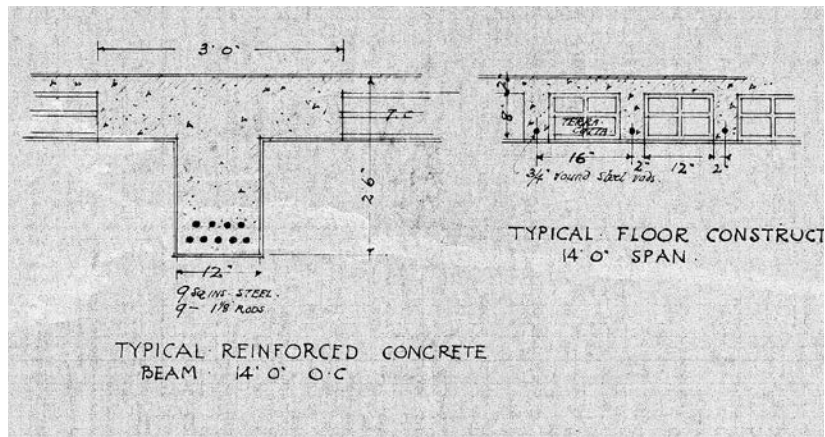
Figure 32. A 1917 section shows the floor structure of the Physics Building. Retrieved from Facilities Management Division Asset Record System, File P-2-T.

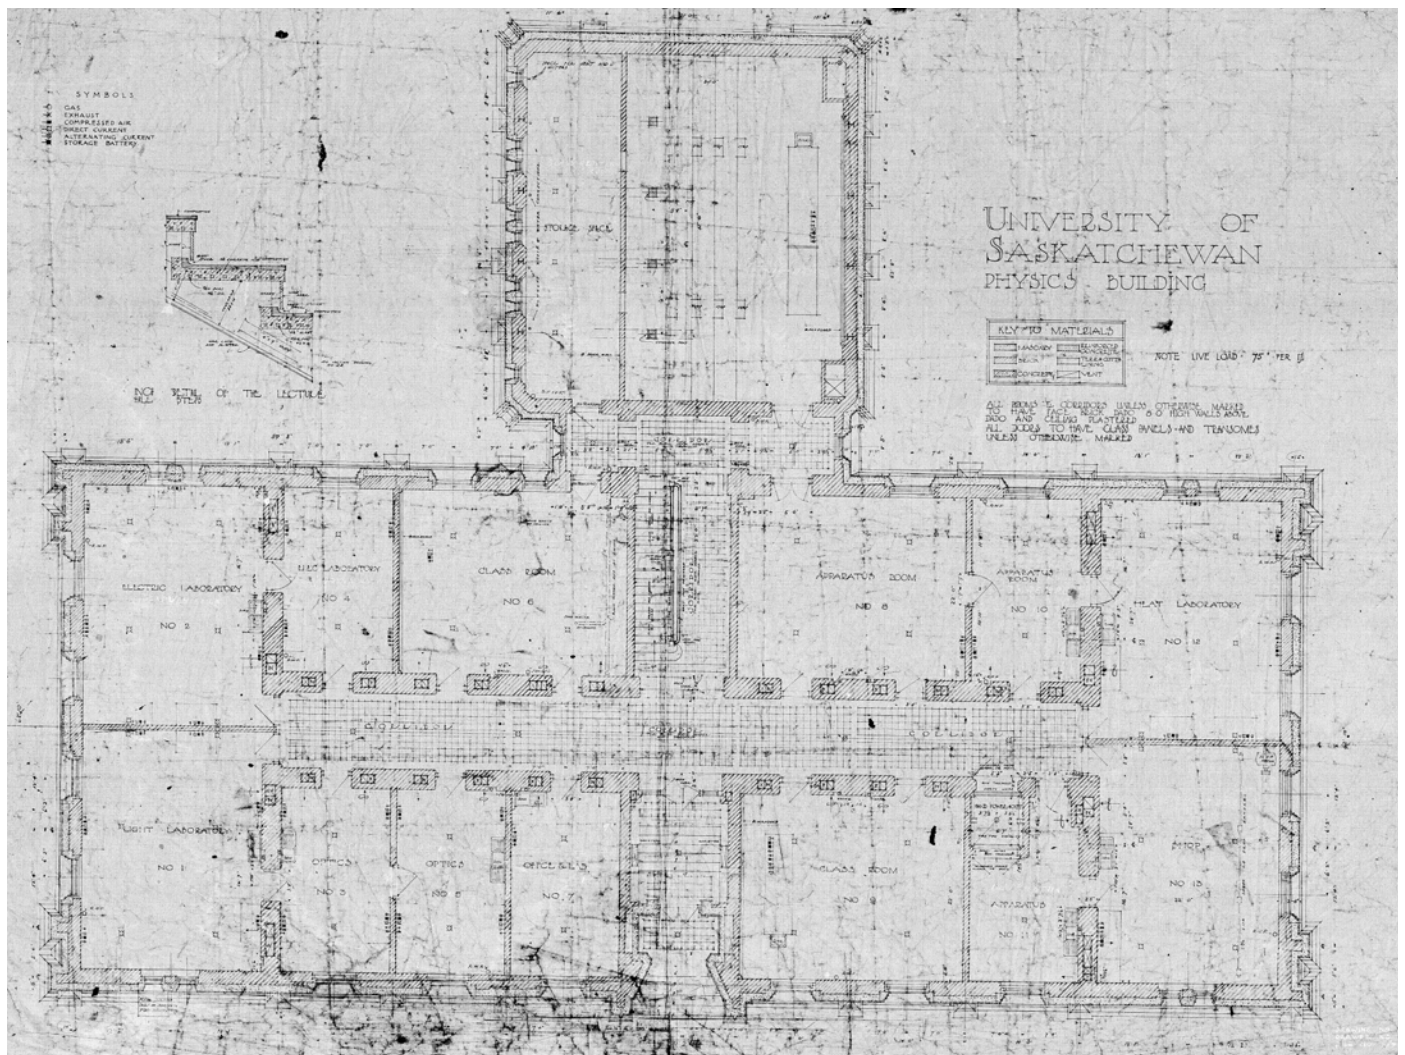
The Physics Building was originally used for classrooms, laboratories, equipment, recitation rooms and offices. It housed biology laboratories until a Biology Building could be constructed. As Figure 35 shows, the ground floor originally housed an apparatus room, an optics laboratory, offices and classrooms. When the building was first occupied in 1921, biology was allotted the two large ground floor labs, the large lab at the west end of the basement and a number of smaller rooms in the basement for offices. Physics occupied the rest of the building aside from a few other assorted uses.

Figure 35. 1917 first floor plan for the Physics Building. Rooms were arranged with the assumption that professors would use minimal lab space in conjunction with classrooms and offices to carry out their research. Retrieved from Facilities Management Division Asset Record System, File P-9-T.

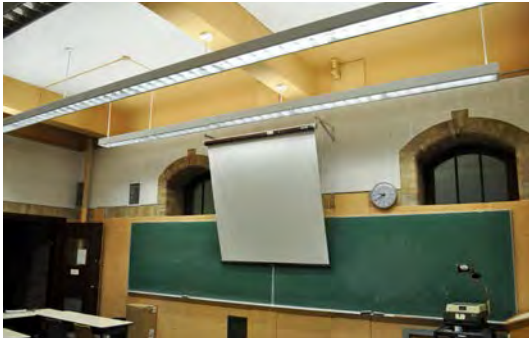
Figure 36. The ground floor has a seminar room where an apparatus room used to be.

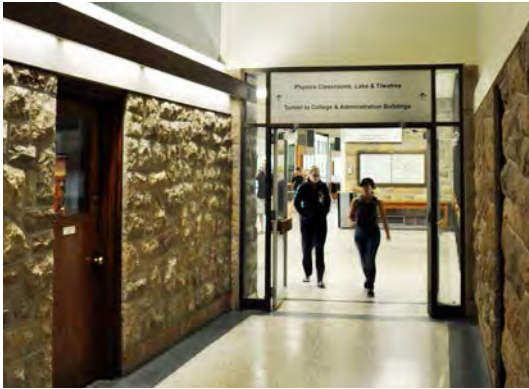
Figure 37. East end of the ground floor corridor.

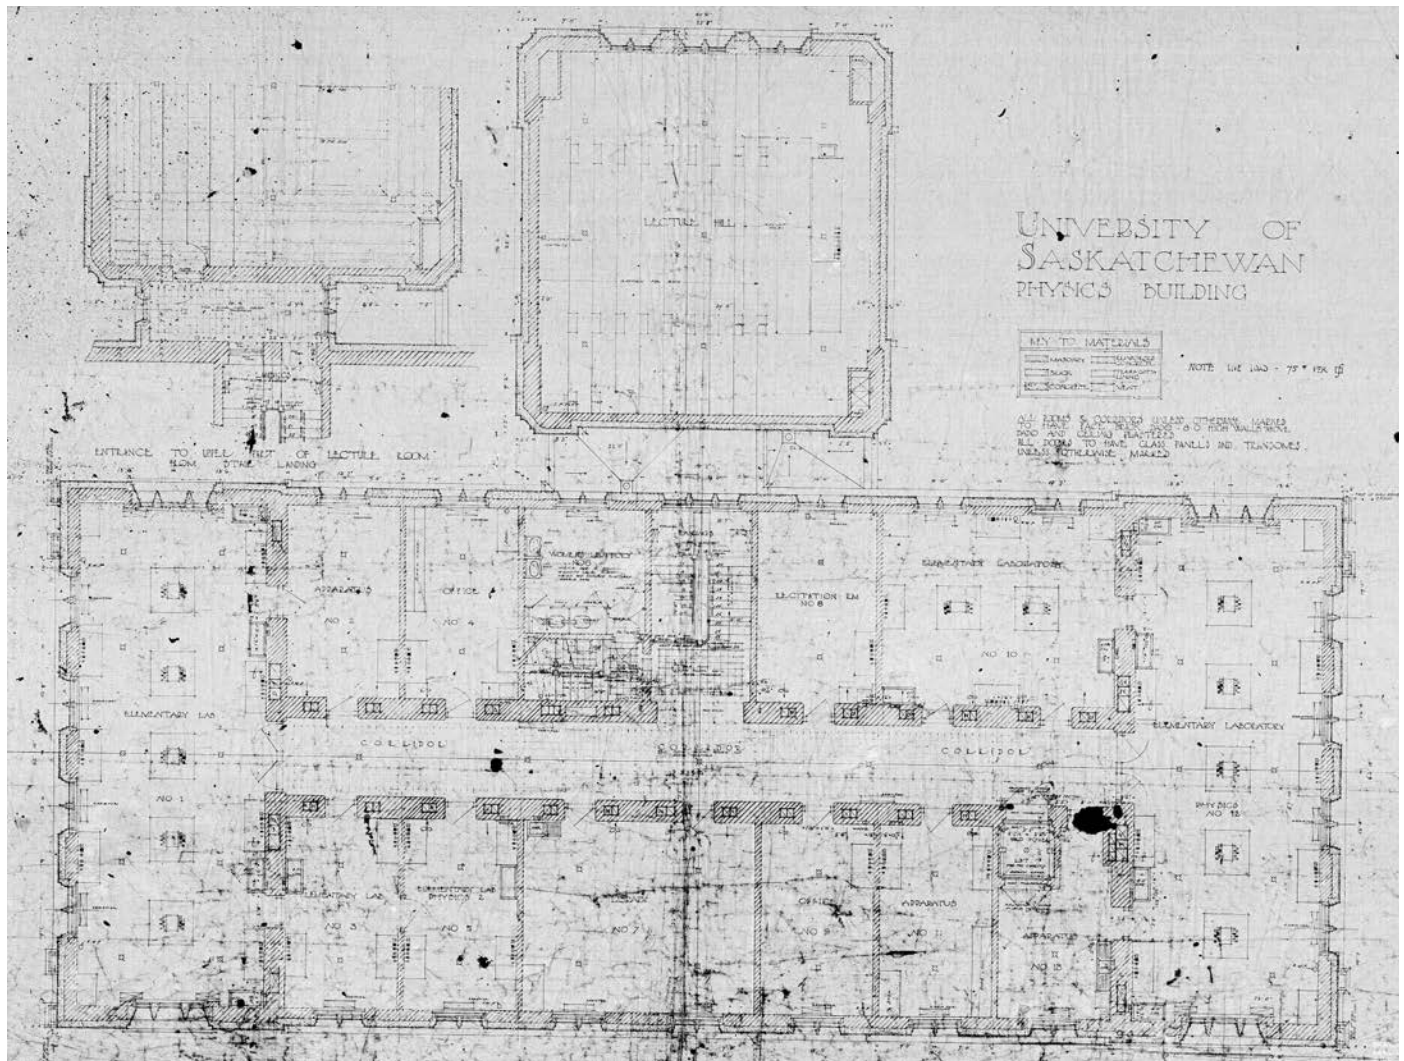
The second floor has undergone much the same transformation as the first floor: from classroom space to office space. Once home to labs, offices, apparatus and recitation rooms it now houses the laboratories and offices of the Institute of Space and Atmospheric Studies. The rooms terminating either end of the first floor corridor are still existent and in use. Figure 38 shows the original uses of the second floor.

Figure 38. The 1917 second floor plan. Retrieved from Facilities Management Division Asset Record System, File P-8-T.

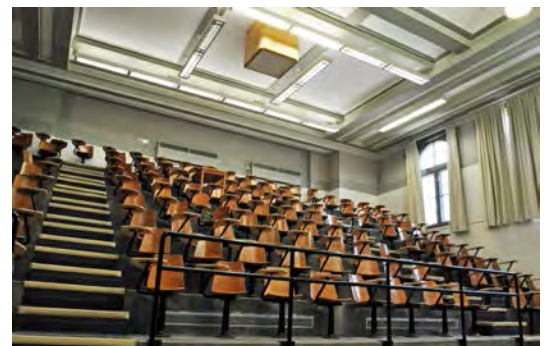
The main lecture hall pictured in Figure 39 is a character-defining element indicative of the building's original use. The room has stayed true to its original purpose and retains its commemorative integrity.

Figure 39. The University of Saskatchewan's first lecture hall.

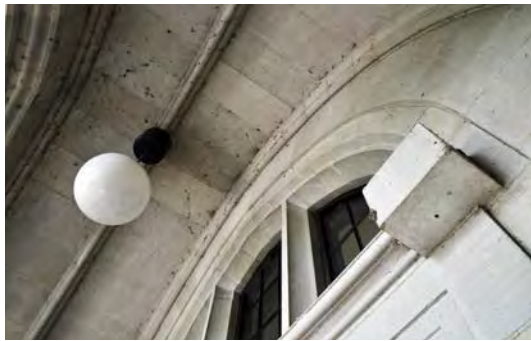
In the circumstances of its delayed construction, the Physics Building may be associated with the First World War and the economic situation it created. The unfinished stone decoration at the main entry is also perhaps an indication of these economic difficulties (Figure 40).

Figure 40. Stone blocks over the entrance to the Physics Buildings were intended for future carved decoration, but were never completed.

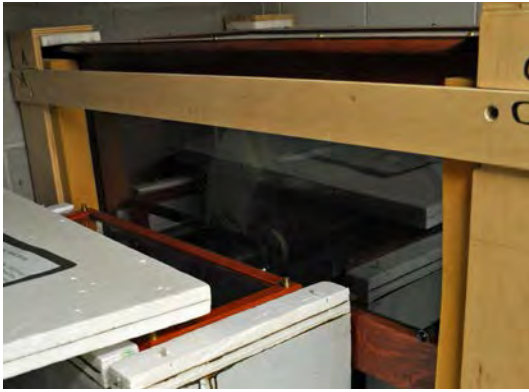
Many objects of heritage value are stored in the building. These are shown in Figures 44 through 47. In the basement of the Physics Addition, old equipment and apparatus are stored. Objects of interest include: glass instruments hand blown by former Department Head Ertle Herrington (Figure 44), parts from the 1948 Betatron (Figure 45) and the first X-Ray unit in Western Canada (Figure 46).

Figure 46. Dr. Herbert Weaver's X-Ray Machine, the Ranney-Wimshurt-Holtz static machine. Dr. Weaver moved to Saskatoon in 1905 and the X-Ray machine arrived in 1906, making it Western Canada's first X-Ray unit.

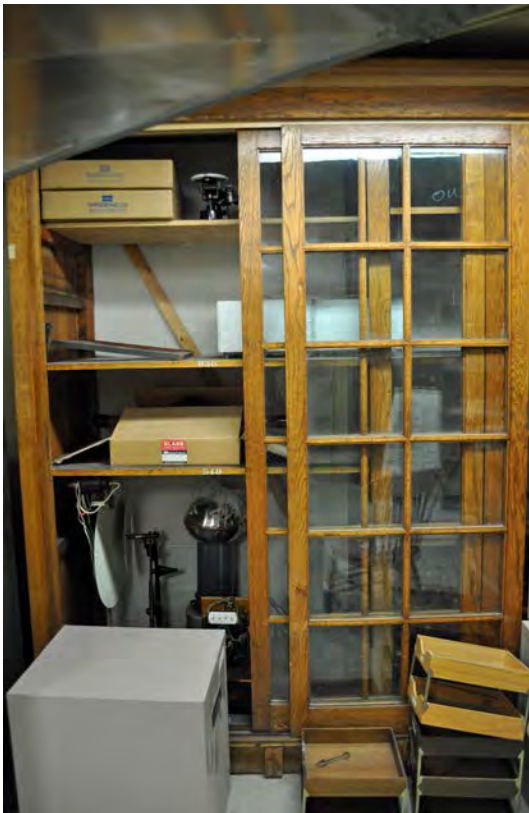
Architects Brown and Vallance designed furnishings for the Physics Building that are shown in Figure 47.

Figure 47. Apparatus cases designed for the building by Brown and Vallance Architects.

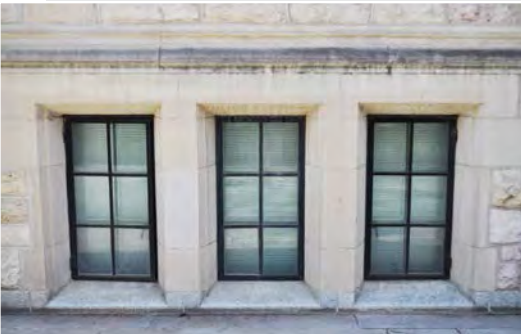
Figure 1. Greystone walls, Indiana limestone trim and window surrounds, painted steel framed windows and granite base course.

'Greystone', in a buff color with scatterings of pink and purple, is the principal exterior material of the Thorvaldson Building. This material is significant both for its local origin and because it characterizes the early architecture of the University of Saskatchewan campus. A fine-grained grey granite forms the building's base, as well as the stairs leading to its grand main entrance. Doors and windows are trimmed in Indiana limestone, which is also used for various other decorative stone elements. All of the stone materials have heritage value as elements defining the character of the building. The stone of the Thorvaldson Building generally remains in a state of excellent commemorative integrity. (For further information on building stones used at the U of S, refer to ['Appendix: Stone'](#)).

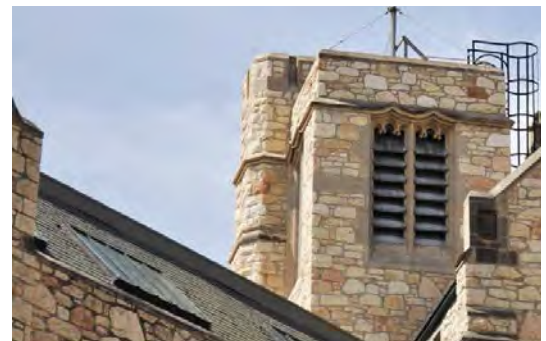
Figure 3. Slate tile roofing, lead covered louvres on exterior venting.

Pitched roofs were originally clad in slate, and most remain so, although it is not known how much original material remains. Roof flashings and ridge caps were formed from copper. Some of these elements have been replaced with prefinished steel, but much of the copper remains in a good state of commemorative integrity (Figure 3). The east wing of the building originally featured a saw-tooth roof with skylights, but this feature has been removed and replaced with a conventional flat roof. Ventilation louvers on the back side of the tower were clad in lead, which remains in place (Figure 3).

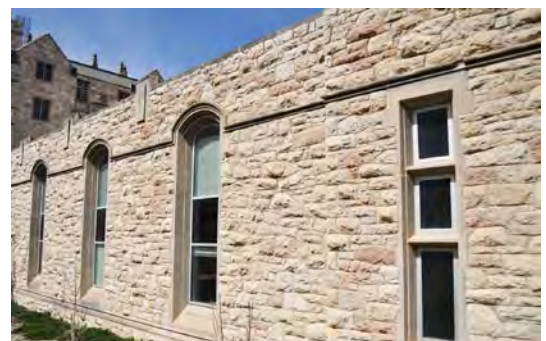
Figure 4. Replacement windows in the northern annex.

The windows of the building are generally single-glazed steel-framed casements of which there is both an exterior and an interior set. These remain in excellent condition with the exception of the east wing. There, the original double-height steel framed windows have been replaced with aluminum framed windows (Figure 4).

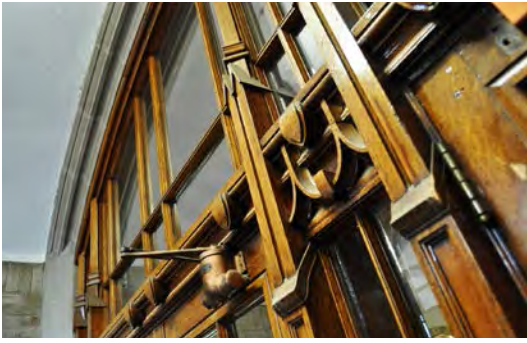
Figure 5. Oak door frame and transom with carved gothic motifs.

The main entrance of the Thorvaldson building features an elaborate portico, with a carved limestone archway leading to a vestibule formed by two sets of oak doors. The exterior doors are replicas of the original oak doors, made in 2011, and mounted in the original oak frame. The interior doors are set into an intricate oak frame and transom, carved with various gothic motifs. This feature is a striking piece of artistry and is in very good condition (Figure 5).

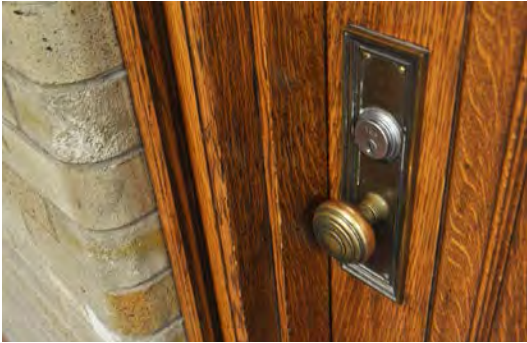
Figure 6. Brick wainscoting, quarter sawn oak door and brass door hardware.

The finish materials of the interior of the building exist in varied states of commemorative integrity. Many of the original oak doors remain, including their brass hardware, and are generally in good condition (Figure 6). Although some have been removed or replaced. Public corridors have red clay terracotta floor tile which is generally in good condition. In the basement some replacements have occurred. In the public corridors and many other rooms, walls are of painted plaster, with brick wainscoting (Figure 6). These character-defining materials are generally in excellent commemorative condition where they have survived.

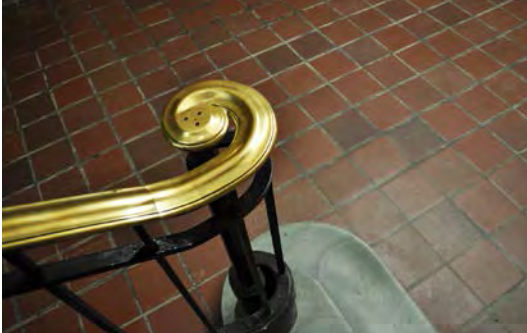
Figure 7. Red terracotta tile, slate stair treads, iron balustrade and bronze banister.

The main stairs of the Thorvaldson Building are a grand feature dominating the entrance hall. The stairs are formed of slate treads, with painted steel stringers, a cast and wrought iron balustrade and a bronze handrail (Figure 7). In 2012, the slate treads and landings on the staircase were replaced with new slate matching the original material.

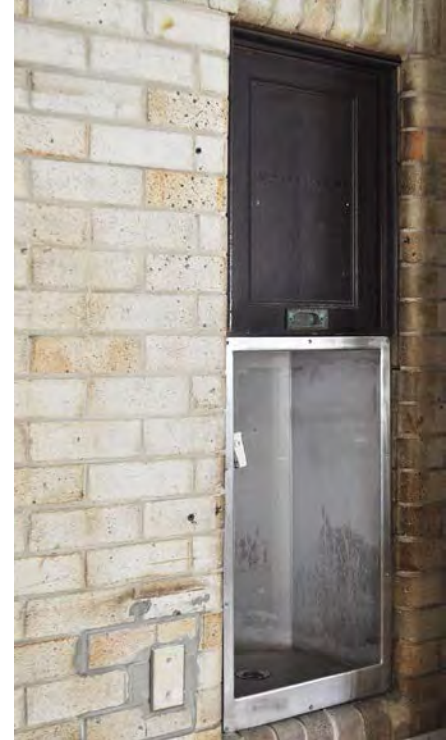
Figure 8. Remaining wood panelling over replaced sink.

In the laboratories, classrooms and offices, some material integrity has been lost. Originally the building featured birch flooring in its laboratories and classrooms, but none remains. The laboratories featured stone sinks made of New York granite with porcelain covers. These have been replaced with stainless steel sinks such as the one shown in Figure 8. Blackboards were specified for all labs and classrooms; three chalkboards of slate and oak remain and are in good condition. The largest of these boards is the sliding chalkboard which is still used in the auditorium today. The oak chart frames in the auditorium space have also been maintained. The brick wainscoting, steel and brass window hardware and wooden trim of the windows has been maintained in the classrooms, labs and many offices (Figure 9).

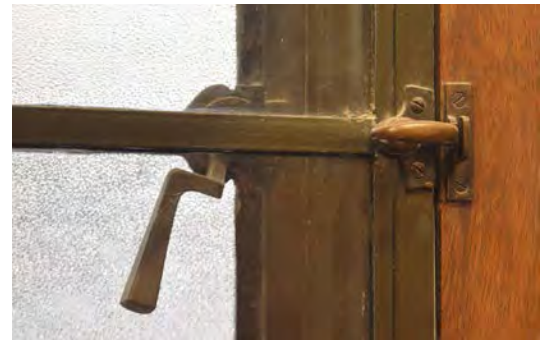
Figure 9. Steel window frames with oak surrounds and brass window hardware.

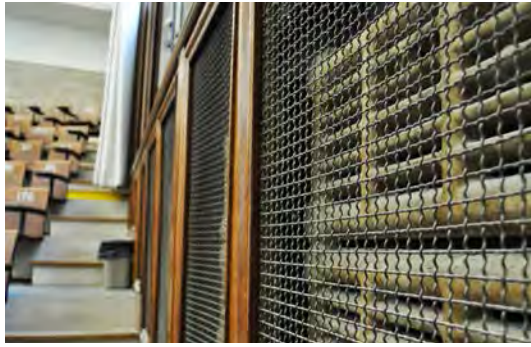
Figure 12. Painted cast iron radiators in original oak cabinet with brass screen.

The auditorium or ‘Airplane Room’ is well-known at the university both for its striking form and for its historical integrity. Its materials are largely unchanged. Painted plaster and brick walls are well-maintained and original. The steel and wood tablet arm chairs are original but are in poor commemorative condition. The tablets record decades of student graffiti with dates as far back as 1933. The concrete of the tiered floor has been covered by vinyl composition tile (VCT), but the risers have their original concrete finish. The brass ventilation grilles have been well maintained (Figure 11). The domed ceiling of the Airplane Room has long been covered in a spray-applied acoustical material. An alumnus who attended class in the space from 1947-1950 recalls that the ceiling was, “like the rest of the ceilings in the building,” and that the asbestos finish on the dome came later (Tom Jasienuk, personal communication, August 17, 2012). With this information it can be assumed that the dome was finished in plaster. Ceramic tiles are still visible in the flat ceiling surrounding the dome. (Structure discussed in section 2.5 Systems). The oak-framed windows remain in excellent commemorative condition. The bottom row of windows have been rendered opaque with the addition of dark steel panels into the window frame as shown in Figure 11. Underneath the large windows is an oak cupboard with brass screens which houses cast-iron radiators. The commemorative integrity of this cabinet is intact (Figure 12).

The original heating system of cast iron radiators, shown in Figure 12, was common at this time. The building’s radiators remain in good condition and are still in service.

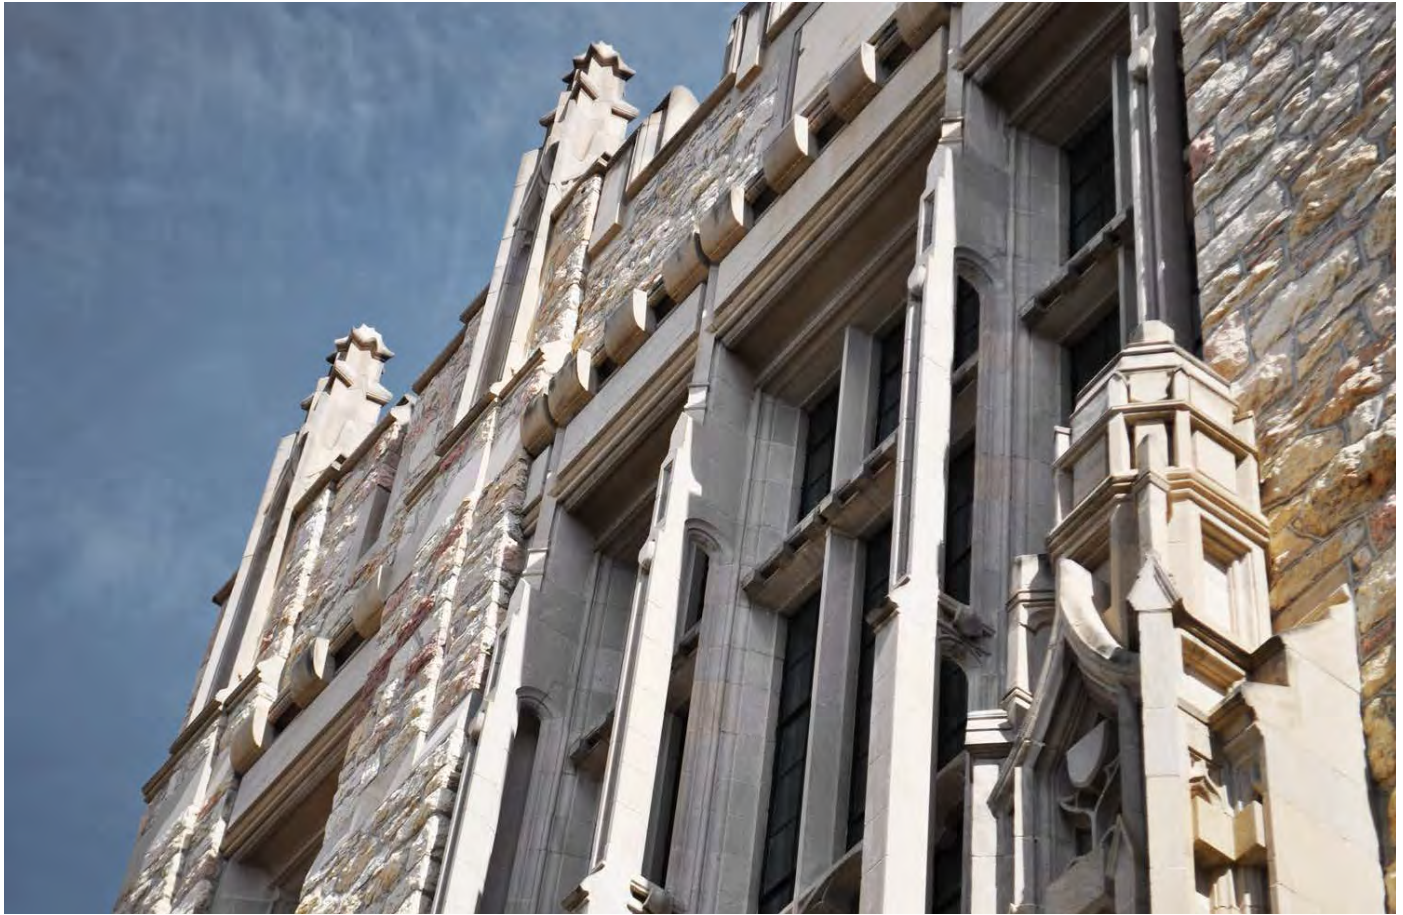
Figure 16. References to flying buttresses in the stonework of the Thorvaldson Building.

The cut and carved limestone reliefs and sculptures on the Chemistry Building differ from those of its predecessors in that they are generally not figural representations, but instead represent purely architectural motifs. For example, there are examples of gothic arches, stylized flying buttresses, battlements, finials and trefoil motifs, but no human figures, gargoyles or grotesques. A unique character-defining element of this building, visible in Figure 16, is its tracery on the large panel of glazing on the front elevation. This carved stone element is a subtle representation of a series of flying buttresses, compressed into the thickness of the window opening. The most exuberant examples of carved stone decoration are found above and surrounding the principal entrance. A ribbed arch forms the entrance, in the manner of a cathedral portal. A brick vault, laid up in a herringbone pattern, separates the portal from the doors (Figure 17). Collegiate Gothic decoration is to be found on virtually all of the building's exterior surfaces. Greystone quoining defines the corners of the building and a crenellated parapet forms its roofline. The uppermost windows are all shaped as gothic arches, as shown in Figure 18. These windows have been maintained in a good state of commemorative integrity. The central wing of the building features a row of double-height arched windows (Figure 4), which are also character-defining elements.

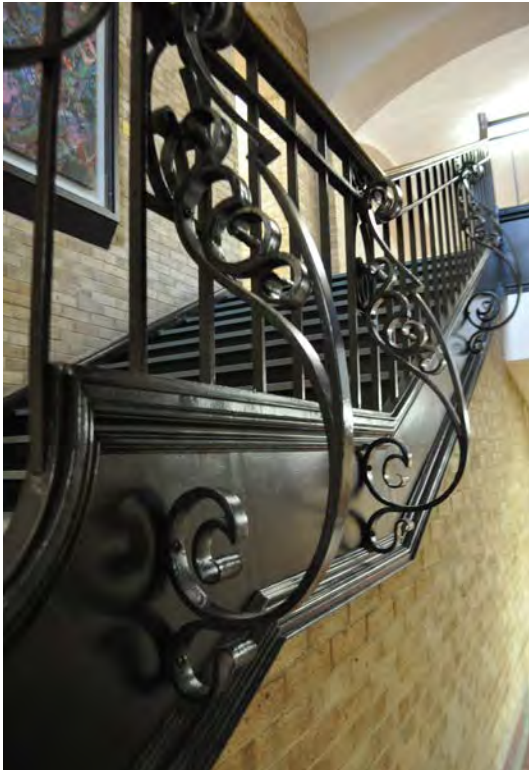
Figure 19. Balustrade detail.

The interior of the building also contains many character-defining stylistic elements. The main entrance has an intricate carved wooden screen surrounding the doors (Figure 5). In the foyer, the ceiling is in the form of a series of intersecting plaster vaults (Figure 18). This staircase, in slate, cast and wrought iron, is a significant character-defining element. (Refer to Section 2.2) The balustrades of the staircase are supported by ornate wrought iron brackets shown in Figure 19.

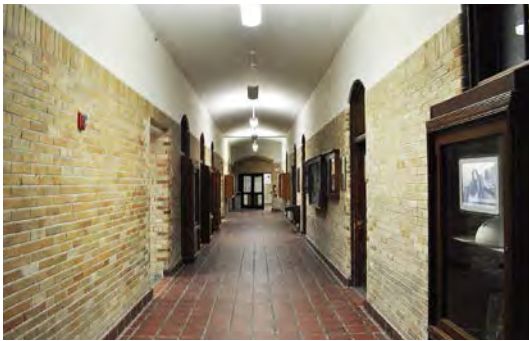
Figure 20. Interior stylistic elements include arched transoms and vaulted ceilings.

Figure 20 shows the brick wainscoting lining corridors and the arched transoms above doorways on the 1st and 2nd floors. (The transoms of the third floor are not arched). All of the corridor ceilings, with the exception of those in the basement, are vaulted. Most of the arched transoms exist in a good state of commemorative integrity with the exception of the basement level, where a dropped ceiling now obscures these character-defining elements, as shown in Figure 21. In some places transoms have also been replaced with an opaque material.

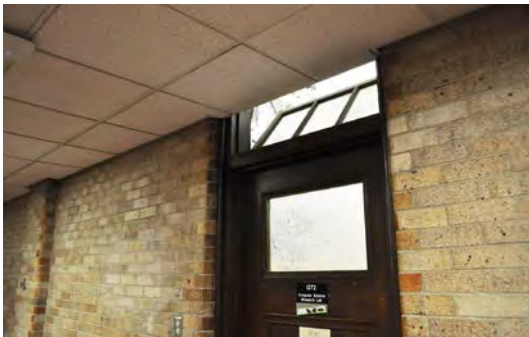
Figure 21. Transoms in the basement have been compromised by a dropped ceiling.

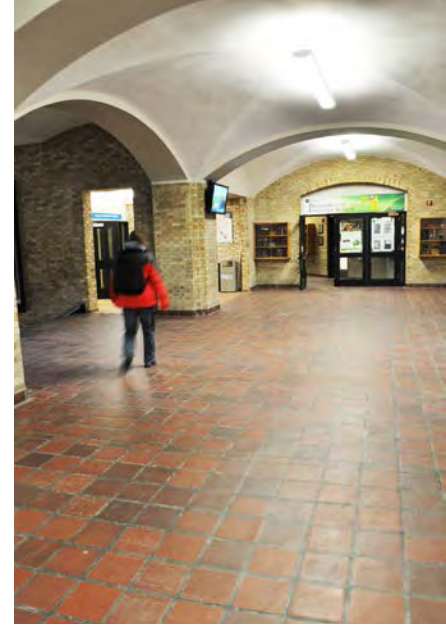
Figure 18. Plaster vault and dome, terracotta tile floor.
