University of Saskatchewan

Heritage Register

September 2013

Facilities Management
Division

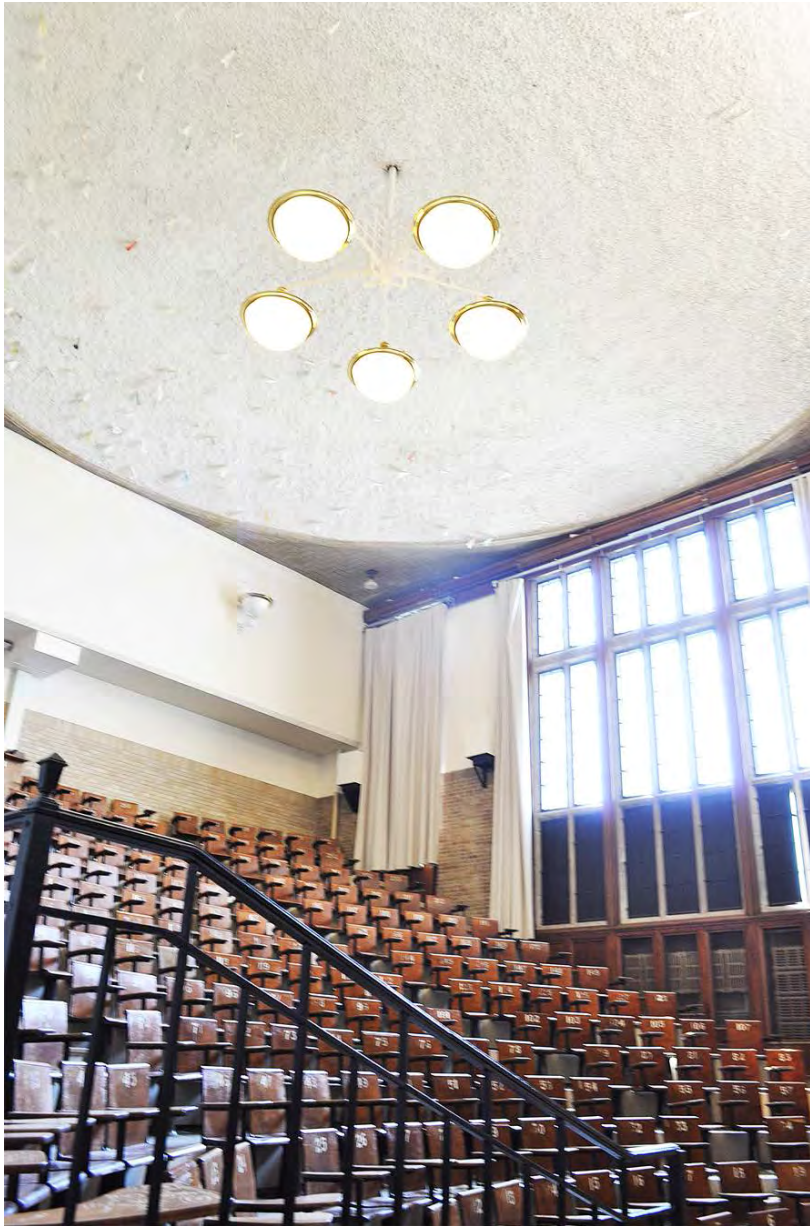
Figure 22. The dome of the 'Airplane Room.'

The auditorium of the Thorvaldson Building, also known as the Airplane Room, exhibits many character-defining elements of style. The most obvious element is the 68 foot dome which crowns the room. The dome remains in good commemorative condition. Its form has been maintained, and although the ceiling has been covered with a fibrous fireproofing material, that material has itself acquired its own historical significance, as discussed in Section 2.8. The location and volume of the Airplane Room are registered on the front elevation of the building, by the large panel of windows above the main entrance. These soaring windows and of the scale of the space itself contribute greatly to the grand style of the building, reinforcing the imposing impression of the stone exterior (Figure 22).

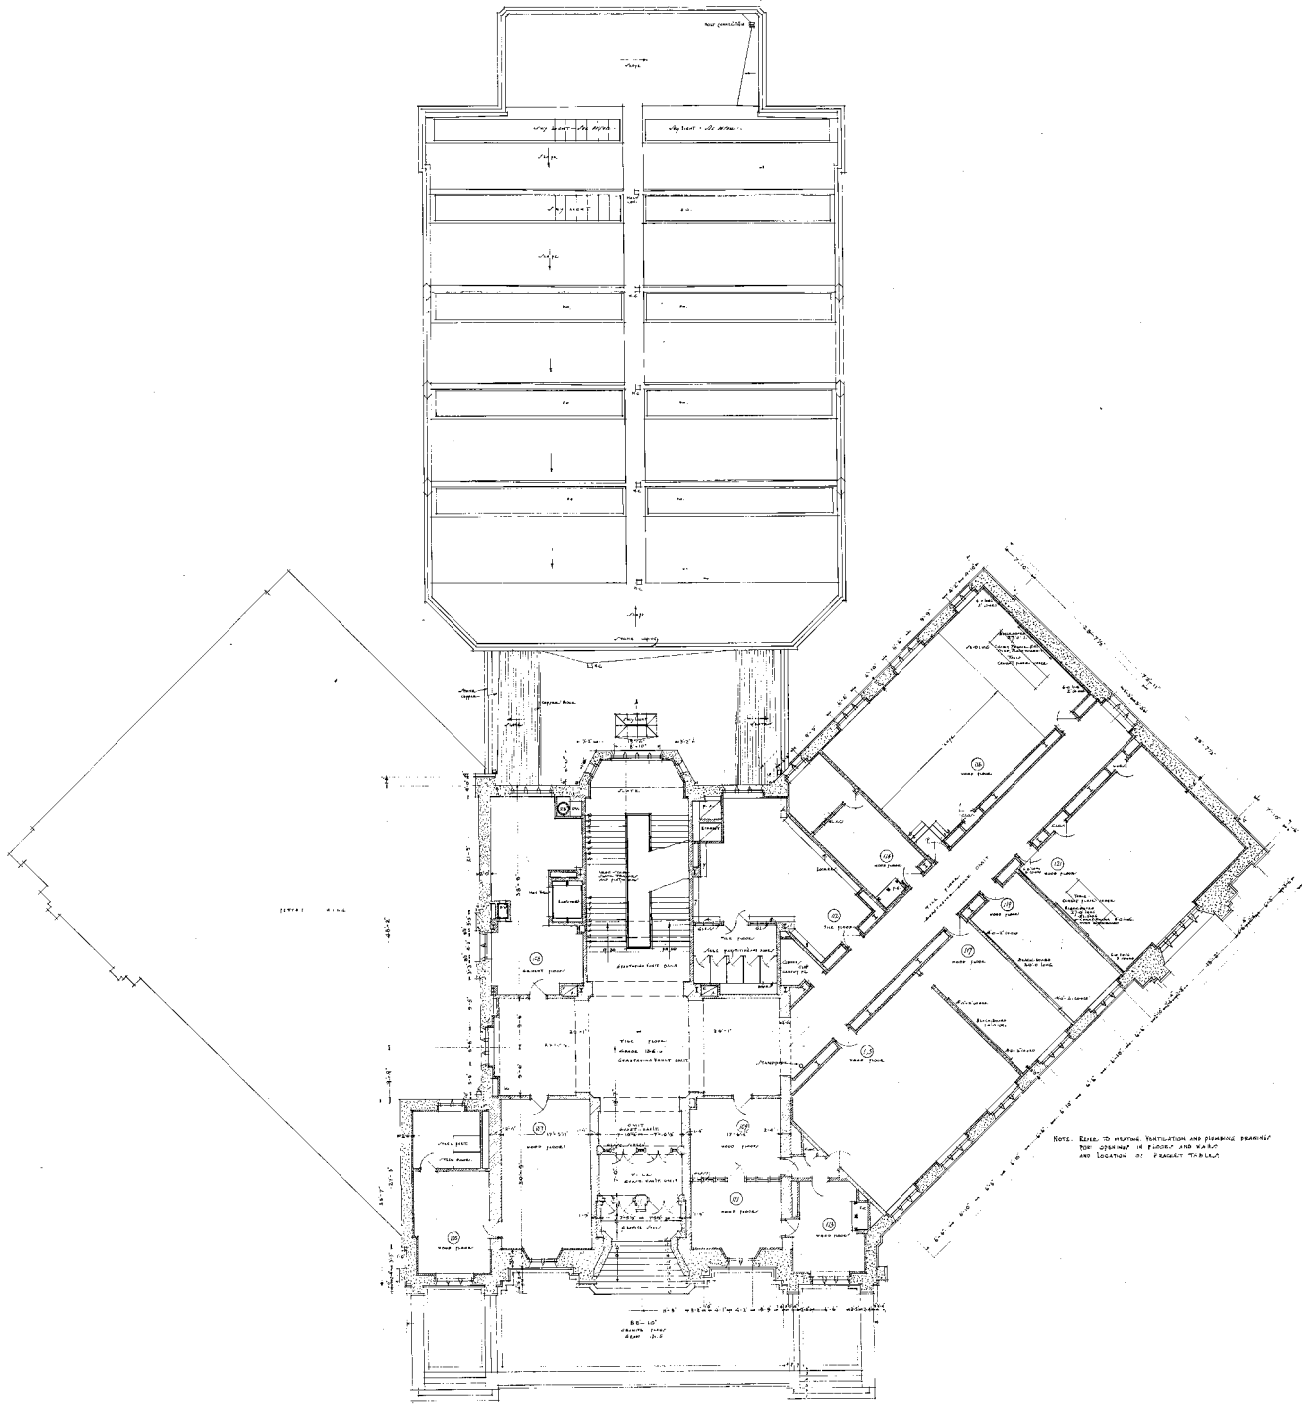
Figure 25. Original ground floor plan. North is oriented to the left. Retrieved from Facilities Management Division Asset Record System, File TB-10-T.

The Thorvaldson Building as originally conceived has an unusual floor plan, shaped in the form of an arrow, with three wings intersecting at 45 degree angles, at the main entrance. This plan was never fully realized, and is missing its north wing, but the shape and configuration of the other two original wings have been maintained to a good degree of commemorative integrity, despite later additions. Figure 25 illustrates the original ground floor plan, with the missing north wing shown in outline. Figures 26 and 27 illustrate an early version of the building that was eventually discarded in favour of the current design.

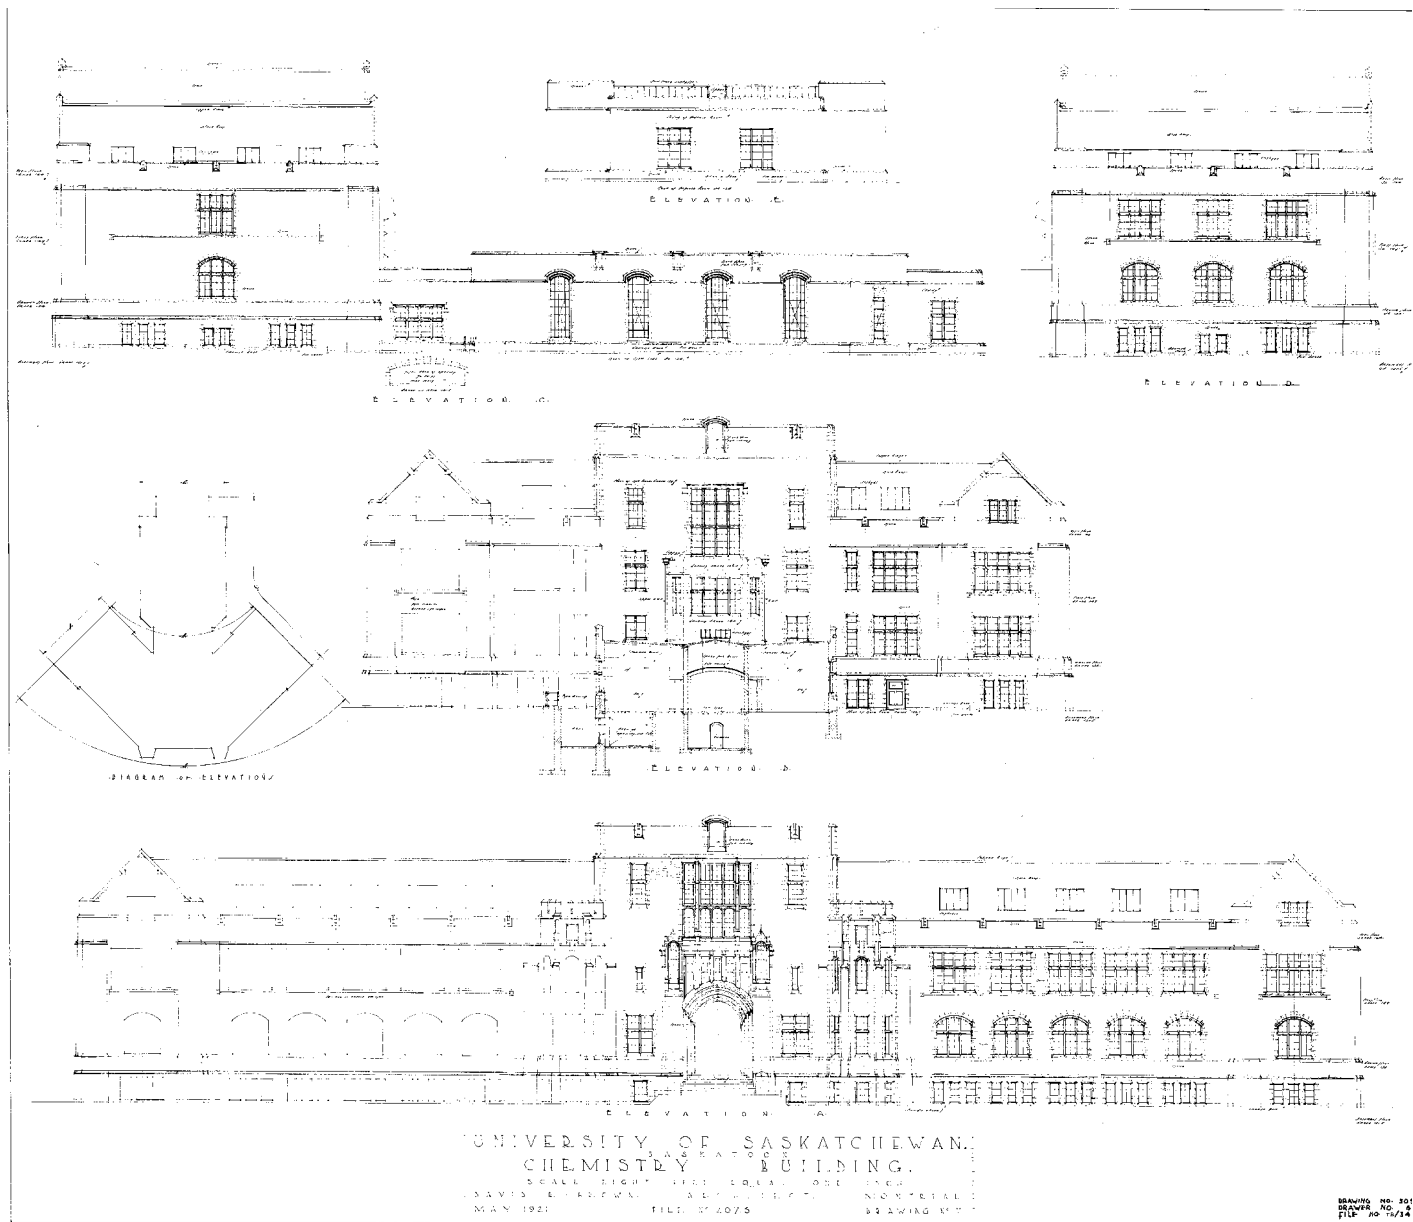
Figure 26. Early elevations show a window configuration different from the one existing today. The entrance in this version is also more simple. Retrieved from Facilities Management Division Asset Record System, File TB-34-T.

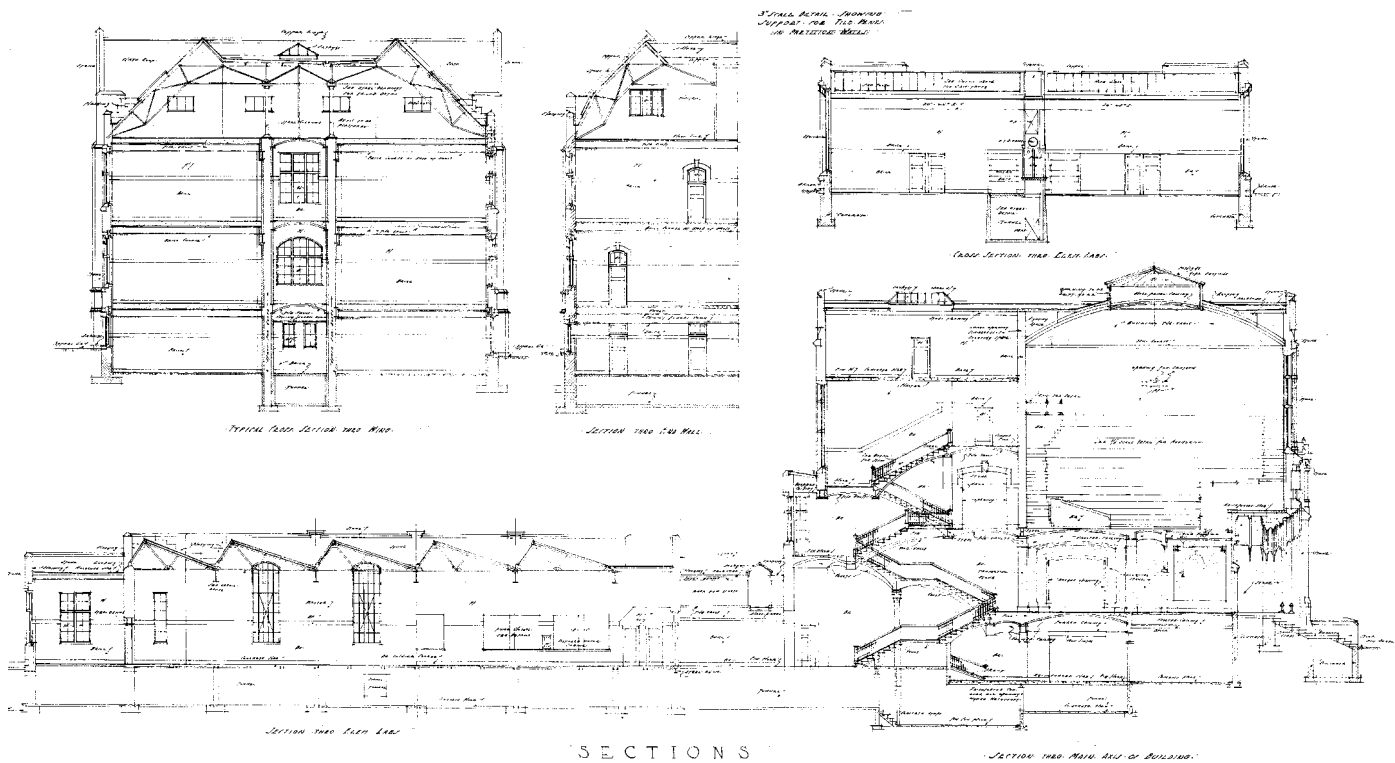
Figure 27. Early sections depict the airplane room with a skylight in the guastivino dome. Retrieved from Facilities Management Division Asset Record System, File TB-2-T.

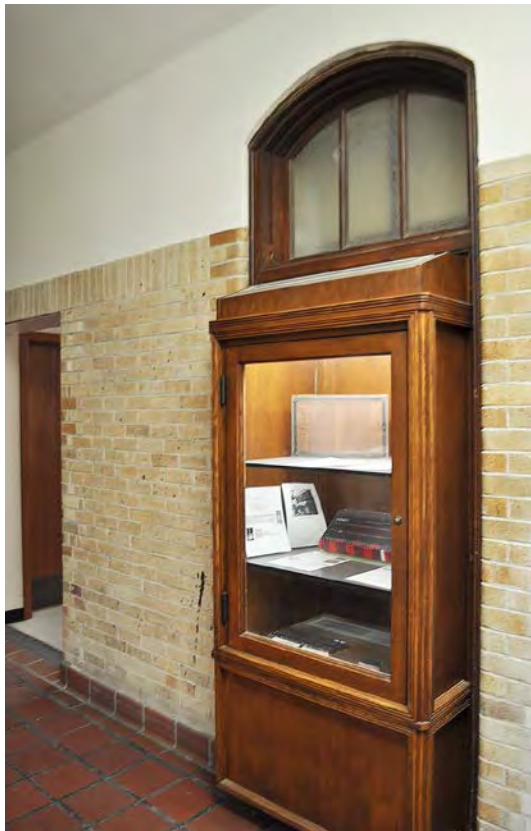
Figure 28. Several doors have been replaced by display cases.

The double loaded configuration of the corridors remains and is a character-defining element. The rooms arranged along these corridors have seen much renovation. The configuration of many rooms has changed to accommodate evolving spatial requirements. Some rooms have been subdivided by the addition of partition walls and others have been combined to create larger spaces through the removal of walls. In order to accommodate the new spatial configurations, some doors in the corridors have been removed and replaced with display cases as shown in Figure 28.

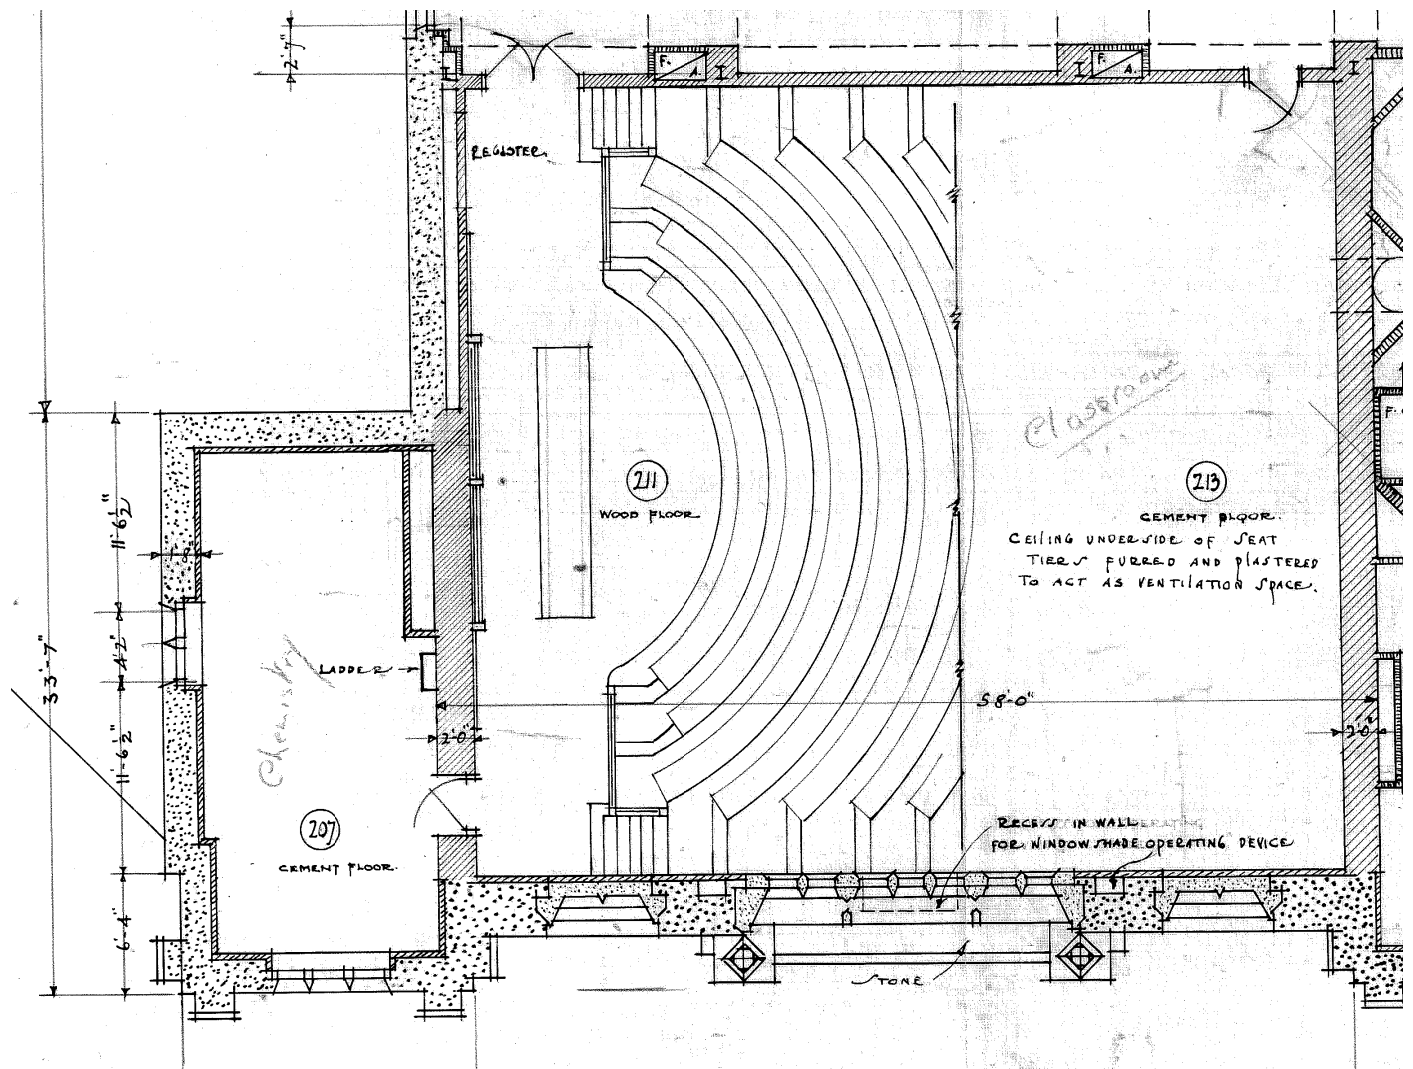
Figure 29. Plan of original configuration of the auditorium. The door to the anteroom exists but is no longer functional. Retrieved from Facilities Management Division Asset Record System, File TB-11-T.

The spatial configuration of the large auditorium, or Airplane Room, has not changed and has a high degree of commemorative integrity. Its volume is based on an almost cubic proportion, bisected by the tiered floor of the seating, such that its height and width are equal, although it is slightly longer than it is wide. The room is crowned with a shallow dome.

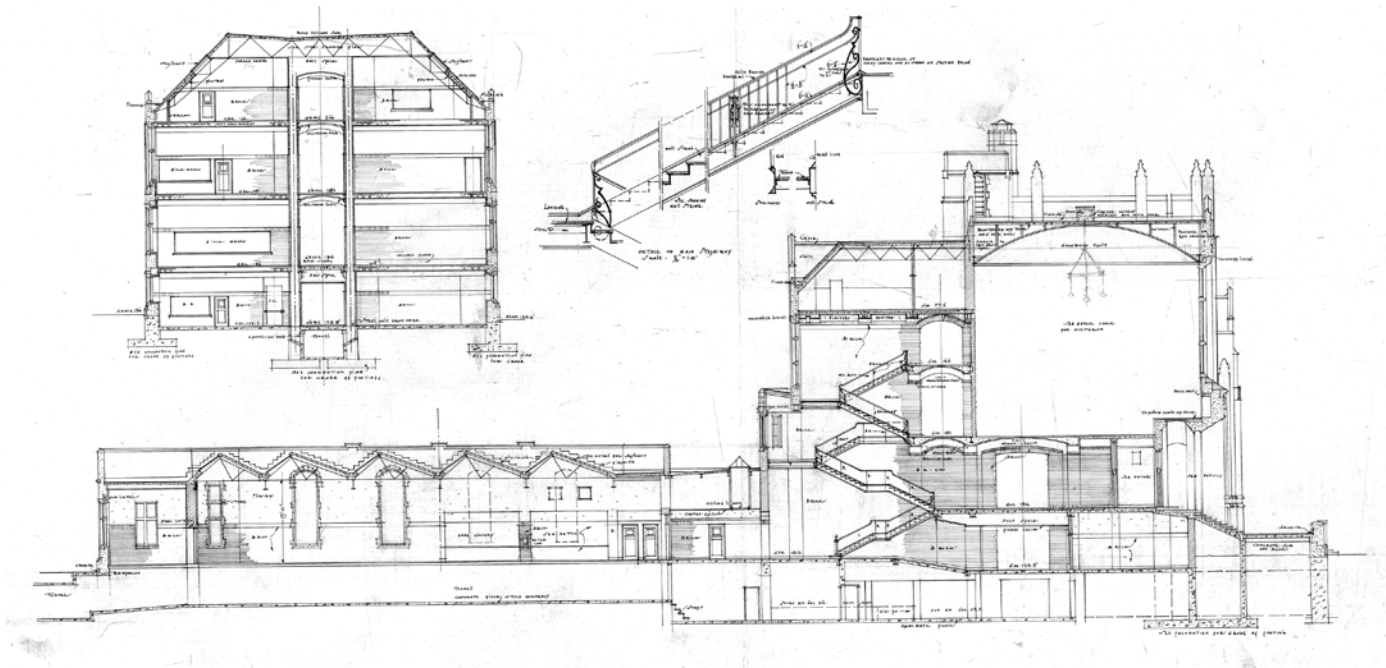
Figure 31. Sections through the building show the structure of the dome and the steel trusses used to support the roof. Retrieved from Facilities Management Division Asset Record System, File TB-15-T.

The dome of the Airplane Room is a feature of particular heritage significance. This dome is an example of the 'Guastavino Tile Vault System', a system for the construction of thin-shelled structural vaults and domes patented in 1885 by a Spanish-American architect and builder named Rafael Guastavino (1842–1908). The Guastavino system was briefly popular in buildings of the Beaux-Arts style at the turn of the 20th century. It was used in prominent buildings such as New York's Grand Central Station and Toronto's Union Station. The system used standardized terracotta tiles and layers of mortar, laid up in an interlocking herringbone pattern, to form a thin, self-supporting shell about 4 tiles deep. The tiles were laid flat and parallel to the arc of the vault, rather than perpendicular to the curve, as in the Roman fashion. The terracotta tiles were about 10 mm thick, and approximately 150 mm by 300 mm in dimension.

The dome of the Thorvaldson Building auditorium constitutes a character-defining element, both as a structural system particular to the historical period of its construction and as a prominent aesthetic feature. As a structural system, the Guastavino tile dome has commemorative integrity, although its original appearance has been compromised. The dome would likely have been finished originally in painted plaster, but is now covered with a spray-on acoustic material. This was done in order to mitigate an echo problem associated with the domed shape, but interestingly, has also contributed to the heritage value of the room in other ways, discussed in Section 2.7.

From the original architectural drawings, the structure of the building appears to be a hybrid system, with a structural steel frame encased in cast-in-place concrete on the interior, and exterior walls consisting of cast-in-place concrete, brick and stone. The roof structures typically consist of concrete slabs supported on steel trusses, with the notable exception of the Guastavino dome. Although a dropped ceiling has been installed in the attic, some of the steel structure at this level is visible. Floors are typically cast-in-place concrete, with embedded hollow clay tile, a system seen also in the [Physics Building](#). The drawings indicate cast-in-place concrete foundation walls and footings.

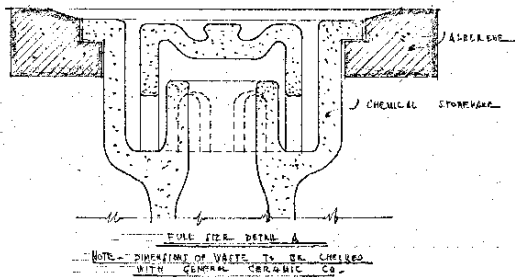
Figure 32. Detail of chemical waste trap showing use of ceramic plumbing and alberene stone sink. Retrieved from Facilities Management Division Asset Record System, File TB-77-T.

The ventilation and plumbing systems in the Thorvaldson Building were considered state-of-the-art at the time of their construction. All fume hoods and vents were covered in an acid proof lining. Labs came equipped with distilled water cabinets made of porcelain and stone. Parts of these oak cabinets still exist, and are visible above their newer counterparts (Figure 8). Labs also were built with sand baths which would put out a fire with a shower of sand if needed. As an additional precaution, water baths were also installed. (The sand baths no longer exist and the water baths have now been replaced). The plumbing at the work benches was specified in the best chemically-resistant materials available at the time: soapstone sinks and ceramic pipes. Figure 32 illustrates the details of the stone sink and ceramic waste trap. This system has been replaced, but some of the original stone sinks has been saved and at the time of this report are located in the sub-basement (Figure 32). The original plans indicated the provision of speaking tubes near the elevator, but these also no longer exist. The labs were equipped with two plumbing lines; one provided water and the other provided a solution of 80% alcohol intended for sterilizing equipment. Former student Tom Jasienuk recalls, “they rarely used the alcohol to sterilize and would fill bottles with it and go party. They’d have to cut it with 7-Up, juice or water because it was too strong...they frequented that tap a lot” (personal communication, August 17, 2012). With the removal of the lab spaces to the annexes the alcohol line was disconnected.

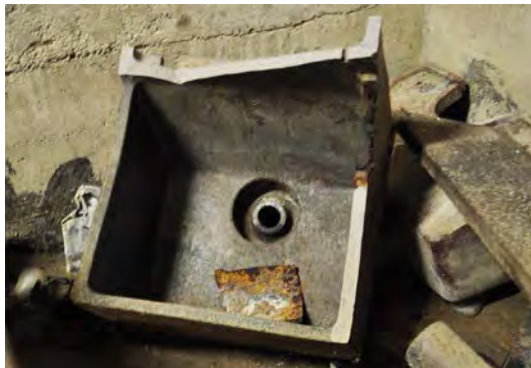
Figure 33. Stone sink located in the sub-basement of the Thorvaldson Building.

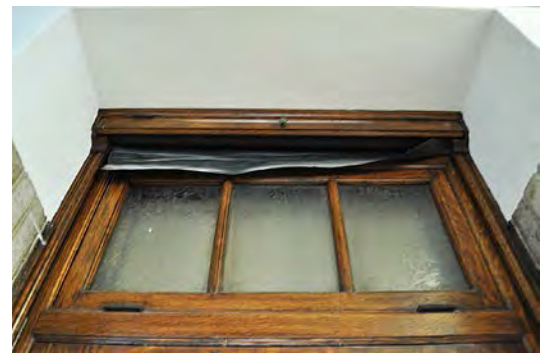
Figure 35. Dark blinds still exist over some of the transoms.

Figure 20 shows the brick wainscoting lining corridors and the arched transoms above doorways on the 1st and 2nd floors. (The transoms of the third floor are not arched). All of the corridor ceilings, with the exception of those in the basement, are vaulted. Most of the arched transoms exist in a good state of commemorative integrity with the exception of the basement level, where a dropped ceiling now obscures these character-defining elements, as shown in Figure 21. In some places transoms have also been replaced with an opaque material.

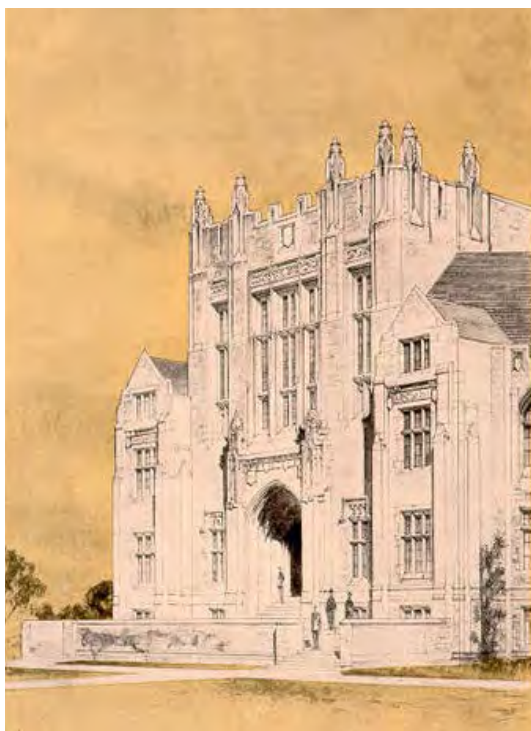
Figure 37. A 1924 architect's sketch of the Thorvaldson Building. Photo A-5955, retrieved from <http://sain.scaa.sk.ca/items/index.php/?search=query=a-5955>

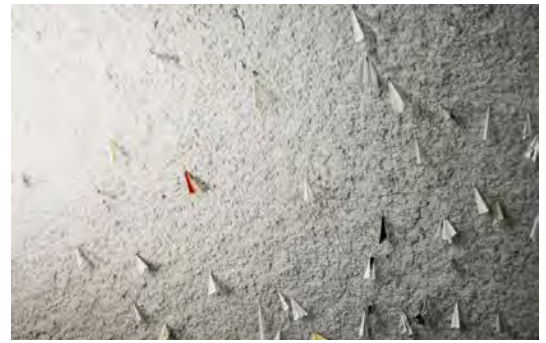
Figure 38. The dome of the 'Airplane Room' with the paper airplanes that inspired the room's name.

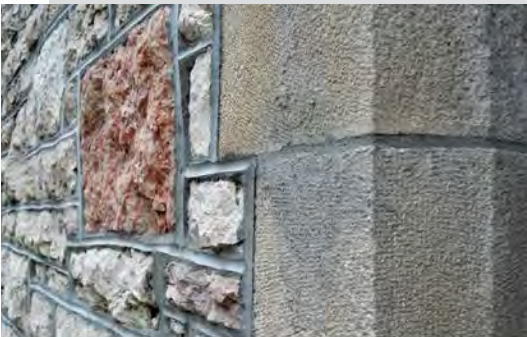
Figure 1. L to R: 'Greystone' and Indiana limestone.

The President's Residence is primarily constructed of the rough-faced dolomitic limestone commonly known as 'greystone', and familiar to much of the campus. The material is significant as it was gathered from the Saskatchewan prairie near the site of the university. Surrounds and other cut stone details are rendered in Indiana limestone (Figure 1). (For further information on building stones used at the U of S, refer to ['Appendix : Stone.'](#)) Slate tiles clad the roof, and at the eaves, exposed wooden rafter ends are visible. Copper eaves troughs and downspouts carry water from the roof to the ground. Figure 3 shows the detailing of the eaves.

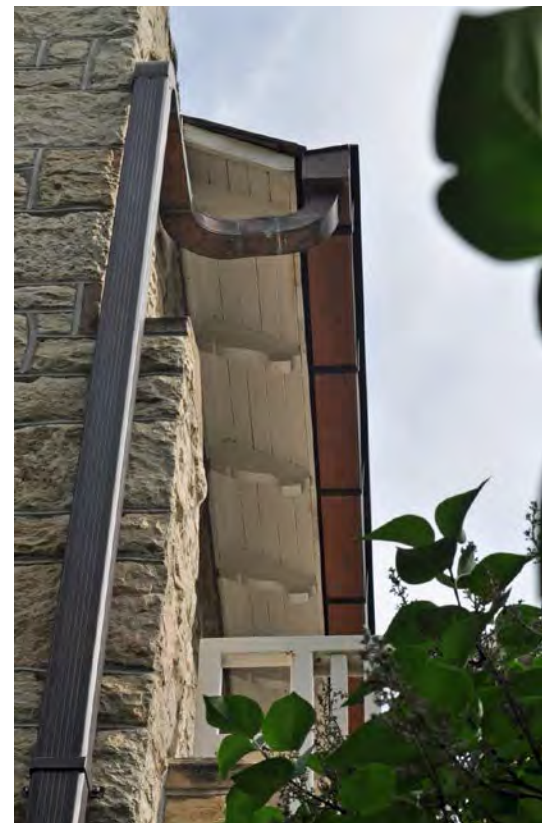
Figure 3. Copper eaves troughs and exposed wooden rafter ends.

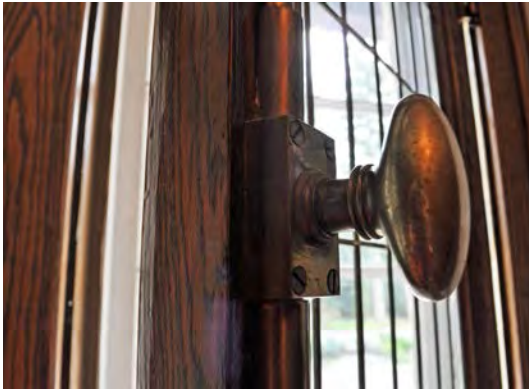
Figure 4. Quartersawn oak window frames with brass hardware and leaded glass.

Due to its use, the President's Residence features numerous Arts and Crafts elements which serve to define its residential character. Many of the glass doors and windows feature character-defining leaded glazing with multiple small lites. This character-defining glazing is also found on interior cabinetry as shown in Figure 19. Doors with a glazed panel across their top third are particularly characteristic of the Arts & Crafts style (Figure 20). The motif cut into the wooden staircase is another characteristically Arts & Crafts element as is the row of three tall, narrow windows shown in Figure 21. Many of the windows of the building are operated by espagnolette bolts. These fittings (pictured previously in Figure 4) are character-defining elements.

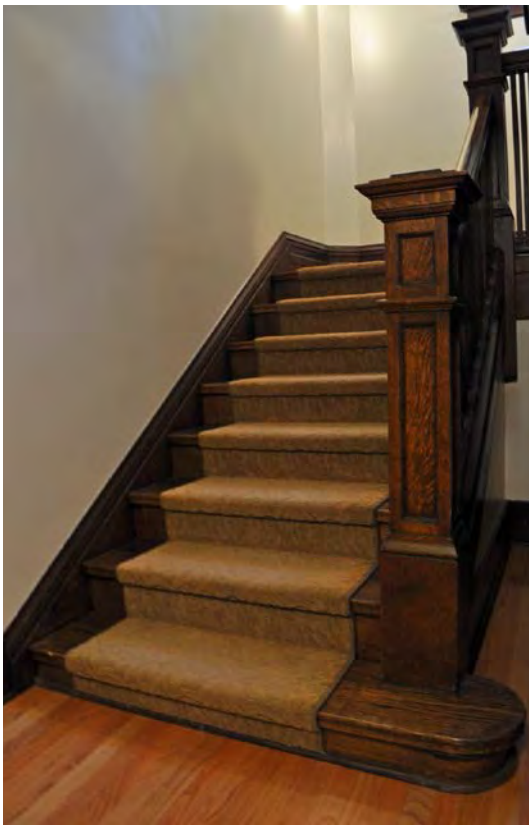
Figure 5. The oak staircase.

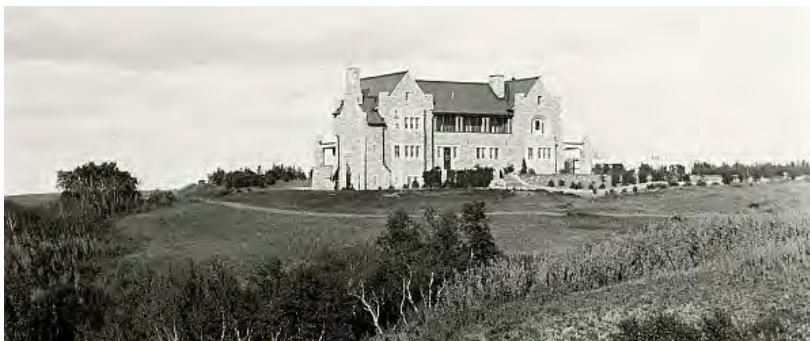
Figure 10. The form of the President's Residence. Photo A-3400, retrieved from http://scaa.sk.ca/gallery/uofs_buildings/

Organized around a central hallway, the President's Residence is compact in form. The building reaches three stories in height above the ground. As a house, the scale of the President's Residence is smaller from most buildings on campus. However, without any other nearby structures to relate to, the President's Residence seems imposing. Its relatively small footprint and great height serve to enhance this effect. The Residence is designed to create a focus for its prominent river front site as shown in Figure 10. Many other early campus buildings were designed to form and enclose outdoor courtyards. The President's Residence is not shaped to frame any outdoor space. Rather, it creates a focal point of the land on which it sits.

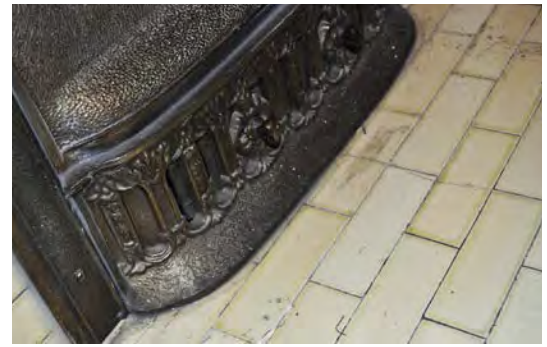
Figure 6. Yellow glazed tile hearth and cast iron fire grate.

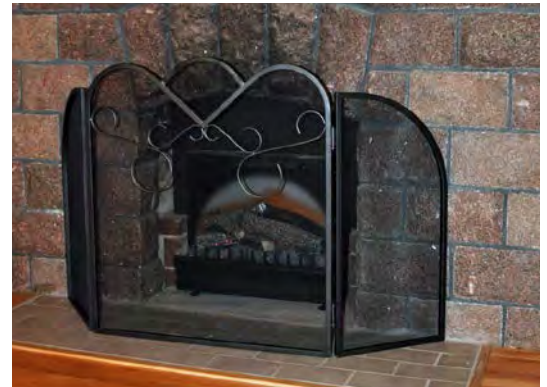
Figure 7. The granite fireplace.

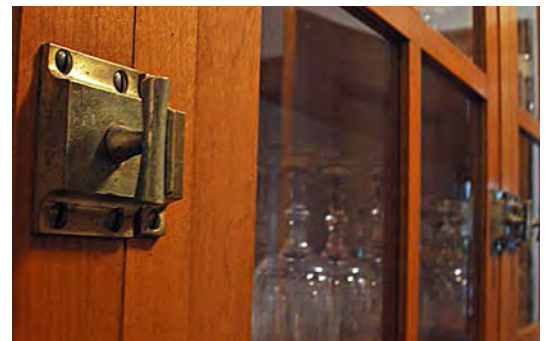
Figure 8. Maple cabinetry with utilitarian brass latches in the pantry.

The pantry adjacent to the kitchen is unique in that its wooden cabinets and trim differ from those in the rest of the house. The pantry cabinets and door surrounds are made out of stained maple (Figure 8). The location of the wood suggests that the house was designed with different materials according to the purpose of the space. The pantry was intended chiefly for use by servants and so maple may have been used instead of oak because service rooms were not intended for public view. This interpretation is reinforced by the hardware on the cabinetry. Brass hardware is found throughout the residence on all windows and doors; however the style of hardware in the pantry is more utilitarian, implying a lower importance. The pantry also features a washboard countertop. The wood of the countertop is a lightly stained oak into which an arrow pattern has been carved, for drainage (Figure 9). A wooden insert has been installed where a sink used to be. The wood and brass in the residence exist in an excellent state of commemorative integrity.

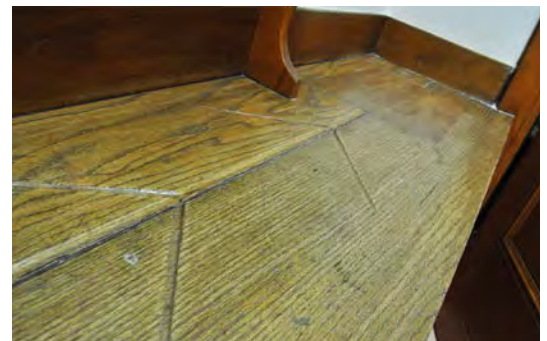
Figure 9. Oak countertop with carved drain board.

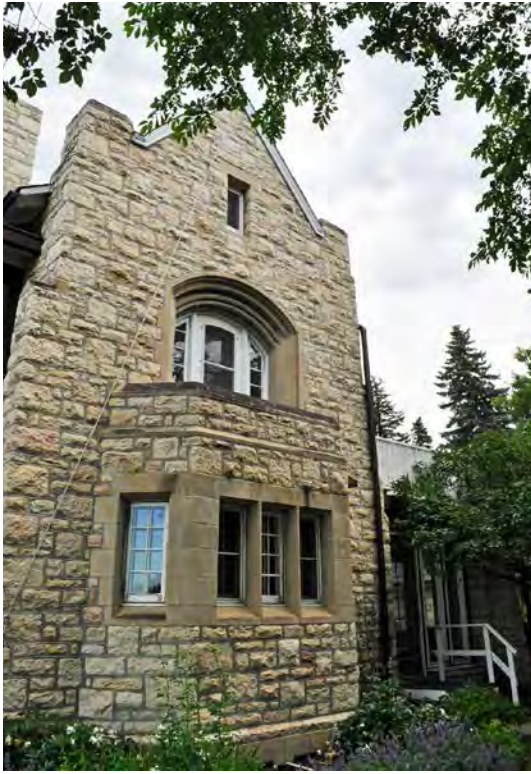
Figure 13. An arched doorway and surround sit atop a bay window.

The President's Residence has numerous Arts & Crafts character-defining elements, including pitched roofs with gable ends, bay and dormer windows, and various stone details. The slate tile material used to clad the roof is an element defining the character of the building. Punctuating the roofline are dormer windows. Both character-defining elements are shown in Figure 11. Oriel windows and bay windows animate the elevations (Figure 12). The small, archery style window above it is also characteristic of the gothic style. Above one bay window, a walkout balcony on the first floor is accessed through an arched doorway which contributes to the Gothic character of the building. (See Figure 13). Arches can also be seen framing one of the covered balconies. The

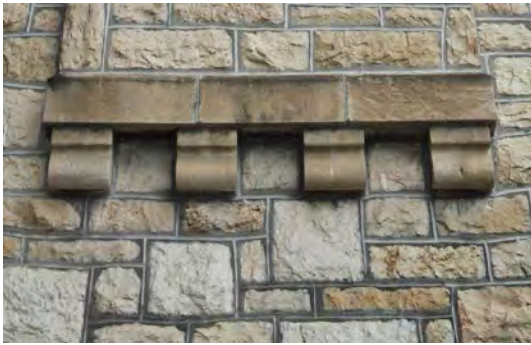
Figure 14. Limestone corbels supporting the underside of a chimney.

stonework of the exterior walls features quoins, buttresses and various other character-defining elements. The decoration applied to such utilitarian features as downspouts and chimneys, shown in Figures 14 and 15 respectively, are also elements of the Gothic Revival styles. Corbels such as those shown in Figure 14 are also used on some of the fireplaces.

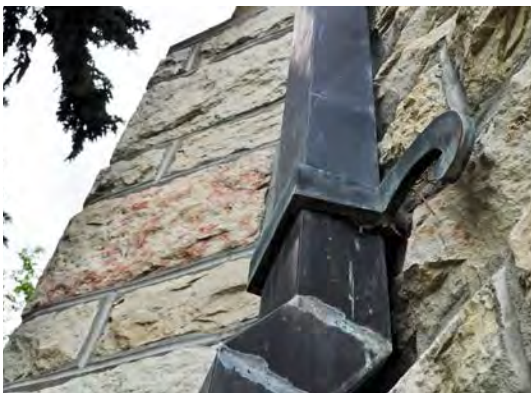
Figure 15. Ornamental bracket on a copper downspout.

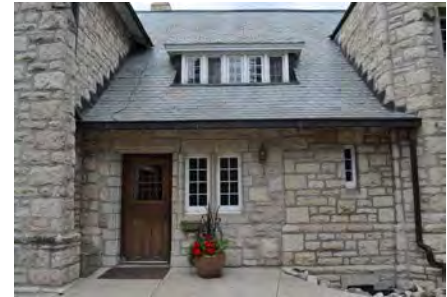
Figure 11. Dormer windows protrude from a roof clad in slate.

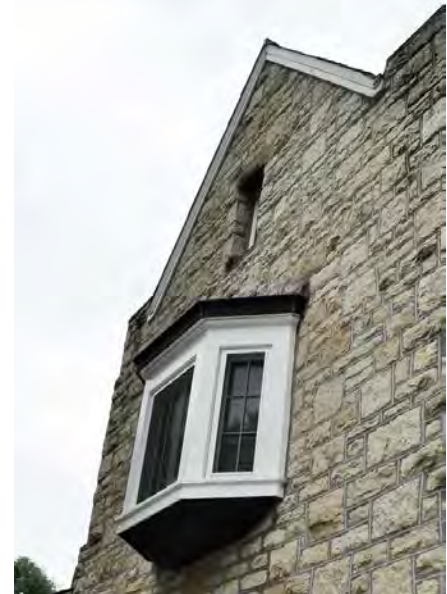
Figure 12. Oriel window with an arched window above it.

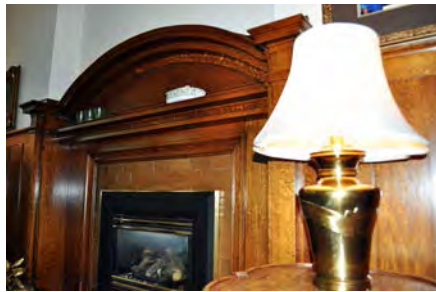
Figure 18. An arched mantle.

The arch and vault are architectural elements characteristic of Gothic Revival styles. The ground floor corridor of this building has a vaulted ceiling as shown in Figure 16. The entrance facing the staircase on the ground floor corridor is framed by a small arch intersecting the vaulted ceiling of the ground floor corridor (Figure 17). Some fireplaces also feature arched mantles, as shown in Figure 18.

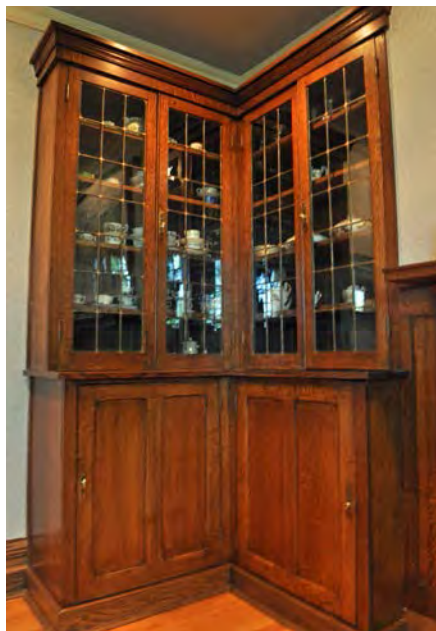
Figure 19. Built in cabinetry features arts and crafts details.

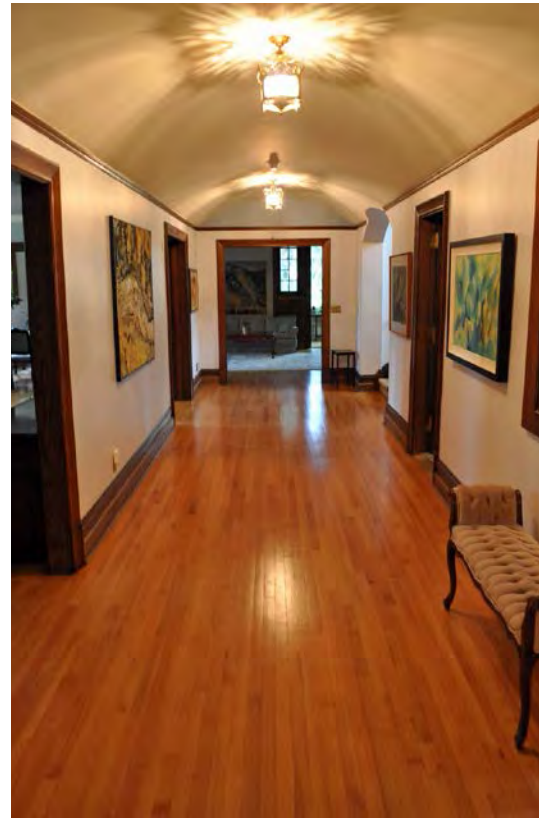
Figure 16. A vaulted corridor.

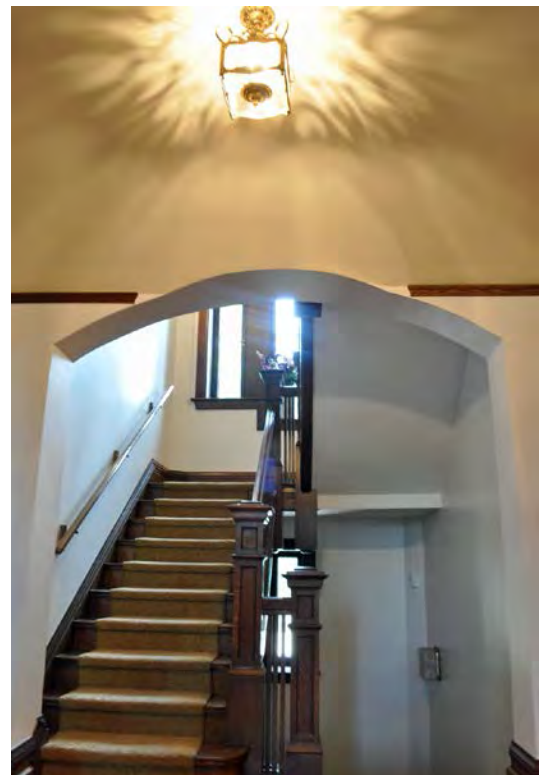
Figure 17. Two intersecting arches marks the entrance to the staircase.

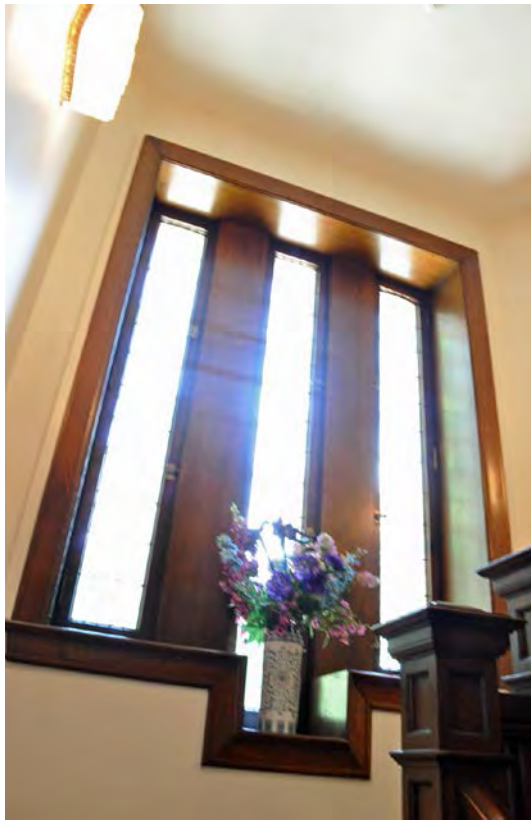
Figure 21. Light shining through an Arts and Crafts style window.

With a floor area of over 10,000 square feet, the President's Residence constitutes a large home, especially by the standards of its time. The building consists of a basement, and three above ground, including an attic. The two principle stories above ground are both arranged around a central corridor. The corridor on the main floor does not have any windows; however, spaces adjacent to it such as the stairwell and entry bring in natural light (Figure 21).

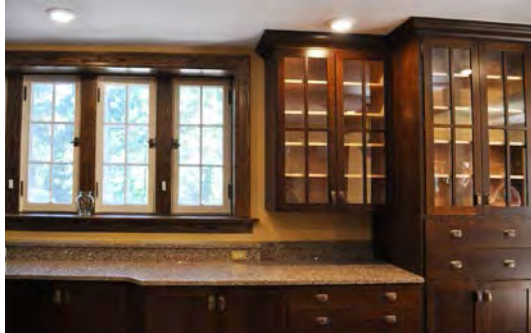
Figure 22. Arts and Crafts style cabinetry.

In 2012, the kitchen was renovated with new oak cabinetry matching the details of the original maple pantry cabinets. Cabinet pulls were replicated from the pantry. Crown and door moldings were copied from elsewhere in the house. Figure 22 illustrates the quarter sawn oak cabinetry detailed in the Arts & Crafts style.

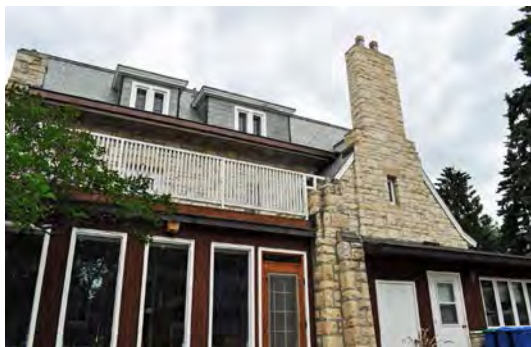
Figure 23. Additions made to the east side of the residence.

Other renovations to the President's Residence have been carried out in a modern idiom. The most salient example is on the east façade, shown in Figure 23. A sun porch enclosed in wood is distinctly modern in comparison to its traditional backdrop. Other examples of this are seen in the enclosure of porches on the north and west sides with modern glazing systems. The 2012 renovations saw some of the doors on the east side replaced with more historically sympathetic counterparts.

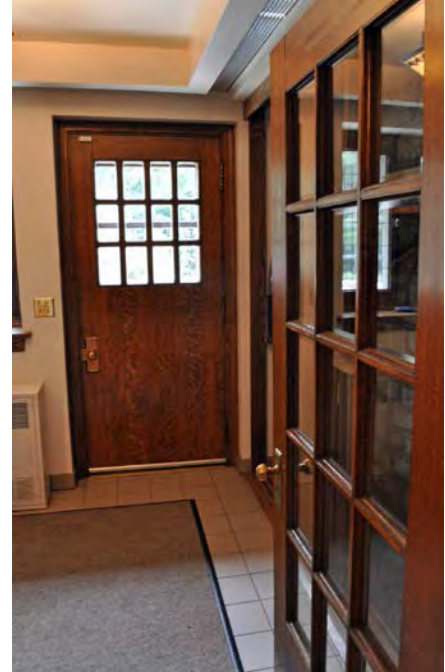
Figure 20. Arts and crafts style doors.

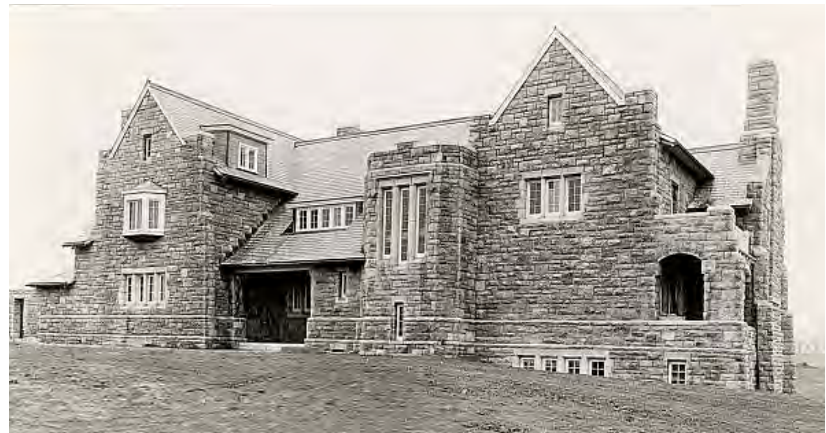
Figure 24. This view, ca. 1913, shows the President's Residence in the final stages of construction and gives an overall impression of the stylistic elements of the exterior of the residence. Photo A-707, retrieved from http://scaa.sk.ca/gallery/uofs_buildings/

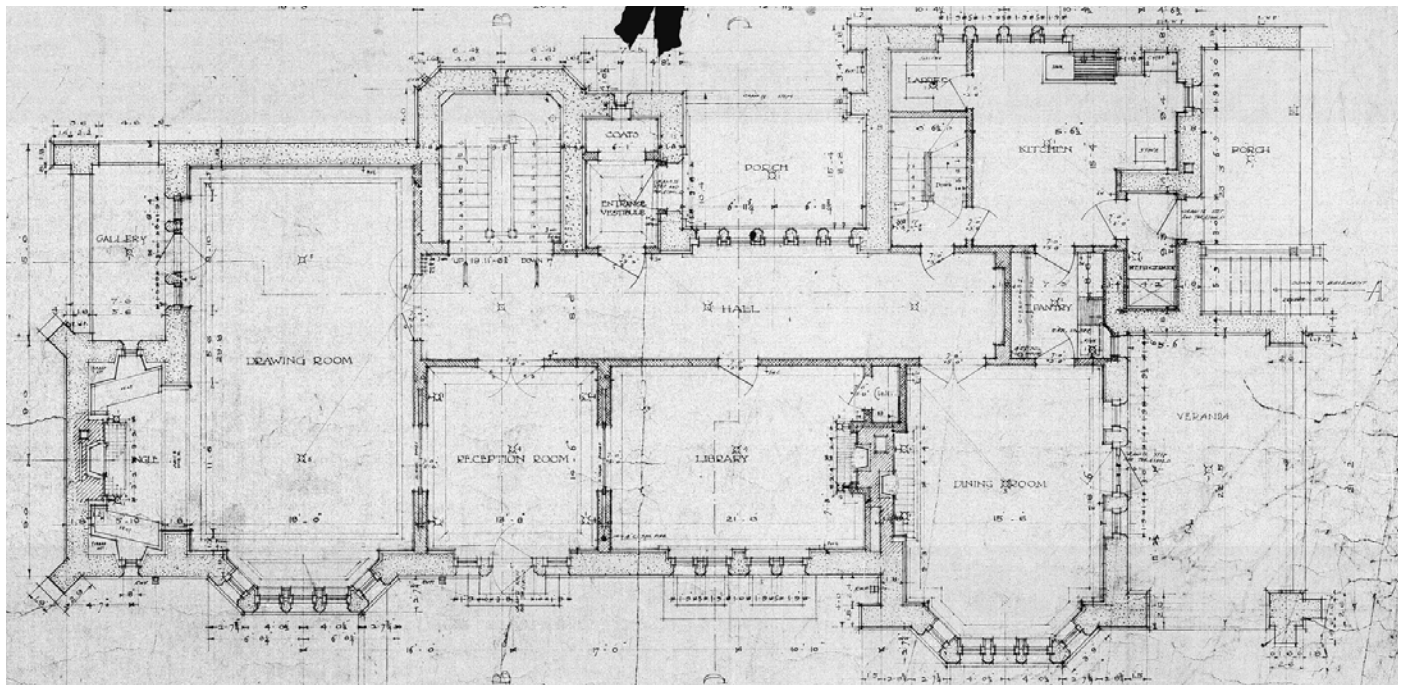
Figure 26. The ground floor plan of the President's Residence. The wall between the library and reception room has since been removed. The east side of the building has been extended. Retrieved from Facilities Management Division Asset Record System, File RP-4-T.

Originally, the layout of the ground floor was very parceled, with numerous partition walls defining separate rooms. Figure 26 shows the ground floor as it originally existed. This has been well maintained with a few exceptions; the front porch has been enclosed to create an entrance hall and the library and reception room have been combined. The result is a much larger and more open space.

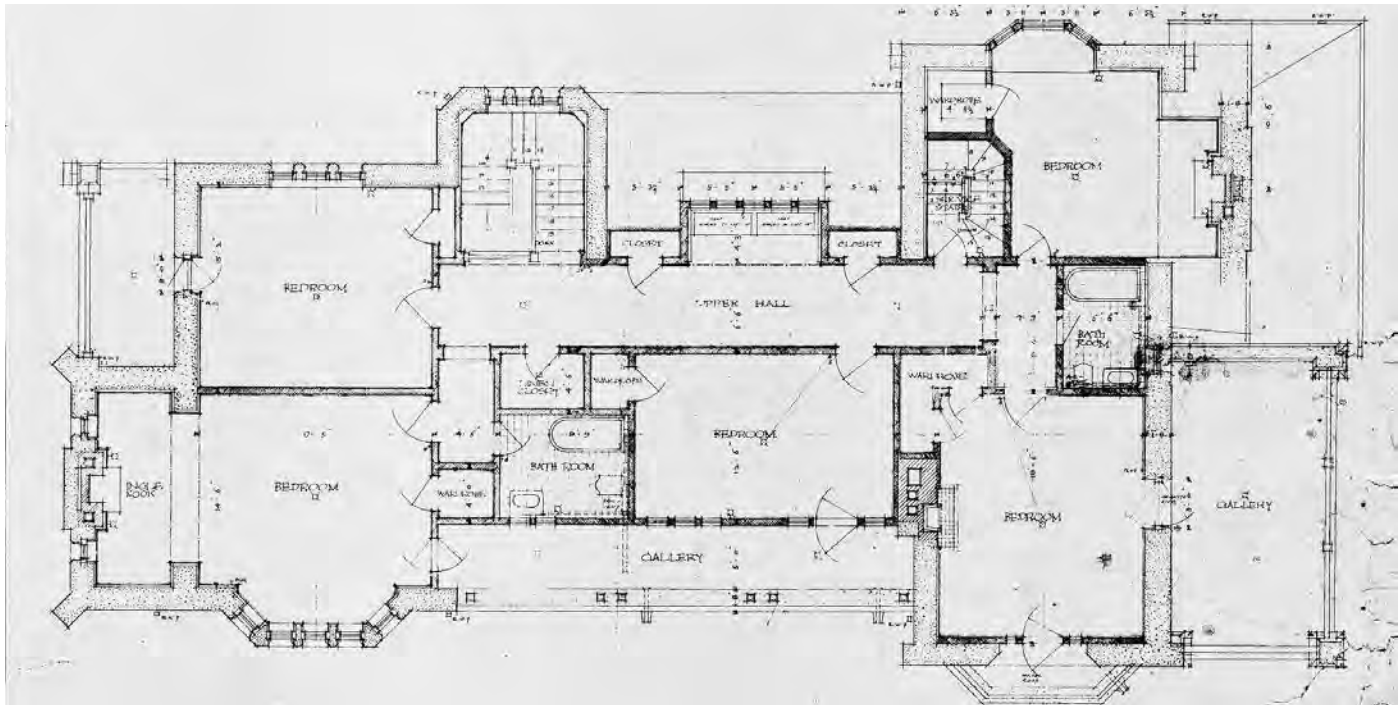
Figure 27. The second floor plan as it was originally constructed. Retrieved from Facilities Management Division Asset Record System, File RP-5-T.

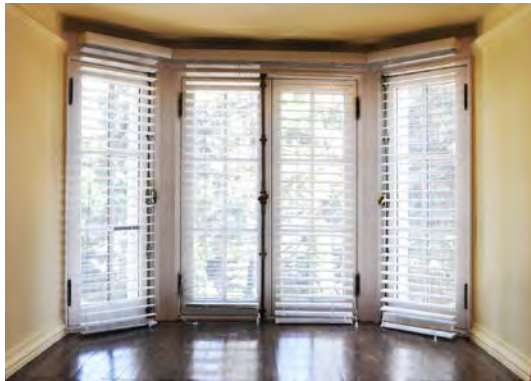
Figure 28. Oriel window seat.

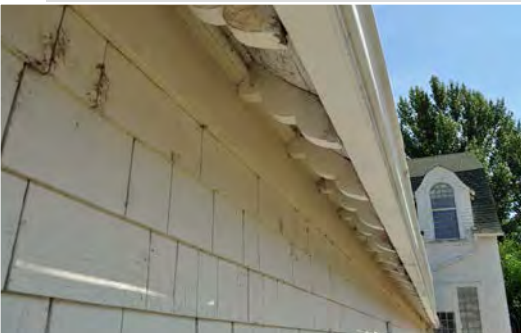
Figure 1. Cedar shingles and exposed wooden rafter ends, both painted.
