University of Saskatchewan

Heritage Register

September 2013

Facilities Management
Division

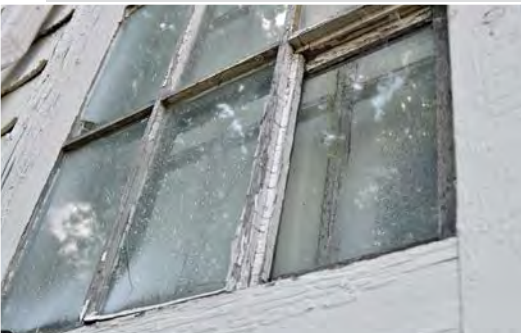
Figure 2. A set of wood-framed storm windows.

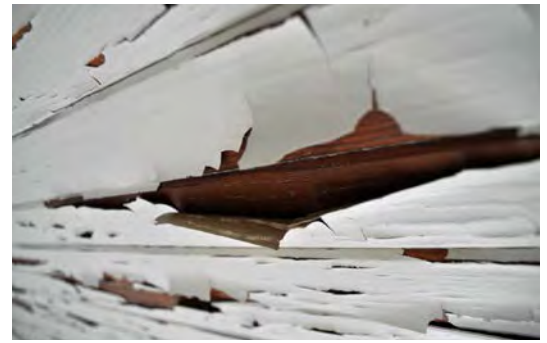
Figure 3. Painted Douglas Fir interior panelling.

Douglas Fir is a prominent material in this building's interior, used as flooring, ceilings and wall paneling. Ceilings and walls appear to have been originally finished with a clear varnish, but have subsequently been painted. Figure 3 shows the condition of the painted Douglas Fir paneling. Doors, also in Douglas Fir, have been painted as well. The high quality of the original fir material is evident in an upstairs closet which has remained unpainted and is shown in Figure 4. Tongue and groove Douglas Fir floorboards have been covered with vinyl composition tile. The building's interior doors feature beveled glass, another character-defining element. Some of these glass panels have been painted or covered (Figure 5). An original chalkboard made of slate is located in the classroom (Figure 6).

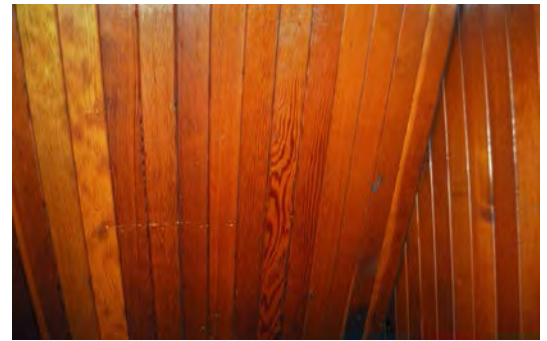
Figure 4. Unpainted Douglas Fir interior panelling.

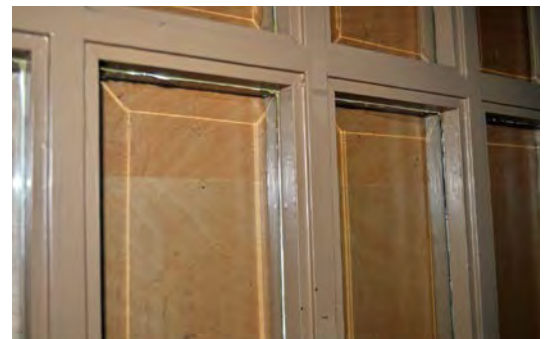
Figure 5. Bevelled glass.

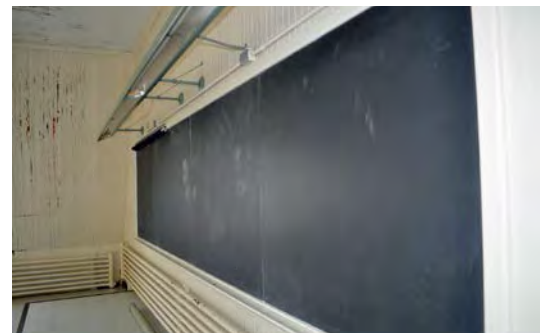
Figure 6. Slate chalkboard.

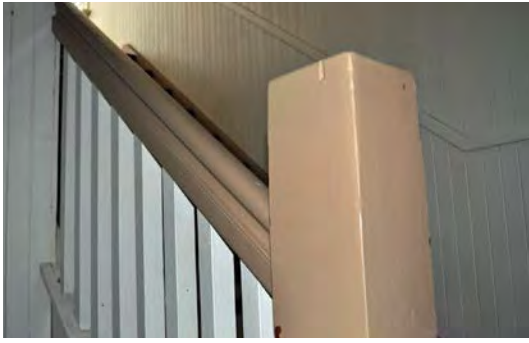
Figure 8. Painted wooden balustrade.

A single staircase, featuring painted wooden balustrades and treads, offers access to the basement and the first floor. The stair treads have been covered in vinyl composite tile. The wooden balustrade has been painted (Figure 8).

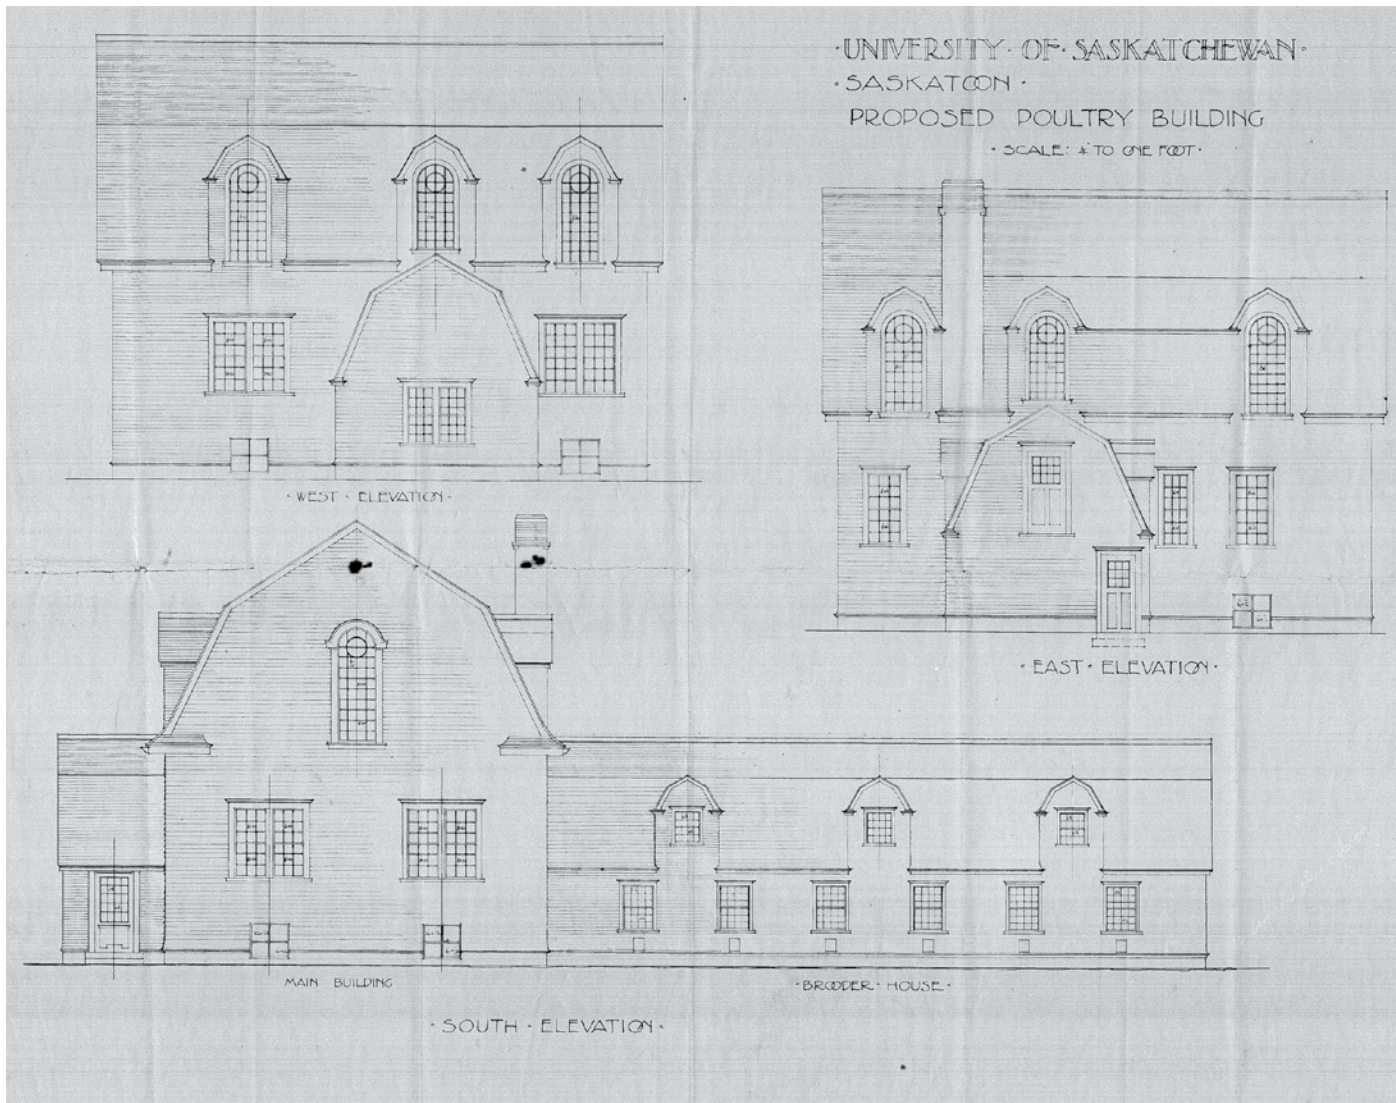
Figure 9. Elevations of the Poultry Science Building showing gambrel roof elements.. Retrieved from Asset Record System, File PH-2-T.

The barn-shaped form of the building, particularly its gambrel roof, is a character-defining element. The gambrel roof is characterized by a shallow-pitched top section and a more steeply-pitched bottom section, with overhanging eaves. This element is illustrated in Figure 9.

Gambrel dormers and decorative truss ends are other exterior elements defining the character of the building (Figures 9 & 10). The gambrel dormers are embellished with wooden roundels to accentuate the arched shape of the windows. (Figures 9 & 11) The building's doors are characteristic of the 'arts and crafts' style. The use of shingles as a cladding material also contributes to the barn-like appearance of the building; the university's prominent [Stone Barn](#) is clad in the same material.

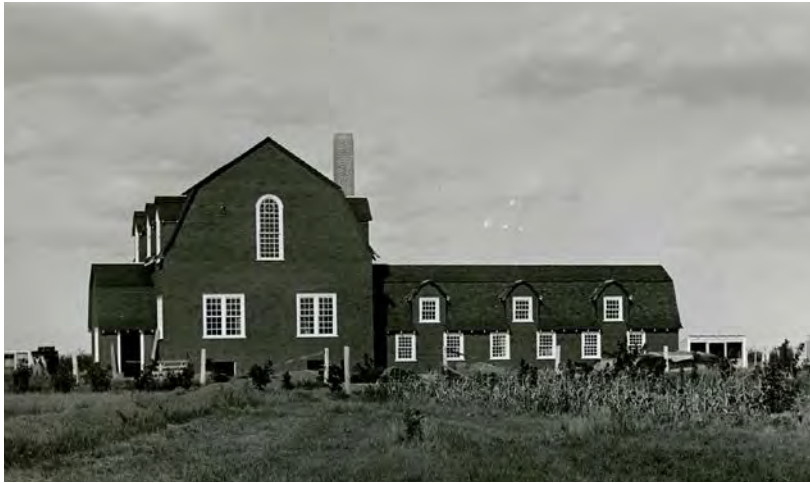
Figure 12. The Poultry Science Building as viewed from the south, ca. 1916. Photo A-681, retrieved from University of Saskatchewan Archives.

Originally, the building featured an elongated ‘brooder house’ (shown in Figure 12) on its east side. In 1959, the small vestibule that protruded from the west face of the building was extended. For a time the building existed with both an east and a west wing before the east wing was demolished in 2000. The form of the new west wing is very similar to that of the former east wing. Figures 12 and 13 show the original form of the building and the current form of the building, respectively. Note the change in the location of the ‘brooder house’ wing. Despite the removal of one wing, and the addition of a new one, the character of the building has been maintained with a good degree of commemorative integrity.

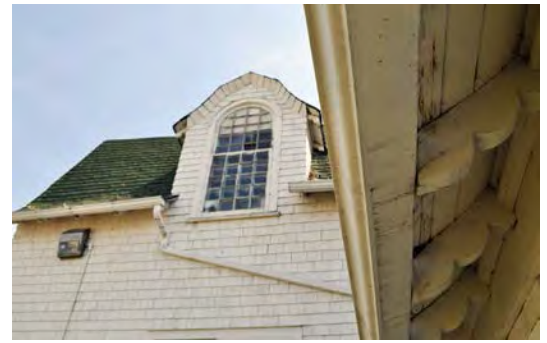
Figure 10. L to R: gambrel dormer, decorative rafter ends.

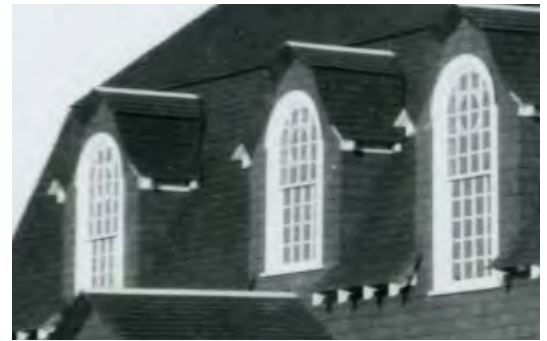
Figure 11. Gambrel dormer windows with wooden roundels, ca. 1918. Photo A-3834, retrieved from University of Saskatchewan Archives.

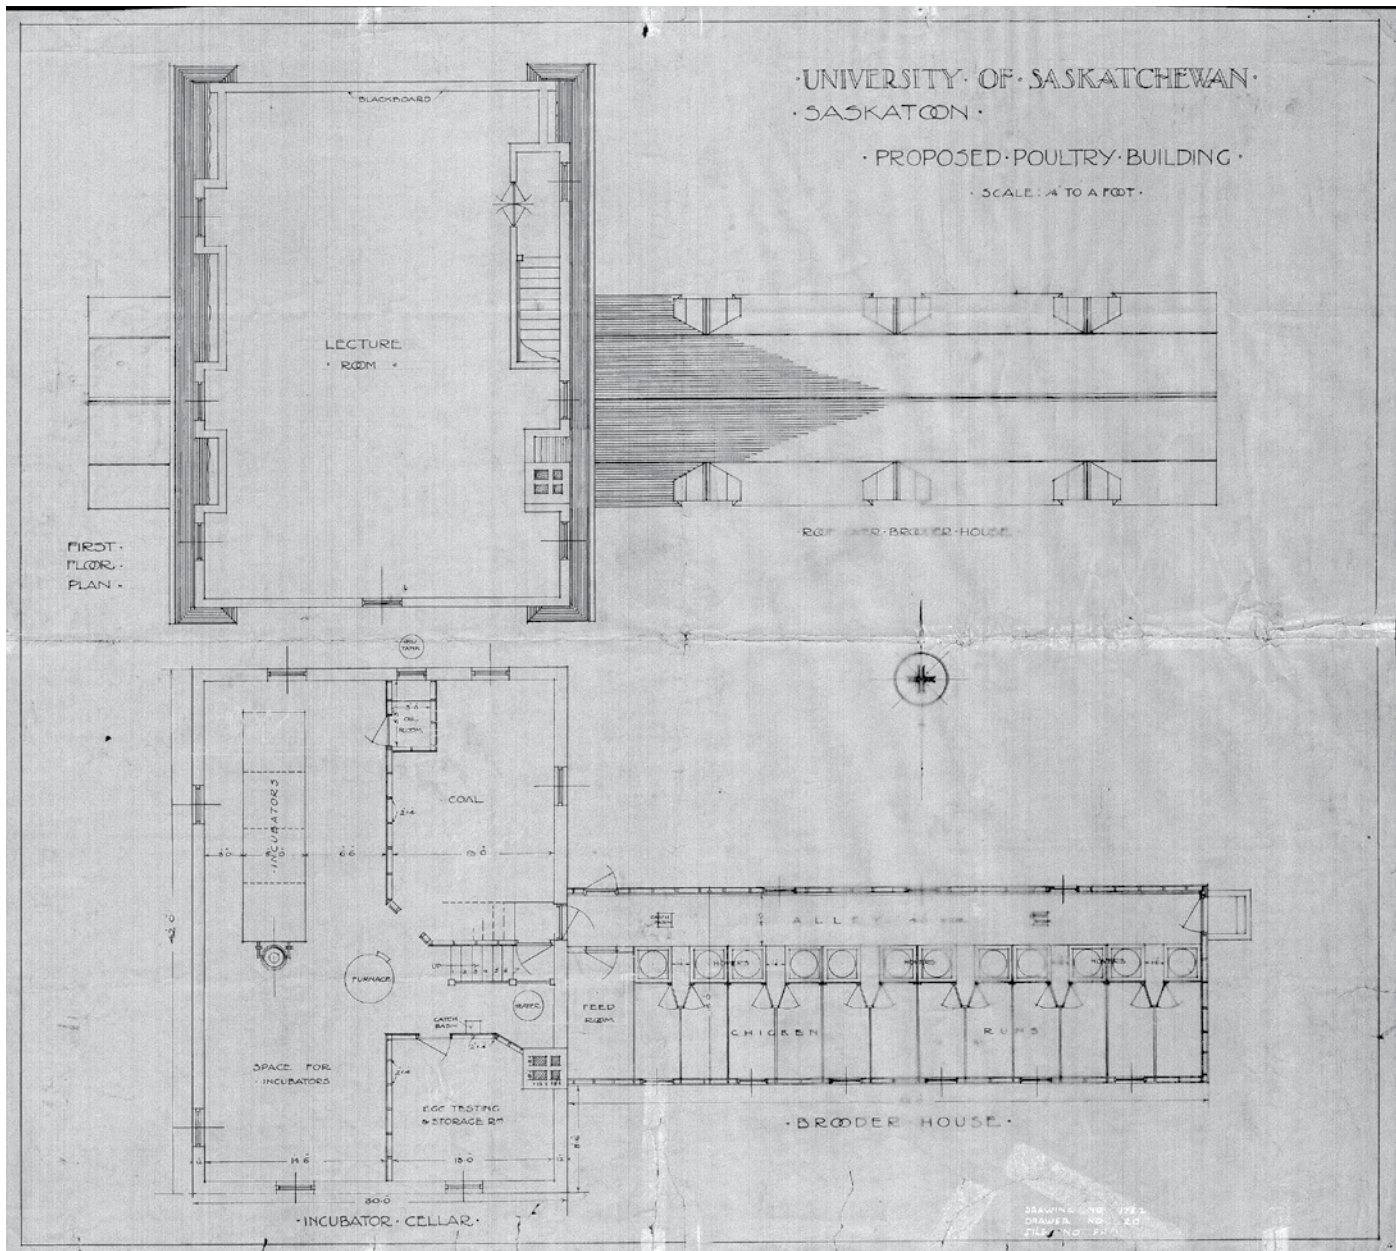
Figure 15. The basement and first floor plan of the Poultry Science Building as it was originally configured. Retrieved from Asset Record System, File PH-3-T.

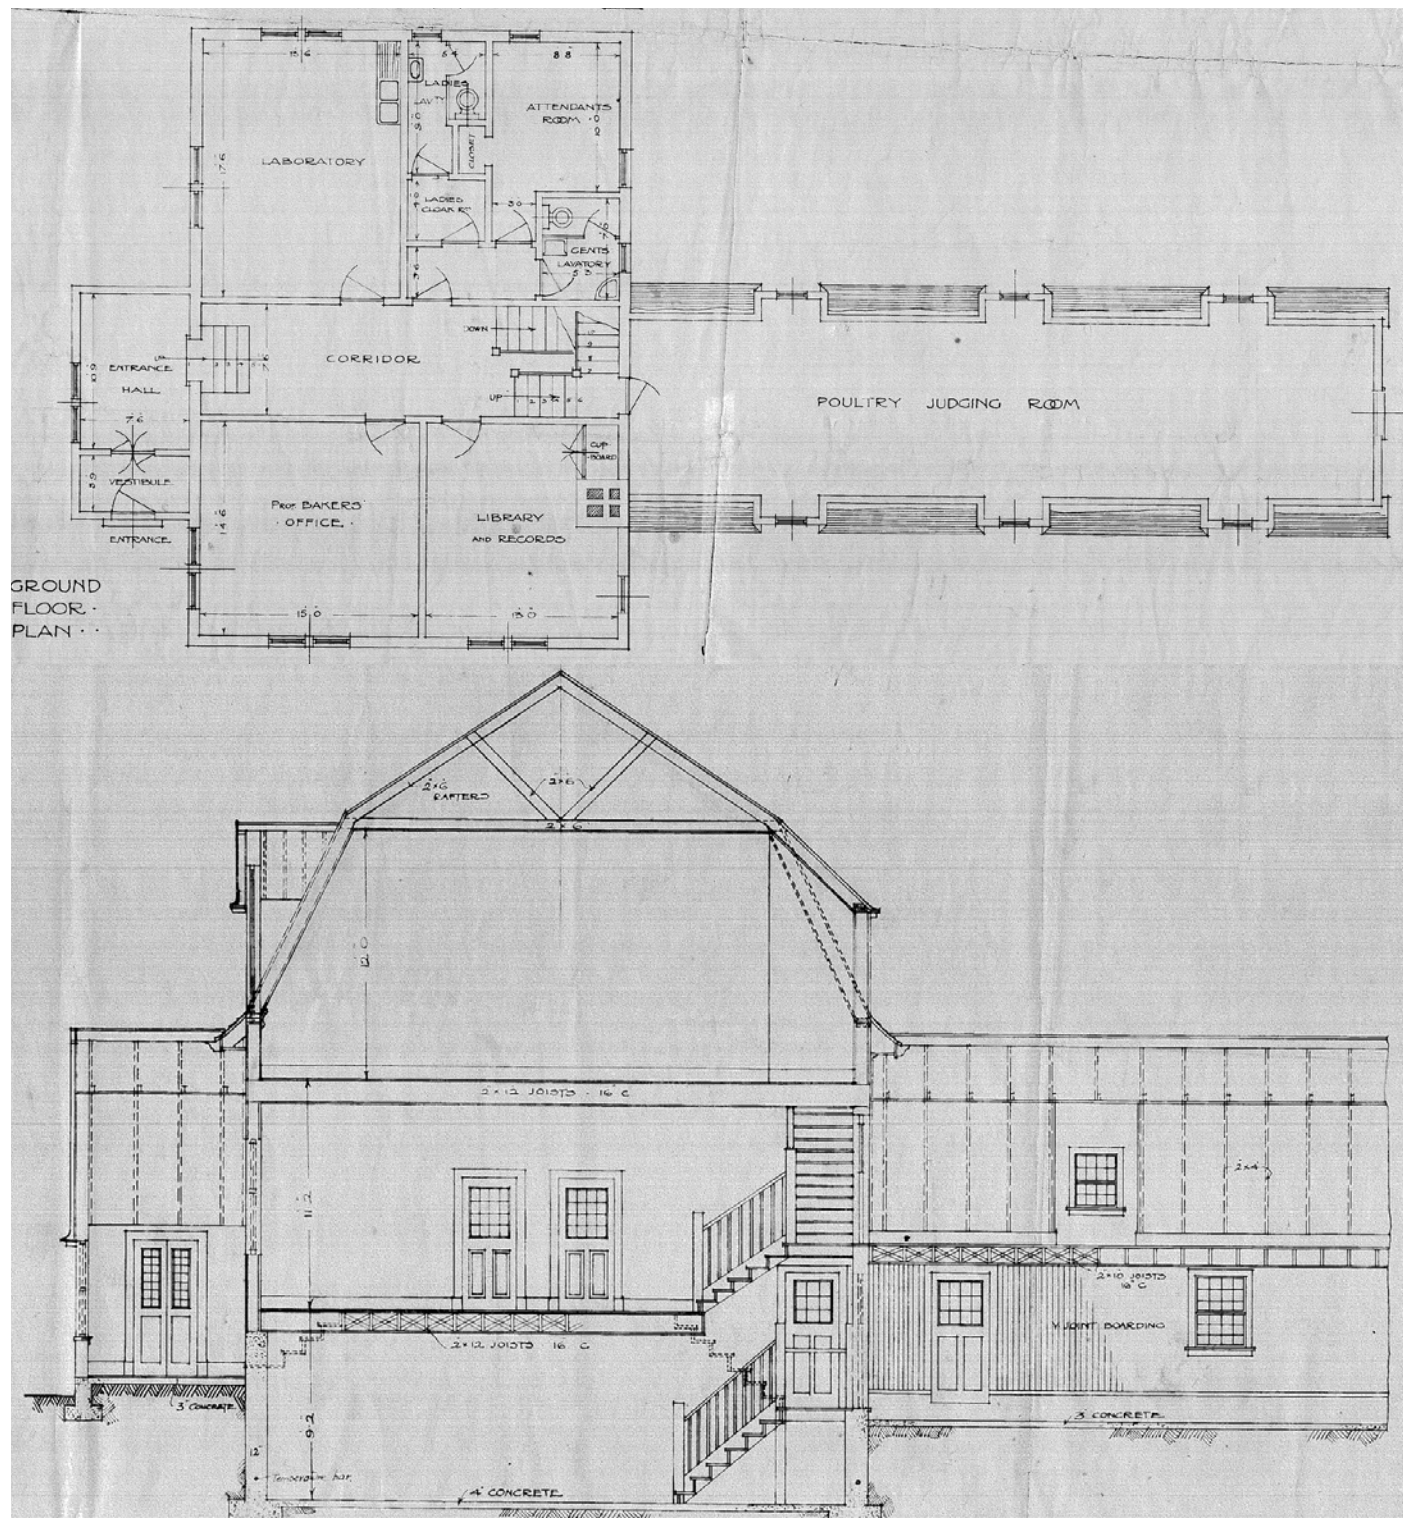
Figure 17. Original ground floor plan and section through the Poultry Science Building. The area labelled 'Poultry Judging Room' no longer exists. The west wing has been extended and the east wing has been removed. Retrieved from Asset Record System, File PH-1-T.

The remaining original portion of the Poultry Science Building consists of a two-storey structure, which is entered through a vestibule (now extended to become a wing). The main floor of the original space is raised up from grade level and is accessed from a short set of wide stairs. The raised main floor is subdivided into a number of individual rooms, as shown in Figure 15. Principal spaces included a poultry judging room, a library and records room, an office for ‘Professor Baker,’ an attendant’s room and lavatories for men and women. A cloak room was also provided for the women. The building’s single staircase offers access to the basement and the first floor loft space. Figure 17 illustrates the relative height differences between floors.

As Figure 17 illustrates, the second floor consists of a single large open space, accessed from a stairwell running up the east side of the building. Tall windows on three sides provide ample natural light. A chalkboard is mounted on the north wall. A small closet exists on the east side of the room, above the stairs. A 12' ceiling height gives the space a light and airy character. The tall gambrel dormer windows create arched niches in the walls of the space. The natural light, arched window niches, open floor plan and the height of the space are all character-defining elements.

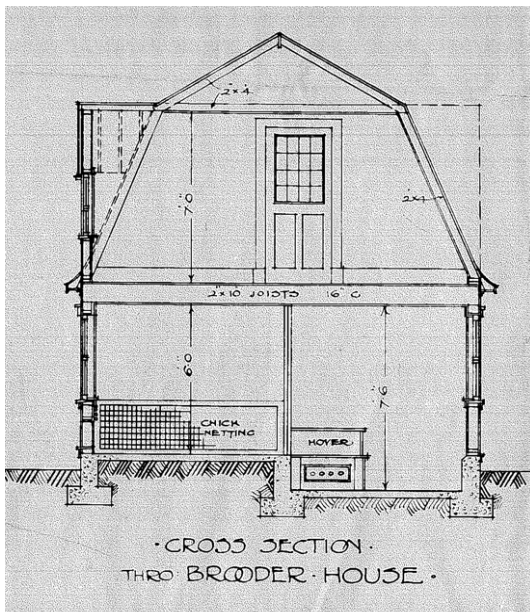
Figure 19. A section through the Poultry Science Building's original brooder house. Retrieved from Facilities Management Division Asset Record System, File PH-1-T.

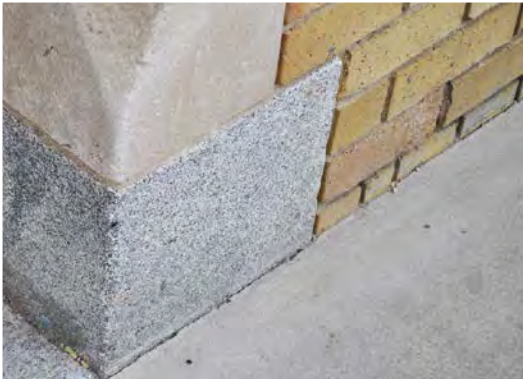
Figure 1. Indiana limestone, grey Canadian granite, yellow brick.

The exterior of Kirk Hall is characterized by yellow brick with Indiana limestone trim and a base of grey granite (Figure 1). Yellow brick is a character-defining material, the intention of which was to denote agricultural buildings. Yellow brick was also used for the Virus Laboratory (now demolished) and the Soils and Dairy Building (now known as the [John Mitchell Building](#)). Limestone and granite are materials used on many buildings at the University of Saskatchewan. As Figure 2 illustrates, windows are single-glazed with green painted rolled steel frames. These windows and their materials also constitute character-defining elements. Exterior doors are oak with brass hardware. The main entrance doors also feature oak-framed side lites (Figure 4) The oak, brass and glazing of the doors are character-defining elements.

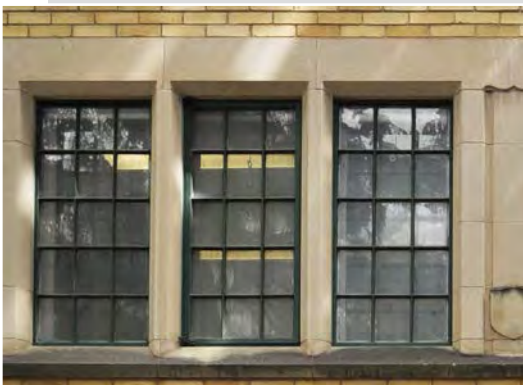
Figure 2. Single glazed steel casement windows.

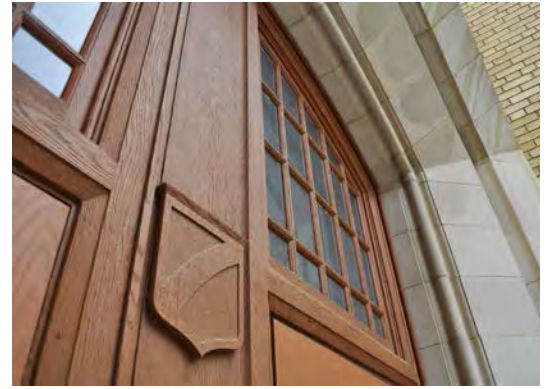
Figure 4. L to R: Oak doors with transom glazing, Indiana limestone, yellow brick.

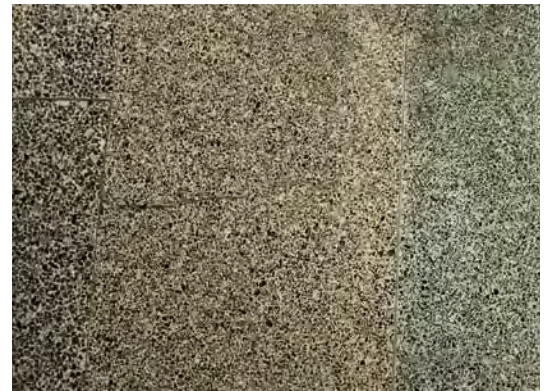
Figure 5. Terrazzo flooring.

The interior of the building is defined by materials different from those used previously at the university. The floors throughout the building are finished in terrazzo as are the stair treads and landings of all three staircases (Figure 5). The condition of the terrazzo varies: in the basement, it has been repaired in several places with terrazzo or polished concrete. The window sills are also terrazzo and generally exist in good commemorative condition. Terrazzo is a character-defining material.

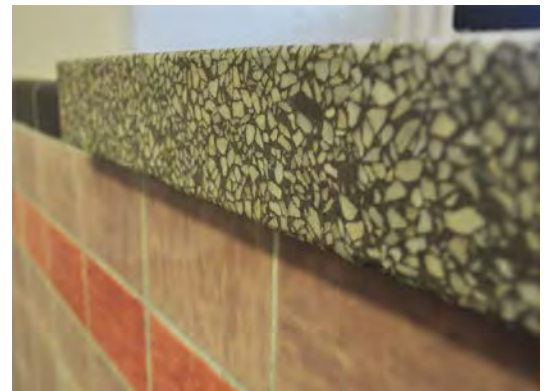
Figure 6. Terrazzo window sill and purple, red and black glazed ceramic tile.

The interior of Kirk Hall is characterized by the use of brick and glazed ceramic tile for walls (Figure 6). In the west end of the basement, walls are faced in yellow brick in both the corridor and interior of the rooms. The brick generally exists in good commemorative condition. A brick fireplace surround also remains in fair commemorative condition (Figure 7). All floor levels feature the use of glazed tile as a wall surface. For example, the staircase shown in Figure 8 features white glazed tile wainscoting with a blue glazed tile border on all floors. The same is found in washrooms and areas formerly used as washrooms. The tiles generally exist in excellent condition. The hearth of the first floor fireplace features character-defining red quarry tile in excellent condition (Figure 9). Most of the hallways feature a painted border on the floor, as seen in Figure 10.

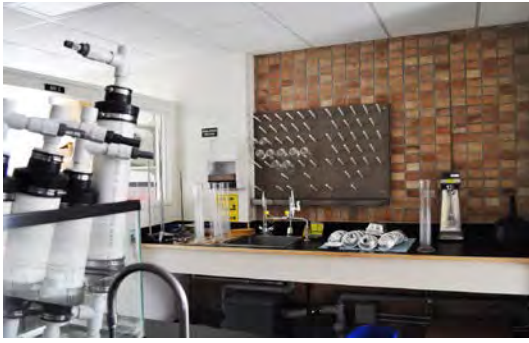
Figure 7. The brick mantle of the basement fireplace now inside a lab.

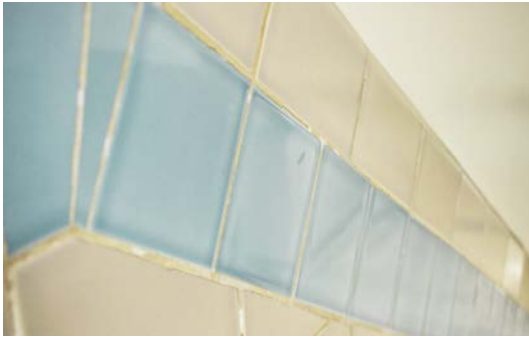
Figure 8. Blue and white glazed ceramic tile.

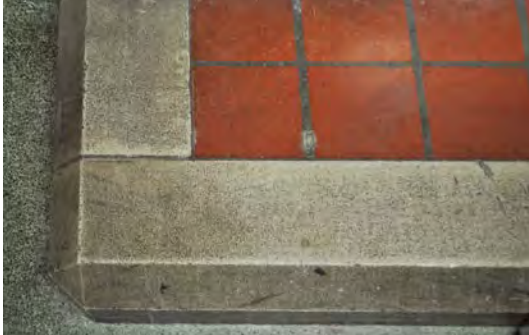
Figure 9. Red quarry tile hearth surrounded by white glazed tile on terrazzo flooring.

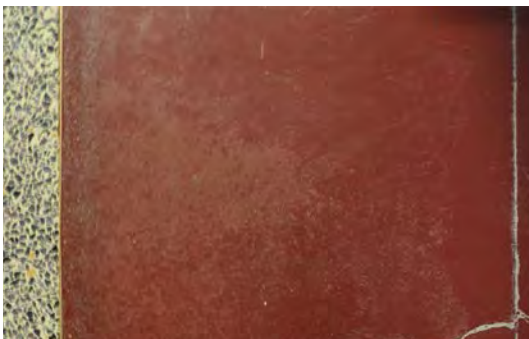
Figure 10. Painted concrete flooring.

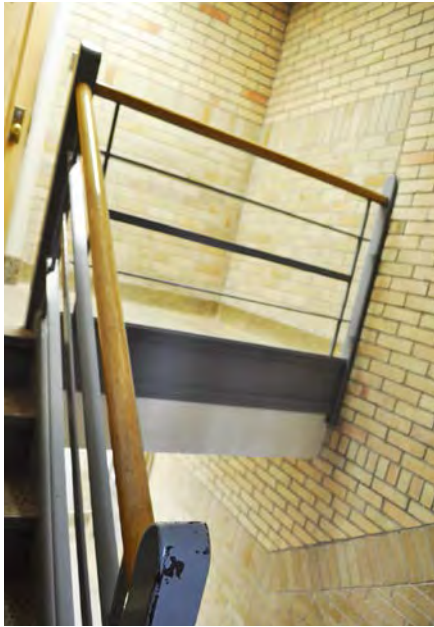
Figure 14. The north staircase: steel stringers, iron balustrade and birch banister. A yellow brick wall is in the background.

The staircases are made with steel stringers, treads and balustrades. The main stair features its original ‘alumilite’ handrail. Other handrails are birch. These steel staircases with their wooden and aluminum banisters are character-defining materials.

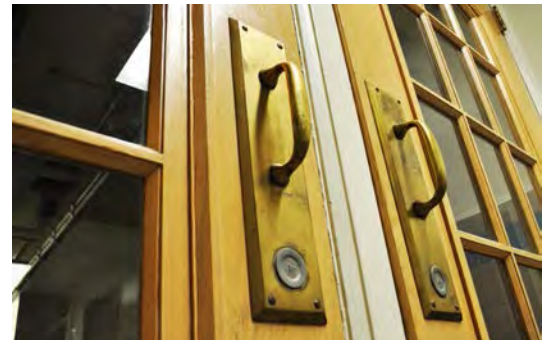
Figure 11. Maple doors with glazed panels and brass hardware.

Various species of wood are used in the building, including oak, fir, maple, pine and birch. This variation represents a departure from the buildings designed by architects Brown and Vallance, who predominantly specified oak. The maple used for the doors in Kirk Hall is a character-defining element. The doors exist in varying states of preservation, with most of the residence room doors having been replaced. The double doors to the auditorium, recreation rooms and cafeteria have been maintained. Originally, doors leading into the central stair were oak and glass; however, these have been replaced by steel doors. In most instances, these replacement doors still feature the original brass hardware. Figure 11 shows a set of doors in the original maple with brass hardware.

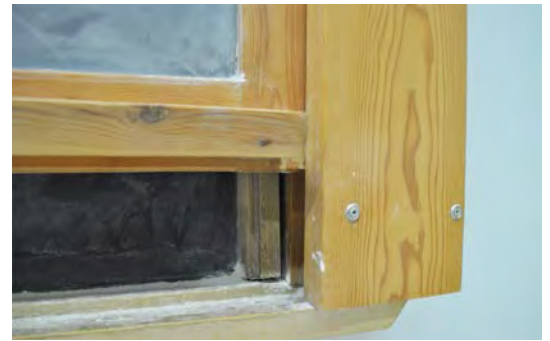
Figure 12. Slate chalkboard beneath a newer chalkboard that has been added over top.

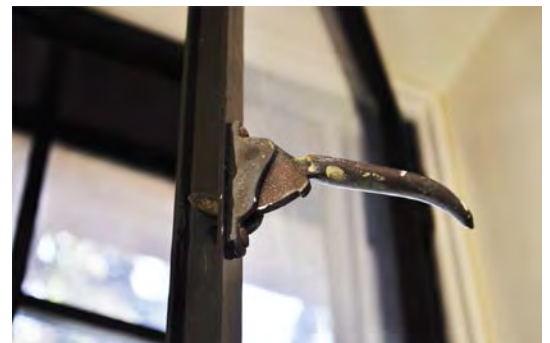
Figure 13. Brass window fixtures attached to a painted steel casement.

with steel cranks that have also all been retained. A character-defining feature of the windows is the use of a large single pane of glass on the interior rather than several separate lites, representing a stylistic change from previous buildings (Figure 13). The brass door hardware has generally been maintained.

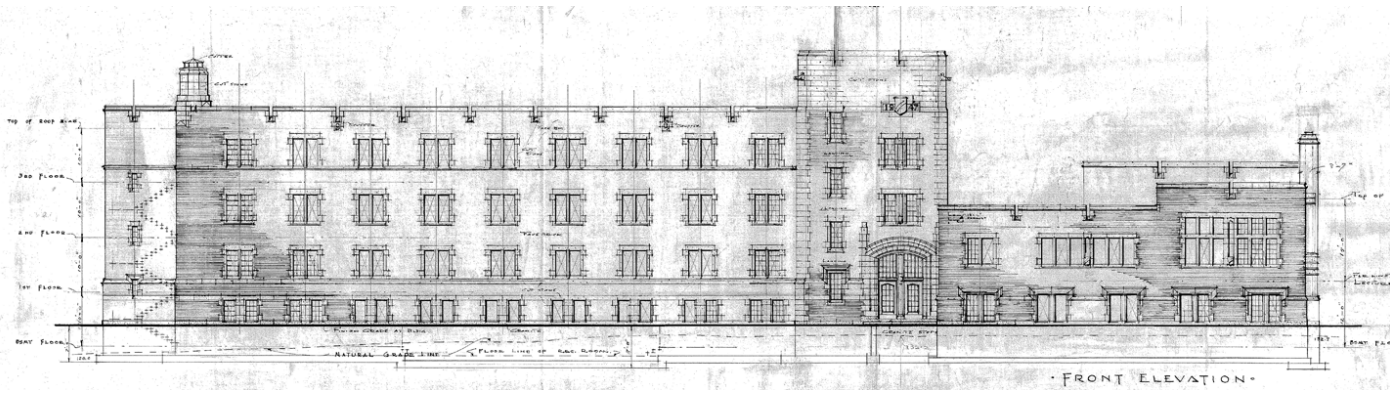
Figure 15. Front elevation of Kirk Hall showing assymetry of design and limited use of gothic ornamentation. Retrieved from Facilities Managment Division Asset Record System, File KH-48-T.

The orthogonal form of the building is of interest for the same reason. Right angles and rectilinear forms characterize Kirk Hall both in plan and elevation. The front entrance and central staircase are contained within a tower protruding from the primary volume (Figure 15). Kirk Hall features flat roofs and cubic volumes. (An elevator shaft added in 2009 is visible on the elevation shown in Figure 16.)

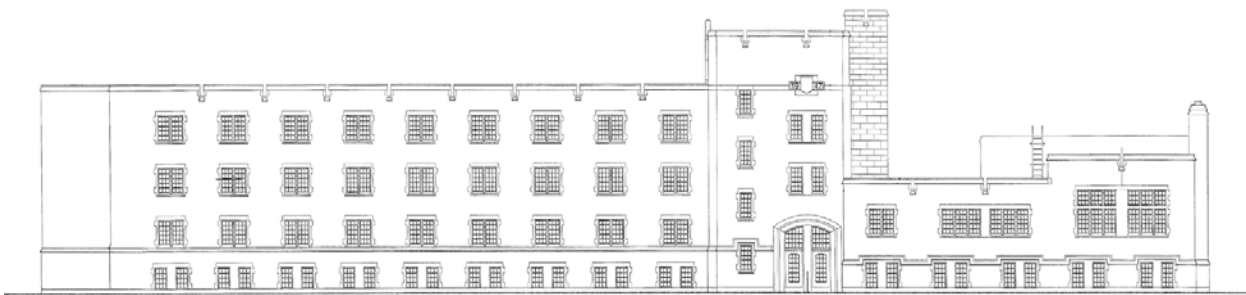
Figure 16. Front elevation of Kirk Hall showing assymetry of design and the addition of an elevator shaft. Retrieved from Facilities Managment Division Asset Record System, File 031-221-T.

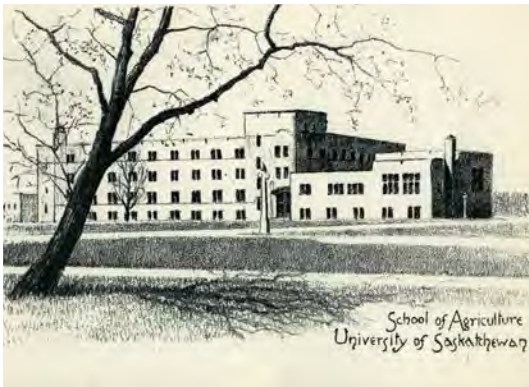
Figure 17. The form of Kirk Hall. Photo A-472, retrieved from University of Saskatchewan Archives.

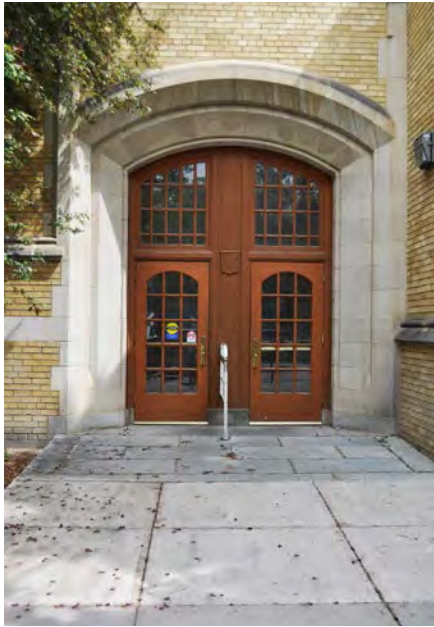
Figure 22. Architrave and doors with arched transom.

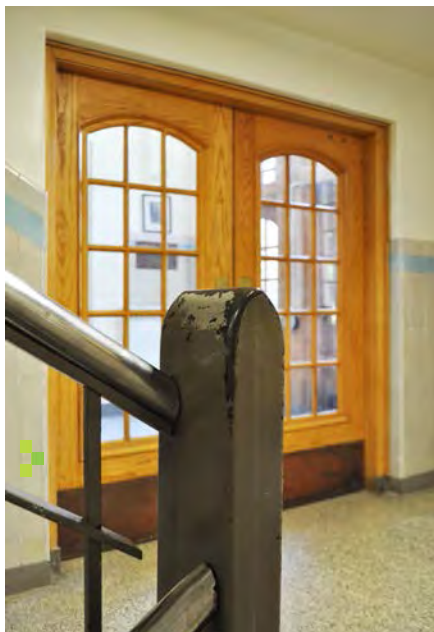
Figure 23. Gothic arch shape on newel post, arched glazing in doors.

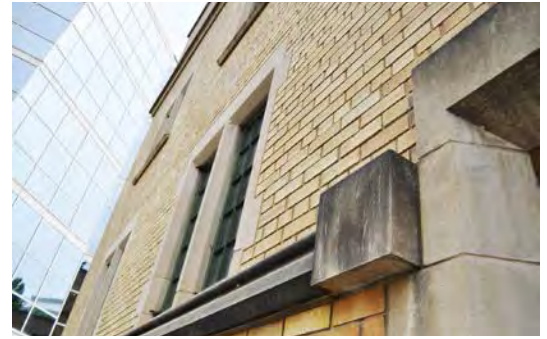
Figure 18. String courses and stone blanks.

exposed concrete. However, despite a subtle shift to the modern idiom, the building contains many other references to the older Collegiate Gothic architectural style. Its limestone quoins, stone string courses (Figure 18) and archer slot windows (Figure 19) are all characteristic examples. Its stone drainage spouts and crenellated parapet are also character-defining elements of the Collegiate Gothic style (Figure 20). The carved stone shields and blank tablets are further gothic character-defining elements (Figure 18, 20 & 21). The main entrance is located in a shallow architrave formed of carved stone. The doors themselves have an arched transom. Figure 22 shows the gothic elements of the entrance. On the interior, the posts of the balustrade take the form of pointed arches (Figure 22). The doors leading to the double height spaces on the first floor have arched windows set into them. All of these gothic references - the tower, architrave and arch motifs - have heritage value and are character-defining.

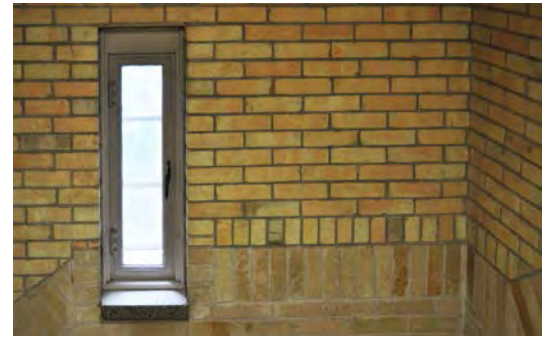
Figure 19. Archer slot style window.

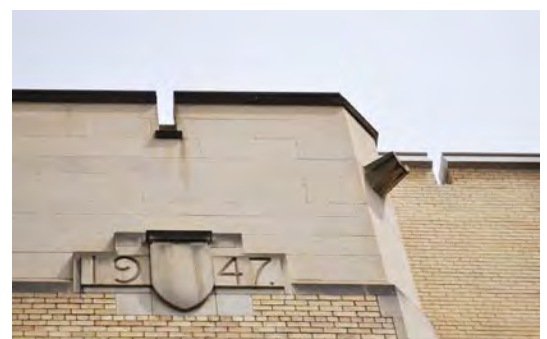
Figure 20. Carved stone shield, parapet and stone drainage spout.

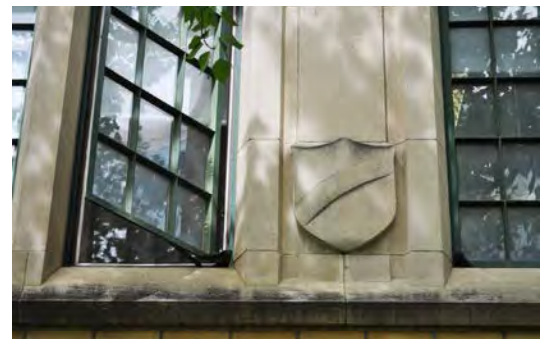
Figure 21. Carved stone shield motif.

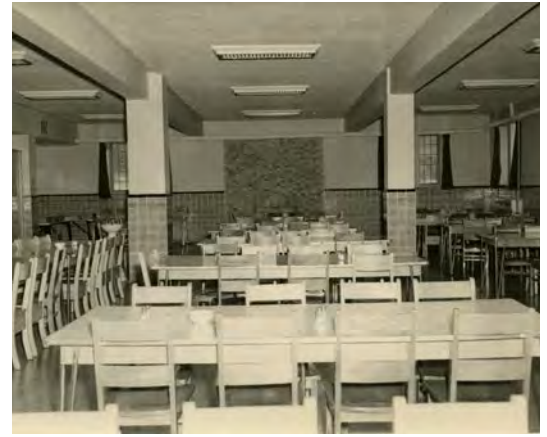
Figure 26. The original configuration of the cafeteria space in the basement. Photo A-484 retrieved from University of Saskatchewan Archives.

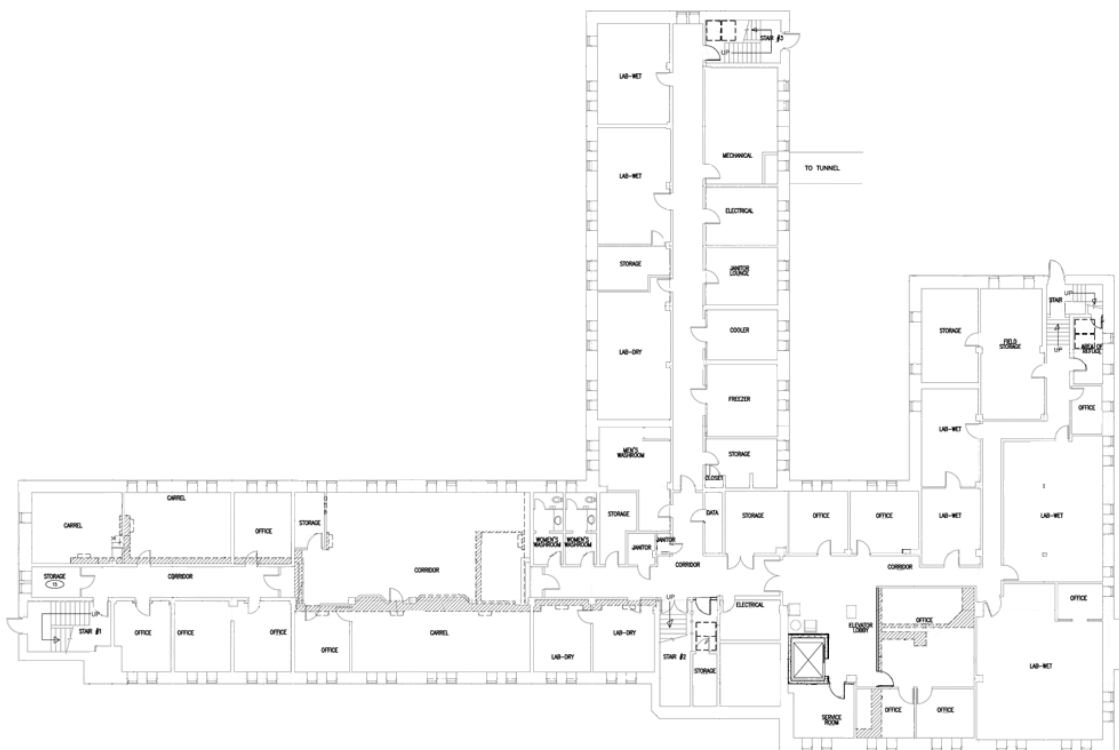
Figure 27. The configuration of the basement level at the time of this report. Retrieved from Facilities Management Division Asset Record System, File 031 KH-226-AB.

The basement has seen the greatest reconfiguration of its spaces. As shown in Figure 27, the eastern end of the building was originally open in plan, housing a cafeteria and a kitchen. Figure 27 illustrates this original arrangement. This section of the plan has been reconfigured into a more compartmentalised floor plan of separate offices and laboratories as shown in Figure 28. Remnants of a fireplace and hearth are a reminder of the cafeteria space. See Section 2.1 Materials, Figure 7. An elevator shaft has also been added causing reconfiguration on all floors.

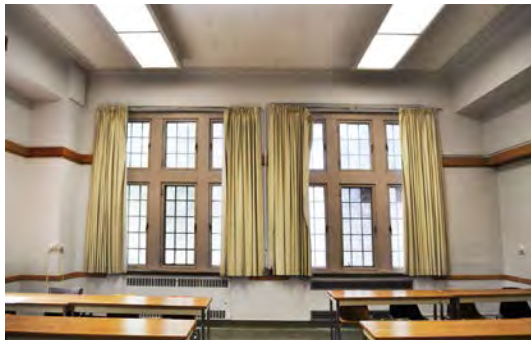
Figure 28. The common room, now a lecture room, has a heigh ceiling.

The ground floor has character-defining spaces in its lecture room and the former common room (now used as a classroom). Both spaces are double-height volumes and feature tall windows. The heights of these spaces and their windows are character-defining elements of the building's spatial configuration. Figure 28 shows the former common room, which has retained its original configuration. The fireplace in the room still exists but has been sealed. In the lecture hall, an elevated projector room was originally an open 'orchestra balcony' with a wooden banister. (Figure 29 illustrates the lecture room).

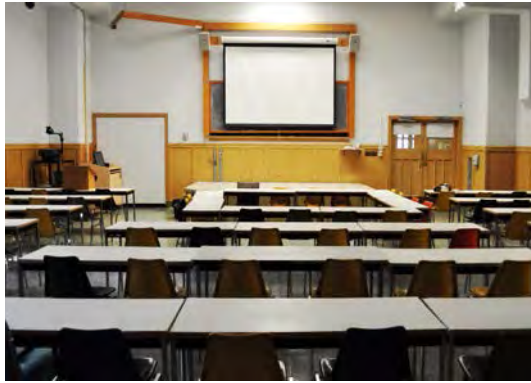
Figure 29. The lecture room. The doors on the left have been removed.

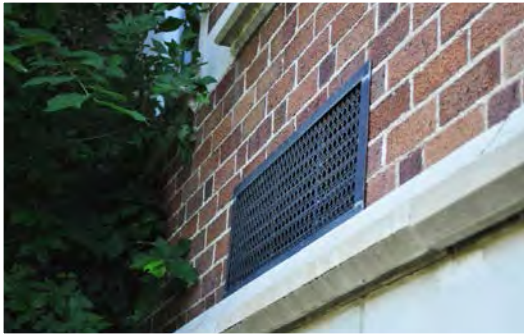
Figure 1. Red brick, artificial limestone and copper grille.

The exterior of the Williams Building is composed of a red-brown facing brick made at Claybank, Saskatchewan and a structural brick made at Estevan. The brick is accented with Tyndall stone and a precast concrete product made to resemble cut limestone. The brick and artificial stone are shown in Figure 1 and the Tyndall stone in Figure 2. The artificial stone around the windows as well as the partition blocks were made in Saskatoon. The Tyndall stone surrounding the doorways came from Manitoba. Exterior hardware such as down spouts and ventilation grilles are made of copper (Figure 1). Copper, Tyndall stone and limestone are all materials common to the main campus at the University of Saskatchewan, and are character-defining materials of the Williams Building. Slate tile roofing is also commonly found on campus. The Williams Building roof was originally slate, but has been replaced with asphalt shingles. Two newer additions have been built with slate tile (Figure 3). For further information on building stones used at the U of S, refer to [Appendix: Stone](#).

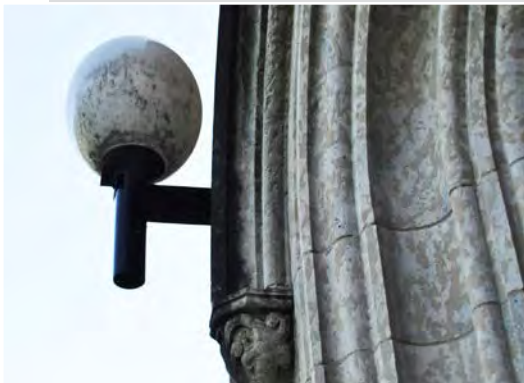
Figure 2. Tyndall stone.

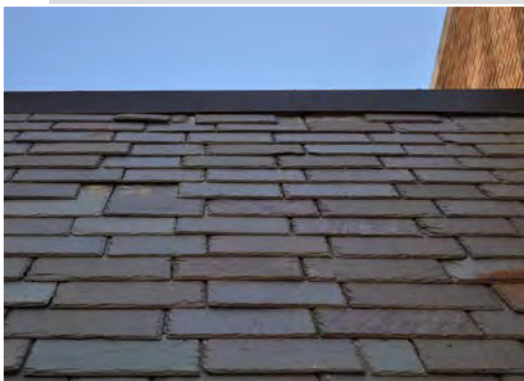
Figure 3. Slate tile roofing.

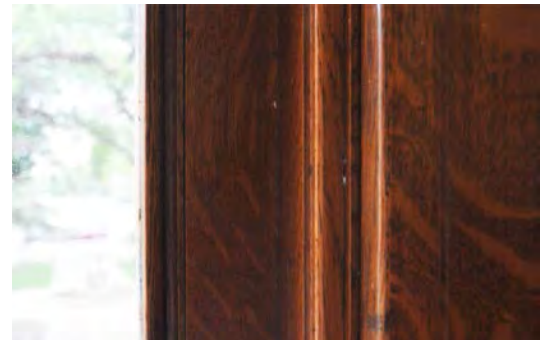
Figure 5. Oak door.

Oak (Figure 5) was used for doors and frames. All of the original oak material has been replaced except for the transoms and lites around the two northernmost entrances. The quarter-sawn oak around these doors and their stained-glass transoms are character-defining elements (Figure 6).

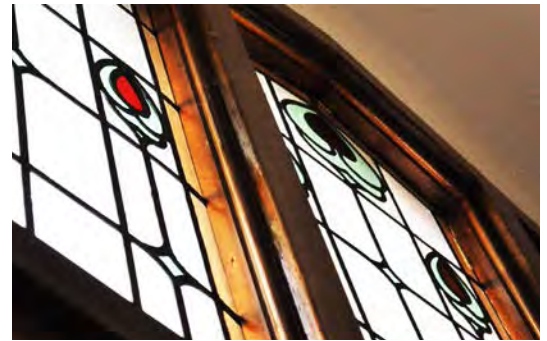
Figure 6. Stained glass.

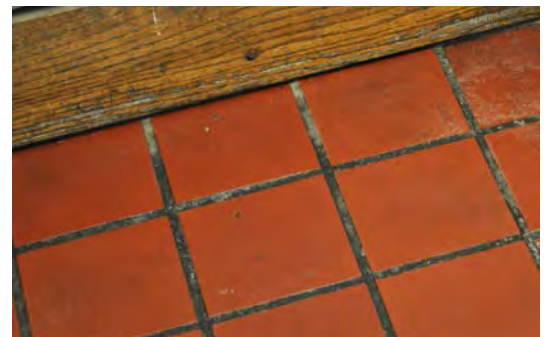
Figure 7. Red clay terra cotta tile located inside the principal entry.

The interior of the Williams Building holds very little heritage value in its materials, as almost all of its original materials have been replaced. The red terracotta floor tiles in the main entrance hall are original. Shown in Figure 7, this tile is in excellent commemorative condition.

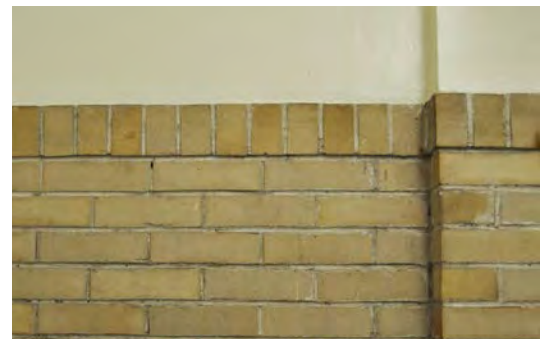
Figure 8. Brick wainscoting.

Some brick wainscoting is still found in the anterooms to the gymnasium (Figure 8). The walls of the gymnasium have been covered with carpet. The original brick wainscoting may exist beneath the carpet. Building plans show that brick wainscoting with plaster walls and ceiling were a common material throughout the entire building. Existing brick wainscoting is a character-defining element of heritage value. The rest of the materials of the auditorium have been compromised; the wooden floor has been replaced with a vinyl composite tile, and the original ceiling has been concealed by a dropped ceiling.

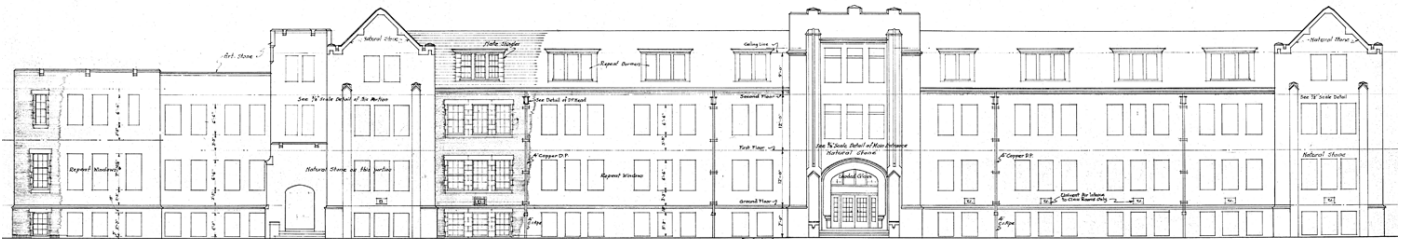
Figure 9. The original west or front elevation of the Williams Building. Retrieved from Facilities Management Division Asset Record System, File WILL-10-T.

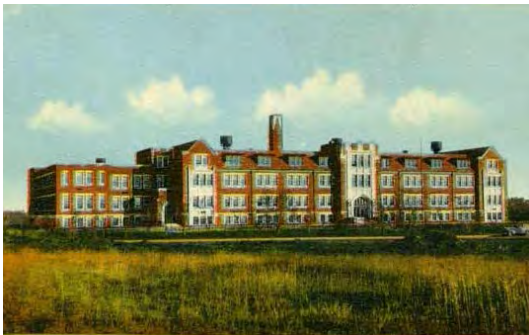
Figure 10. The form of the Williams building in 1943 before the renovations. The high chimney pictured here was removed. Retrieved from http://spldatabase.saskatoonlibrary.ca/internet/LHR_RADQuery.htm

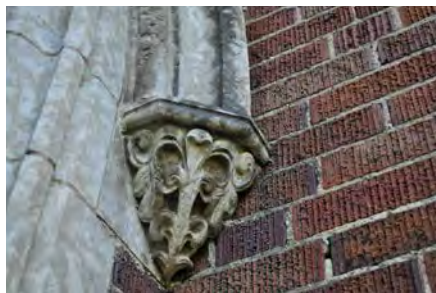
Figure 16. Foliated cut stone ornamentation.

The Williams Building is Collegiate Gothic in its architectural style. Character-defining elements include the carved stone entries and their accompanying gothic arch transoms (Figure 12). String courses and quoining around the windows are also character-defining elements of the gothic style in good commemorative condition (Figures 12 & 13). The cut stone above the principal entry features trefoil and quatrefoil arches (Figure 15). The foliated cut stone ornamentation around the doors is also a character-defining element (Figure 16). The cut stone detailing serves to enhance the verticality of the building.

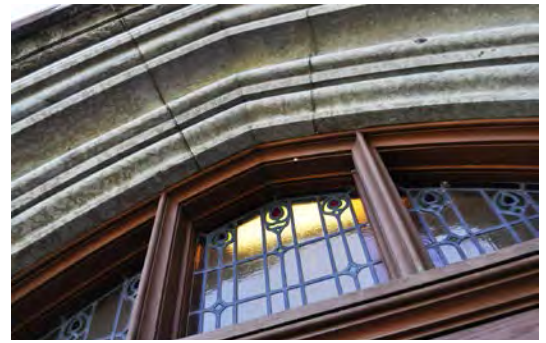
Figure 12. Gothic arch and transom.

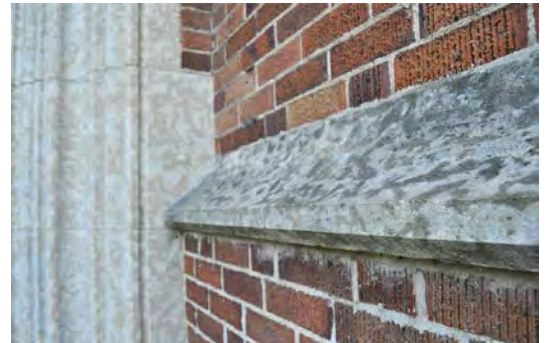
Figure 13. Tyndall stone string course.

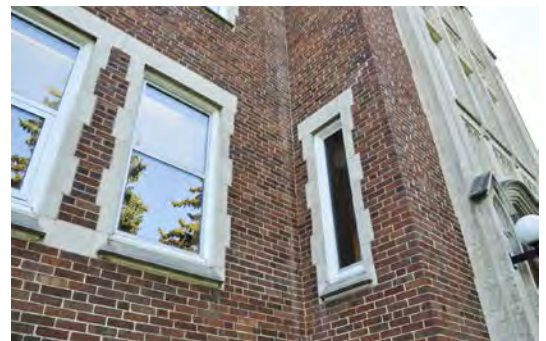
Figure 14. Stone quoins around windows, an archer slot window.

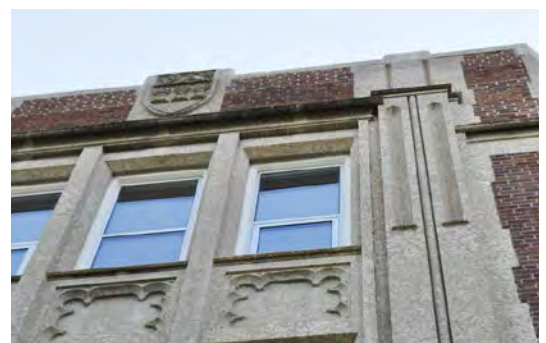
Figure 15. Gothic trefoil arches and the Sasaktchewan crest carved into the vertical stone elements surrounding the principal entry.

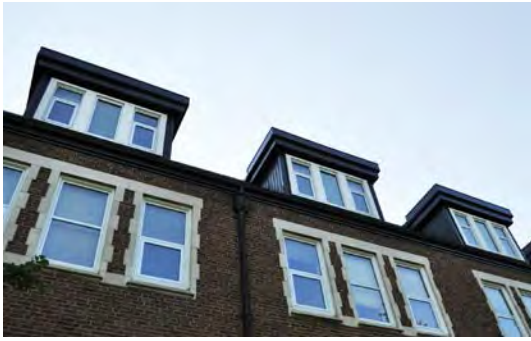
Figure 18. Dormer windows.

The roofline features a crenellated brick and stone parapet (Figure 17) on tower elements marking the two front entrances, gables and a pitched roof punctuated by dormer windows. The dormer windows have been maintained in their style but their materials have largely been replaced (Figure 18). The building also features narrow archer style windows surrounded by cut stone (Figure 14). The auditorium or gym still features double-height arched window openings, although the windows themselves have been replaced and covered with bars on the interior and the lower portion of the windows has been covered with brick, as shown in Figure 19. The arched windows lend character to both the interior and the exterior of the building. Figure 20 illustrates many of the character-defining elements of the building's exterior.

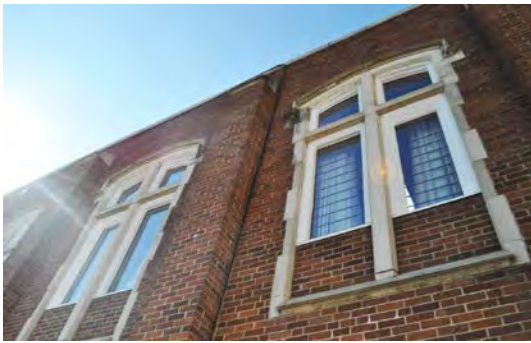
Figure 19. Arched windows.
