University of Saskatchewan

Heritage Register

September 2013

Facilities Management
Division

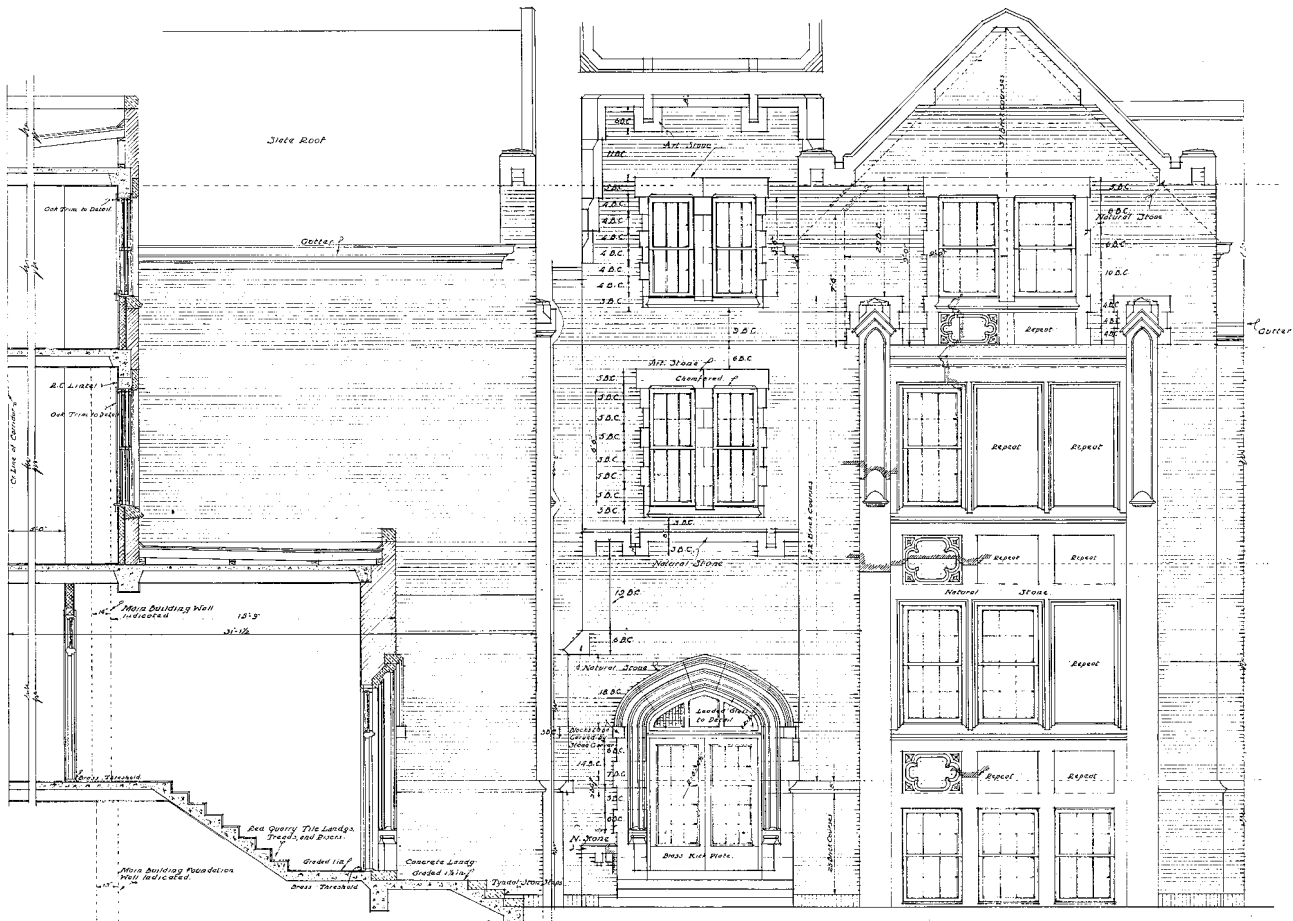
Figure 20. Gable and tower details including gothic arch entry, trefoil spandrels, crenellated parapet, cut stone quoins, tower and statuary niche references. Retrieved from Facilities Management Division Asset Record System, File WILL-12-T.

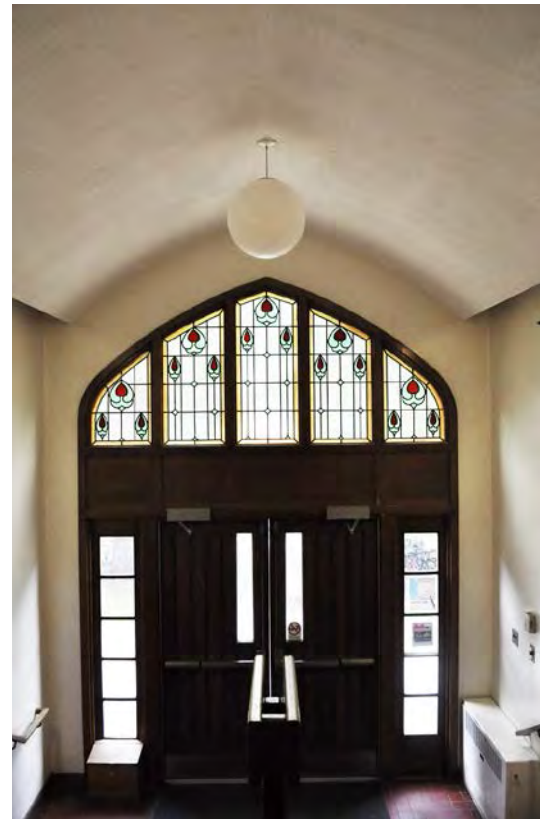
Figure 21. Gothic arch transom.

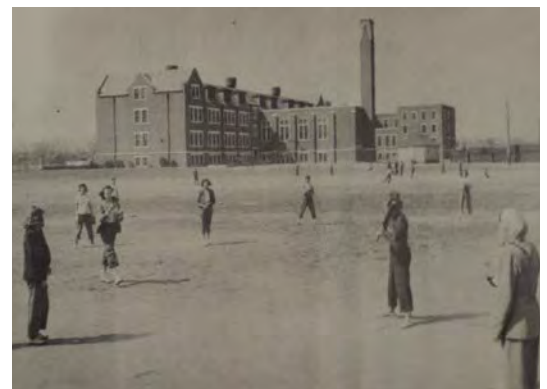
Figure 23. A 1949 photo of the building shows its exterior before the 1970's renovations. Retrieved from *The First Fifty Years: R.J.D. Williams Provincial School For the Deaf*.

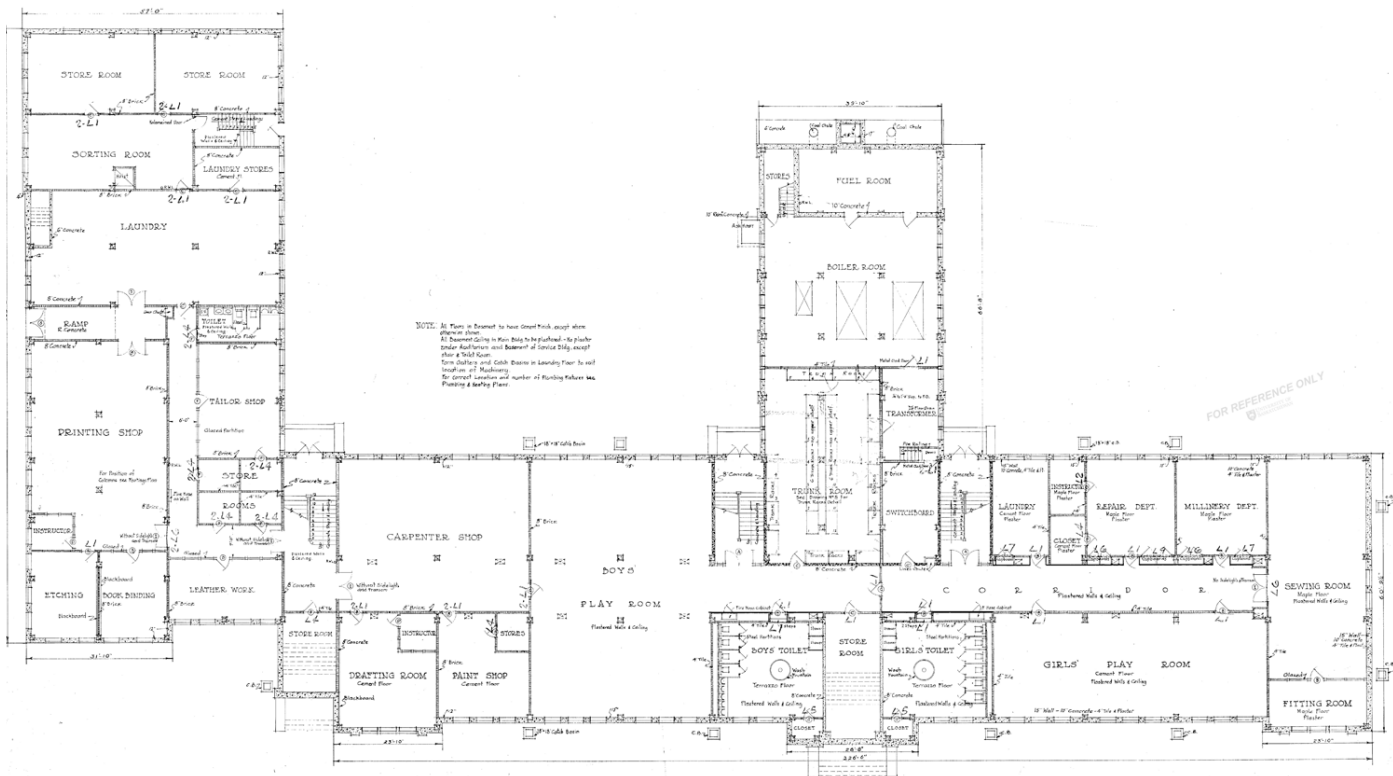
Figure 24. The original basement configuration of the Williams Building. Retrieved from Facilities Management Division Asset Record System, File WILL-4-T.

The basement originally had large open areas for the boys play room and carpentry shop. These have been enclosed and the basement is now substantially reconfigured. A daycare is now located in the south-west corner of the basement. Figure 24 shows the original configuration of the basement.

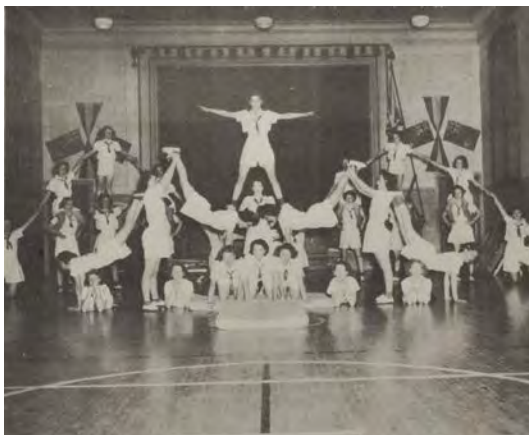
Figure 25. A photo, ca. 1945, shows how the auditorium was originally configured. Retrieved from *The First Fifty Years: R.J.D. Williams Provincial School For the Deaf*.

The most notable change to the spatial configuration of the building has been the expansion of the auditorium on the main floor to become a gymnasium. The expansion saw the removal of several south-facing arched windows. The windows still existing in the space have had their bottom portions filled in with brick. The stage and the open gallery overlooking this space from the second floor have also been removed. A staircase at the west end of the gymnasium has been added. Figure 25 shows an interior view of how the auditorium was originally configured with a stage.

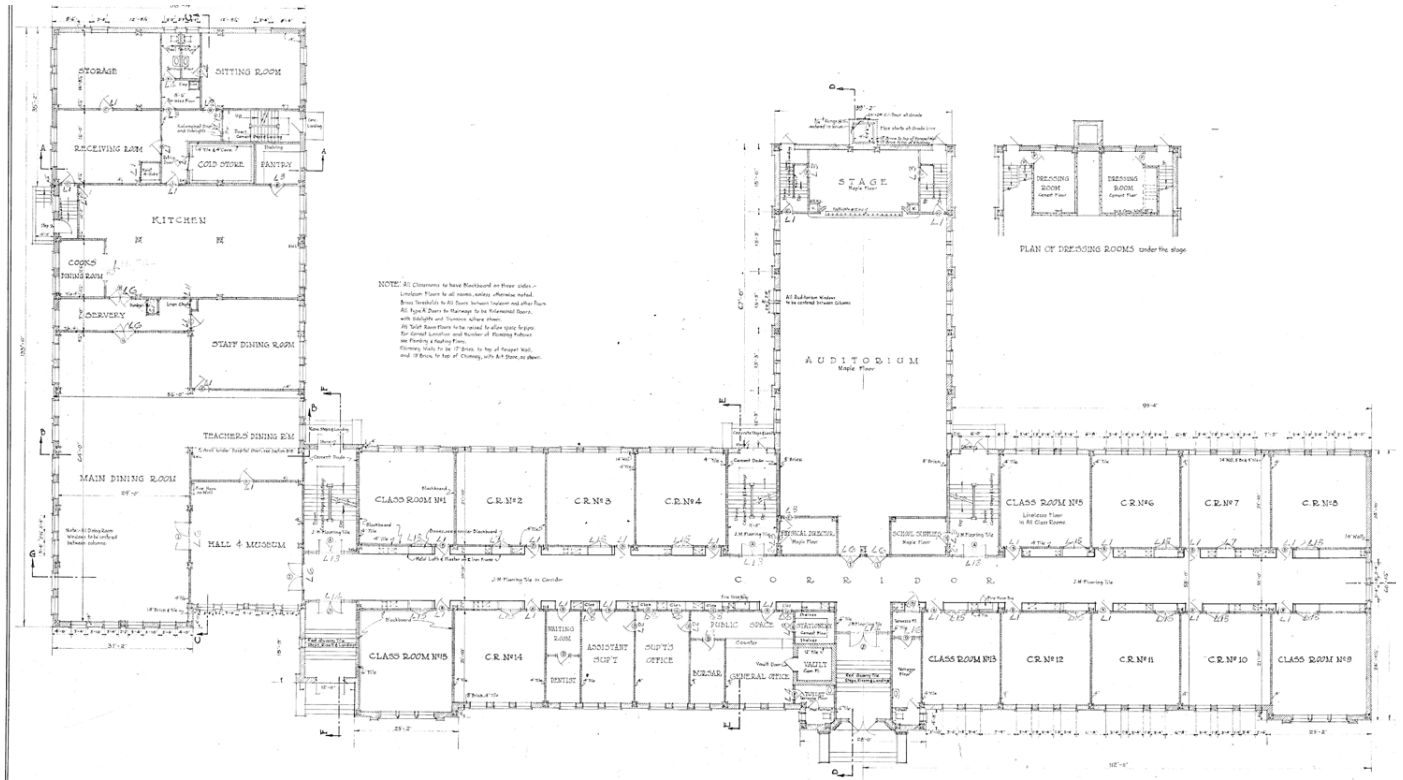
Figure 26. The original first floor plan of the Williams Building. Retrieved from Facilities Management Division Asset Record System, File WILL-5-T.

Figure 26 shows the original main floor plan including the layout of the auditorium. Figure 27 shows the expansion and reconfiguration that converted the auditorium into a gymnasium. Outside the auditorium, the first floor has retained its configuration, arranged around a double-loaded corridor. Some rooms have been expanded through the deletion of partition walls. The northeast portion of the main floor has seen significant reconfiguration with its conversion from a dining area to a series of research gymnasiums and offices.

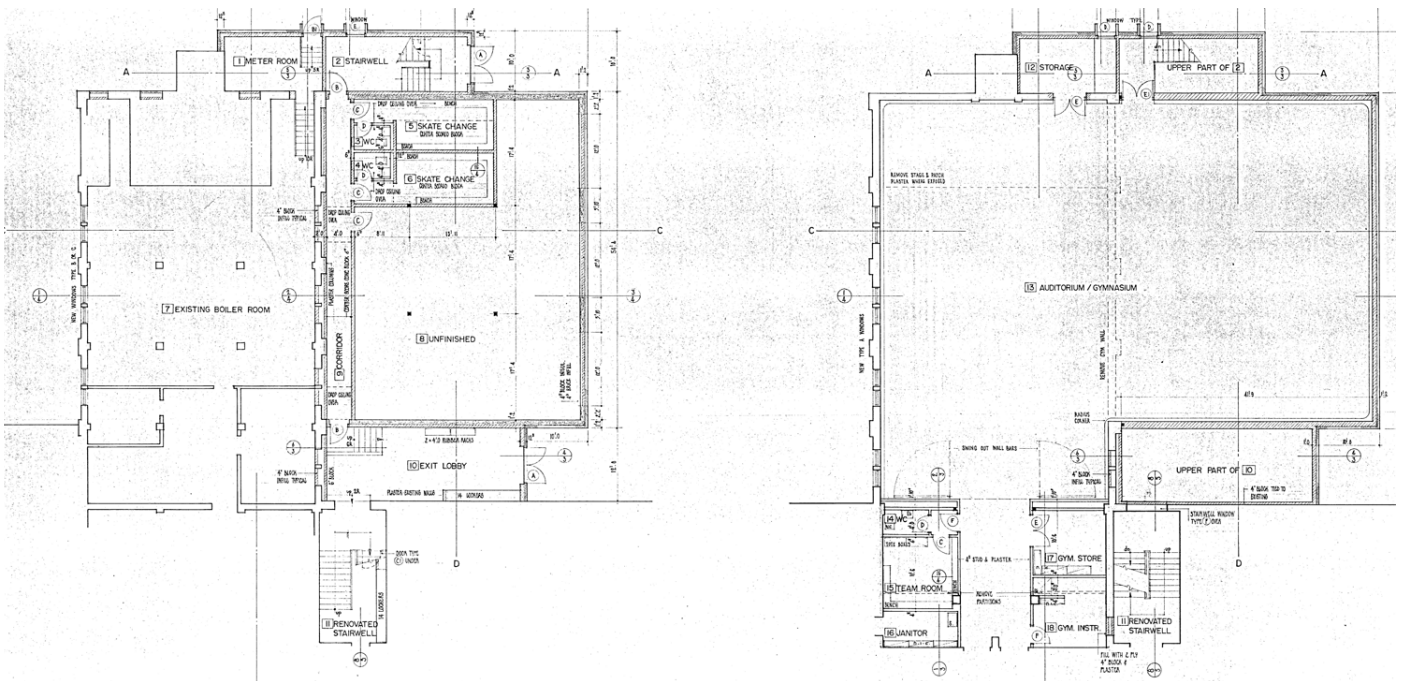
Figure 27. The expansion of the auditorium, L to R: the basement plan, the first floor plan. Retrieved from Facilities Management Division Asset Record System, File WILL-147-T.

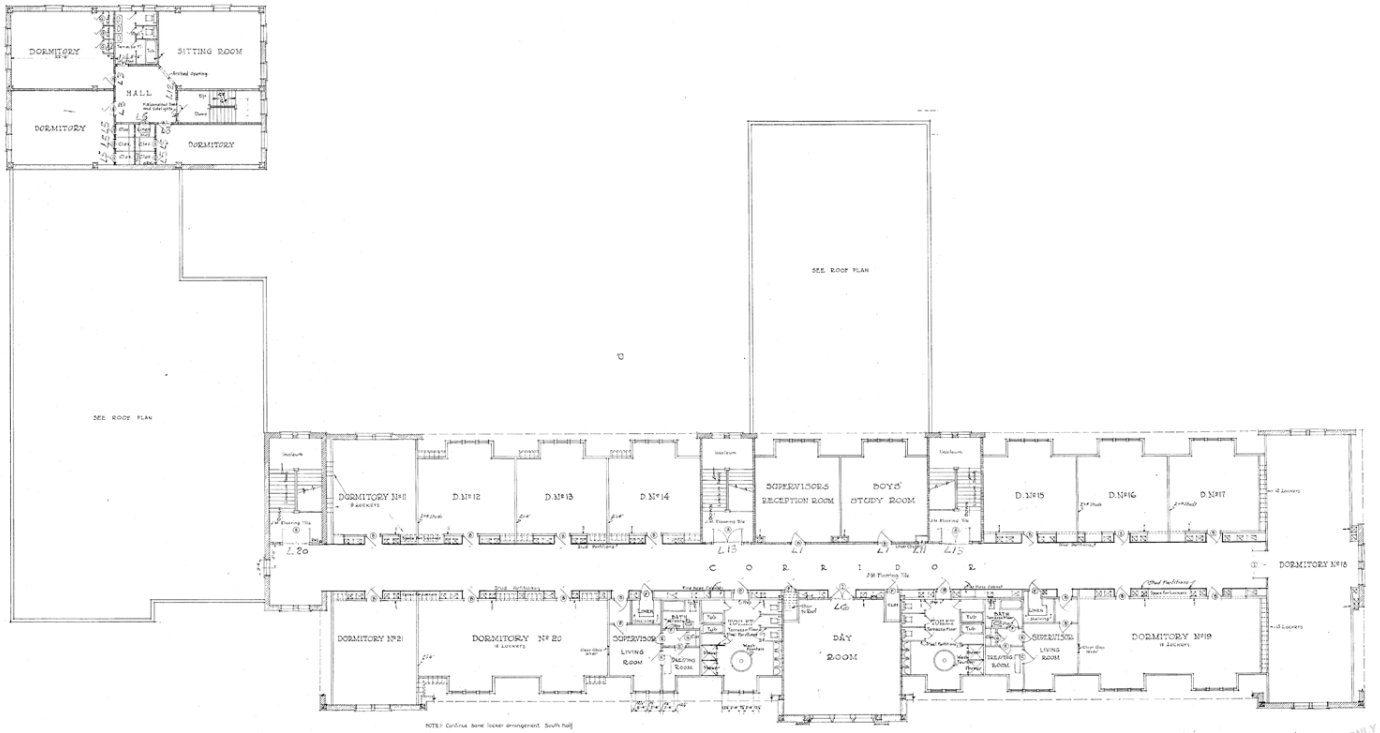
Figure 28. The original third floor plan of the Williams Building. Retrieved from Facilities Management Division Asset Record System, File WILL-7-T.

The second and third floors of the Williams Building have retained their configuration as a series of rooms arrayed along a central double-loaded corridor (Figure 28).

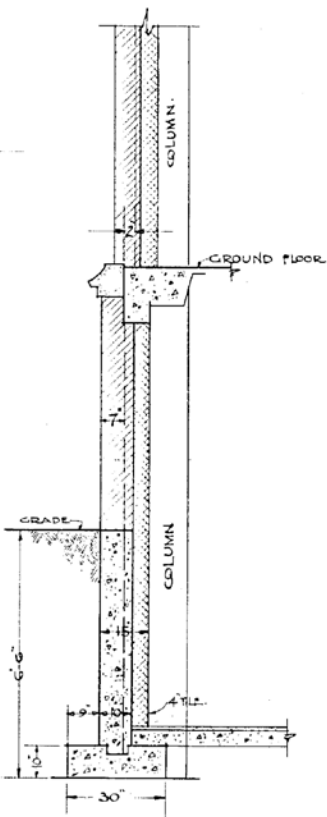
Figure 29. Typical exterior wall section. Retrieved from Facilities Management Division Asset Record System, File WILL-37-T.

The structure of the Williams Building appears from the original drawings to be a cast-in-place concrete frame. Floors are composed of cast-in-place concrete on a ribbed metal lath overlaid with steel tile and concrete. The foundation walls and footings are in cast-in-place concrete, and roofs are framed in a combination of steel and wood. Figure 29 shows a typical exterior wall section.

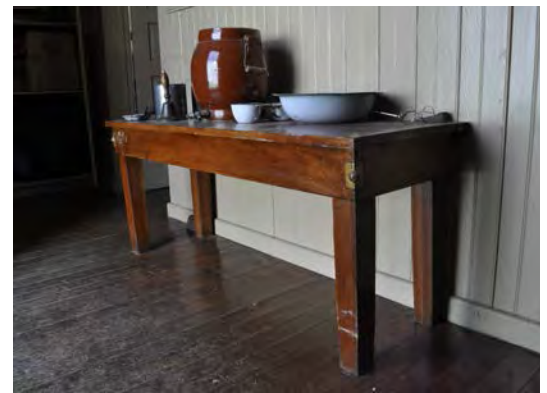
Figure 4. Wood-paneled interior wall and wooden floor. In the background a wooden door is visible. The photo also features some objects associated with the historical period of the school house such as a lunch bucket, school bell, chamber pot and spectacles.

The interior of the school retains its wooden floor. The interior walls are plaster, the lower portion of the interior walls are faced with painted wood. The window shutters are made of painted wood as well. Figure 4 shows these elements.

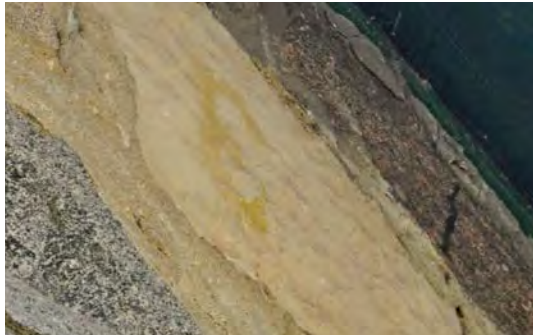
Figure 7. On the building's southeast corner, an upside-down '3' is visible on a rock. This marking is a trace of the process used to disassemble and reassemble the building.

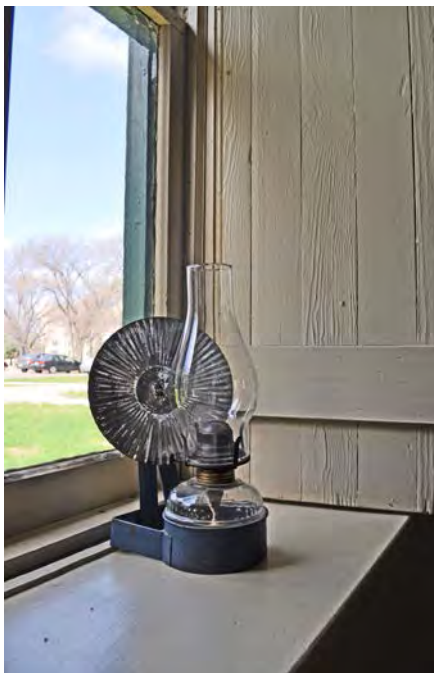
Figure 9. A wooden window frame and shutters. These shuttered windows allowed for the spaces illumination. When natural light was not accessible, gas lamps with reflectors such as the one pictured would have to be used.

The eastern and western walls of the school feature windows which would originally have provided the main light source for the space. Figure 9 shows a window complemented by a gas lamp with a reflector, which would have supplemented natural light at night. The use of natural lighting is a character-defining element.

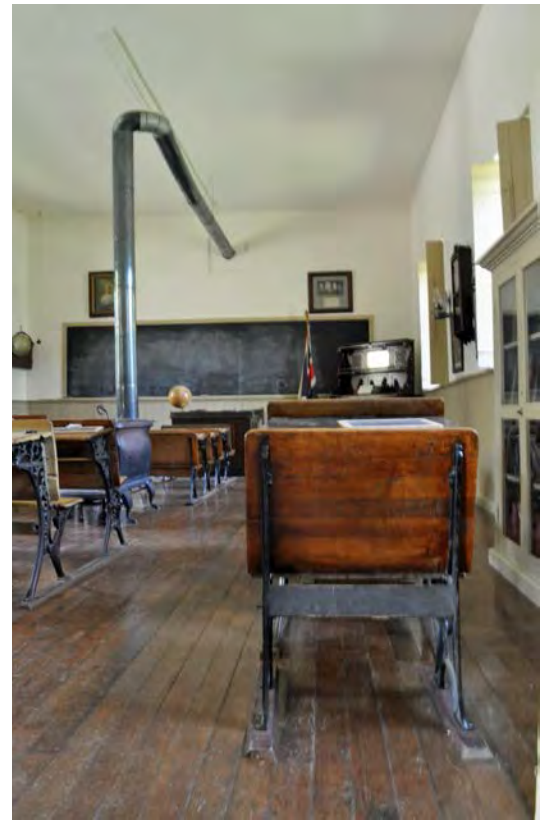
Figure 8. The spatial configuration of the one room school house. Desks oriented towards the chalkboard with the stove in the centre of the room.

The building is accessible through a single door on its north face. Upon entrance, visitors are greeted by a small vestibule. Beyond the vestibule is the single classroom. The south side of the school is windowless, providing an uninterrupted surface for the blackboard. This dictates the orientation of the room's furnishings towards the south of the room so that pupils face towards the chalkboard. Figure 8 shows the spatial configuration of this 'one room school house', characteristic of this type of building. The desks were arranged on skids so they could be pushed easily into the ante room to make space for social events.

The school house was heated by a single pot bellied stove. The original stove was located against the back wall of the room. The current stove is not original to the building, but is contemporary with it, and was donated by Mr. J.J. Black of Paynton. It has been refitted to burn gas and now sits in the centre of the room, due to modern regulatory requirements. A large stove pipe conceals the gas supply line. (Refer to Figure 8.)

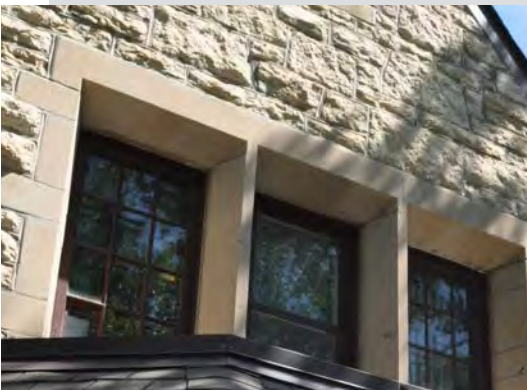
Figure 1. Sandstone window surround set into a field of greystone.

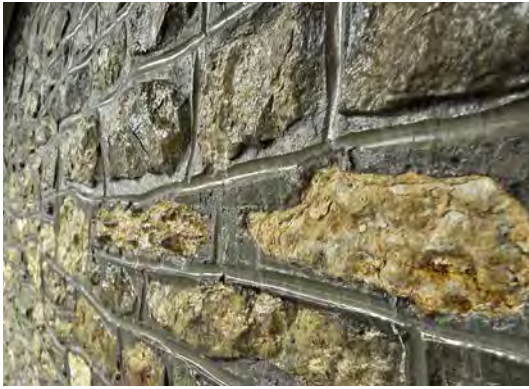
Figure 3. A greystone wall which now forms part of a basement meeting room.

The interior of the building has been altered to a great degree, and much of the commemorative integrity of the original interior is lost. A greystone wall in the building's basement shown in Figure 3 has been well maintained and integrated into the building's new use.

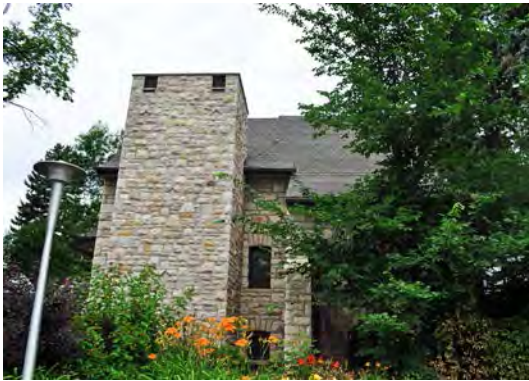
Figure 4. An elevator shaft and the deletion of several windows have greatly changed the eastern facade.

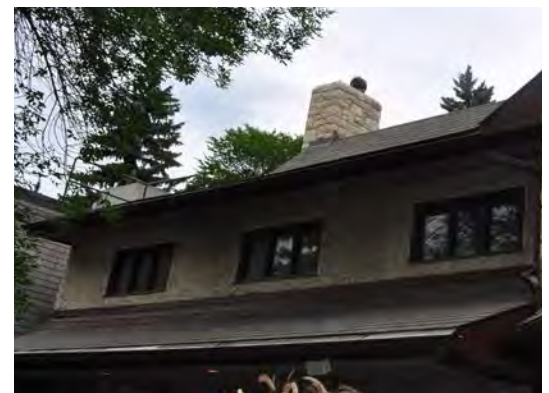
Figure 7. Alteration to former dormer windows.

Slate tiles, a character-defining material of many early University of Saskatchewan buildings, have recently been replaced by asphalt shingles. The exterior of the building originally featured two dormer windows punctuating the roofline on the south elevation. With renovations in the 1960's and 1970's these dormers were replaced by a single large dormer forming a first floor addition (Figure 7). A dormer window was also removed from the east roof. Figure 4 shows the current eastern facade. Figure 8 shows the original configuration of the east and west facades.

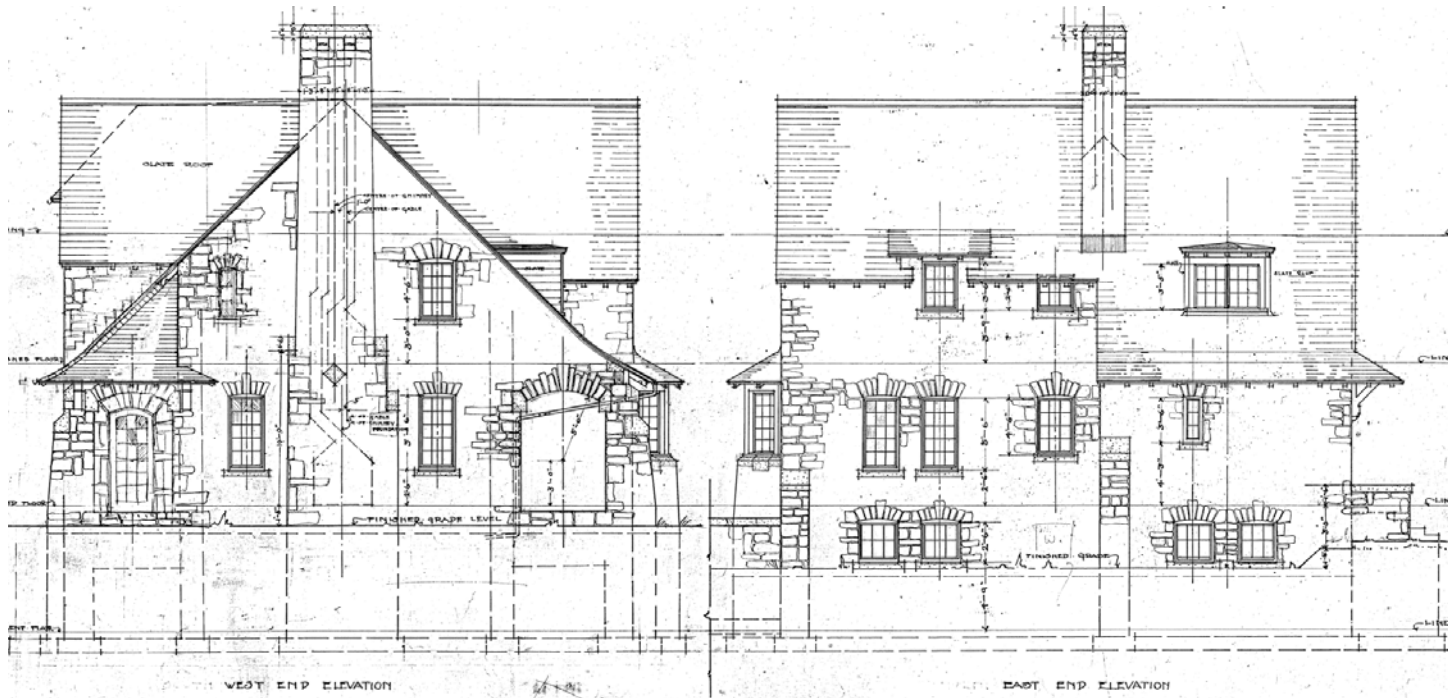
Figure 8. L to R: The west and east facades as they were originally designed. The east facade has since lost several of its windows to renovations. No windows or doors have survived on the west facade. Retrieved from Facilities Management Division Asset Record System, File F-6-T.

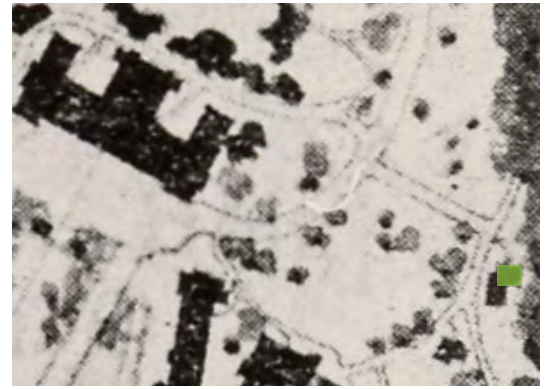
Figure 10. The location of the University Club is indicated in green on the original 1909 Campus Plan. The plan is oriented with North to the left. The MacKinnon Building is located in the upper left corner of the plan.

The location of the University Club, shown in Figure 10, reflects its history as a residence for the Dean of Agriculture. The home was located so as to be near the University Farm and allow the Dean of Agriculture good access to the barns and paddocks. The University Club also exists in close proximity to the [MacKinnon Building](#) as this building was originally intended to become the College of Agriculture building. The proximity of the University Club to the agricultural buildings is thus a character-defining element.

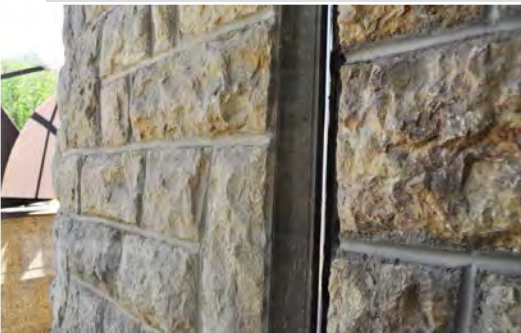
Figure 1. Exterior and interior greystone separated by glass.

The exterior of the dental clinic is a modernist composition mixing the traditional materials of the University of Saskatchewan campus with contemporary materials. Rough-faced 'greystone' (Figure 1) is used to form a base for the building and encloses the basement and ground floor. Cut Tyndall stone is used as a cladding material for the third floor (Figure 2). The second floor is enclosed in a glazed curtain wall, such that the Tyndall stone volume of the third floor appears to float above the heavier greystone base (Figure 2). These three primary exterior materials – greystone, Tyndall stone and glass – and the expressive manner in which they are deployed, are character-defining elements. The main entrance is accessed across a bridge made of cast-in-place concrete, with an exposed-aggregate finish (Figure 3). This material is also used on the interior.

The exterior materials are also used extensively on the interior of the building. The greystone walls of the ground floor wrap around and continue into the interior of the building at a glazed entrance vestibule (Figure 1). Floors in the ground floor lobby are red terra cotta tile (Figure 4). The floor of the dental clinic was originally patterned to relate the small scale of the individual work spaces to the large scale of the clinic, but has since been replaced (Figure 5). The ceiling in the lobby is an exposed concrete waffle slab. The underside of the structural floor slab is expressed as a feature in several other locations. Figures 2 and 6 show examples of the waffle slab exposed on the exterior and the interior respectively. A system of oak ceilings and bulkheads are used to conceal services (Figure 6). Oak is also used for some doors and window sills. Douglas Fir makes up the partitions between dental chairs on the second floor. Walls are composed of exposed-aggregate concrete or a ribbed concrete block (Figure 7). Oak, concrete and concrete block are character-defining materials.

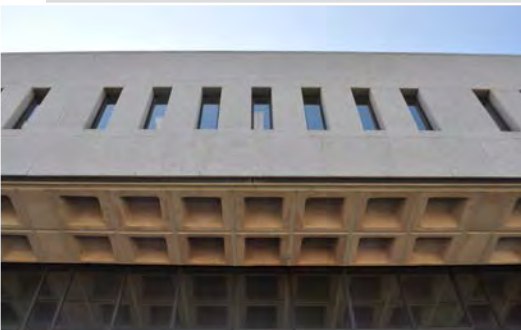
Figure 2. Top to bottom: Tyndall stone with punched windows, concrete waffle slab and glazed curtain wall.

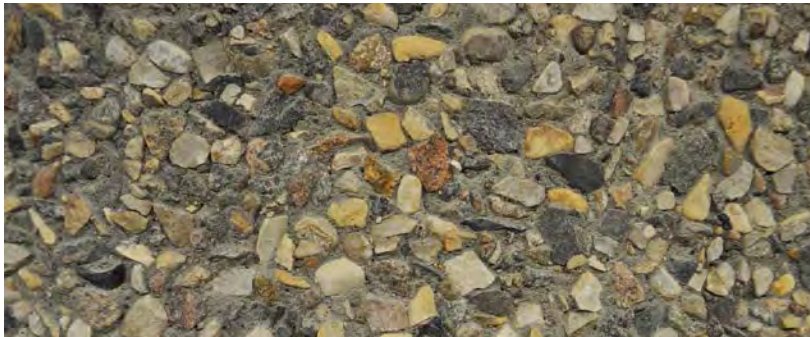
Figure 3. Exposed aggregate concrete.

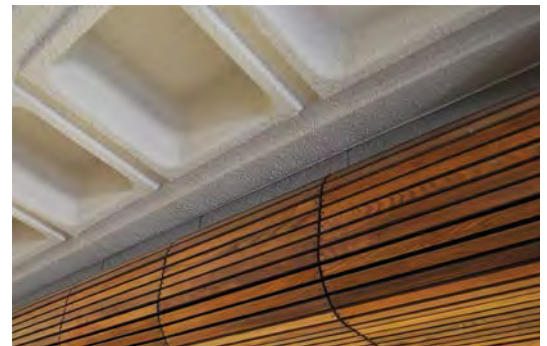
Figure 6. Exposed concrete waffle slab, oak ceiling bulkhead.

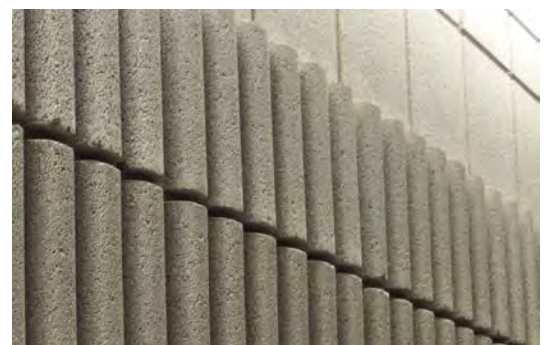
Figure 7. Exposed ribbed concrete block.

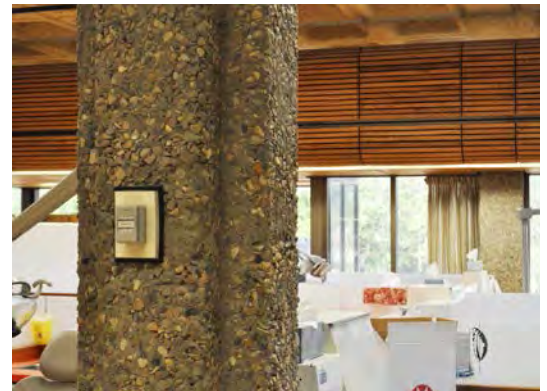
Figure 15. Concrete columns with exposed aggregate finish.

Structural elements are used to particular expressive effect in the Dental Clinic. On the second storey, concrete columns are left bare as shown in Figure 15, and are finished to expose their stone aggregate. On all floors, portions of concrete waffle slabs are revealed. The central stair leading from the entrance lobby up to the Student Clinic on the second floor is designed such that its stainless steel handrails form its structure, and treads are suspended by their balusters. The effect is that the treads appear to float, without obvious means of support (Figure 16). Exposed and expressed structural systems are character-defining elements of the Dental Clinic.

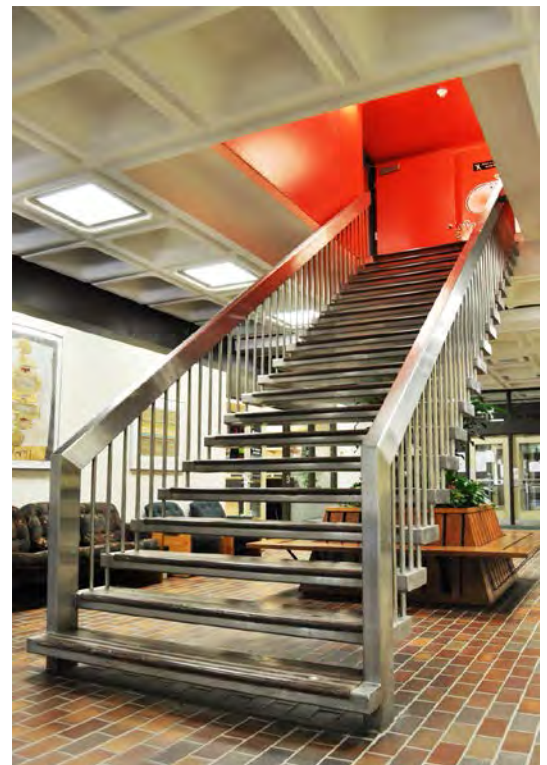
Figure 16. Central stair.

Architect John Holliday-Scott often specified accent colours in his work. In the case of the Dental Clinic, the colour red was used to bring warmth to the architecture. The colour, most notably appearing above the central stainless steel stair (Figure 16), is a character-defining element.

The Student Clinic is accessed via a large open stairwell placed at the centre of the ground floor plan directly visible upon entry into the building. Secondary access is provided by an elevator and fire stairs at the north and south ends of the building. The central staircase between the first and second floors is a character-defining element (Figure 16).

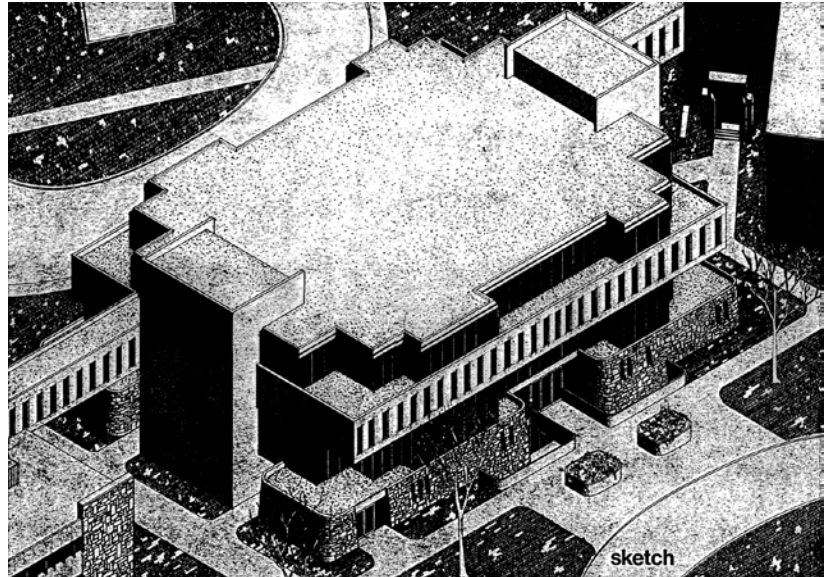
Figure 17. Preliminary sketch including a proposed fourth floor. Retrieved from Facilities Management Division Asset Record System, File DC-63-C.

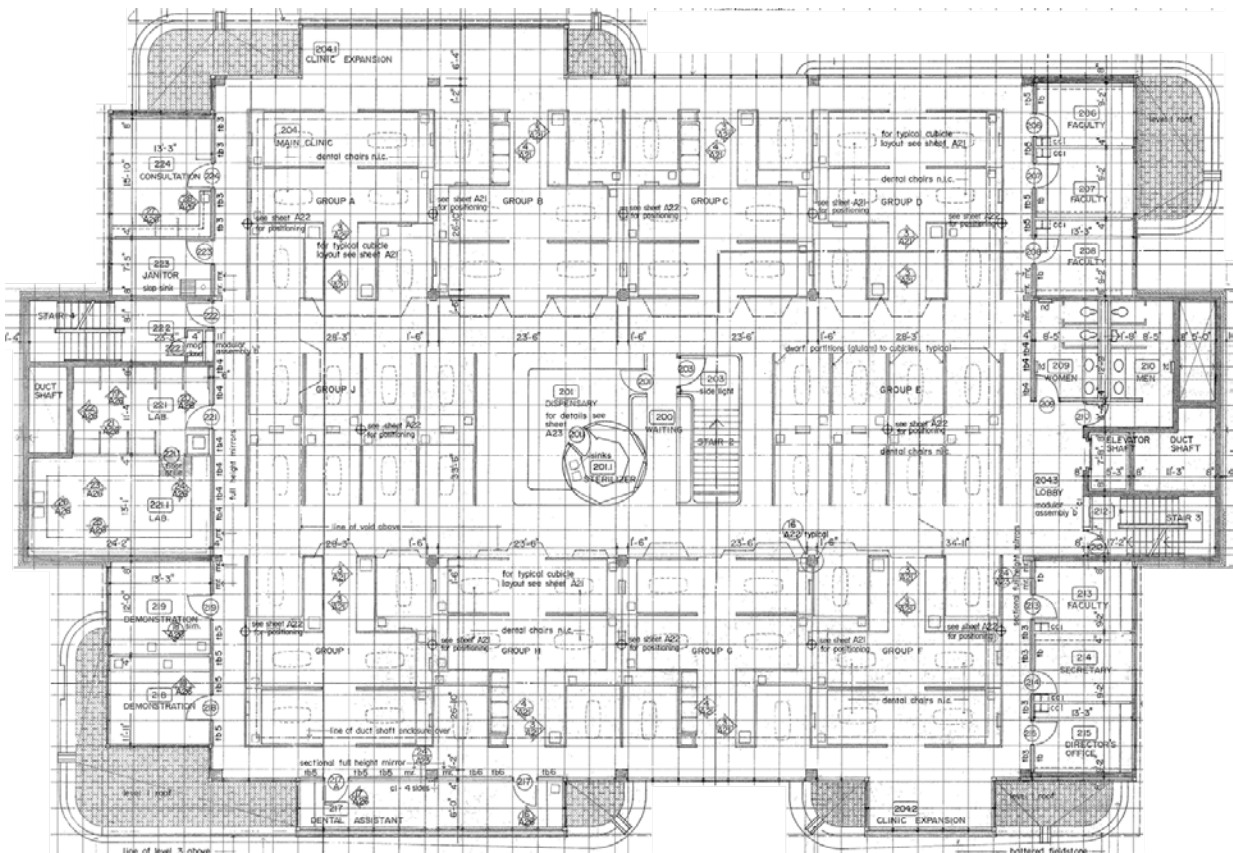
Figure 23. Second floor plan. Retrieved from Facilities Management Division Asset Record System, File DC-377-C.

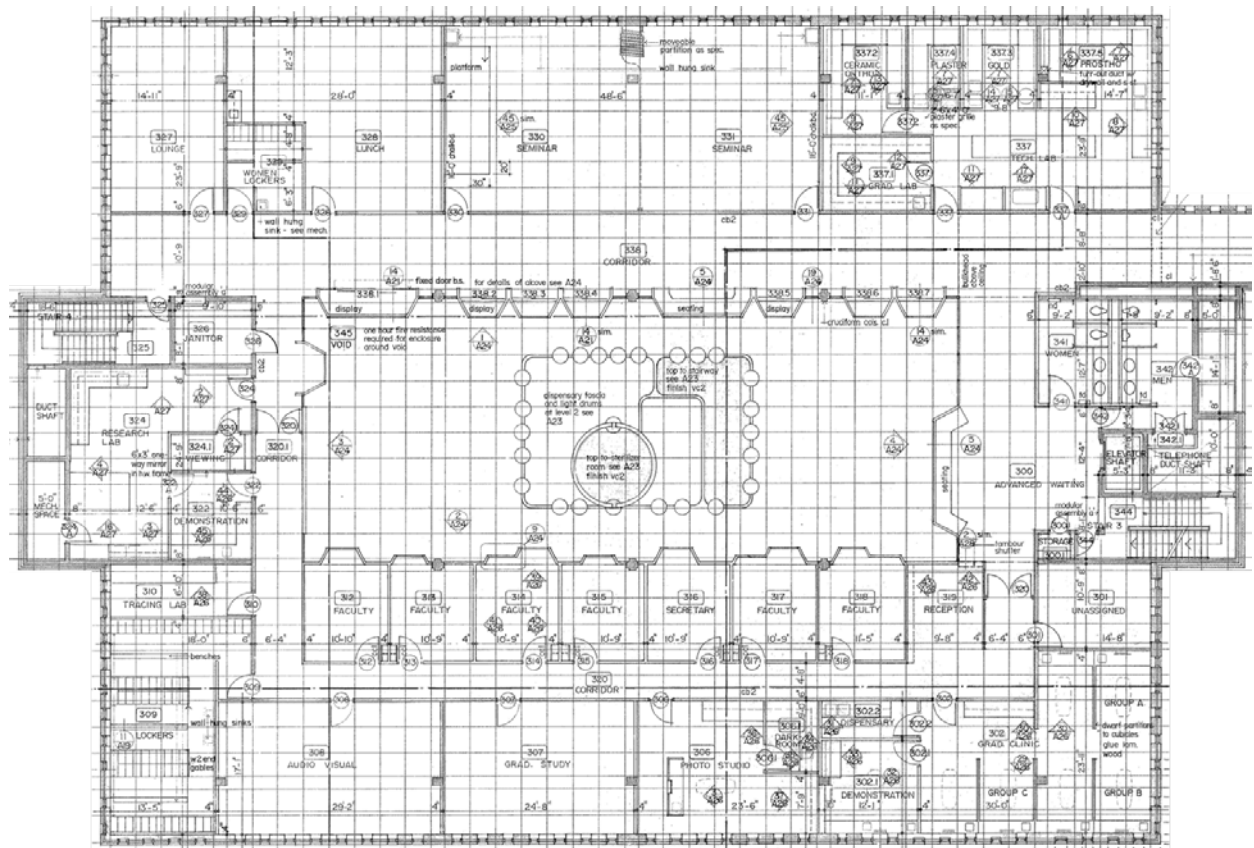
Figure 24. Third floor plan. Retrieved from Facilities Management Division Asset Record System, File DC-376-C.

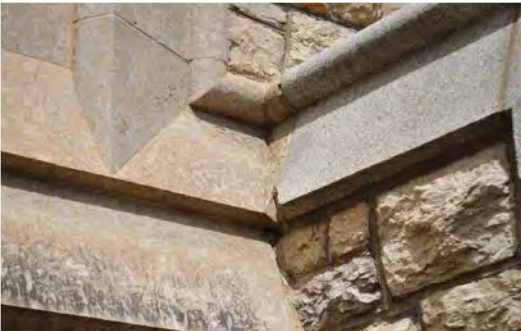
Figure 1. Stone materials: greystone and Tyndall stone.

The exterior of the Health Sciences A Wing is faced in materials common to the University of Saskatchewan. The most prominent of these character-defining materials is 'greystone,' the local stone used on many earlier buildings. Greystone is complemented by cut Tyndall stone ornamentation (Figure 1). A granite base and steps (Figure 2) complete the stone materials of the exterior. The greystone, Tyndall stone and granite are all character-defining elements. The greystone that surrounds the entrance stairwell exists in a threatened state of commemorative integrity due to the poor condition of its mortar joints (Figure 2). All other stone is in good commemorative condition. (For further information on building stones used at the U of S, refer to ['Appendix: Stone.'](#)) Other materials visible on the exterior include oak doors and stained glass (Figures 4 & 5). The oak and stained

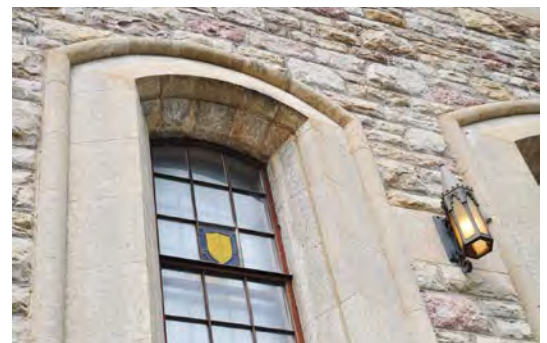
Figure 4. Arched windows with stained glass crest and steel light fixtures.

glass are also character-defining elements. On either side of the oak doors are steel light fixtures. Steel is also used for the window frames which are visible from the building's exterior. The stained glass and steel elements are shown in Figure 4. Copper flashing completes the character-defining materials of the building's exterior.

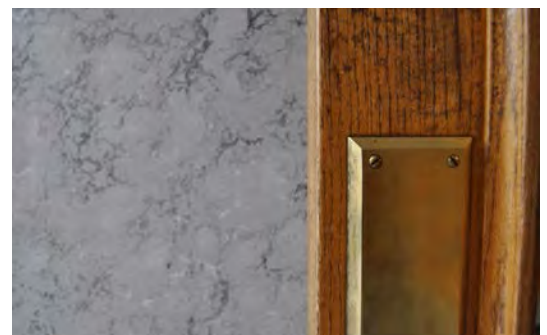
Figure 5. Oak, brass and marble.

The vestibule inside the principal entrance has heritage value due to its granite and marble finishes. The vestibule has walls and flooring of grey marble paneling shown in Figure 5. The marble panels are complemented by polished black and grey granite surrounds shown in Figure 6. The granite and marble are character-defining elements of the building's interior. The wall mounted materials are in excellent commemorative condition, but the granite flooring shows wear.

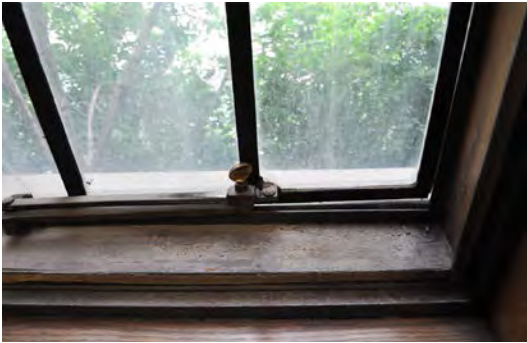
Figure 7. Steel sash window with brass fittings and oak trim.

Window frames are of painted cold rolled steel. Most of the window frames appear to be original and many still have operable casements. Window hardware is generally original and of brass, as in many other buildings at the University (Figure 7). The original steel window frames and hardware are character-defining elements.

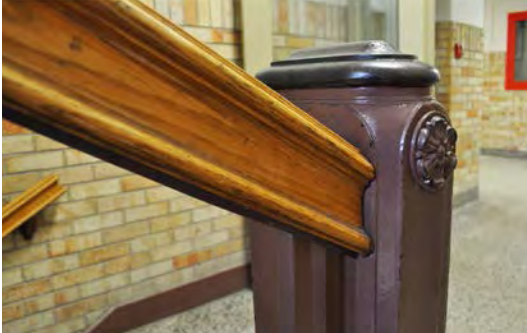
Figure 8. Oak handrail and cast iron newel post with flower motif.

Staircases feature steel stringers, cast iron newel posts, steel balustrades and oak handrails (Figure 8). The corridors have painted plaster walls with brick wainscoting. The brick is in excellent commemorative condition. The plaster shows signs of deterioration in many places. The brick and plaster wall treatment is character-defining. The terrazzo flooring has brass strips, thresholds, drains and clean out covers. Terrazzo is used extensively in the building and also makes up wall bases, stair treads and window sills. The terrazzo and its brass components are character-defining materials that have retained their heritage value to a good degree of commemorative integrity (Figure 9). Original brass frames are also found on a few bulletin boards (Figure 10).

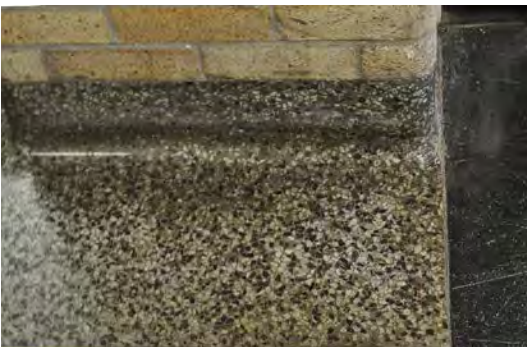
Figure 9. Yellow brick and terrazzo flooring with brass strips.

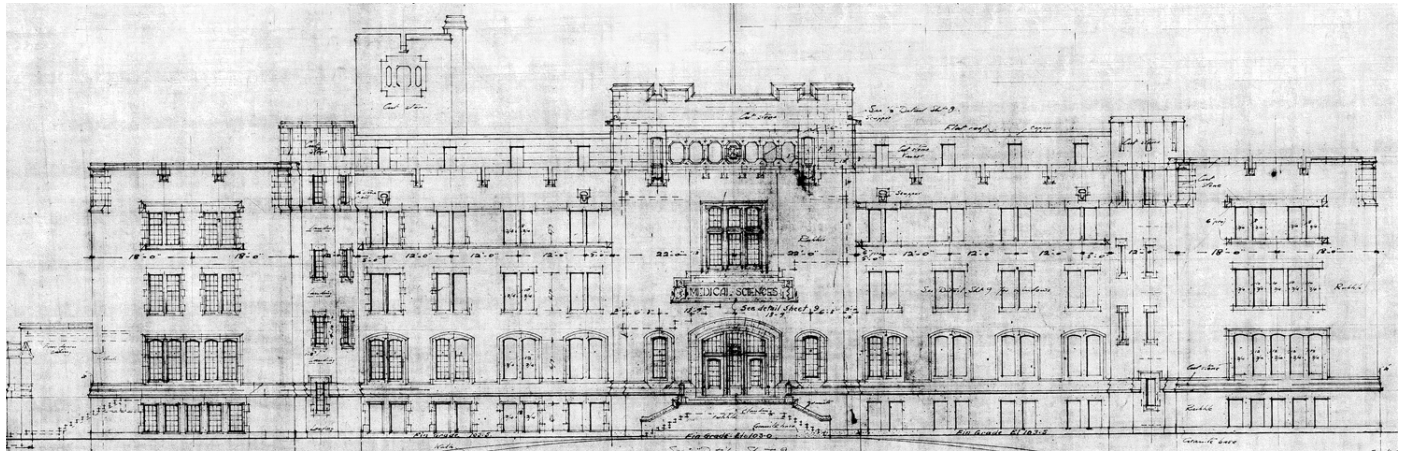
Figure 11. Front elevation. Retrieved from Facilities Management Division Asset Record System, File HS-44-T.

The Health Sciences Building was one of the later buildings to be constructed at the University of Saskatchewan in the Collegiate Gothic style. In plan, the building is arranged in the classic Elizabethan E-shape. Figure 11 illustrates the original front elevation of the building. Subsequent additions have obscured the E-shaped plan of the building from the rear, but the original front elevation has been well preserved.

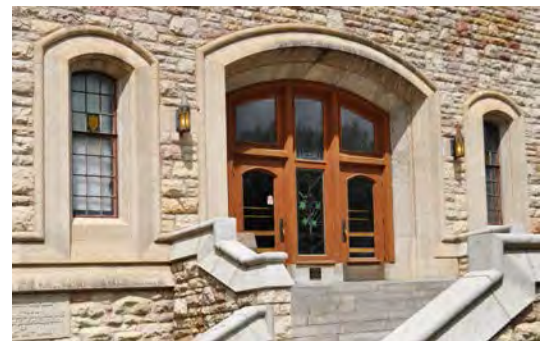
Figure 12. Arched entrance and windows.

The front elevation is symmetrical in composition, with the main entrance located centrally, and marked by a tower and a set of stone steps. Figure 12 shows the main entrance to the building, with its arched opening. Lanterns are hung on the walls on either side of the main entrance. The central tower is decorated with a crenellated parapet, statuary niches, scuppers and a row of octagonal windows (Figure 13). Stairwells are rendered on the front elevation as turrets (Figure 14). The stonework features decoration in the form of statuary niches, cut stone blanks and shields. A carved stone shield above the main entrance features the motif of the staff and snake, in reference to the medical professions (Figure 15). A prominent Tyndall stone stringcourse marks the base of the building (Figure 16). The parapet of the Health Sciences Building is constructed in cut Tyndall stone, and is one of the few modifications to the original front elevation, having been raised during the construction of the B-Wing, in 1968. It is decorated with crenellation in the form of archer style slots, and stone scuppers. Features of the Collegiate Gothic style such as arched openings, tower and turret forms, and carved stone decoration, are all character-defining elements.

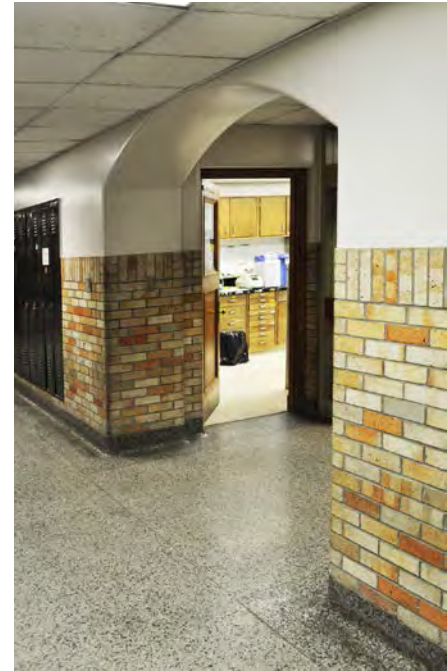
Figure 17. Arched entry, terrazzo floor and brick wainscoting.

The interior of the building still holds some heritage value, although many original features have been lost to renovations. The brick wainscoting and original terrazzo floors in the corridors generally remain and are in good condition. Several arched openings remain (Figure 17). Most of the original features and finishes in the stairwells remain in place (Figure 8). Cast iron newel posts are decorated with a flower motif that is also found elsewhere on campus. Many of the stained glass windows visible from the exterior are also visible from the interior (Figure 18).

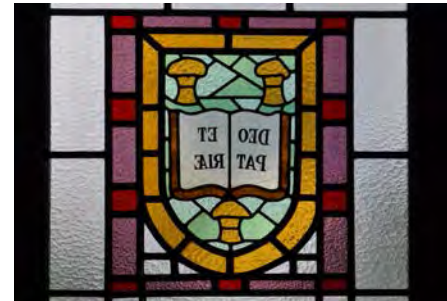
Figure 18. Stained glass University of Saskatchewan crest.

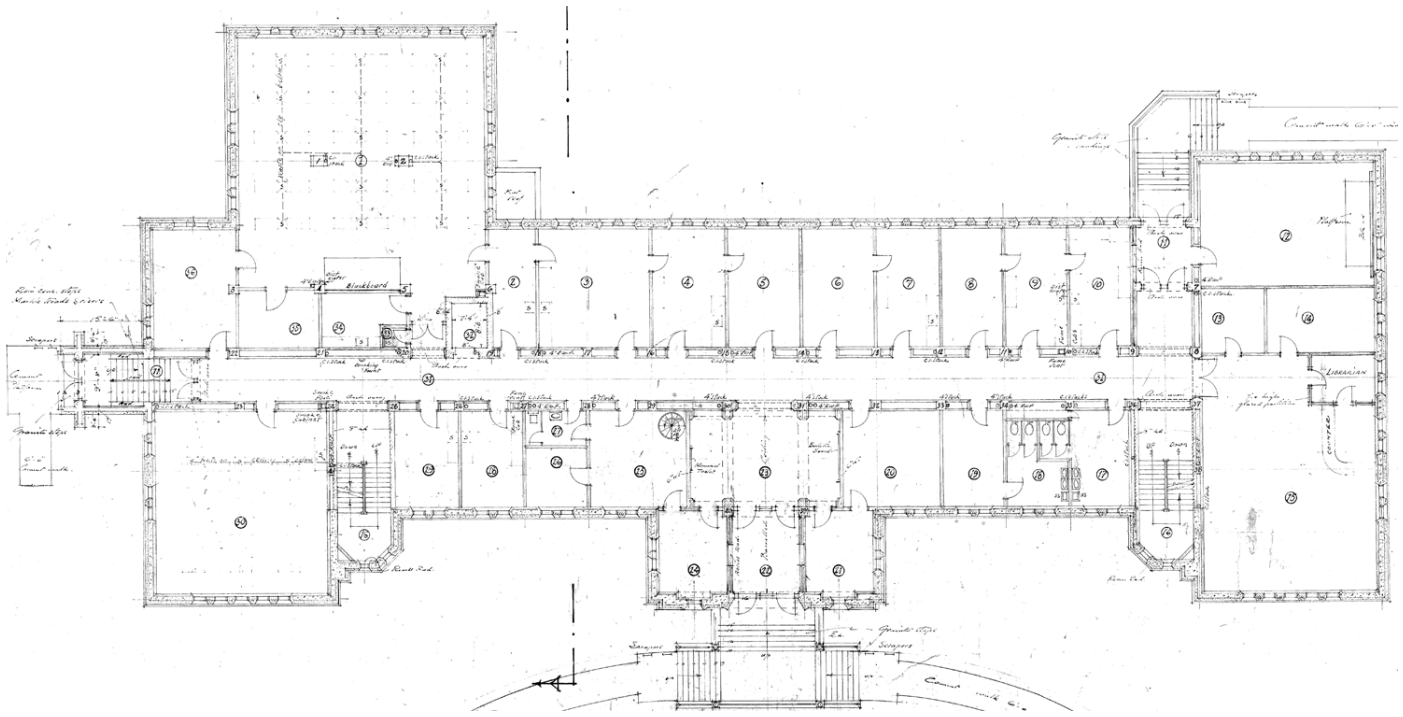
Figure 22. Original first floor plan. Retrieved from Facilities Management Division Asset Record System, File HS-49-T.

A comparison of Figures 22 and 23 shows the type of reconfiguration that generally took place on all floors. The addition of the B Wing to the west side of the building saw the deletion of all of the windows and doors on that façade. The staircase shown in the original plans on the west side of the building no longer exists. Rooms were removed from the west side of the building to make way for wider connective thoroughfares. On both the first and second floors, the large open plan rooms of the north wing have been extensively subdivided. The basement and the fourth floor (Figure 24) are the only levels which have escaped this reconfiguration.
