University of Saskatchewan

Heritage Register

September 2013

Facilities Management
Division

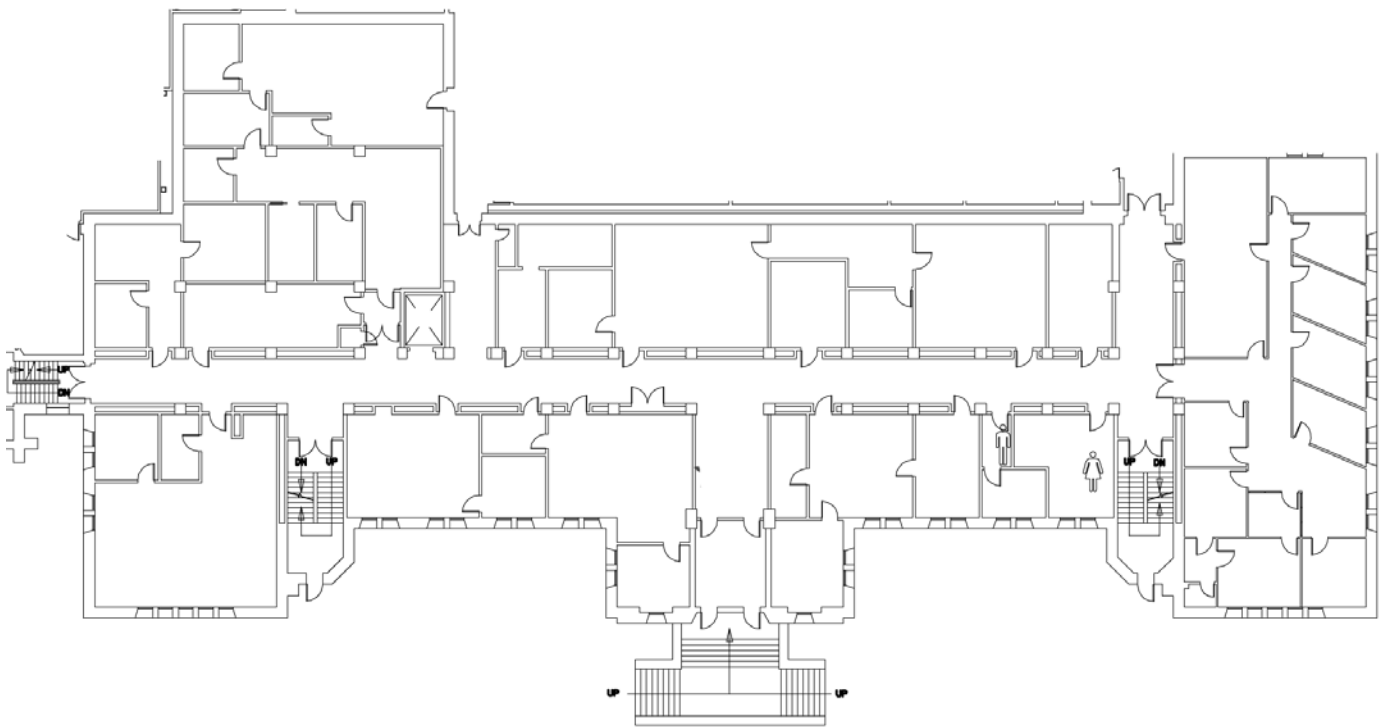
Figure 23. First floor plan after reconfiguration. Retrieved from Facilities Management Division Asset Record System, File 049-2139-T.

A comparison of Figures 22 and 23 shows the type of reconfiguration that generally took place on all floors. The addition of the B Wing to the west side of the building saw the deletion of all of the windows and doors on that façade. The staircase shown in the original plans on the west side of the building no longer exists. Rooms were removed from the west side of the building to make way for wider connective thoroughfares. On both the first and second floors, the large open plan rooms of the north wing have been extensively subdivided. The basement and the fourth floor (Figure 24) are the only levels which have escaped this reconfiguration.

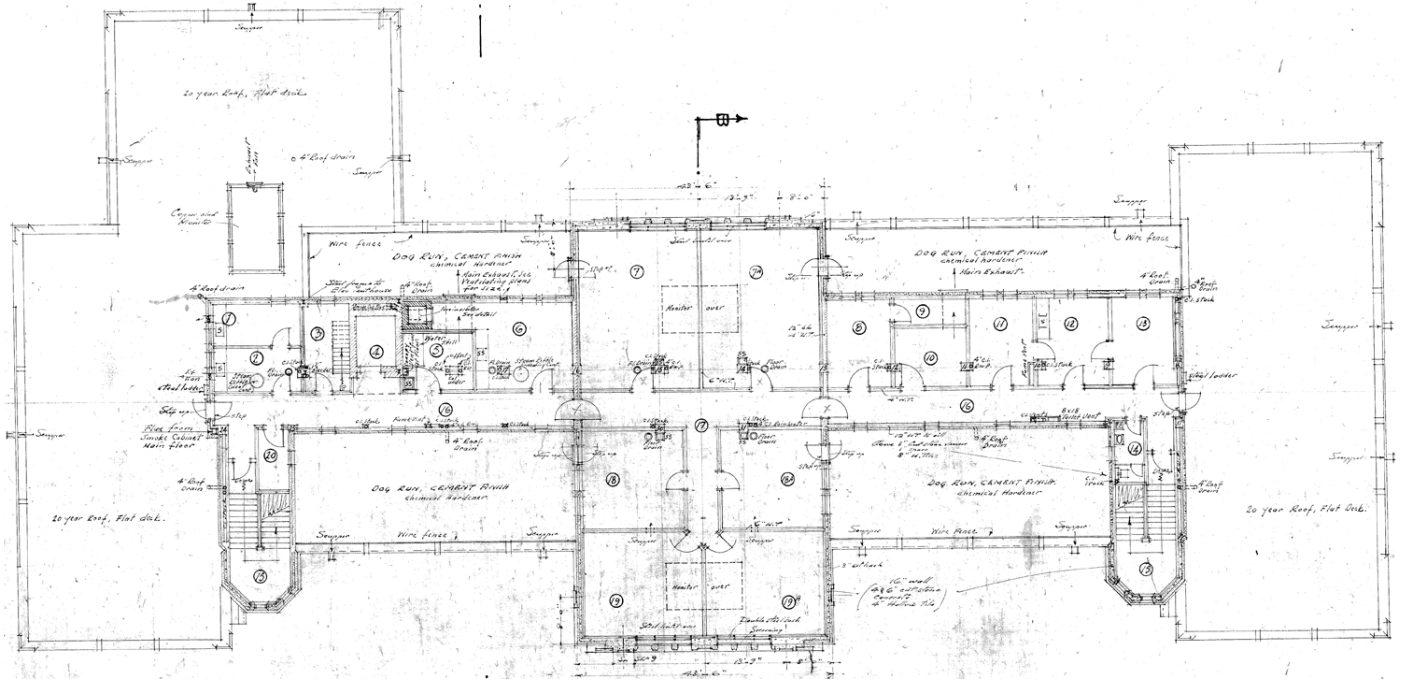
Figure 24. Original fourth floor plan. Retrieved from Facilities Management Division Asset Record System, File HS-46-T.

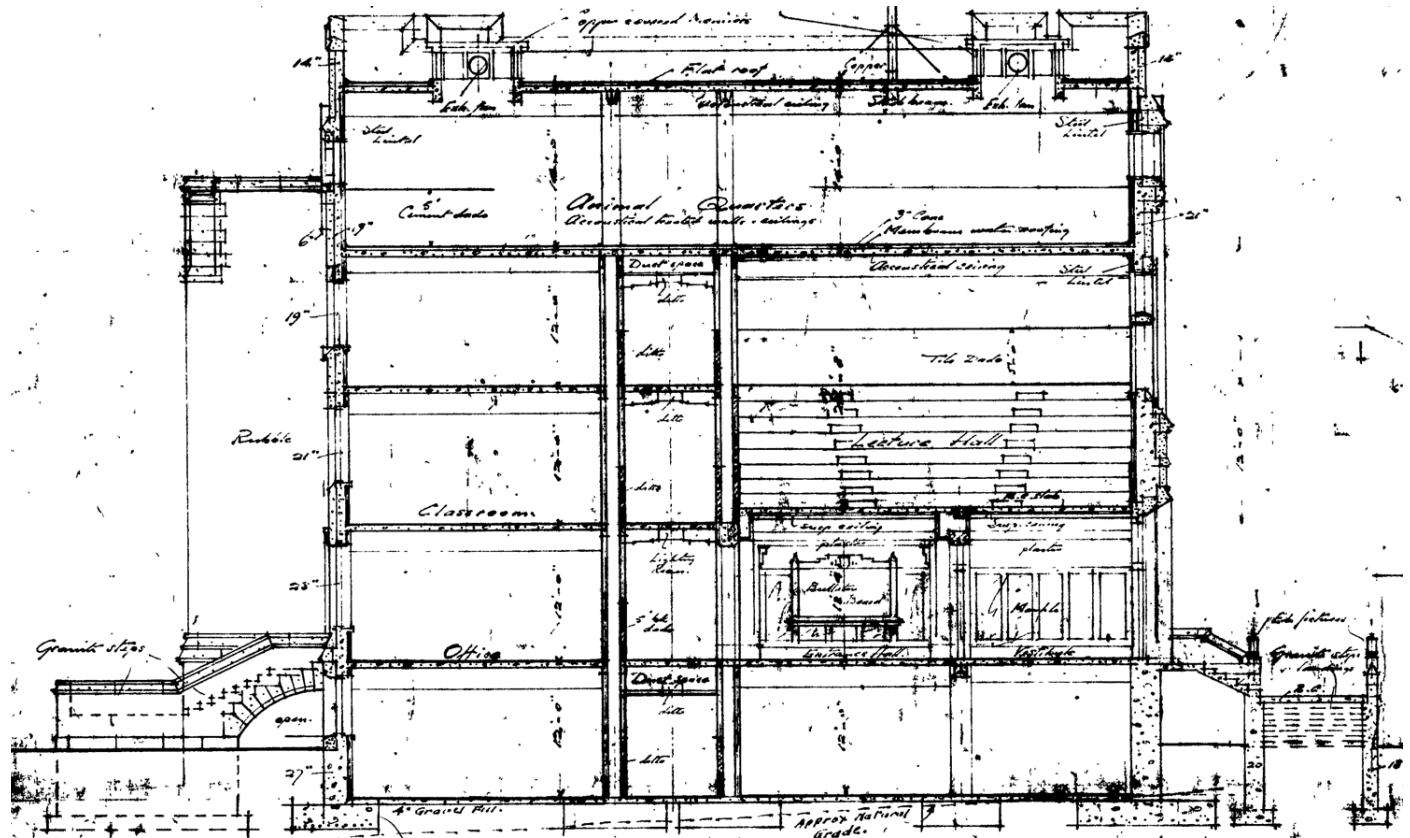
Figure 25. Section through the building showing double height lecture theatre. Retrieved from Facilities Management Division Asset Record System, File HS-45-T.

A character-defining space was lost in the conversion of the double height lecture room of the second floor into a single height classroom. Figure 25 shows the original space in section. Figure 26 illustrates the original appearance of the space. A new floor was added to create a series of small rooms on the third floor where the upper portion of the lecture hall formerly existed. Figure 27 shows the current configuration of the space. The double height stained glass windows that originally allowed daylight into the space from the east have been concealed inside a small service stair. Figure 28 shows the rooms that were added on the third floor.

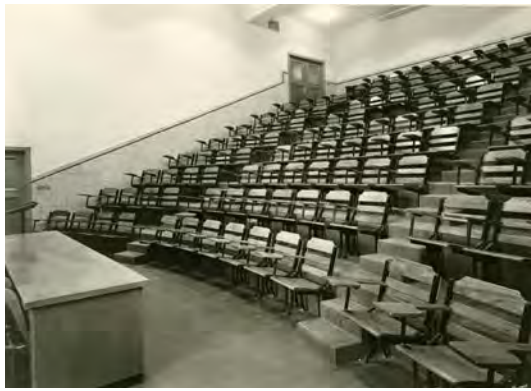
Figure 26. The lecture room as it was originally constructed. Retrieved from Buchan, D.J., *Greenhouse to Medical Centre Saskatchewan's Medical School 1926-78*.

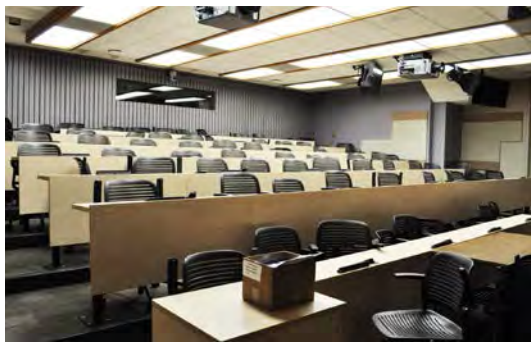
Figure 27. Current configuration of second storey lecture room.

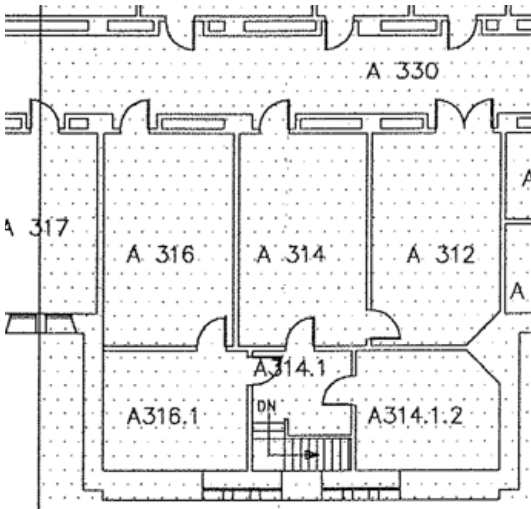
Figure 28. Current configuration of the former upper portion of the lecture theatre. Retrieved from Facilities Management Division Asset Record System, File 049-2149-T.

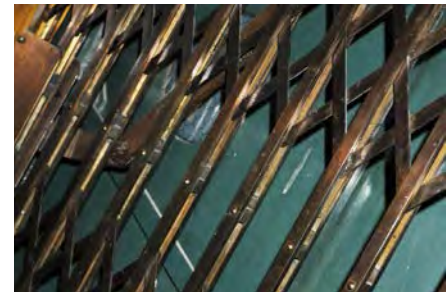
The Health Science Building was one of the first at the university to be constructed with an elevator. The original elevator is still intact and functioning in the building. It has steel doors with circular windows. Inside the steel doors are bronze scissor gates that are operated by the user (Figure 29). The style and materials of the elevator are character-defining elements.

Figure 29. Elevator gates.

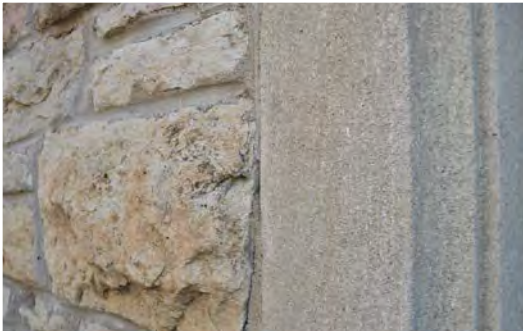
Figure 1. Greystone and Indiana limestone.

The stone facade of the Memorial Union Building (MUB) is an important character-defining element. The exterior of the building is composed of 'greystone' walls, cut Indiana limestone trim and Tyndall stone steps and thresholds (Figures 1 & 2). Tyndall stone and greystone are both found on the interior surrounding the commemorative fireplace on the second floor. The roof is clad in slate, and flashing, downspouts and gutters are in copper (Figure 4). The original exterior materials of the

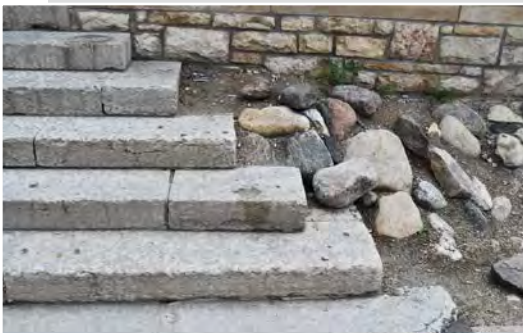
Figure 2. Tyndall stone steps.

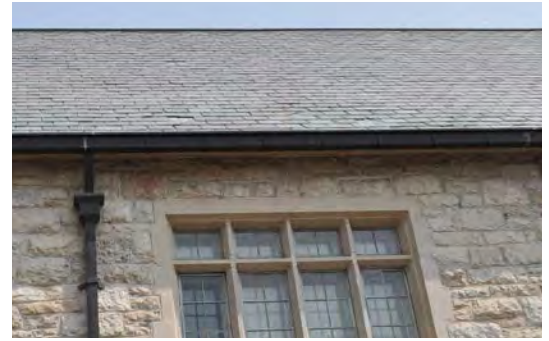
Figure 4. Slate tile roof and copper downspout.

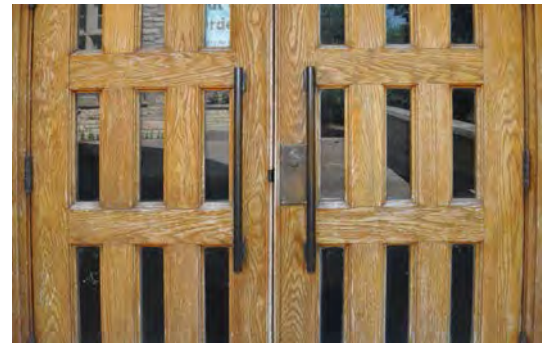
Figure 5. Oak door with glazed panels, brass door pulls, hinges and lock.

The windows and doors of the building contribute to the character of both the interior and the exterior of the building. The building has two sets of large oak doors with brass kick plates and hardware (Figures 5 & 6). The main entrance doors see the most use and show signs of wear. The interior vestibule doors are also in poor condition. The northern door and its brass fixtures are in good commemorative condition. The oak doors and brass fittings are character-defining elements.

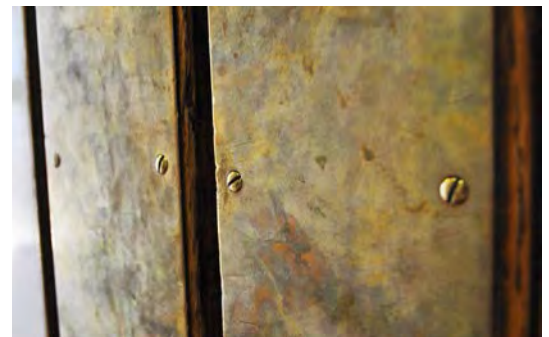
Figure 6. Brass door pushes.

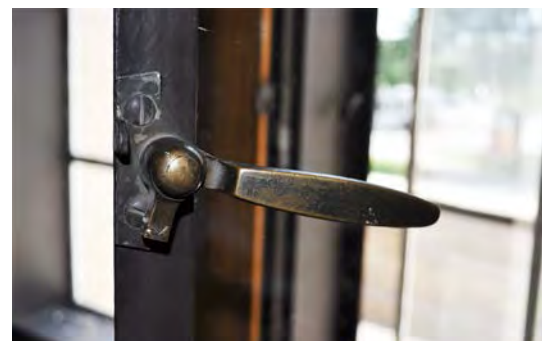
Figure 7. Steel sash, brass window handle.

Painted steel-framed sash windows are used throughout the building, with limestone trim on the exterior and oak trim on the interior. The windows are single-paned, but are arranged in two layers, with an interior and exterior set for each opening. The window hardware is in brass (Figure 7). The second storey windows have window sills made of a buff coloured marble (Figure 8). The same marble makes up the cenotaph commemorating the war dead and it exists in a state of excellent commemorative integrity. On other floors, the window sills are made of terrazzo. The windows and their materials are in excellent commemorative condition with few exceptions and are character-defining elements. The marble of the cenotaph is also a character-defining material element.

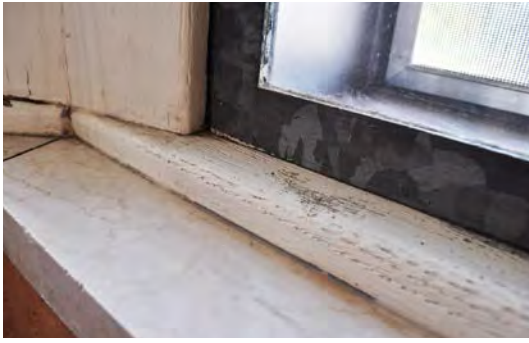
Figure 8. Marble window sill, painted oak window frame and steel sash.

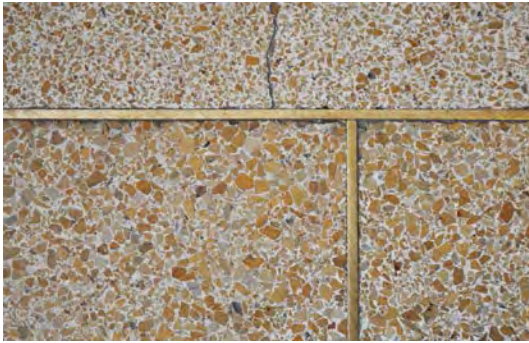
Figure 9. Terrazzo with brass strips.

Much of the original flooring materials have been replaced. The ground floor and main staircase have retained their terrazzo finish (Figure 9). The staircase (Figure 10) is formed of cast-

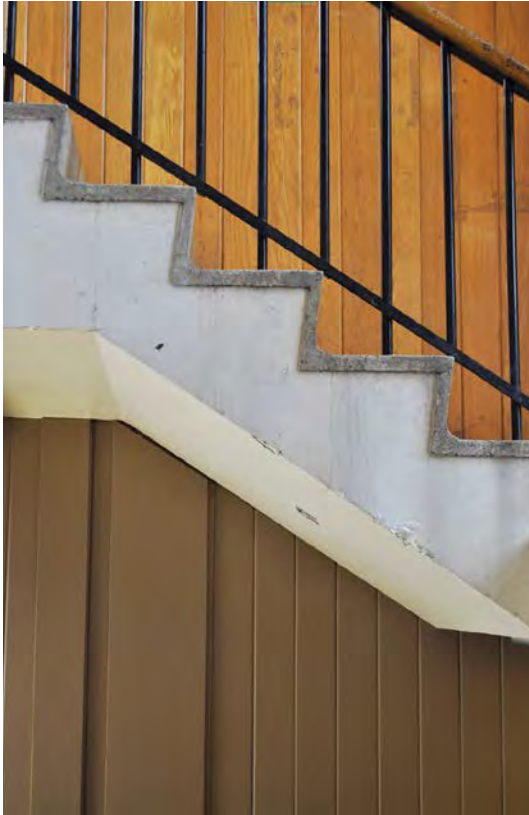
Figure 10. Oak paneling, unpainted at top and painted at bottom. Terrazzo stairs with steel balustrade and oak banister.

in-place concrete with terrazzo treads and risers, painted steel balusters and an oak handrail. The stairwell features oak wall paneling. The original materials of the staircase and stairwell are character-defining elements.

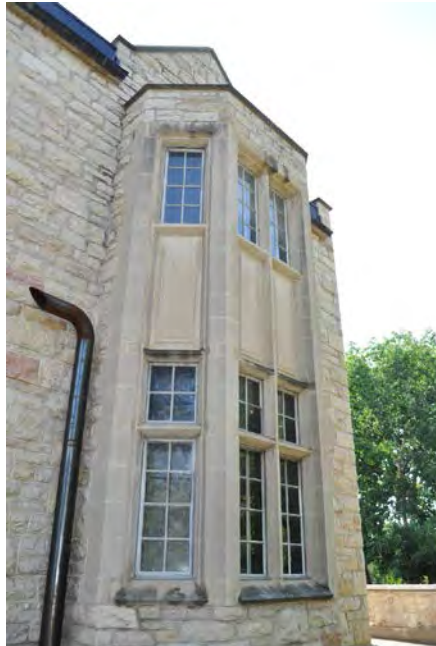
Figure 15. Bay window.

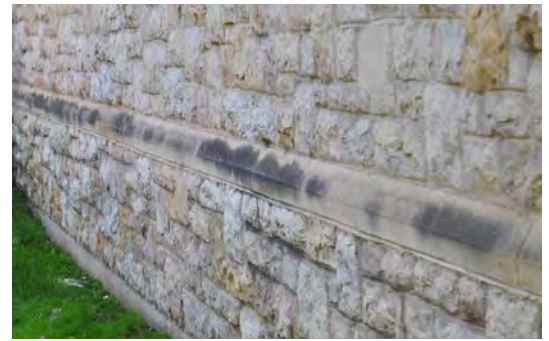
Figure 12. Indiana limestone string course in a greystone wall.

The exterior detailing is somewhat simplified compared to earlier examples of Collegiate Gothic architecture at the university. The Memorial Union Building has greystone quoins on its corners and limestone string courses (Figure 12). Cut and carved stone features include false slot windows (Figure 13) in the gable ends and a sign carved in relief on a low wall of Indiana limestone (Figure 14). A bay window (Figure 15) balances the north elevation (Figure 16). Stone spandrels, also visible in Figure 15, accompany many of the windows. Cut stone arches surround arched doorways on both the north (Figure 17) and west facades. The west entrance is enclosed in a shallow architrave. All of these are character-defining elements of the Collegiate Gothic style. The arch of the west facing entrance is currently obscured by a canopy. Historic pictures show that a stone blank is hidden

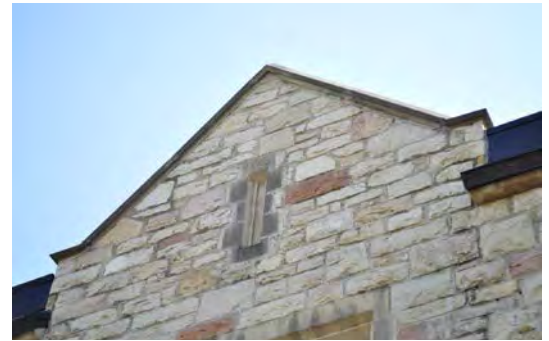
Figure 13. Archer style slot under peaked parapet roof form.

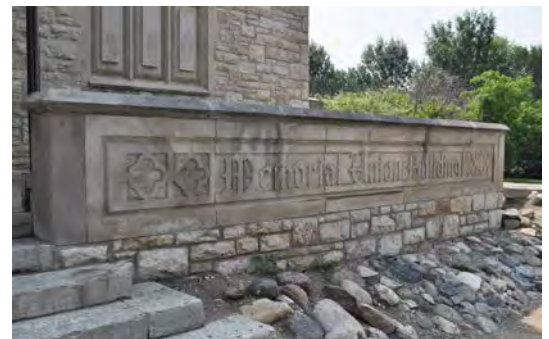
Figure 14. 'Memorial Union Building' in cut stone.

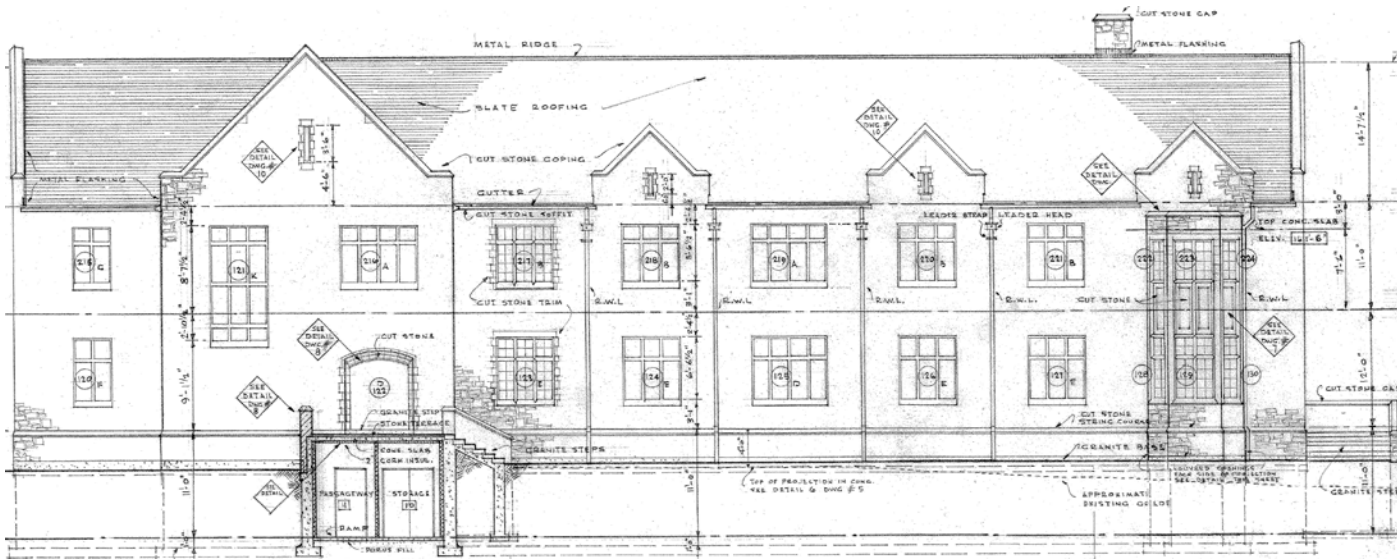
Figure 16. North elevation. Retrieved from Facilities Management Division Asset Record System, File MU-44-T.

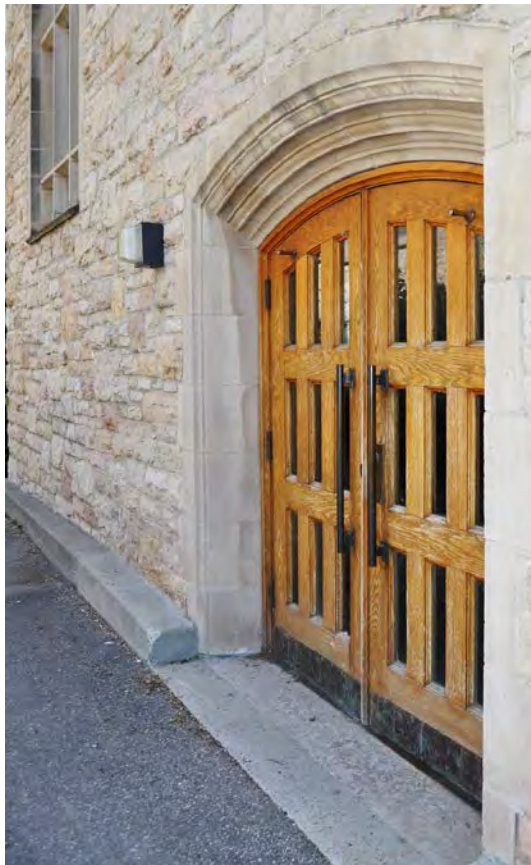
Figure 17. Cut stone arched entrance and doors.

by the canopy as well. The canopy reduces the commemorative integrity of the façade as it obscures the character-defining elements of the arch and the stone blank.

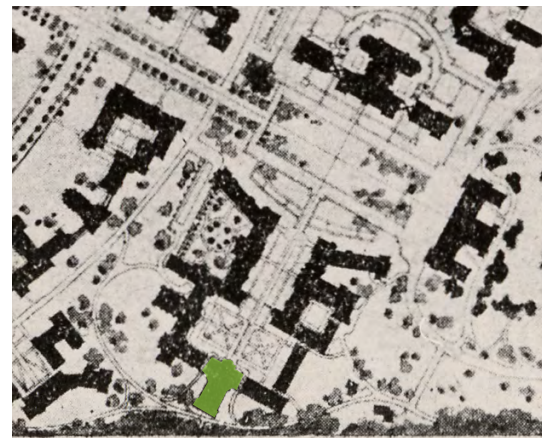
Figure 20. The building indicated in green on the 1909 Campus Plan is in the approximate location of the Memorial Union Building.

With the completion of the building, Voyageur Place (as it was later known) became enclosed on three sides, open only to ‘[The Bowl](#)’ (Figure 19). The 1909 Campus Plan by architects Brown and Vallance shows a building in this location (Figure 20). Although not realised exactly as planned, the Memorial Union Building is in keeping with the original intent.

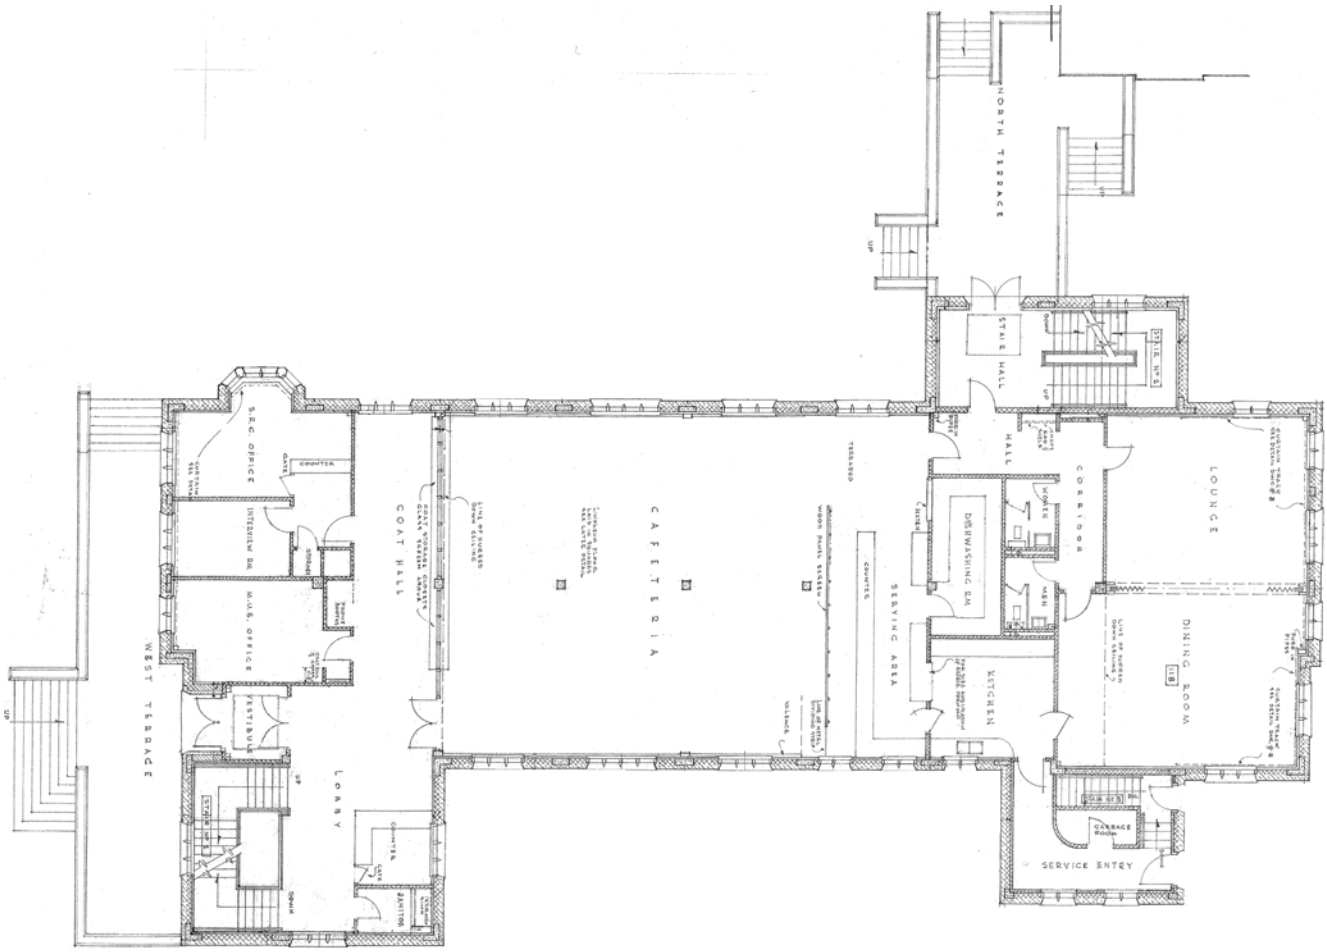
Figure 21. Original first floor plan. Retrieved from Facilities Management Division Asset Record System, File MU-46-T.

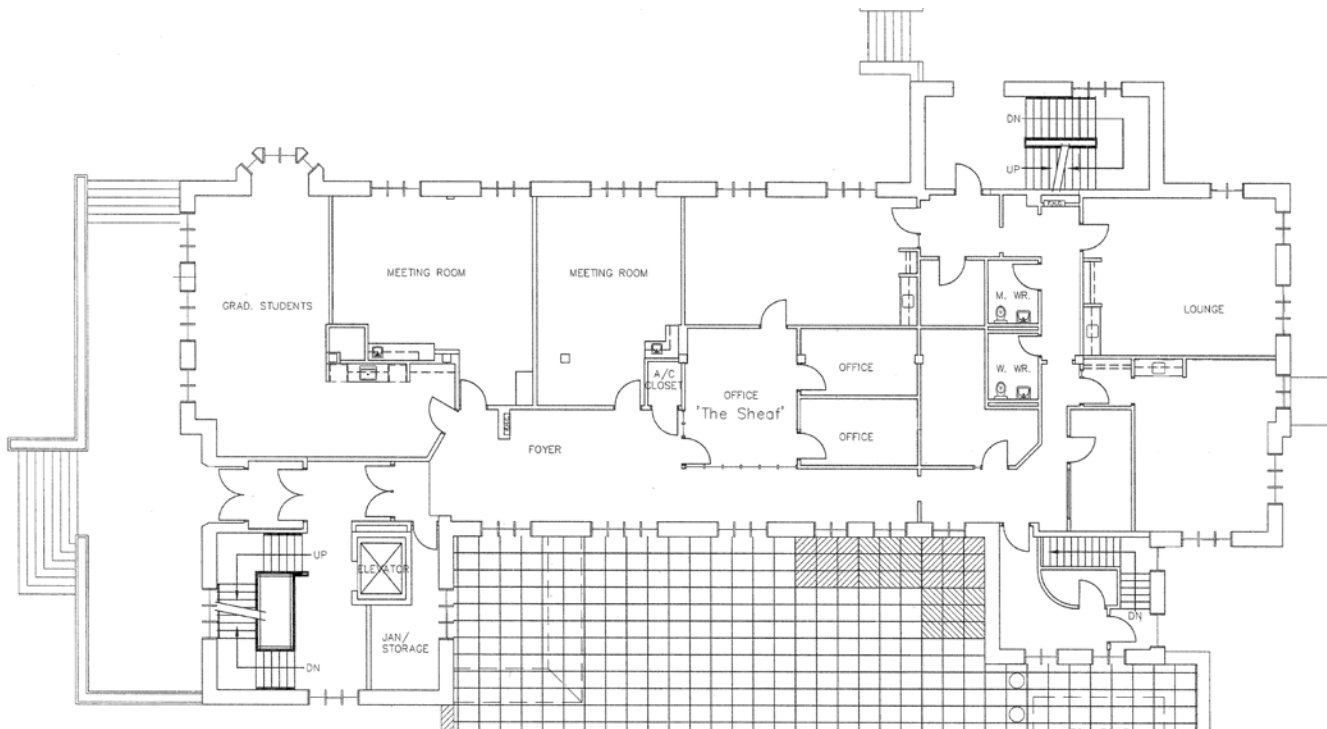
Figure 22. First floor plan as it currently exists. Retrieved from Facilities Management Division Asset Record System, File 051-405-T.

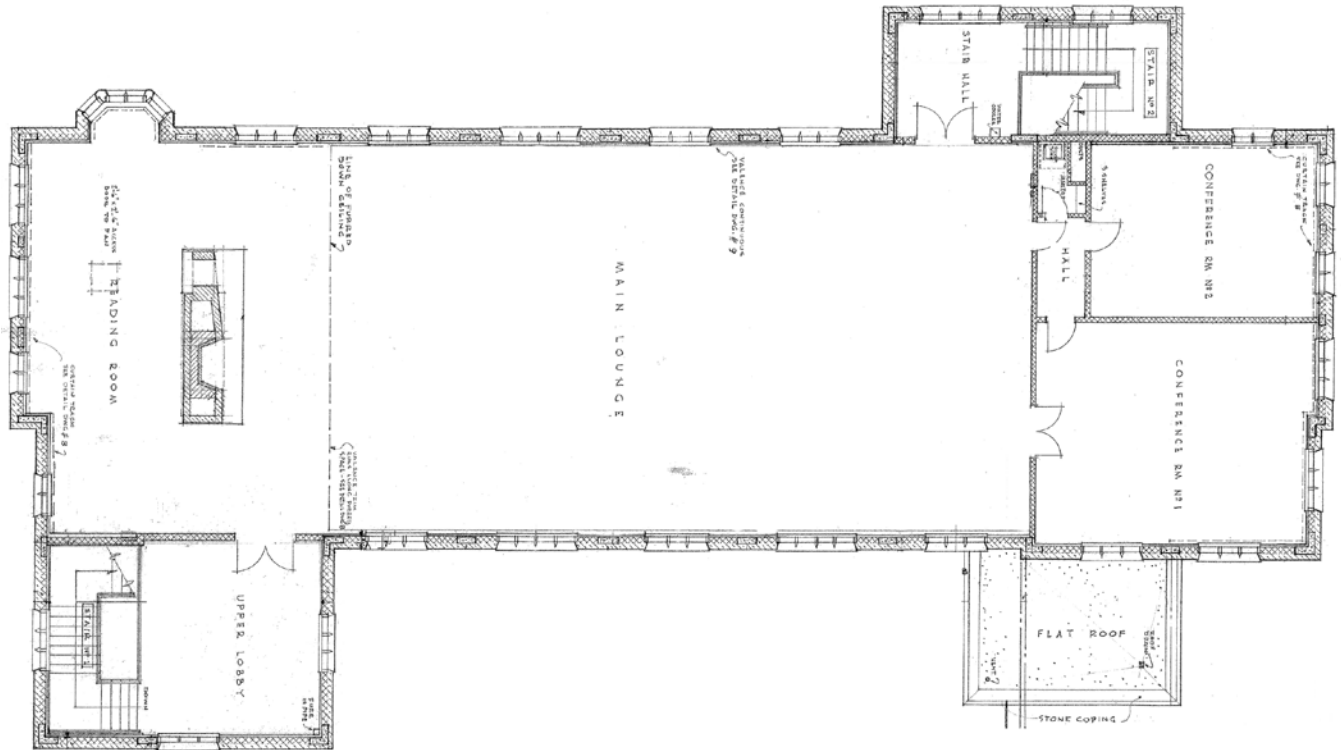
Figure 23. Original second floor plan. Retrieved from Facilities Management Division Asset Record System, File MU-45-T.

The second floor originally contained a large lounge space, with smaller conference rooms at the east end (Figure 23). The large greystone fireplace and marble memorial tablet formed the central feature of this space (Figure 24). The configuration of the second storey has been essentially maintained. The conference rooms have been replaced by washrooms, but the lounge has been maintained in the form of a café, and the memorial fireplace remains intact.

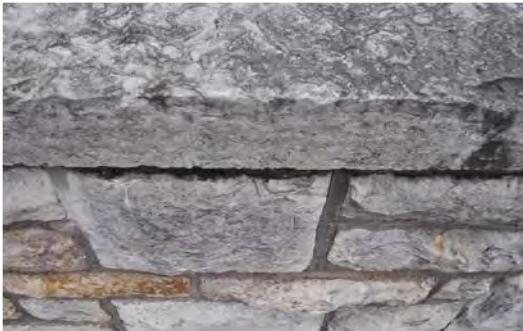
Figure 1. Tyndall stone and greystone.

Although the Murray Building is designed in the Modern style, a conscious decision was made not to discard historic campus materials and scale. The exterior materials of the building include greystone, Tyndall stone and granite (Figures 1 & 2). Greystone and Tyndall stone, by this time, were firmly established as a unifying feature of the University of Saskatchewan campus. The Murray Building honoured this tradition, but re-imagined the meanings of these materials in the way they are expressed. Whereas earlier, greystone was used in a structural capacity, to support the weight of the building, here it is used as a non-structural cladding. Because the stone wall is no longer structural, the architect is free to arrange the elements of the wall at will. Formerly, Tyndall stone, was used for trim and decoration, particularly around individual windows. Here it is also used in conjunction with windows, but rather than serving to accentuate individual openings, it is used in the form of spandrel panels, to unify and define larger blocks of fenestration. Decoration is omitted, but large areas of window

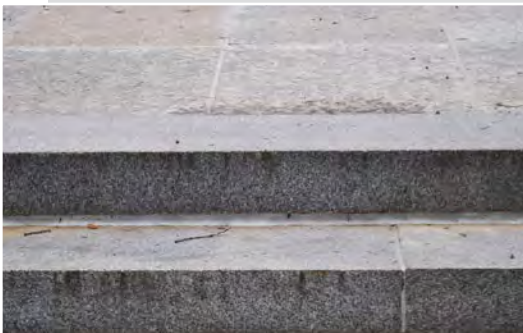
Figure 2. Granite steps and Tyndall stone pavers.

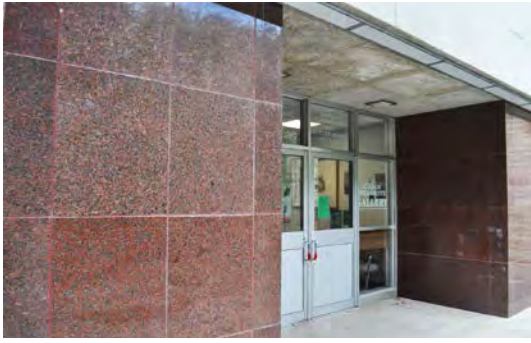
Figure 4. Pink granite, Tyndall stone soffit and curtain wall glazing.

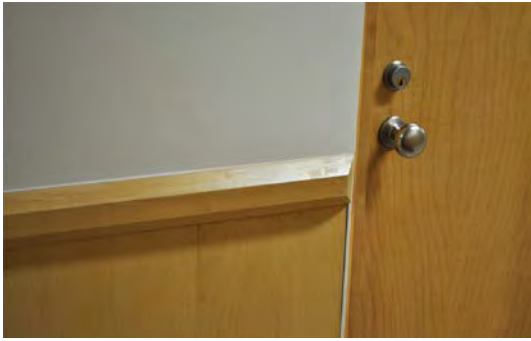
Figure 5. Maple wainscoting and door with steel knob.

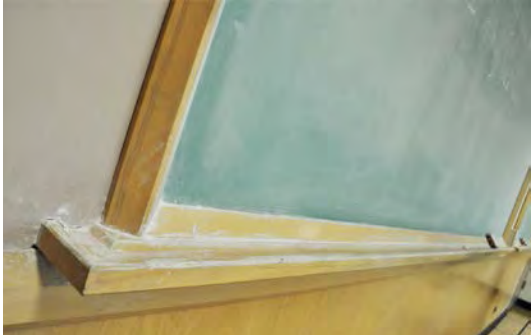
Figure 6. Maple framed chalkboard.

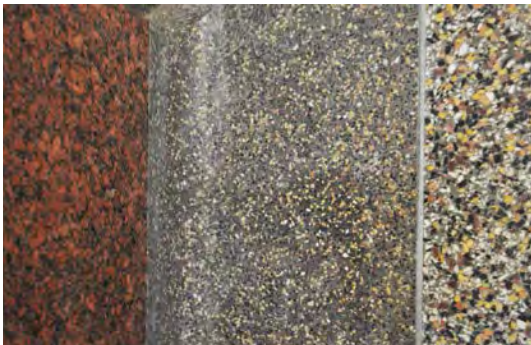
Figure 7. Pink granite wall and terrazzo flooring.

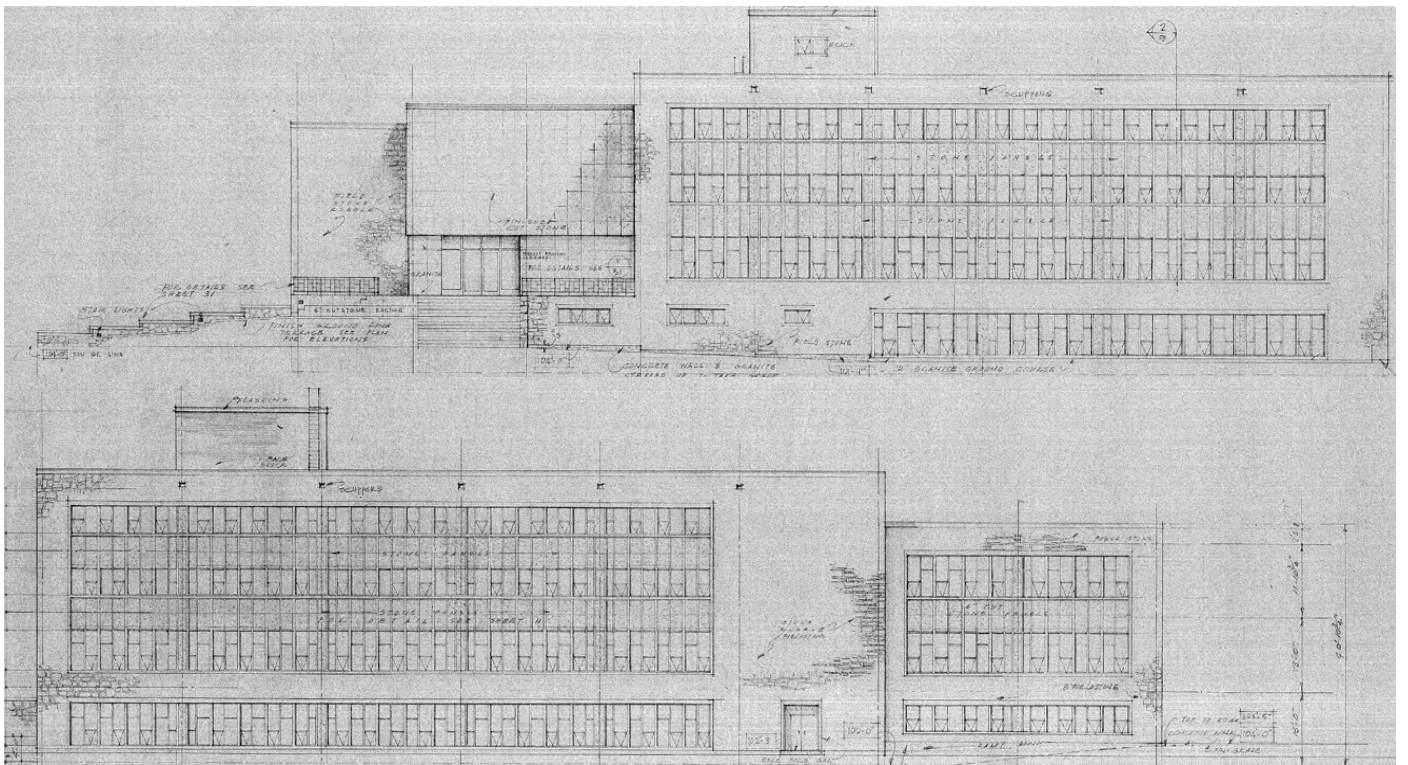
Figure 9. Elevations of the Murray Building. Retrieved from Facilities Management Division Asset Record System, File MM-52-T.

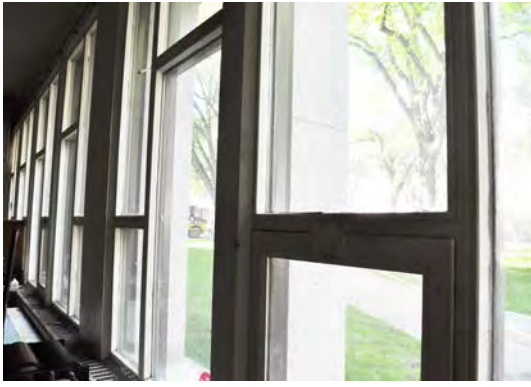
Figure 10. Alternating, repetitive window pattern.

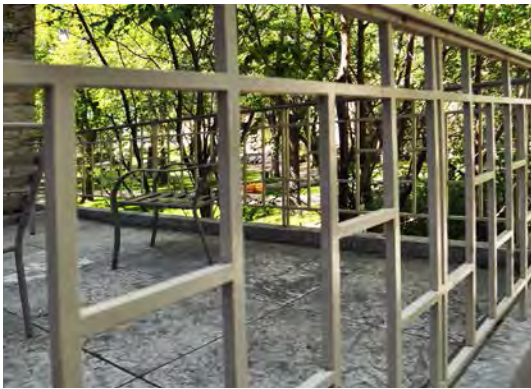
Figure 11. Steel balustrade.

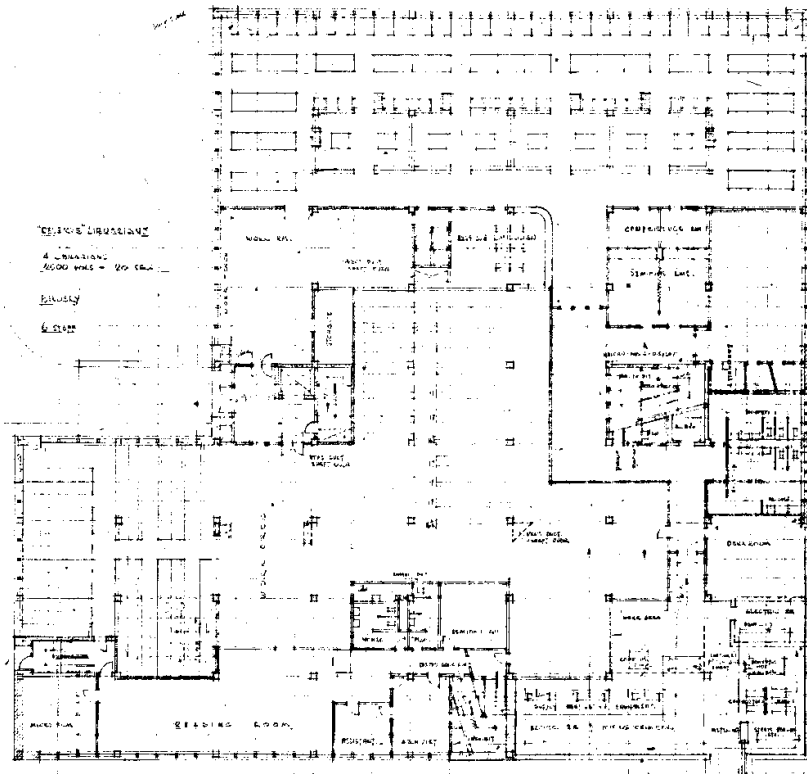
Figure 13. Ground floor plan. Retrieved from Facilities Management Division Asset Record System, File 053-4-T.

Technological changes, such as the use of concrete and steel structures and the adoption of electric lighting, permitted changes in the form and spatial configuration of buildings, although sometimes these effects took several years to manifest themselves. The Murray Building illustrates one such change in its use of deep floor plates. Previously, buildings tended to have narrow floors permitting windows in most rooms. Artificial lighting allowed buildings to be designed with larger floor areas. As a large university library, the function of the building lent itself to this form; books could be stored in rows of stacks that did not require access to windows. The general spatial configuration suggested by this approach was for floors arranged with stack space at their core, and a ring of offices and study spaces around the perimeter. Larger floor plates also permitted larger rooms and open plan configurations. These configurations characterize the original design of the Murray Building (Figures 13-15).

The Saskatchewan Archives is still located in the building's ground floor and retains its commemorative integrity. Its layout has scarcely been changed. Figure 13 shows the original ground floor plan with the archival space in the lower left.

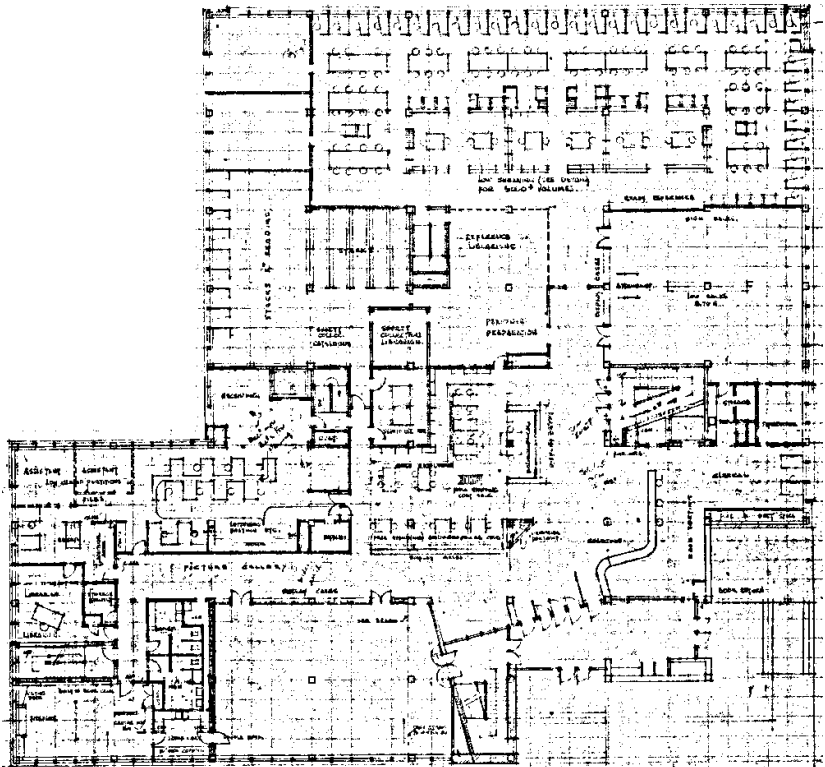
Figure 14. First floor plan. Retrieved from Facilities Management Division Asset Record System, File 053-3-T.

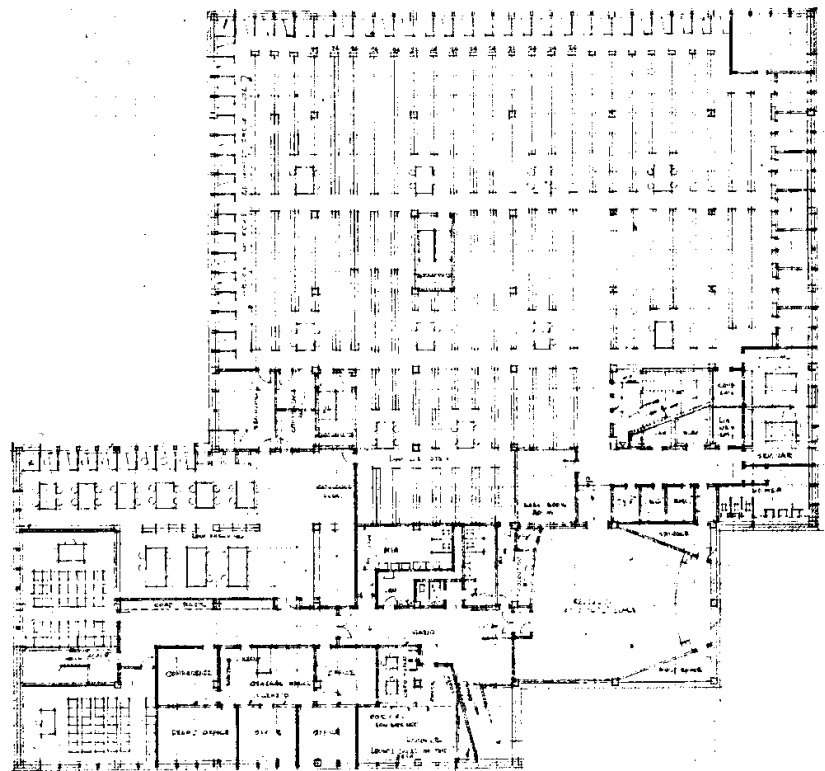
Figure 15. Second floor plan. Retrieved from Facilities Management Division Asset Record System, File 053-2-T.

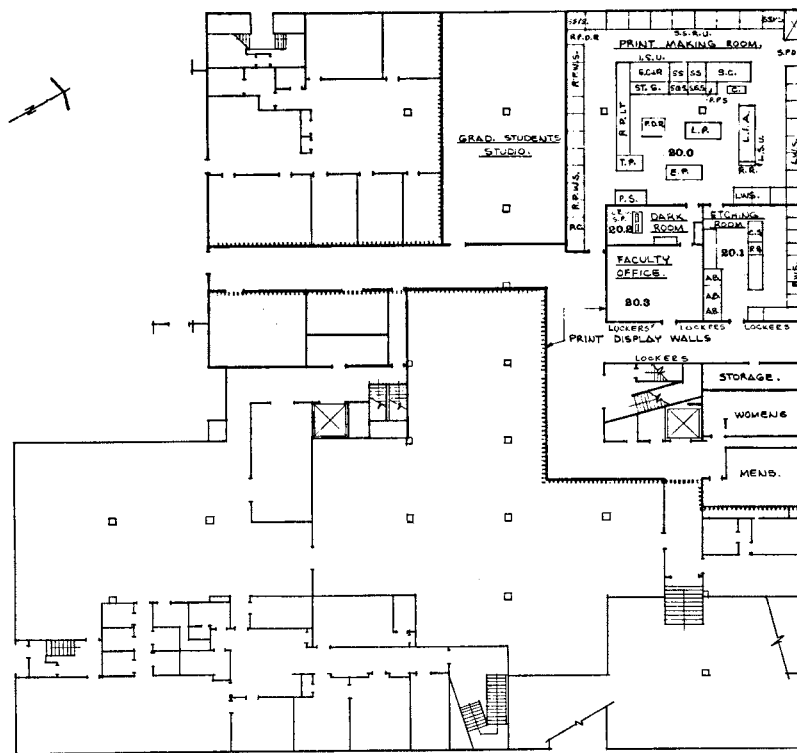
Figure 16. Ground floor plan after 1973 renovation. Retrieved from Facilities Management Division Asset Record System, File 053-512-T.

The spatial configuration of the Murray Building has been significantly altered by numerous interior reconfigurations and its interiors maintain little heritage value. The layout of the building has been fragmented with the piecemeal allocation of parts of the building to library uses and parts to the Department of Art & Art History. The result has been a division of the building characterized by a lack of access and interconnection. Figures 16 through 18 show the results of the 1973 reconfiguration to accommodate the Arts Department in the building.

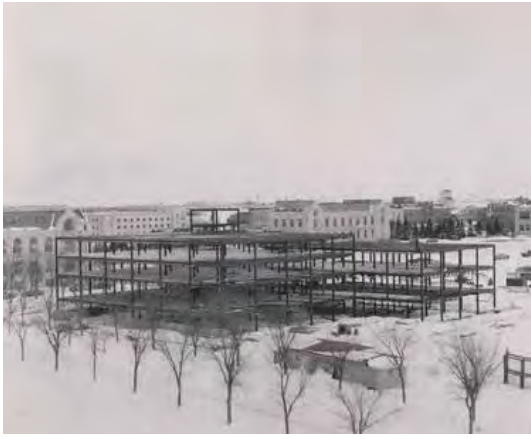
Figure 19. The steel structure of the Murray Building, winter 1954-1955. Photo A-597, retrieved from <http://sain.scaa.sk.ca/items/index.php/university-of-saskatchewan-archives;isdiah>

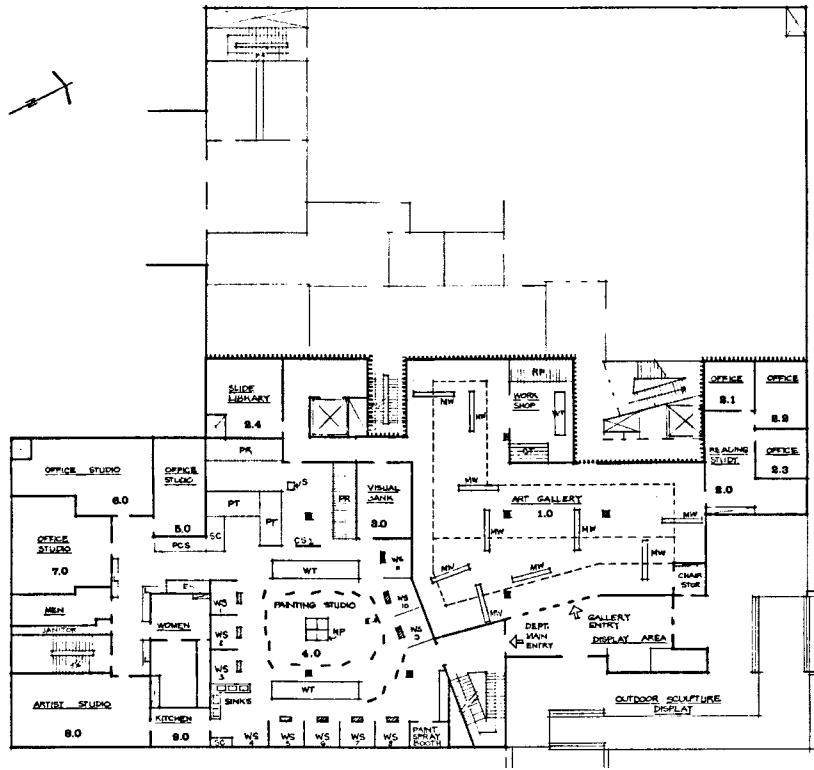
Figure 17. First floor plan after 1973 renovation. Retrieved from Facilities Management Division Asset Record System, File 053-511-T.

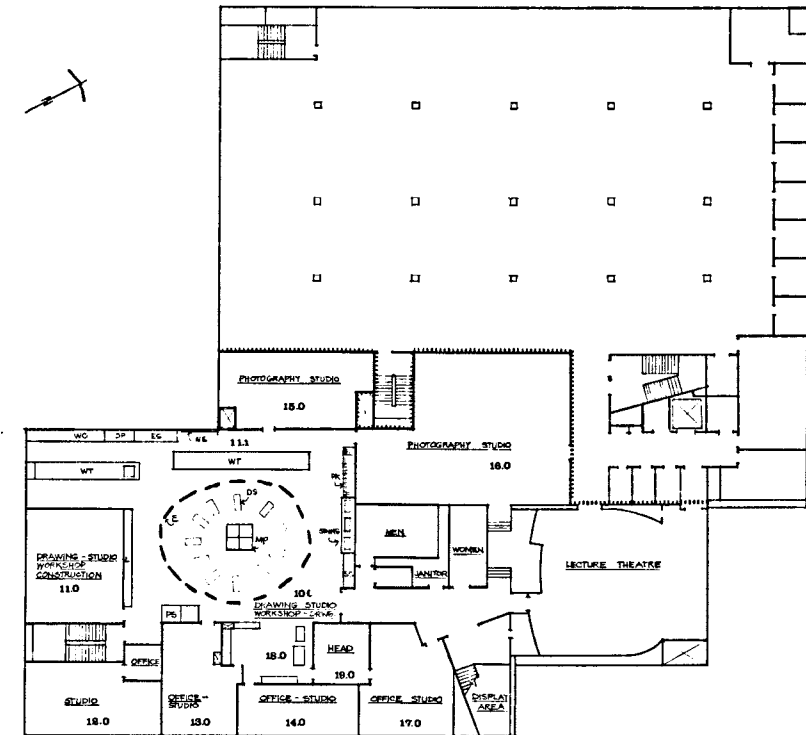
Figure 18. Second floor plan after 1973 renovation. Retrieved from Facilities Management Division Asset Record System, File 053-510-T.

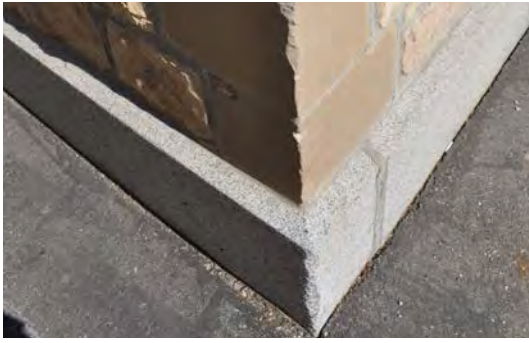
Figure 2. Corner made of limestone with greystone on either side, on a base course of granite.

The MacKinnon Building was constructed of high quality materials, most of which remain in an excellent state of commemorative integrity (Figures 2 & 3). Its exterior was built largely of the locally-sourced dolomitic limestone commonly referred to as 'greystone'. The base of the building is supported by granite of a light grey color with black flecks. The building's arches, architraves, crenellation, quoining and other stone ornamentation are all fashioned out of Bedford or Indiana limestone. (For further information on building stones used at the U of S, refer to '[Appendix: Stone](#).') The roof of the MacKinnon Building is clad in slate tile with copper flashing, gutters and downspouts.

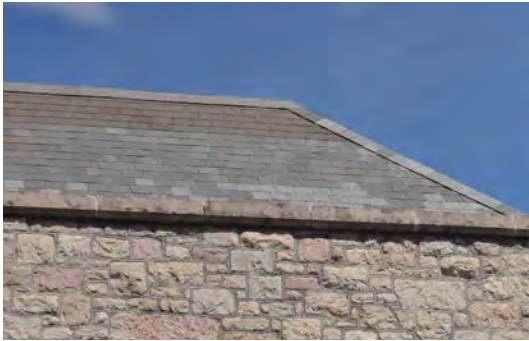
Figure 3. Slate tile roofing.

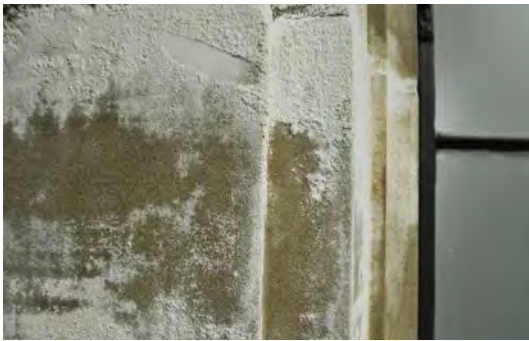
Figure 4. Stone with efflorescence.

Portions of the original exterior stone walls are now enclosed within the [Administration Building](#), which was added to the east of the MacKinnon Building. Some of the enclosed stone shows white residue or efflorescence as shown in Figure 4. Aside from this, the building's stone is in excellent commemorative condition.

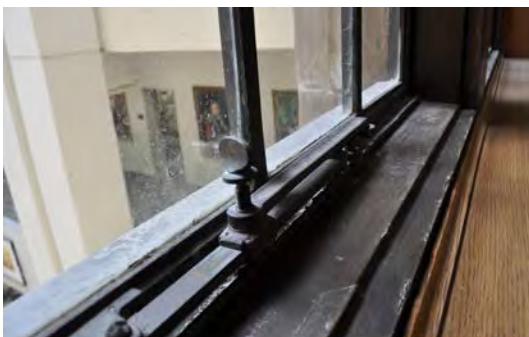
Figure 5. L to R: Steel window frame and fixture with oak sill.

The public spaces on the interior of the MacKinnon Building, such as its corridors, stairwells and the lecture theatre called Convocation Hall, have been preserved and restored. Among the building's interior features are arched doors and door surrounds of stained quarter sawn oak, with bronze and steel hardware. Some oak baseboards remain while some have been replaced in kind. Window frames are steel and in many cases windows retain the original panes of glass. In some cases, new aluminum-framed windows have been added to the interior side of original window openings for increased thermal performance. Some windows have bronze hardware and oak surrounds. Figure 5 shows a steel-framed window, with an oak surround and bronze hardware.
