University of Saskatchewan

Heritage Register

September 2013

Facilities Management
Division

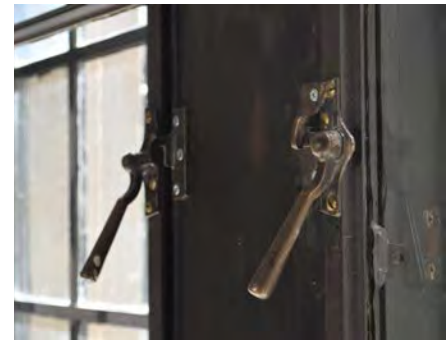
Figure 6. Bronze window hardware in the MacKinnon Building's Convocation Hall.

The public spaces on the interior of the MacKinnon Building, such as its corridors, stairwells and the lecture theatre called Convocation Hall, have been preserved and restored. Among the building's interior features are arched doors and door surrounds of stained quarter sawn oak, with bronze and steel hardware. Some oak baseboards remain while some have been replaced in kind. Window frames are steel and in many cases windows retain the original panes of glass. In some cases, new aluminum-framed windows have been added to the interior side of original window openings for increased thermal performance. Some windows have bronze hardware and oak surrounds. Figure 5 shows a steel-framed window, with an oak surround and bronze hardware.

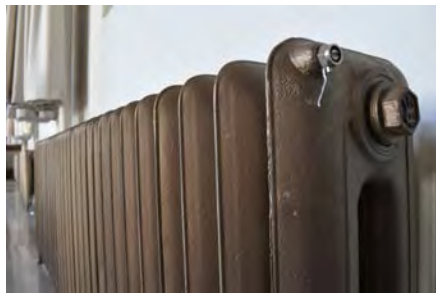
Figure 10. Cast iron radiator, plated in bronze.

In the corridors and stairwells, walls are finished in a glazed terracotta tile made to resemble stone. Floors are finished in slate and clay tile (Figure 7). Stair cases have steel stringers, cast iron risers, slate treads and painted steel and cast iron balusters with oak handrails (Figures 8 & 9). The slate stair treads are original and have been worn down from years of use (Figure 9). Throughout the building, original fixtures such as cast iron radiators and steel standpipes have been maintained (Figure 10).

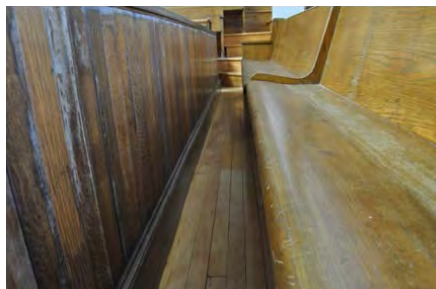
Figure 11. L to R: Original oak balcony, hardwood flooring and wooden seats.

Convocation Hall is a large ceremonial assembly space forming the centrepiece of the MacKinnon Building. All of the wood and steel windows in Convocation Hall are original. Original plaster walls including its two arcaded aisles, have been restored. A large skylight was uncovered during the renovation work and was re-established. Minor changes have been made to the stage, ceiling, and floors. The lighting fixtures are not original, but are remnants of a later renovation. The balcony level in Convocation Hall has an original oak baluster, seating pews and floor. These original wooden features are shown in Figure 11.

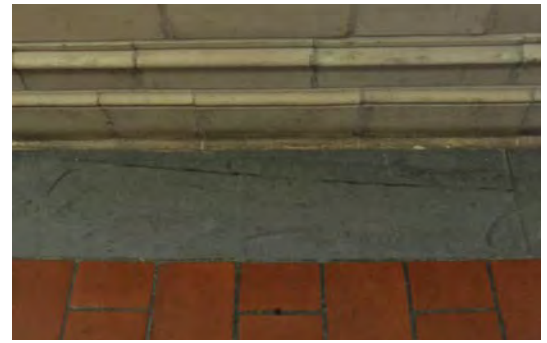
Figure 7. Top to bottom: terracotta wall and base, slate and day tile floor.

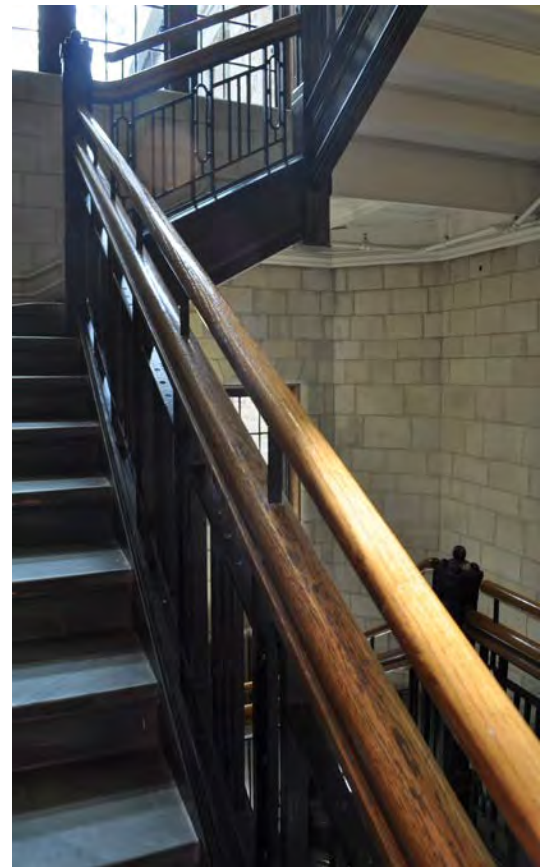
Figure 8. L to R: Slate Stairs, steel stringers, wooden handrails.

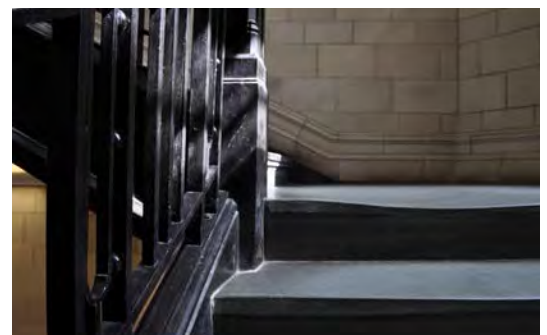
Figure 9. Slate stair treads.

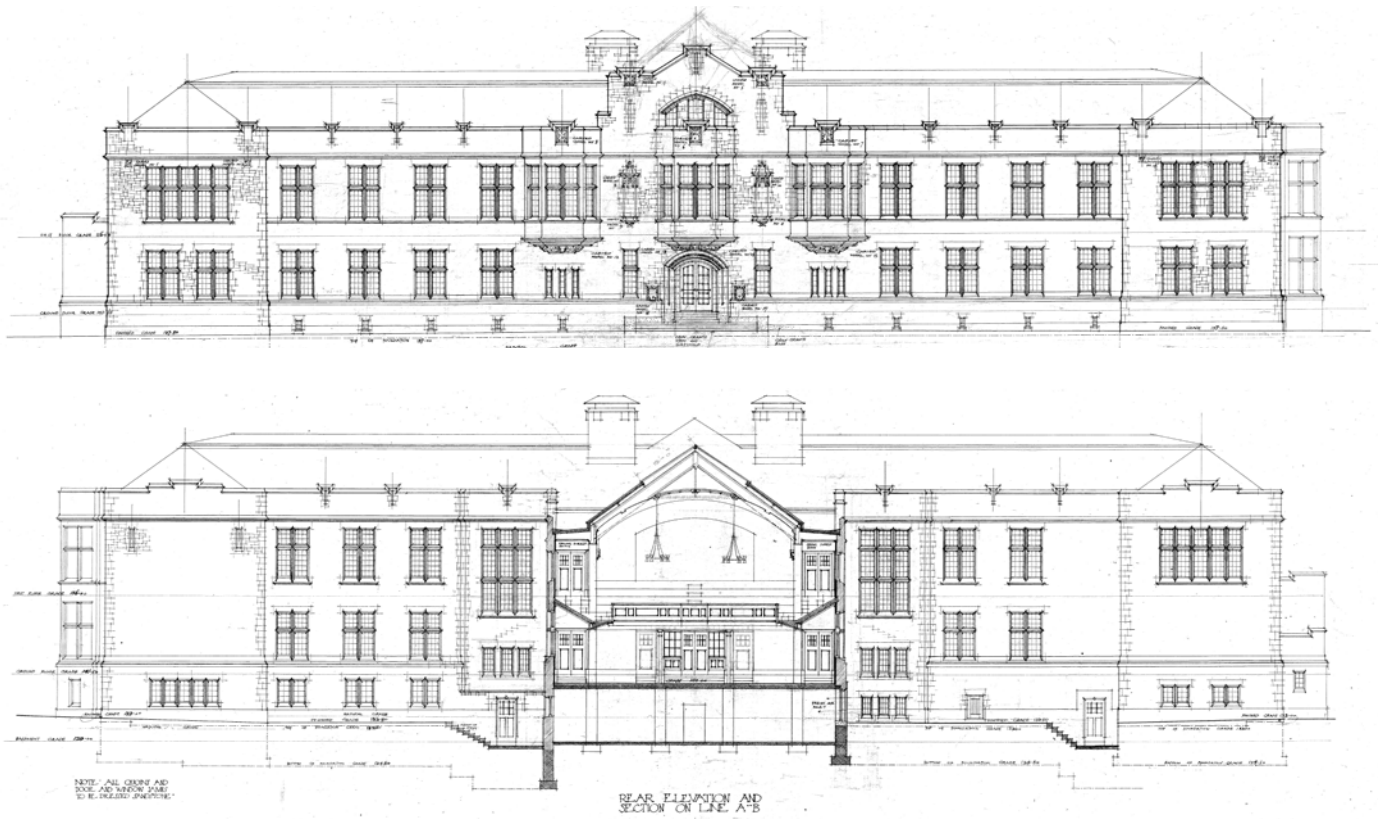
Figure 12. Front and rear elevations of the MacKinnon Building by Montreal Architects David R. Brown and Hugh Vallance show the long, low massing that came to define campus buildings. Retrieved from Facilities Management Division Asset Record System, File A-B-6T.

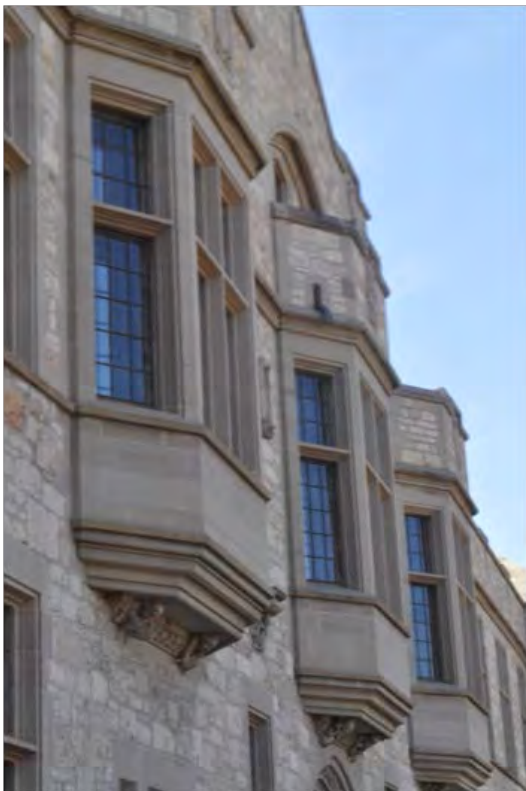
Figure 13. Oriel windows adorn the facade of the MacKinnon Building.

Several elements define the Collegiate Gothic style employed on the MacKinnon Building and are character-defining elements. The building's front façade is symmetrical in composition. The main entrance forms the central element in the design, marked by a pedimented bay and a row of three large oriel windows in the second floor (Figures 12 & 13). Statuary niches, visible in Figure 14, flank the central oriel window. Figure 15 shows the main entry, recessed within a shallow vault and featuring an arched oak door. The use of the arch, particularly the pointed or gothic arch, is a typical feature of the Collegiate Gothic style. The roofline features a crenelated parapet (Figure 14), another common feature of Collegiate Gothic buildings. Quoining – the visual emphasis of the exterior corners of the stone walls - is visible in Figure 17.

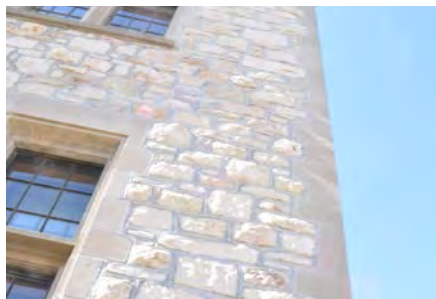
Figure 17. Sandstone quoining.

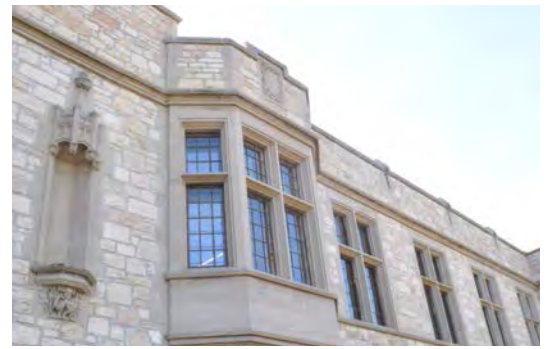
Figure 14. Crenellation along the roofline and an oriel window and statuary niche on the left.

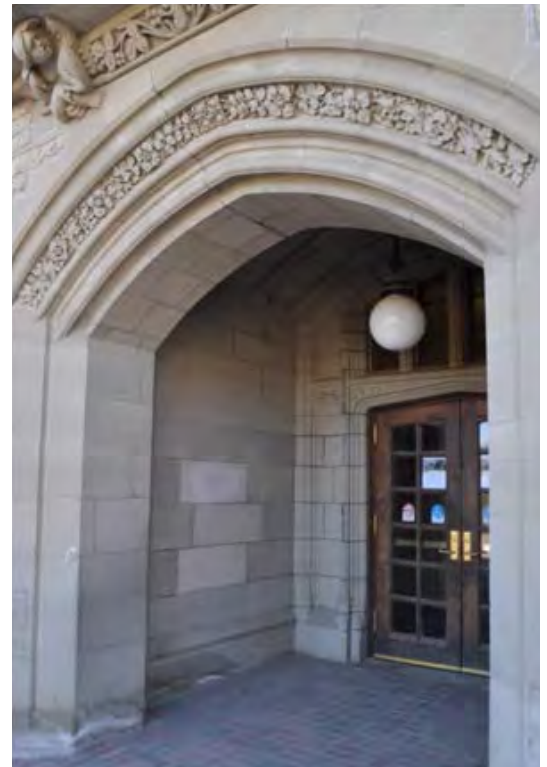
Figure 15. The MacKinnon Building's principle entry recessed within an arch, featuring an arched door.

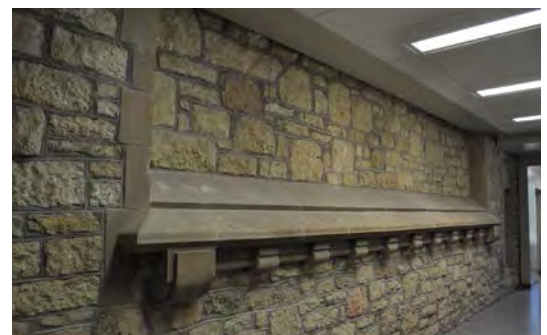
Figure 16. Stone corbels and string course.

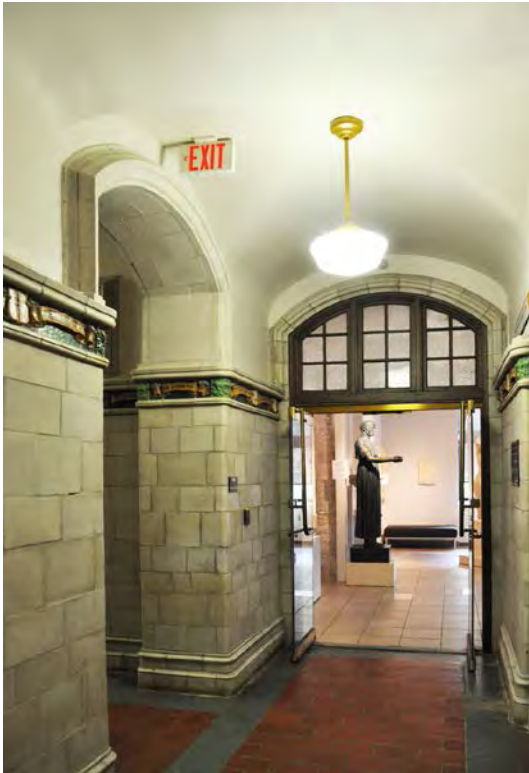
Figure 20. Interior arched entries and transoms surrounded by a terracotta wainscot under a vault ceiling.

The interior of the MacKinnon Building also contains Collegiate Gothic character-defining elements. The corridors feature arched oak doors and transoms, vaulted plaster ceilings and terra cotta wainscot. Many of these interior character-defining stylistic elements are shown in Figure 20 and exist in excellent commemorative condition. The two main staircases are character-defining elements for the level of decorative detail incorporated into their balustrades (Figure 21). The vaulted ceiling and arcaded aisles of Convocation Hall are also character-defining elements of both style and spatial configuration.

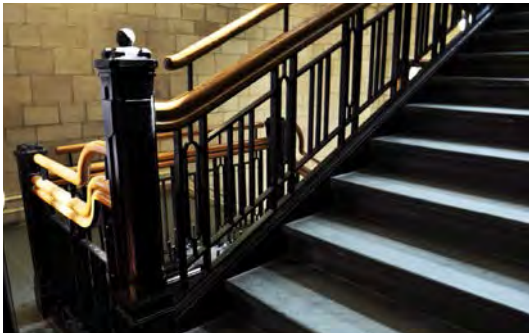
Figure 21. Ornamented balustrade.

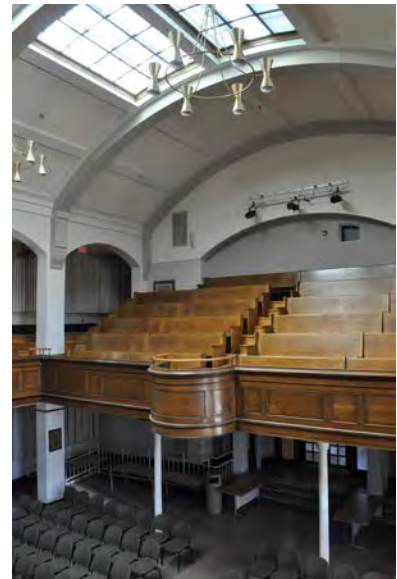
Figure 22. Vaulted ceiling with skylights and accompanying arches in Convocation Hall.

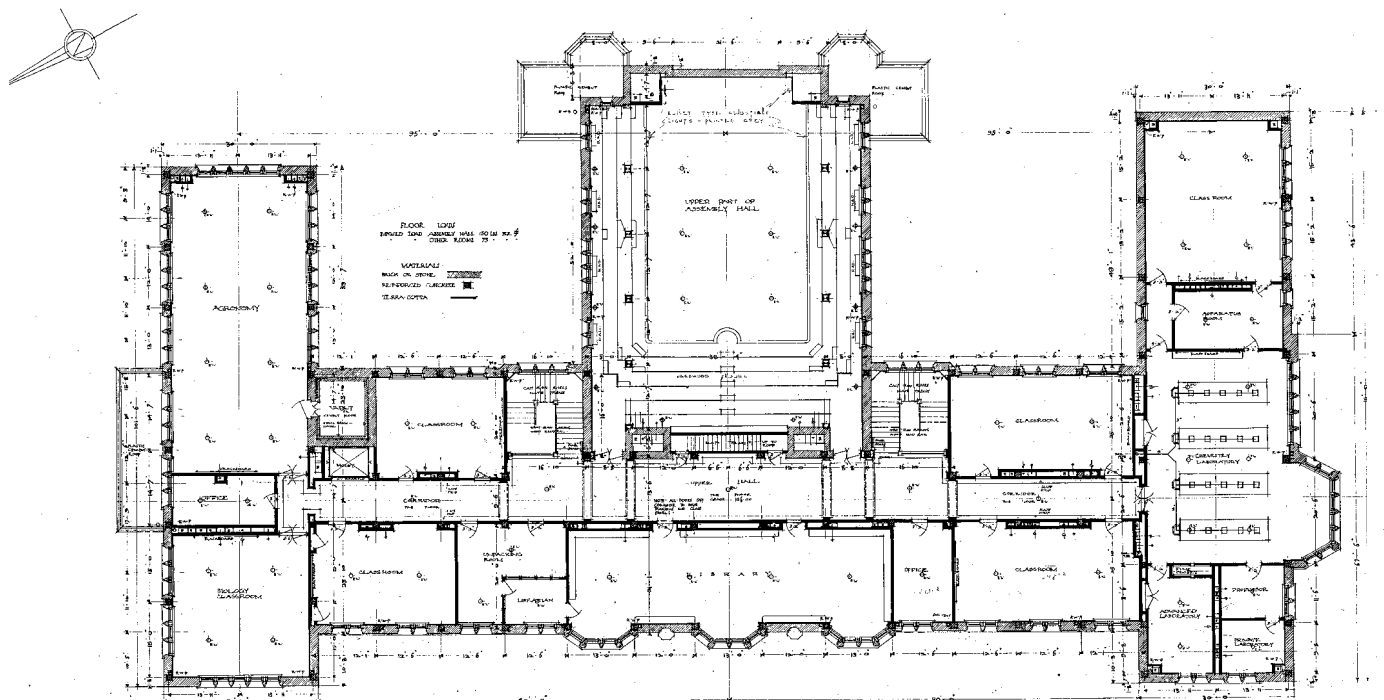
Figure 24. Original second floor plan of the MacKinnon Building revealing narrow floor plate, double loaded corridors and original uses. Retrieved from Facilities Management Division Asset Record System, File A-B-4T.

The MacKinnon Building's narrow interior layout and double-loaded corridors reflect common building practices at the turn of the 20th century (Figure 24). As electric lighting was still relatively new in 1909, the MacKinnon Building was designed with a large number of windows and a narrow footprint, allowing the deep penetration of natural light. Double height windows in stairwells and other public spaces are also character-defining. The skylight in Convocation Hall is another way in which the building was designed to take advantage of natural light (Figure 22). Convocation Hall is a grand, double height space with a vaulted ceiling and large balcony. The proportions of the space and its stylistic elements make it a character-defining space.

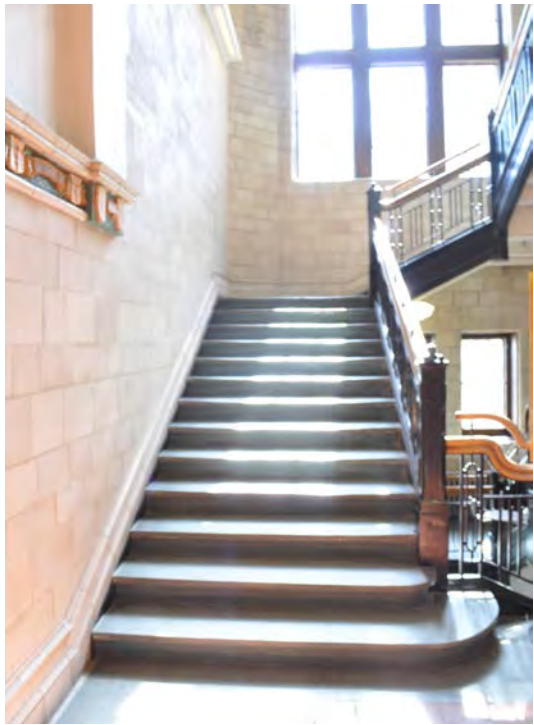
Figure 25. Public spaces have ample natural light due to the amount of glazing and the narrow floorplan.

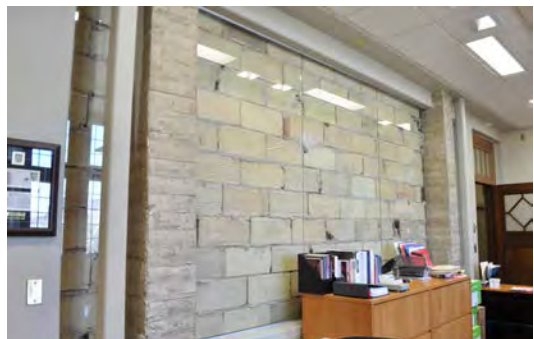
Figure 27. A portion of the concrete structure revealed.

The MacKinnon Building was built with a cast-in-place concrete frame, supporting concrete floor slabs and a roof structure consisting of wood decking on a system of steel beams and trusses. At the time of its construction, concrete was still a new technology and its application was not well understood. The poor design and execution of the concrete frame and floor structures revealed themselves in later years, and structural failures forced the closure of the building in 1997. Subsequently, the MacKinnon Building was extensively restored.

The building's original structure, including its failed components, have been reinforced by a new secondary steel structure, but have been retained for commemorative purposes and are displayed throughout the building. The presidential suite contains three 'windows' – where aspects of the original structure have been preserved and displayed behind glass. Many more are found in the southern wing and an old electrical box is preserved in the north. Figure 27 shows a section of the original concrete structure displayed within the President's office suite. The ceiling of the University Art Collection space has been left entirely exposed in order to leave the original ceiling and construction practices of the period visible.

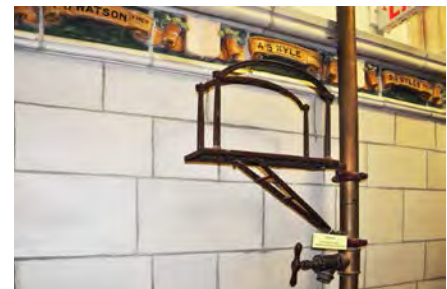
Figure 28. Non - functioning fire hose carrier.

The building's corridors have retained the old fire hose carriers, which are longer functional but have been retained for commemorative purposes (Figure 28).

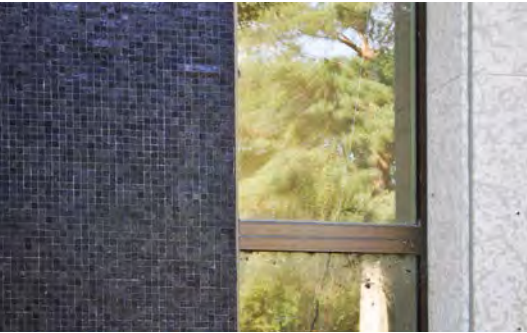
Figure 3. Dark purple ceramic tile, aluminum framed glazing, Tyndall stone.

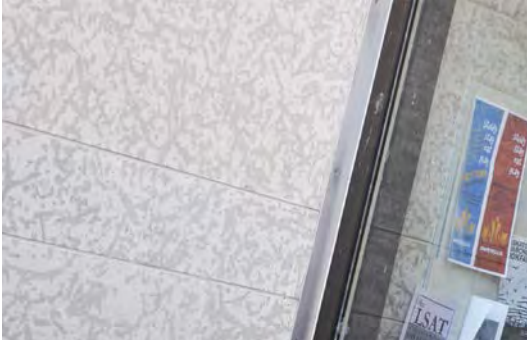
Figure 6. Tyndall stone on the exterior and interior separated by glazing.

Exterior materials are often extended to the interior: at the glazed link joining the Law and Commerce buildings, Tyndall stone and greystone are both extended from the exterior to the interior, separated only by a sheet of glass (Figure 6). The glazed entrance lobby and the link between Commerce and the [Arts Complex](#) are also differentiated from other areas of the building by the use of Welsh quarry tile as a flooring material. The tile flooring of the links and the interior application of exterior materials are character-defining elements.

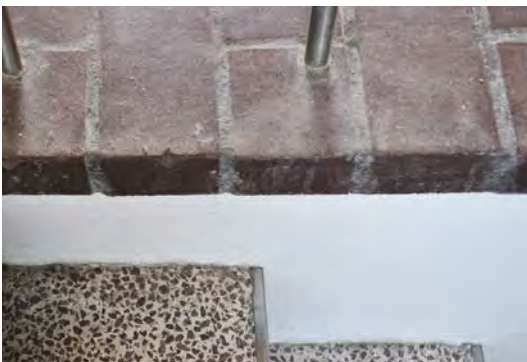
Figure 7. Terrazzo and Welsh quarry tile.

Staircases throughout both buildings have terrazzo treads and landings with steel balustrades (Figures 7 & 8). Exit stairs have wooden handrails. The central stair in the entrance lobby is a beautiful feature of the building. It is designed such that its steel handrails form its structure, and its stainless steel and terrazzo treads are suspended by tension rods that form its balusters. In this way the whole element is made lighter, such that it appears to float in the light-filled space of the glazed lobby. The stair in the entrance lobby is a character-defining element.

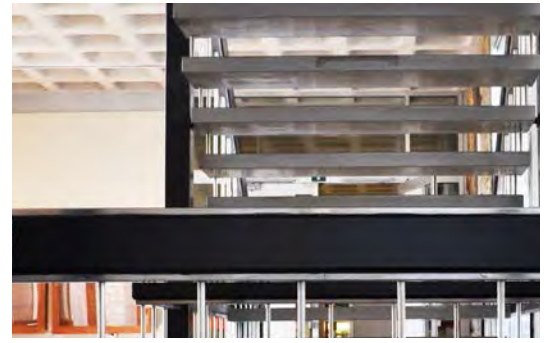
Figure 8. Steel and terrazzo staircase.

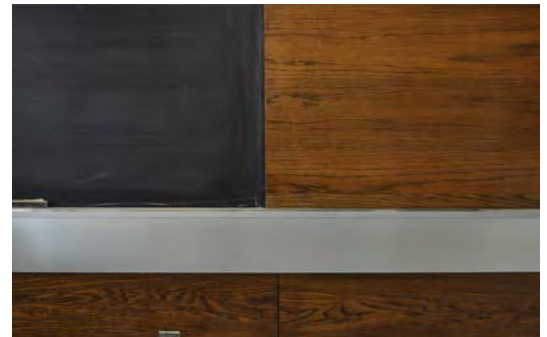
Figure 9. Oak chalkboard cover, oak wall panel with aluminum trim.

Aluminum, marble wall tile and dark stained oak are found throughout the interior of the Law Building. Oak paneling with aluminum trim is used in the 'Moot Court' room. An oak jury box, witness stand, judges' bench and rolling chalkboard and frame are also found in this room (Figure 9). (See Section 3 Associated Objects). Oak is also used extensively in the Law Library in the shelving, study carrels, tables and other millwork. Oak is also generally used for doors and transoms, and wall paneling. Columns in the Law Building are faced with natural anodized aluminum and brown marble tile, and have oak baseboards (Figure 12). Other columns were clad in white vinyl. The balustrade on the second floor corridor overlooking the library is a low wall made of striated, painted concrete. This balustrade, shown in Figure 13, is topped with a steel and oak hand rail. Painted concrete, dark stained oak, marble and aluminum are character-defining materials of the Law Building.

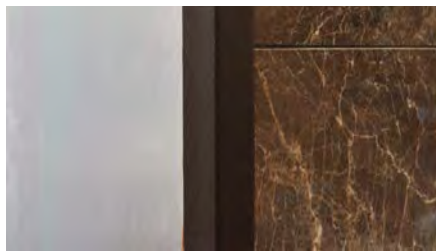
Figure 12. L to R: natural anodized aluminum and brown marble.

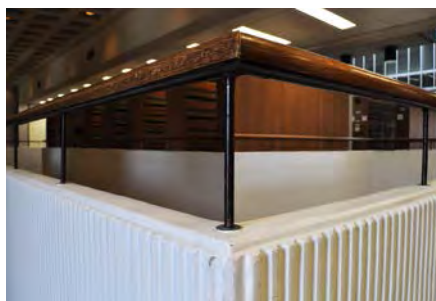
Figure 13. Striated painted concrete wall, steel and oak guard rail.

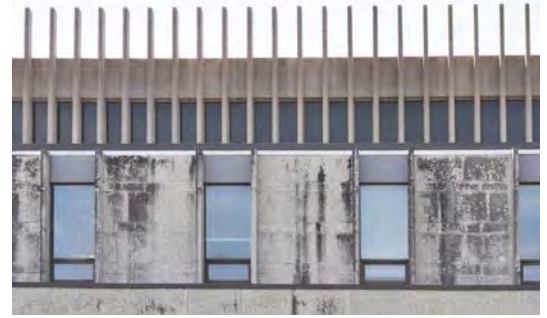
Figure 15. Precast concrete spires.

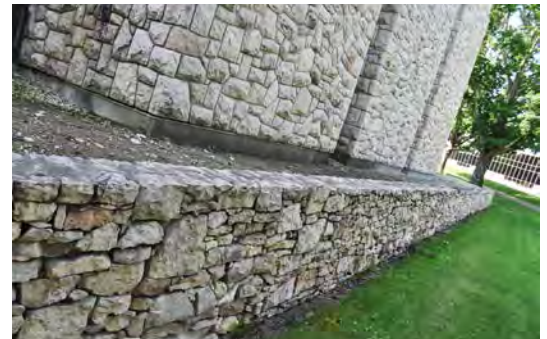
Figure 16. Rusticated greystone base.

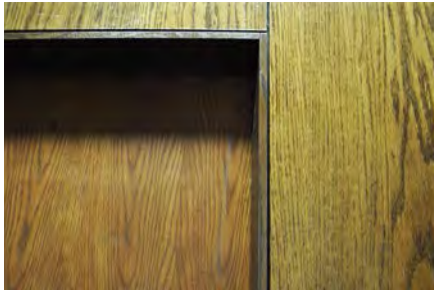
Figure 20. Continuity of material surface: oak door and narrow oak frame in an oak clad wall.

surfaces are used to define a form or volume, such as the faculty lounge and reading rooms on the second floor, which are rendered as discrete oak boxes projecting into the space of the library. This expression is supported by beautiful detailing; the oak doors leading into these rooms are built with narrow oak frames such that their material surface is uninterrupted (Figure 20).

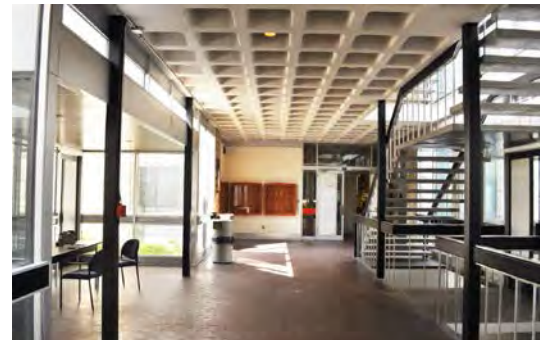
Figure 22. Exposed steel columns and concrete waffle slab.

The use of exposed structural elements is another hallmark of Modernist architecture employed to full expressive effect in the Law and Commerce Buildings. The concrete waffle slabs forming the floor structures of the building are exposed as finished ceilings in the entrance lobby and in the library (Figures 21 & 22). In the lobby, also, steel columns are left exposed. The stair in the entrance lobby, with its open treads suspended from above by steel tension rods, recalls a classic Modernist precedent: Eero Saarinen's suspended stair in the General Motors Technical Center in Detroit (1949-55) (Figure 23). The complex spatial configuration of the Law Building, with the library as its central focus, evokes the interconnected spaces of Paul Rudolph's Yale School of Architecture (1959-63) (Figure 25 & 26).

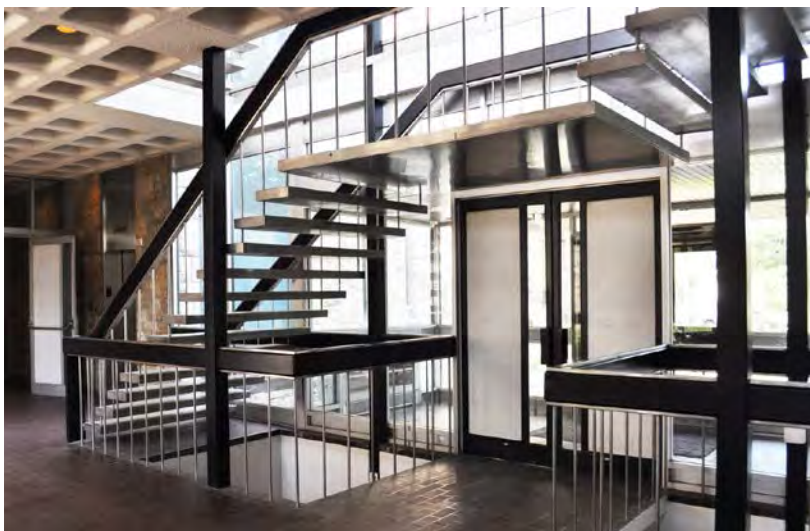
Figure 24. Stair in lobby.

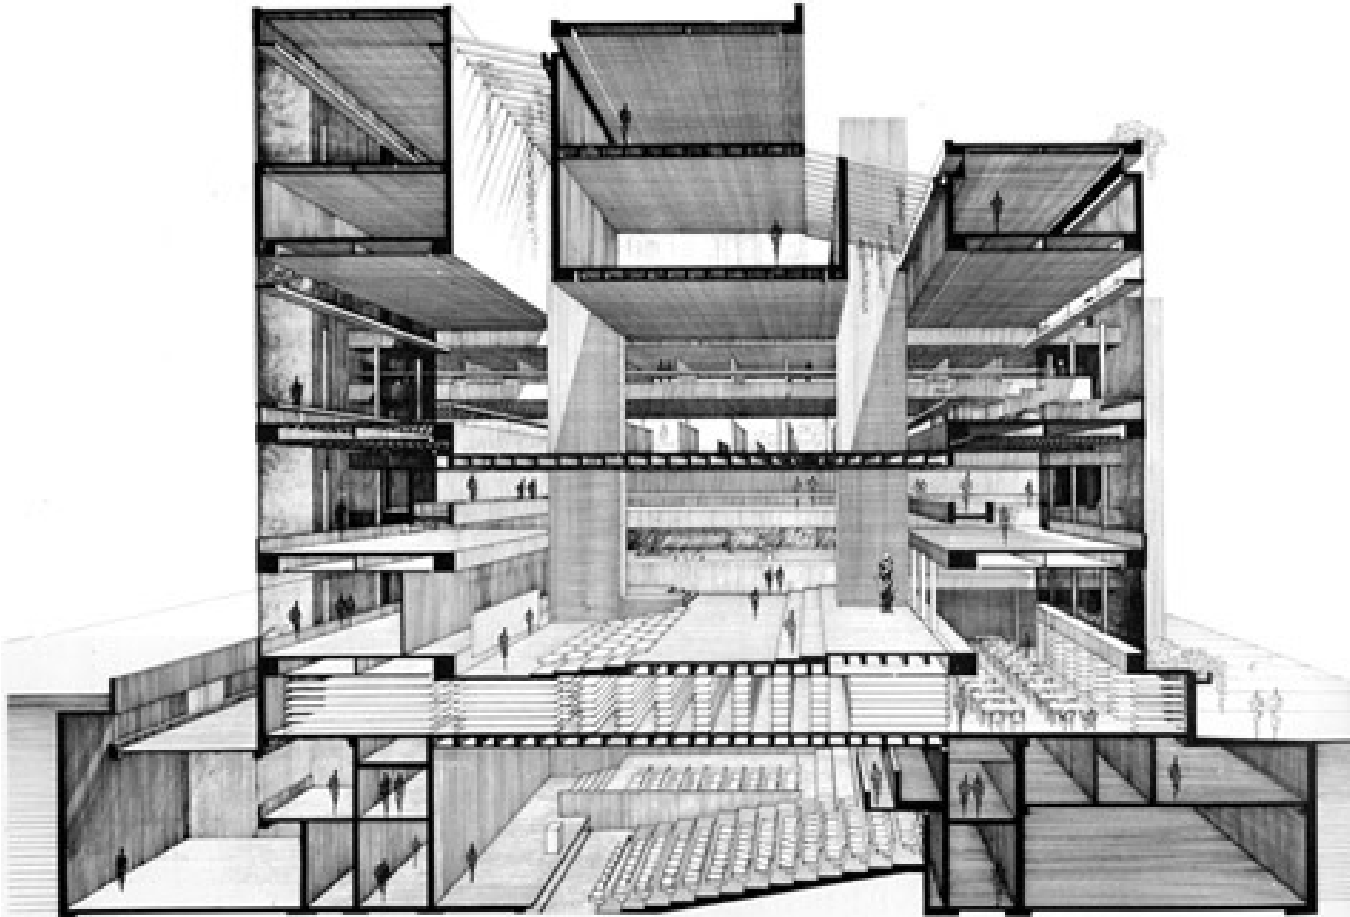
Figure 25. A perspectival section through the Yale School of Architecture by Paul Rudolph. Retrieved from <http://places.designobserver.com/feature/reading-rudolph/12607/>

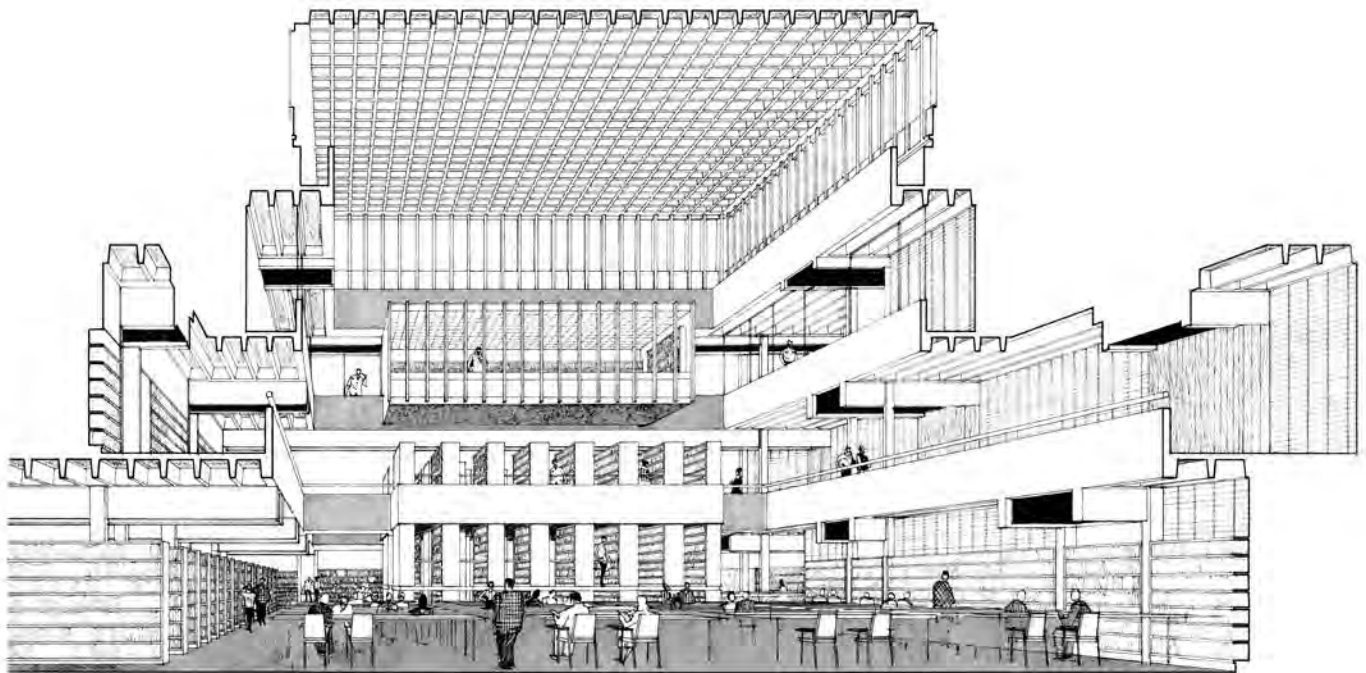
Figure 26. A perspectival section through the Law Library. Retrieved from Facilities Management Division Asset Record System, File LC-49-P.

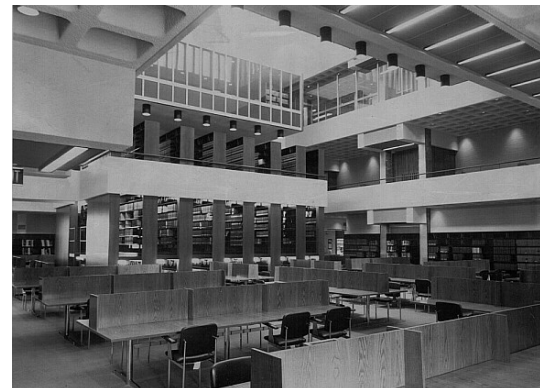
Figure 28. Law library.

The Law Building is roughly square in plan, and three stories in height, in addition to its basement. It is planned with the three-storey volume of the Law Library in the middle of the ground floor (Figure 28). This forms a central core, around which all of the other program elements – book stacks, classrooms, seminar rooms and offices are arranged. Holliday-Scott looked to the Parliamentary Library in Ottawa as a precedent for the interior of the Law Library, not for its shape or detail, but for the feeling that the space elicits (Figure 29). Holliday-Scott felt that in the case of the Law Building it was inappropriate to conceal the stacks as in some libraries. The Parliamentary Library served as an example of a, “building in the round...that has a mass that builds to the center,” (Holliday Scott, personal communication, September 5, 2013). The arrangement of stacks around a central space is clearly legible in the design of both the Parliamentary Library and the Law Library.

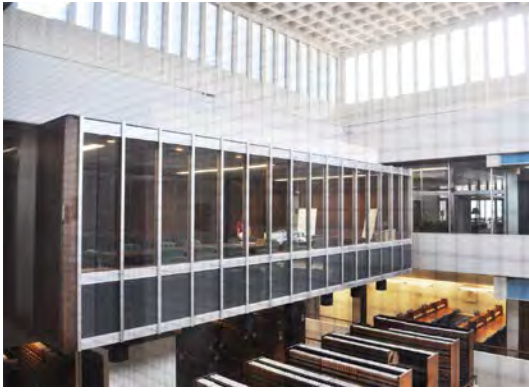
Figure 30. Projecting volume in the law library.

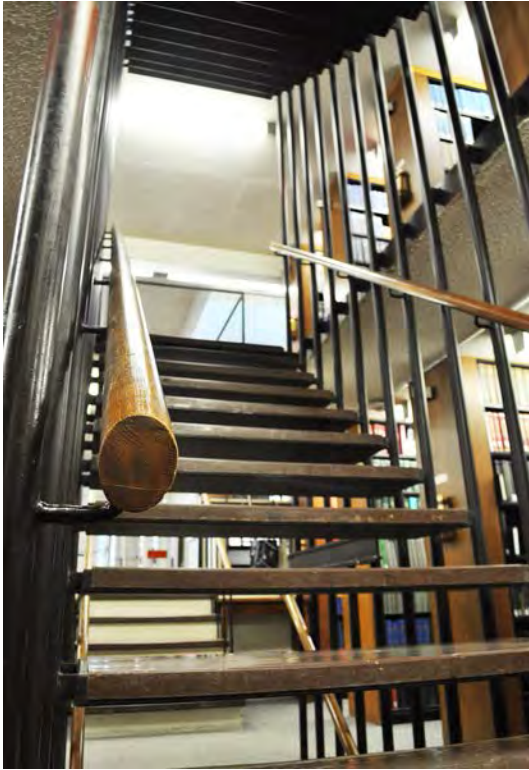
Figure 31. Library staircase.

The Law Library is arranged over two floors, including all of the ground floor and parts of the first floor. Provisions for additional book storage space were made in a basement level, initially left unfinished but completed in 1980. The reading room is at the centre of the ground floor library space, ringed by book stacks and library support functions arranged around the perimeter. It is a soaring light-filled space, stretching more than three storeys in height and crowned by a cupola with clerestory glazing (Figures 26 & 28). On the first and second floors, corridors encircle the space and overlook the reading room. A smaller faculty reading room and a faculty lounge project out into the space on the second floor (Figure 30). Contained within the volume of the reading room, a separate structure of book stacks spans between the basement and first floors and is connected back to the first floor by two short bridges. In this structure, four floors of bookshelves are compressed into the vertical dimension of the three adjacent floors, and the structure has its own internal stair (Figure 31). The Law Library, in its materials and spatial form is a character-defining element.

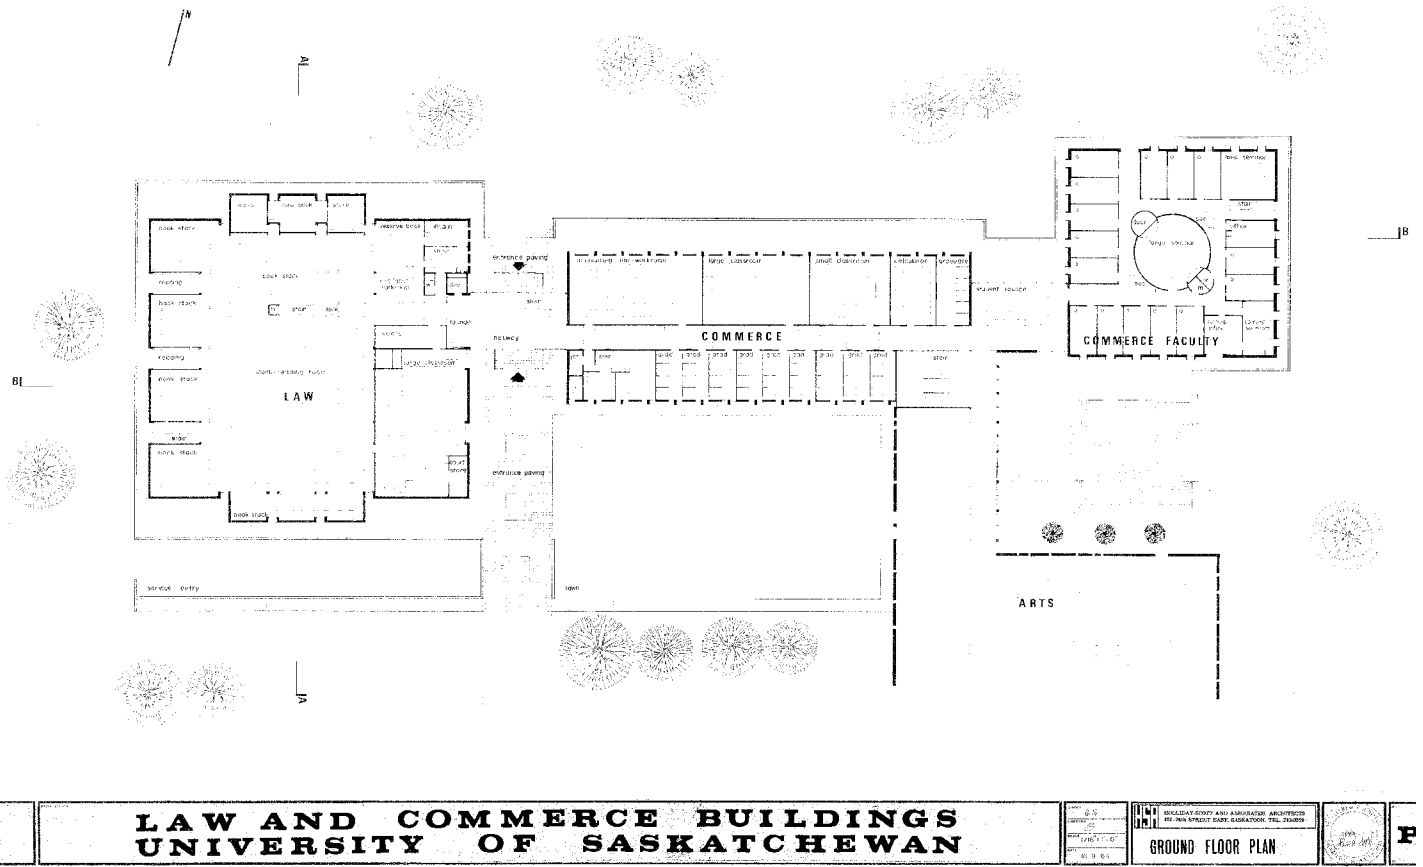
Figure 32. The original ground floor plan of the Law & Commerce Complex. Retrieved from Facilities Management Division Asset Record System, File LC-55-P.

The Commerce faculty wing is somewhat smaller than the Law Building, but is similarly square in plan. On each of its three floors, a large circular room is located in the centre of the plan, containing a faculty lounge on the second floor and seminar rooms on the ground and first floors (Figures 32 & 33). The central portion of the second floor is illuminated by clerestory glazing in a large square cupola (Figure 35). On all three floors, smaller offices and seminar rooms are arrayed around the perimeter.

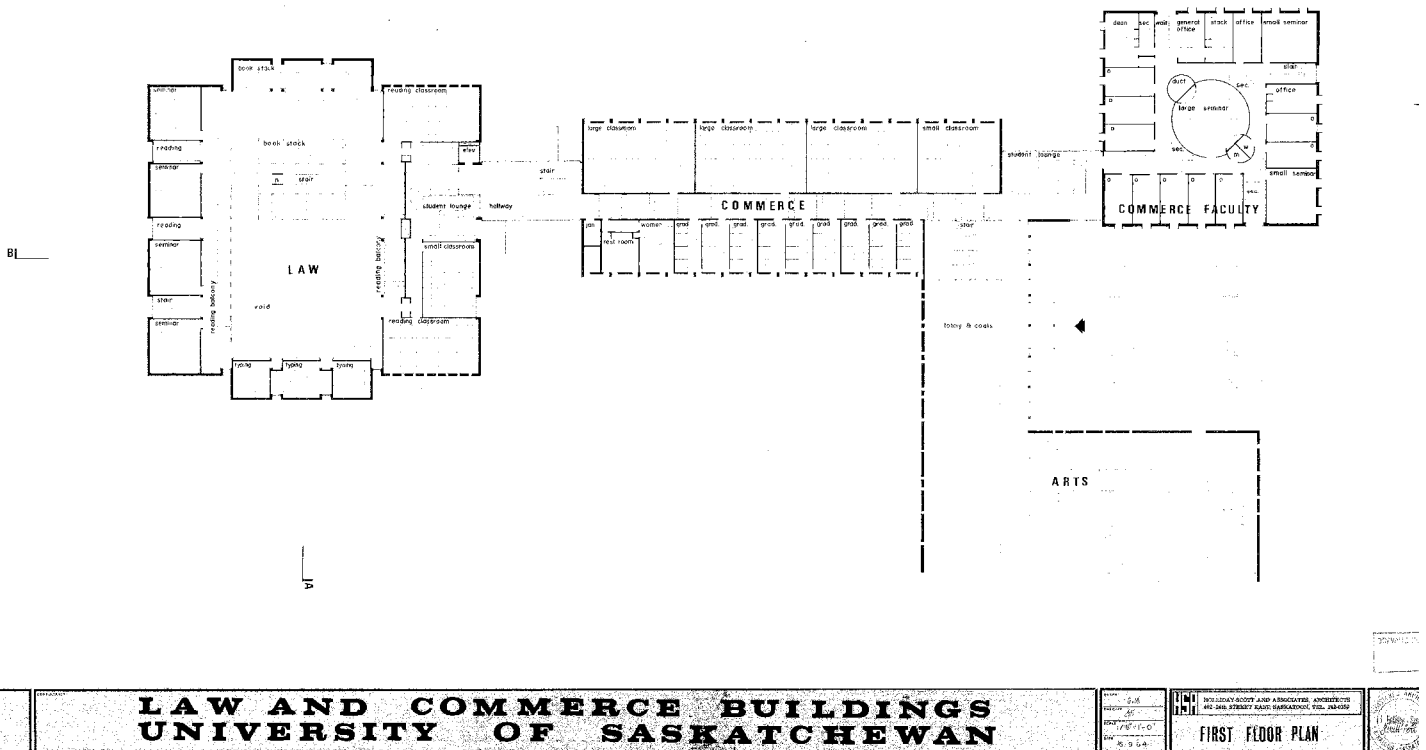
Figure 33. The original first floor plan of the Law & Commerce Complex. Retrieved from Facilities Management Division Asset Record System, File LC-199-C.

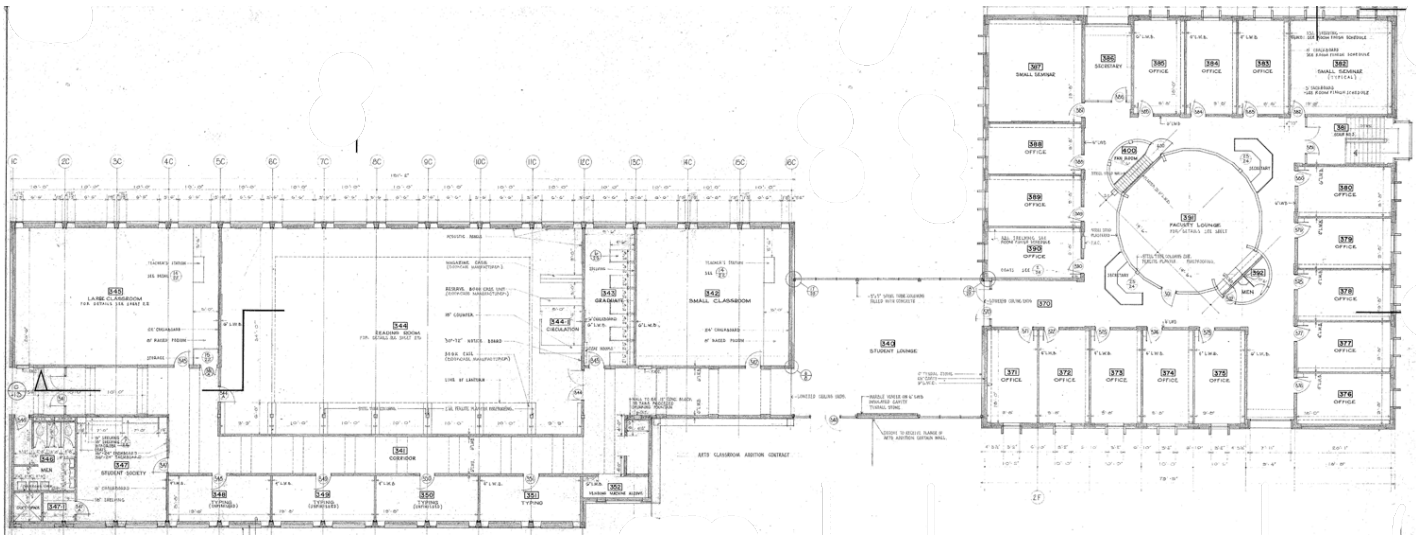
Figure 34. The original second floor plan of the Edwards School of Business. Retrieved from Facilities Management Division Asset Record System, File LC-199-C.

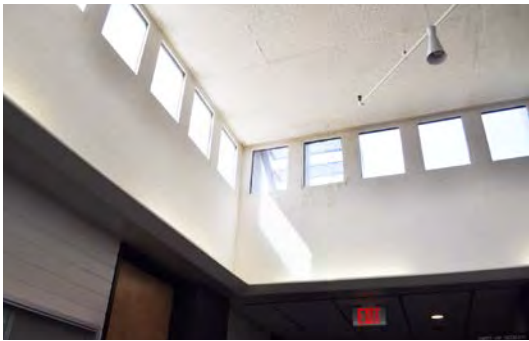
Figure 35. Clerestory glazing in the Edwards School of Business.

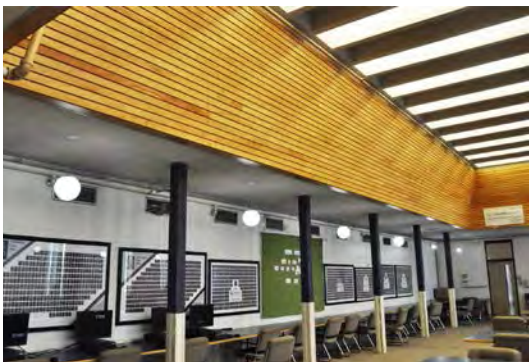
Figure 36. The Commerce Reading Room.

The Commerce classroom wing is a three-storey linear form, connecting the Law Building and Commerce faculty wing. On each floor, a series of classrooms is arranged on the north side of a double-loaded corridor. Graduate student offices, washrooms and other support functions are arranged on the south side. A large reading room was also provided on the north side of the second floor, featuring a high ceiling, lined with wood and illuminated by a row of skylights. The reading room is a character-defining element (Figure 36).

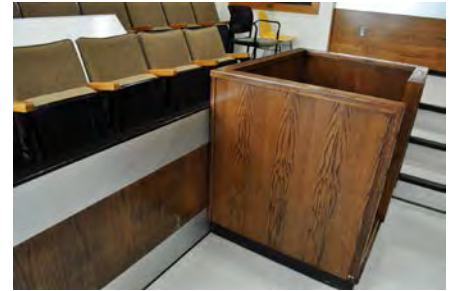
Figure 42. Oak and aluminum jury box and oak witness stand.

Holliday-Scott designed a jury box and witness stand to accompany the Moot Court classroom. These furnishings and their materials are original to the building (Figure 42).

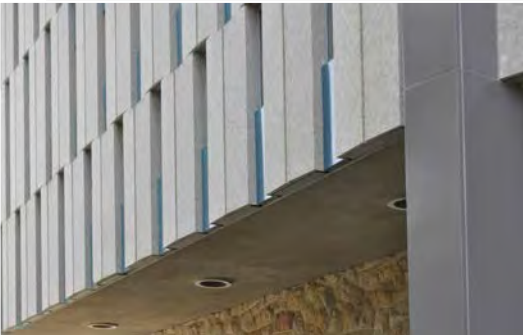
Figure 1. Theatre wing, with Tyndall stone panels, blue porcelain enameled spandrels and grey column covers.

The design of the Arts Complex introduced new building materials to the campus and used traditional materials in new ways. Porcelain enameled steel panels are employed extensively on the exterior elevations and in the interiors (Figure 1). Tyndall Stone is the primary cladding material of the tower and theatre pavilion (Figures 1 & 2). Greystone is used as the main cladding material of the two classroom wings, and also at the base of the tower and theatre.* Glazing is an important element in the design of the complex, being used extensively to enclose the connective spaces in the building that link the four principle wings.

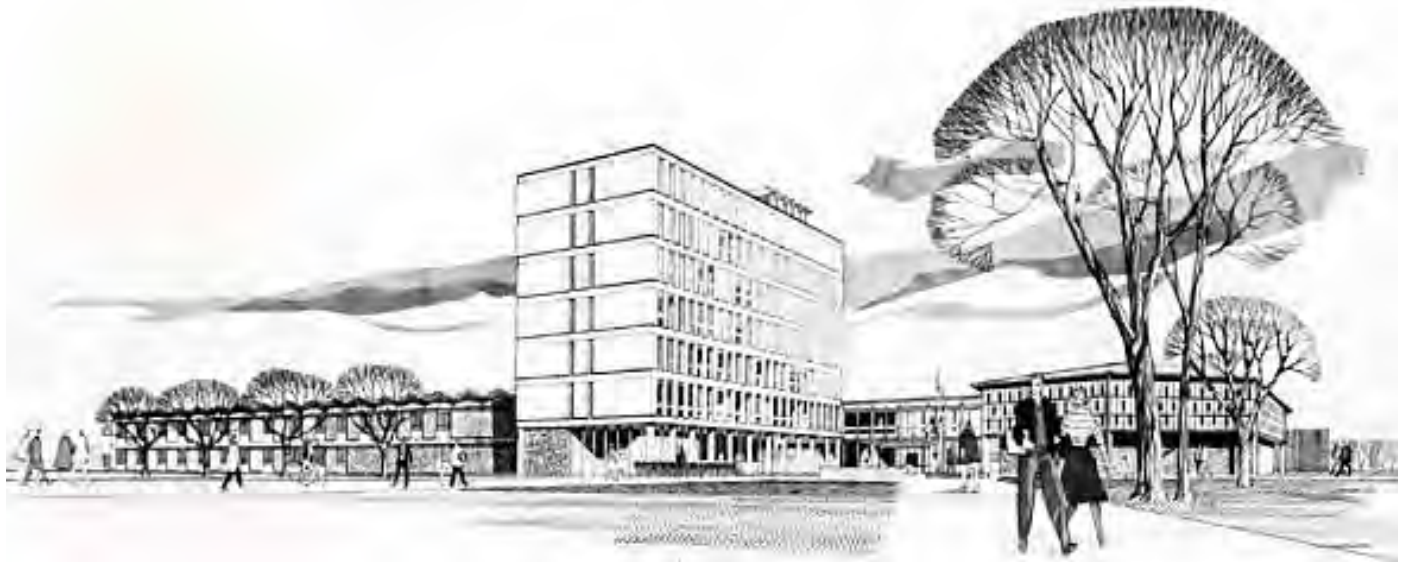
Figure 3. Architect's sketch of the Arts Building. The Arts Tower is depicted at its original height of seven storeys, before the addition of the final four floors. Photo A-112, retrieved from http://scaa.sk.ca/gallery/uofs_buildings/

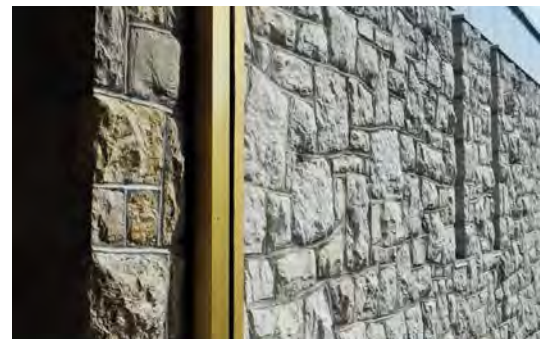
Figure 4. Greystone divided by glazing framed in gold anodized aluminum.

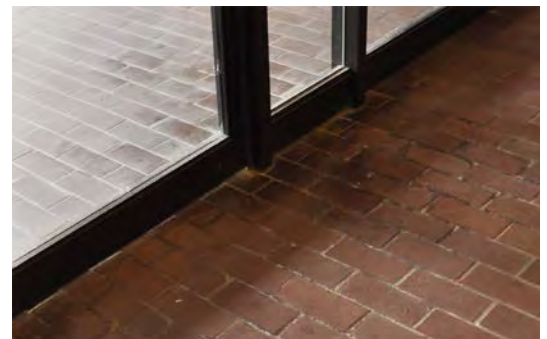
Figure 5. Brick flooring.

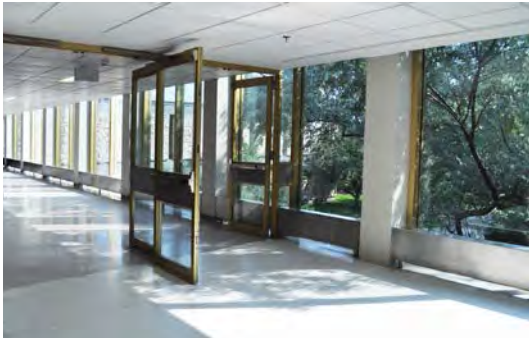
Figure 6. Glazed circulation space.

The components of the complex are separated from one another but also connected by glazed lobbies and links. This use of glazing as a compositional device to allow the expression of separate functions is another common feature of Modernist architecture (Figure 6). The approach also serves to denote public and circulatory spaces.

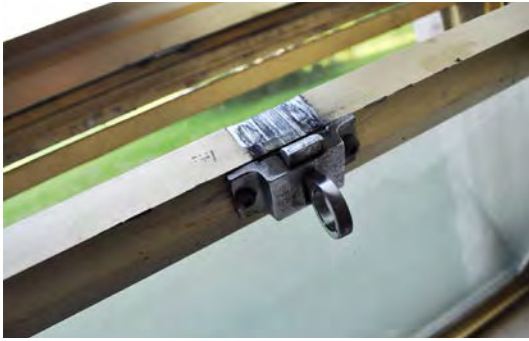
Figure 7. Gold anodized aluminum window frame, with steel hardware.

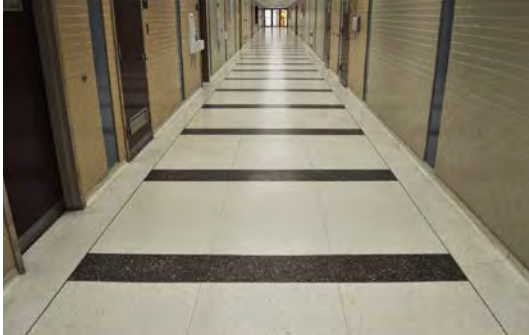
Figure 8. Terrazzo flooring, painted brick wall with blue porcelain enameled panels.

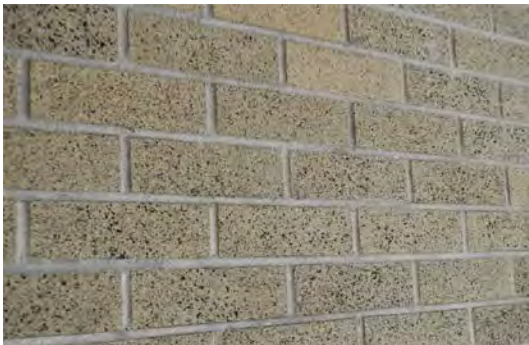
Figure 9. Buff coloured brick.
