University of Saskatchewan

Heritage Register

September 2013

Facilities Management
Division

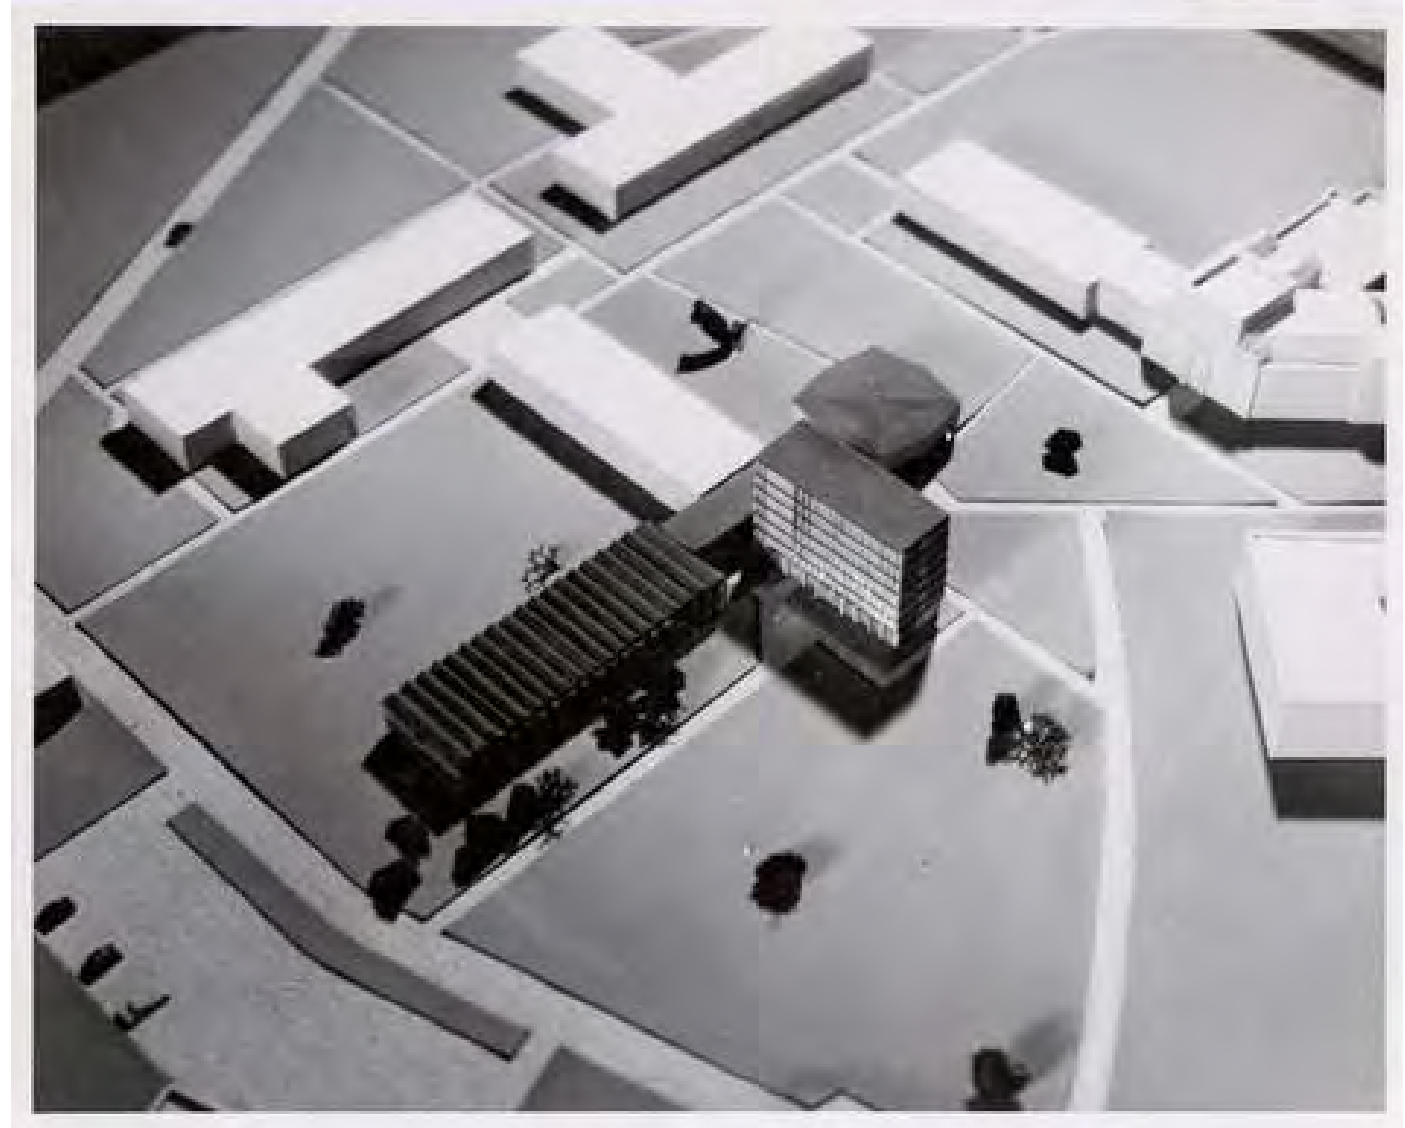
Figure 10. A 1959 architect's model of the Arts Complex. Note that here the tower is portrayed at only seven storeys and the north wing of classrooms is not yet designed. Photo A-110, retrieved from http://scaa.sk.ca/gallery/uofs_buildings/

Conforming to the Modernist dictum ‘form follows function’, the Arts Complex is designed as a series of discrete wings or pavilions, differentiated by use: an office tower, a lecture theatre pavilion, and two classroom wings. The four components of the complex are arranged in plan in a rough cruciform, connected at their intersection by a glazed entrance lobby. Each part has a distinct form corresponding to its function. The office wing is an 11 storey tower, the theatre wing is an octagonal pavilion, the first classroom wing is a two-storey block with a distinctive saw-tooth roof, and the new classroom wing is a two-storey volume with a flat roof. The four parts of the complex are visible in Figure 10, although this early model shows the lower first phase of the tower, and the new classroom wing is not yet fully developed.

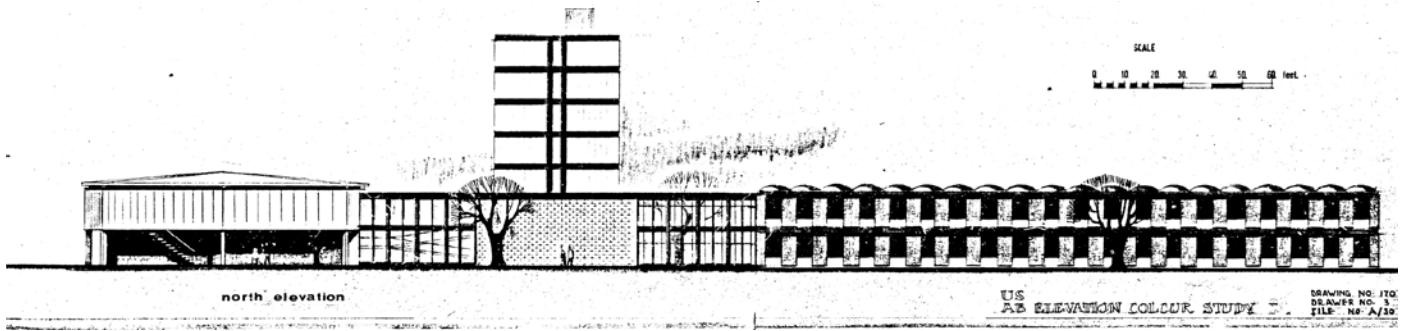
Figure 11. An undated elevation of the Arts Complex by Shore and Moffat Architects. Here the roof of the west classroom wing features repetitive arches rather than the saw-tooth roof that was constructed. Retrieved from Facilities Management Division Asset Record System, File A-30-T.

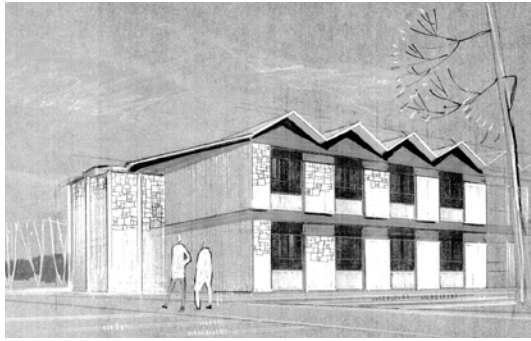
Figure 12. Perspective drawing of a portion of the west classroom wing and its saw-tooth roof. Retrieved from Facilities Management Division Asset Record System, File A-31-T.

The west classroom wing is a two-storey block defined by its distinctive saw-tooth roof (Figure 12). This use of repeated geometrical shapes to achieve a decorative effect is very common to Modernist architecture of the 1960’s. The roof form is carried into the interior as a motif used in the ceilings of the corridors (Figure 13).

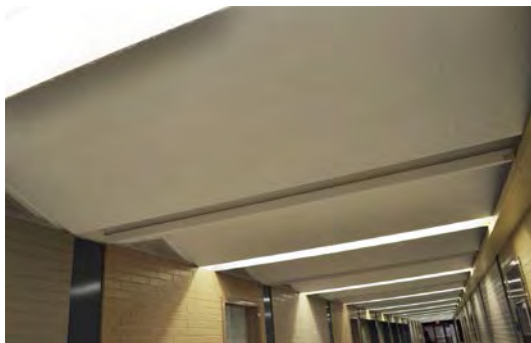
Figure 13. Saw-tooth ceiling in the west classroom wing.

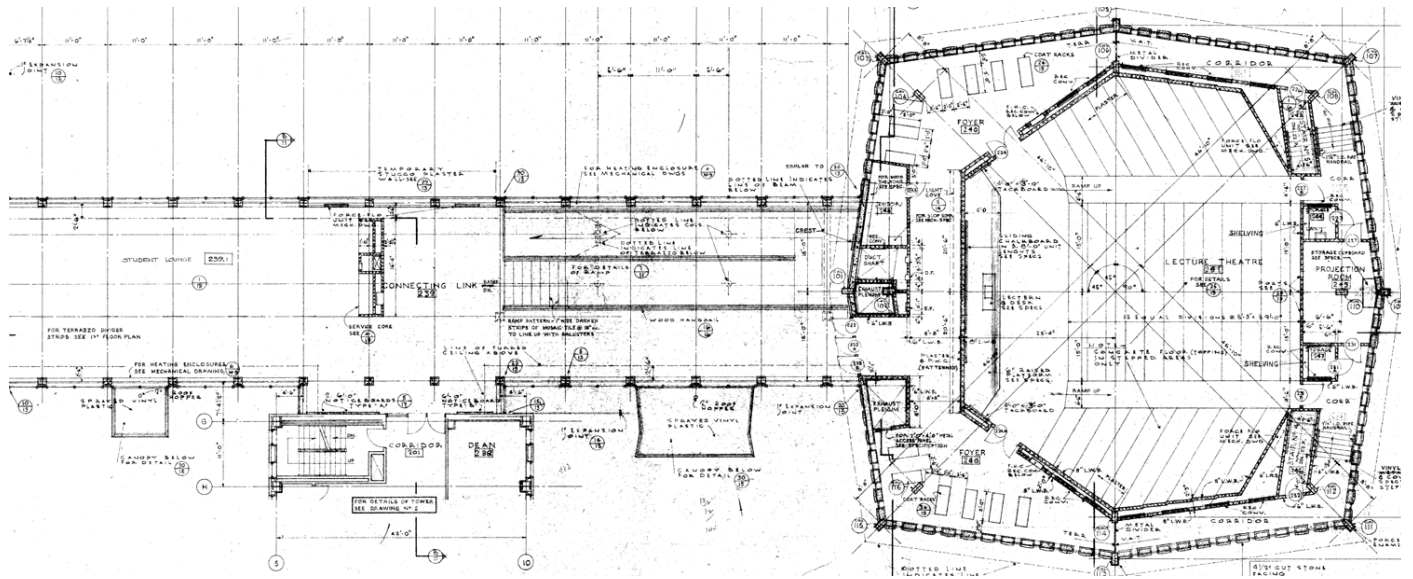
The theatre wing takes its form from the shape of the space it encloses (Figure 14). The octagonal theatre is wrapped by a larger octagonal volume, with the gap between them creating the required circulation and support spaces. The narrow windows that surround the theatre provide a muted light into the space surrounding the lecture hall. Shown in Figure 15, the quality and pattern of light provided by these windows is a character-defining element.

Figure 14. Plan of the Theatre Wing. Retrieved from Facilities Management Division Asset Record System, File A-339-AB.

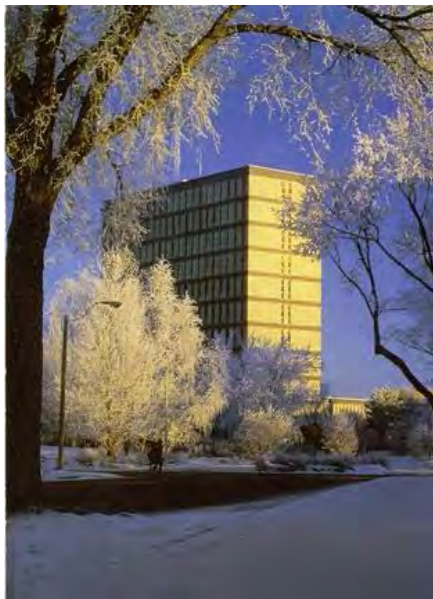
Figure 16. The 11 storey Arts Tower, 1985 photo. Photo A-10999 retrieved from <http://sain.scaa.sk.ca/>.

The Arts Tower in its final form is shown in Figure 16. Its architects referred to the tower as a, “most attractive narrow slab tower,” (Billinton, 1995). It was intended to symbolize the central place of the arts at a university. The tower is a building form embraced by the architects of the modern period. It was rational in its structure and arrangement,

composed of near identical units repeated horizontally and vertically as required. It exploited the technologies of industrial construction and the capabilities of new materials. Steel and concrete could stretch to new heights and the elevator made it all practical. The Arts Tower, with its simple rectilinear form, its absence of applied ornament, its repetition of windows and stone panels as a compositional device, is an iconic example of Modernist architecture at the university and a character-defining element of the building (Figure 17).

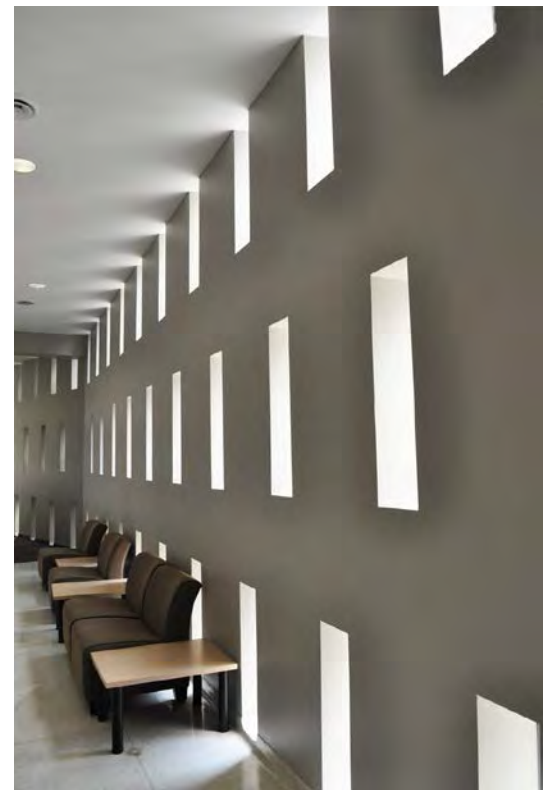
Figure 15. The quality of light provided by the narrow windows surrounding the theatre.

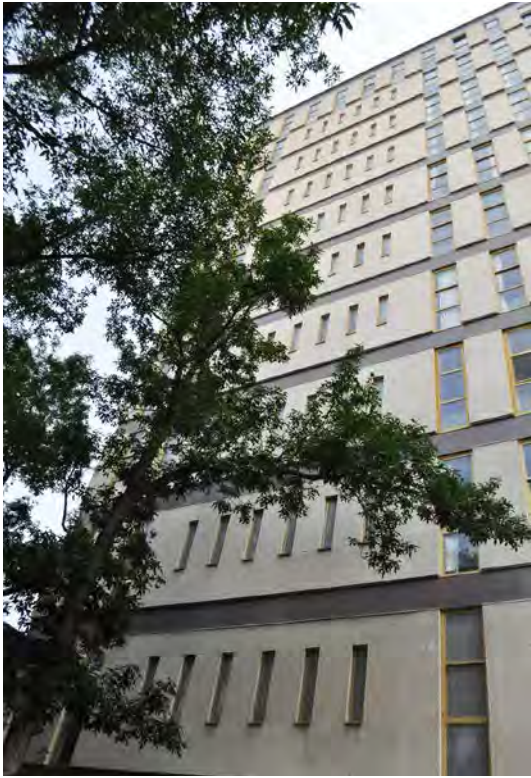
Figure 17. The west side of the Arts Tower.

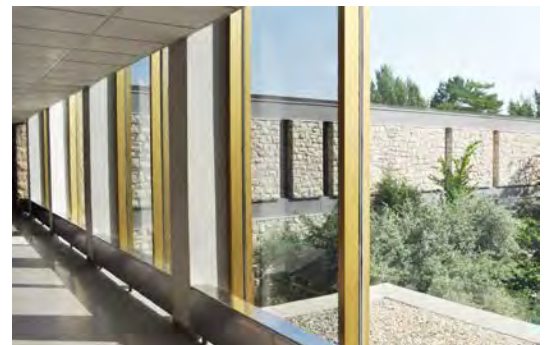
Figure 20. Glazed circulation space.

The connective and circulatory spaces of the Arts Complex are characterized by an extensive use of glazing, a corresponding quality of light and a strong connection to the outdoor spaces around the building (Figure 20). The main entrance lobby is located at the intersection of the four wings, and features a sculptural ramp connecting the ground floor to the second floor, and the entrance to the large lecture theatre (Figures 21 & 22). The Arts Ramp and its naturally lit lobby space are important character-defining elements.

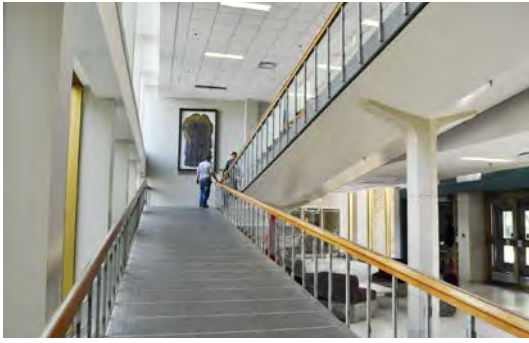
Figure 21. The 'Arts Ramp.'

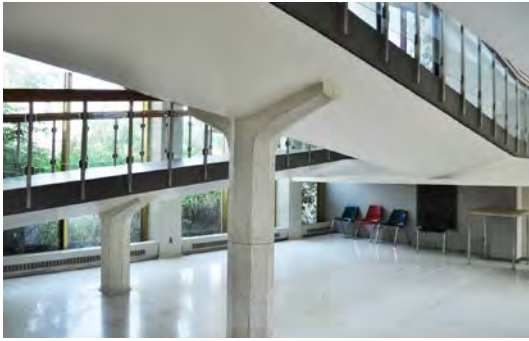
Figure 22. Expressive structure under the 'Arts Ramp.'

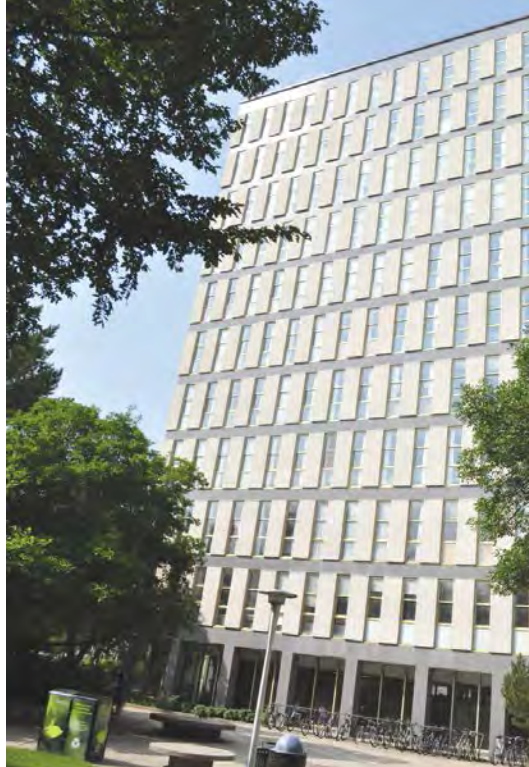
Figure 23. The Arts Tower. The colonnade at the base is clad in grey porcelain enamel. The same material expresses the location of the floor plates above.

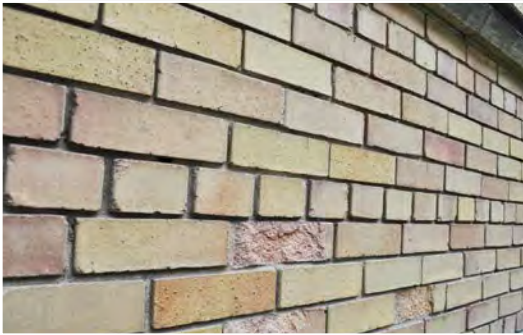
Figure 1. Yellow brick showing some spalling.

The exterior of the John Mitchell Building is faced in yellow brick, with Indiana limestone trim and a base of grey granite. Yellow brick was used at the time to denote agricultural buildings, such as the Virus Laboratory (now demolished) and Kirk Hall. The condition of the exterior of the John Mitchell Building is generally good; however, some of the brick is beginning to spall (Figure 1). The use of limestone for cut stone decoration and granite as a base was common at the university in this period. The limestone has some surface staining evident on the string courses (Figure 2). (For further information on building stones used at the U of S, refer to 'Appendix: Stone'.)

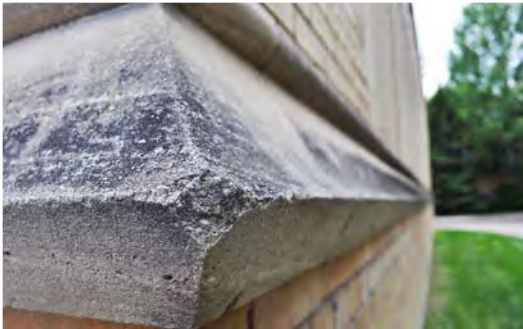
Figure 2. Limestone string course.

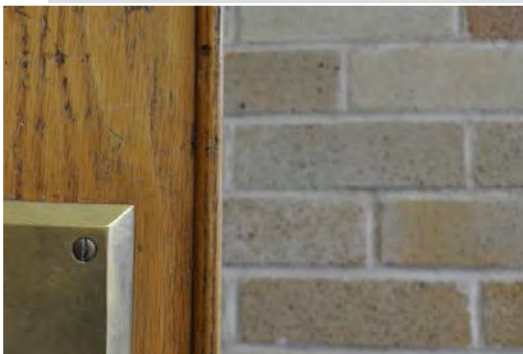
Figure 3. L to R: brass door hardware, oak, yellow brick.

Exterior doors and frames are oak (Figure 3). The primary entrance doors have been replaced, but their frames are original. Windows are single-glazed with painted rolled steel frames. Two sets of windows are provided for each opening; an interior set composed of two large panes and an exterior set with multiple divisions. Window hardware is painted steel and brass (Figure 5). Two spaces, formerly a dairy and a soils lab, but now used as drama studios, feature large windows composed of 8" glass block (Figure 6). Yellow brick, Indiana Limestone, granite and oak are character-defining materials (Figure 4). The painted steel-framed windows and glass block windows are also character-defining and are both in excellent commemorative condition.

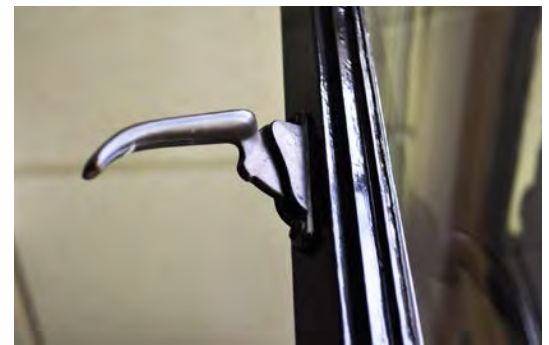
Figure 5. L to R: brass window clasp, painted steel sash window.

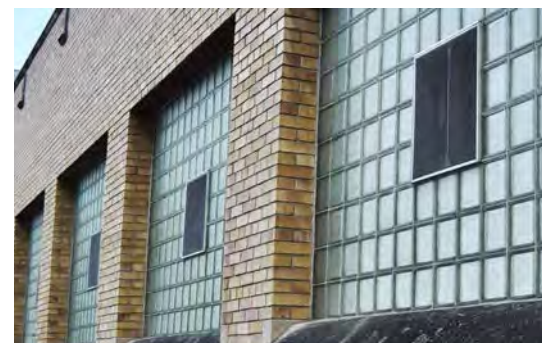
Figure 6. Glass block windows.

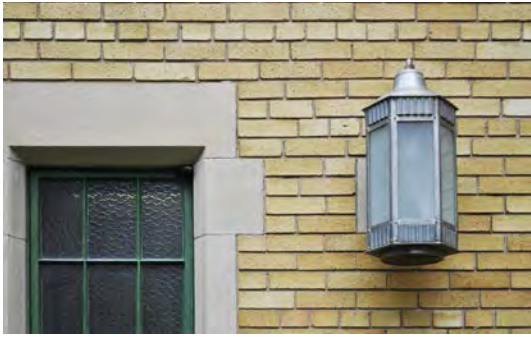
Figure 7. Exterior window materials: steel sash window, limestone surround and yellow brick wall.

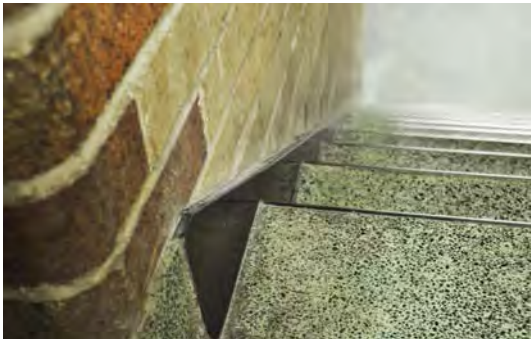
Figure 8. L to R: Interior brick, terrazzo stair treads.

On the interior, corridor walls feature brick as a wainscoting, with painted plaster walls and ceilings above. The interior brick is predominantly yellow, but as shown in Figure 8, corners are accentuated with red brick. Other interior materials include terrazzo flooring and window sills. The interior brick and terrazzo are in excellent commemorative condition, with the exception of a few instances where the terrazzo flooring has been replaced with vinyl composite tile (VCT). The studios now feature sprung flooring raised above the level of the corridor flooring. The original terrazzo flooring likely still exists underneath. The washrooms retain their character-defining wainscoting of blue and white glazed tile as do the surrounds for the drinking fountains in the hallways. This tile, shown in Figure 9, is in excellent commemorative condition. The walls of the north and south studios have glazed tile wainscoting that has been painted.

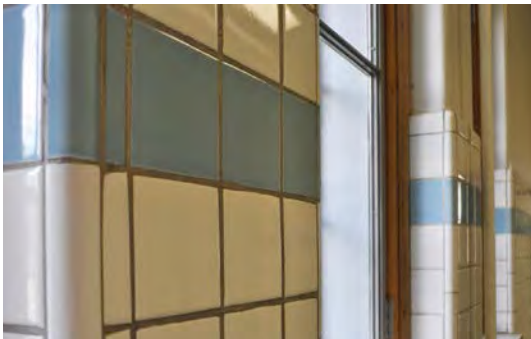
Figure 9. Glazed ceramic tile.

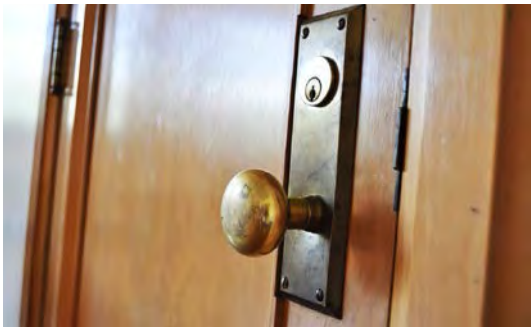
Figure 10. Maple door with brass hardware.

On the interior, doors and frames are in maple, and windows also have maple trim (Figure 10). Many rooms also feature a maple dado rail (Figure 11). The doors exist in varying states of commemorative integrity. Most appear to be original. Most of the original door hardware has been maintained; these brass knobs and hinges are character-defining elements.

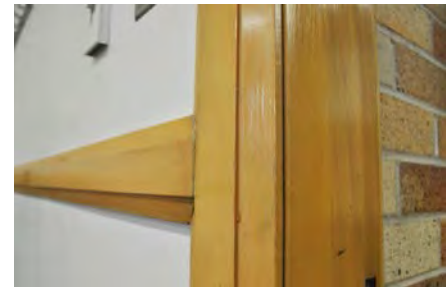
Figure 11. Maple door frame and dado rail.

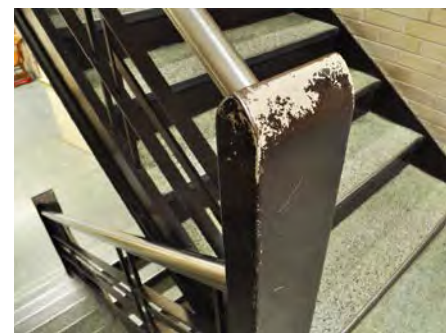
Figure 12. Staircase materials: steel stringers, risers and balustrade with terrazzo treads and landing.

The staircases (Figure 12) consist of metal risers, stringers and balustrade accompanied by an ‘alumilite’ handrail, with terrazzo treads and landings. These materials exist in good commemorative condition and are character-defining elements.

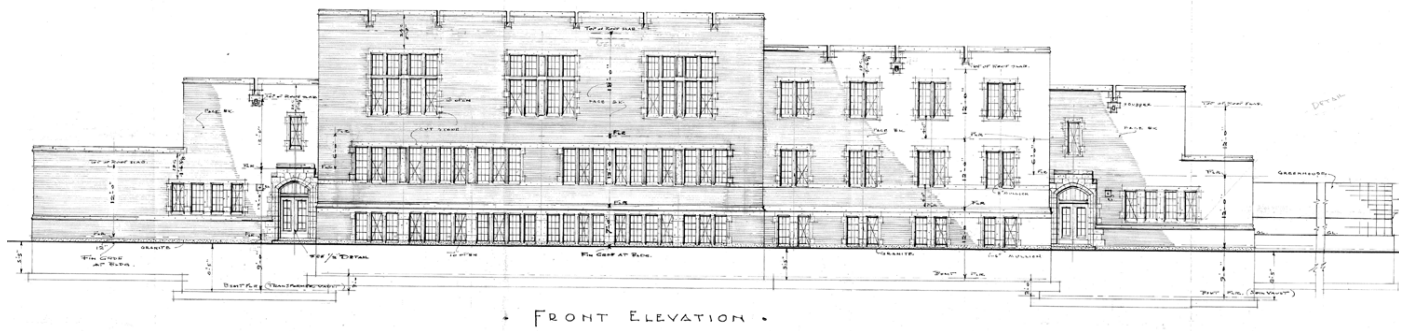
Figure 13. Front elevation of the John Mitchell Building depicting asymmetry and uneven roof plane. Retrieved from Facilities Management Division Asset Record System, File J-5-T .

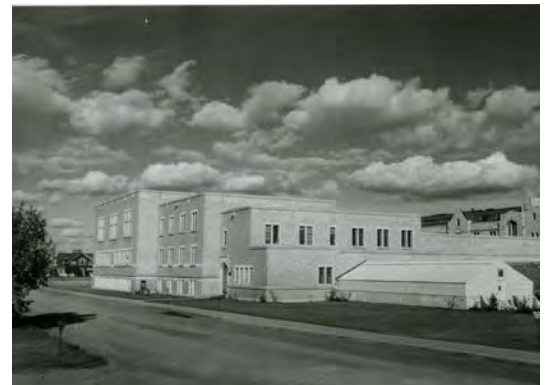
Figure 14. The form of the John Mitchell Building with the original greenhouses appended to the south side. Photo A-468 retrieved from University of Saskatchewan Archives.

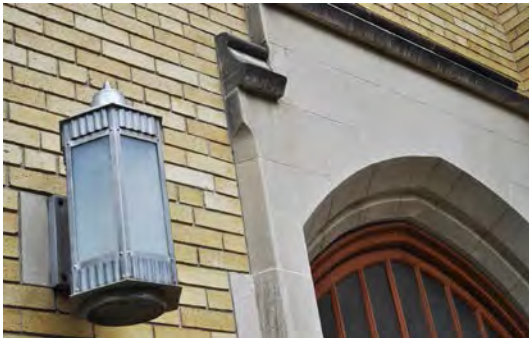
Figure 15. L to R: ornamented lantern, transom in the form of a gothic arch.

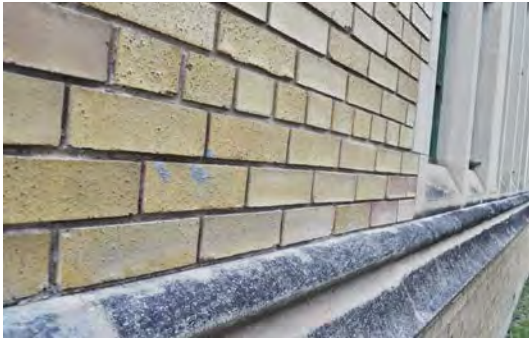
Figure 16. Limestone string courses and window surrounds.

The familiar characteristics of the Collegiate Gothic style are all present in this building, but are fewer in number and are simplified in detail compared with earlier examples of this style. Windows are rectangular rather than arched, but still feature cut stone trim on the front elevation. The exterior windows are composed of multiple panels, in keeping with earlier precedent, although notably the interior windows have larger panes. The principle entrances feature gothic arched openings, and lanterns, both illustrated in Figure 15. The roofs are flat, but their parapets still feature a crenelated profile. Cut stone string courses and scuppers add some detail to otherwise unadorned walls (Figure 16). There is cut limestone trim and quoining around each window.

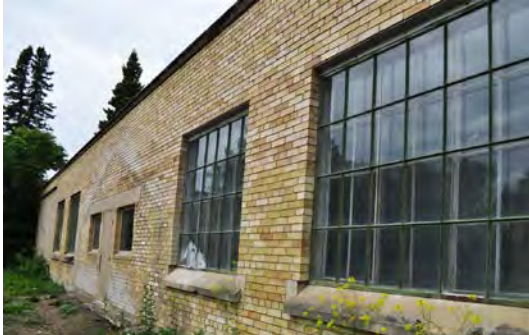
Figure 17. Factory-style windows on the south side of the building.

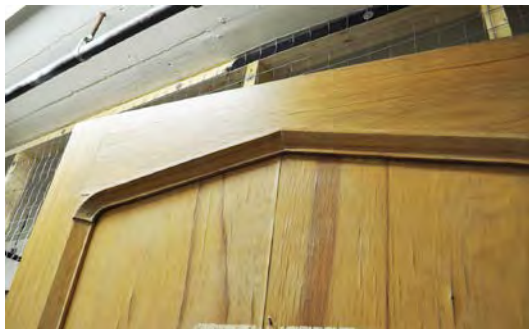
Figure 18. Gothic arch motif on door.

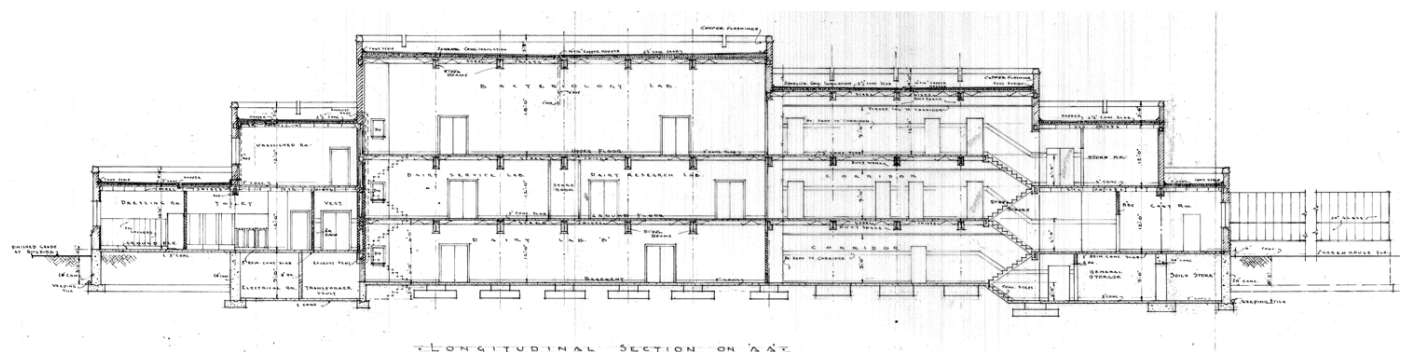
Figure 22. Longitudinal section through the John Mitchell Building showing split level configuration. The largest space is the Hangar Studio or former Bacteriology Lab. Retrieved from Facilities Management Division Asset Record System, File J-3-T.

On the first floor, a double height space at the front of the building contained a bacteriology lab. It is now known as the 'Hangar Studio' and is used for instruction in drama and dance. (The name 'Hangar Studio' likely derives from the former home of the Drama Department, the Hangar Building, which was demolished in 1994). This room has retained its high ceiling and tall windows, which are character-defining elements. Figure 22 illustrates the space in section. Figure 26 is a recent photograph.

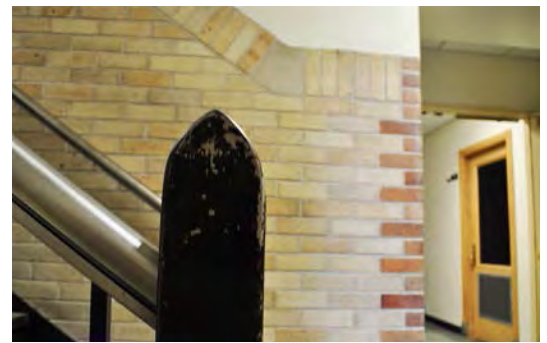
Figure 19. Gothic arch motif on newell post.

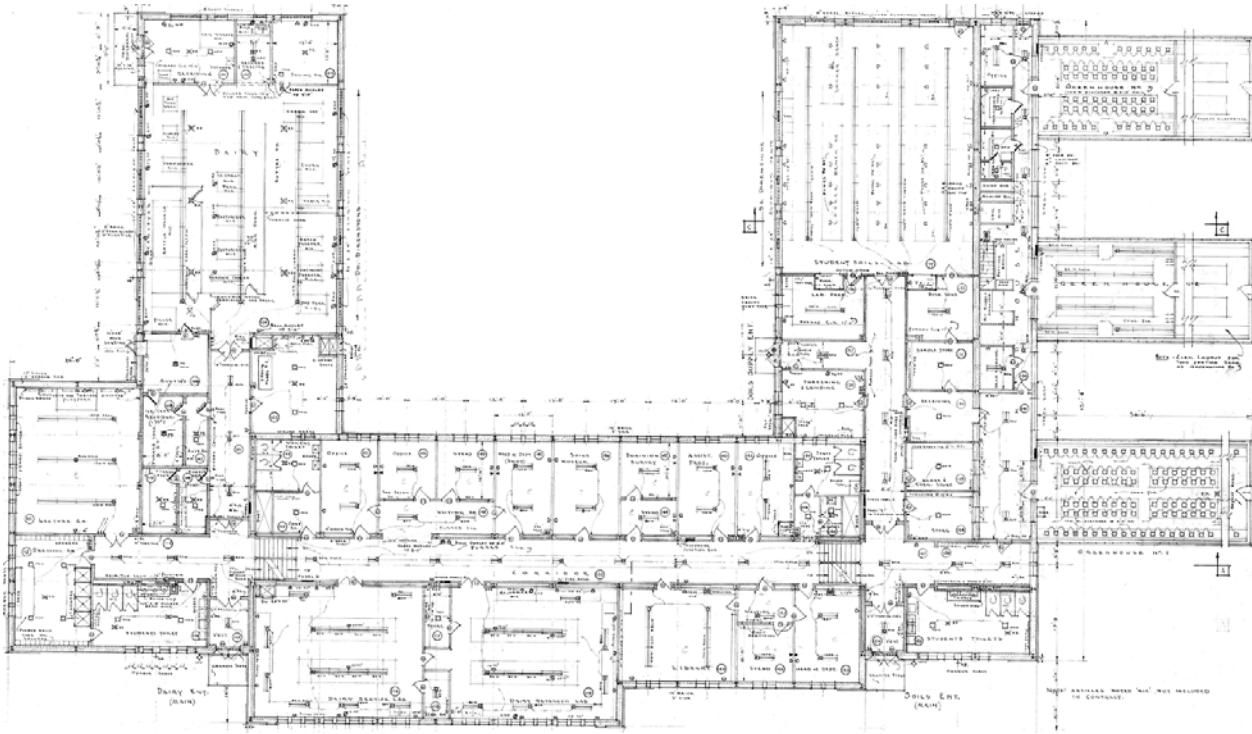
Figure 23. The first floor plan of the John Mitchell Building showing original configuration and uses. Retrieved from Facilities Management Division Asset Record System, File J-7-T.

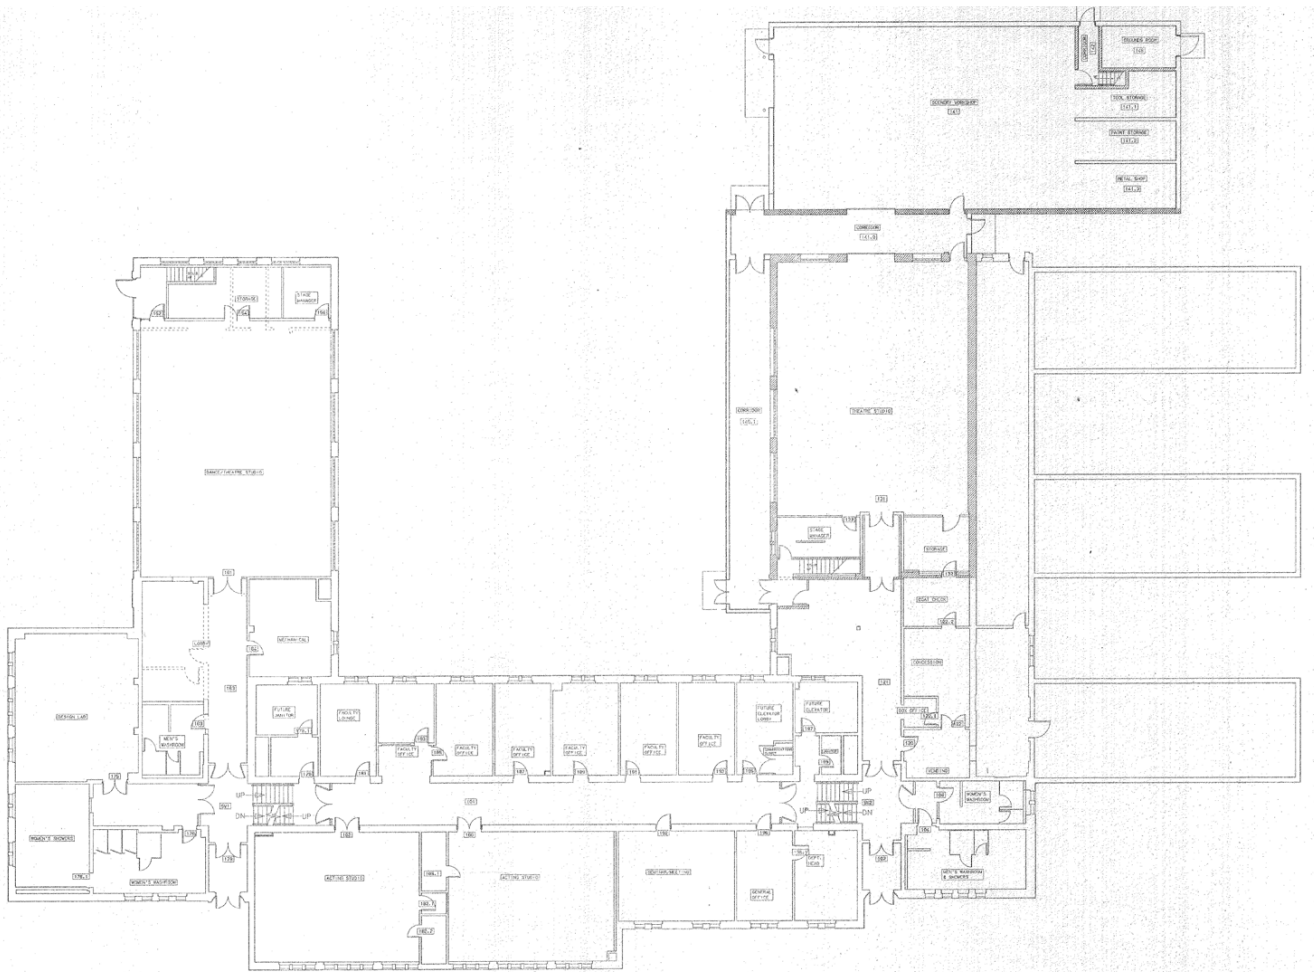
Figure 24. The first floor plan of the John Mitchell Building with the 1992 addition. Retrieved from Facilities Management Division Asset Record System, File 064-278-C.

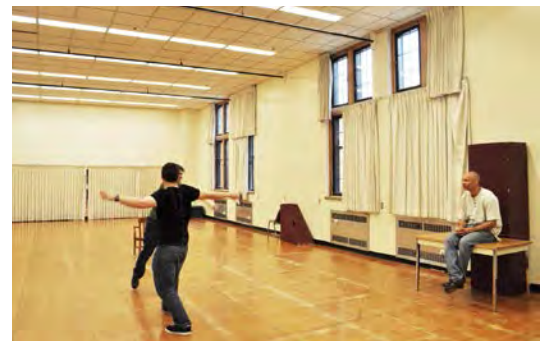
Figure 26. The Hangar Studio's double height ceiling and windows.

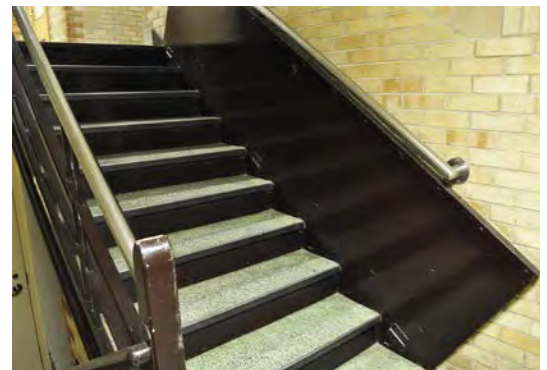
Figure 27. Stair with retractable ramp.

The stairs leading from the basement level to the ground floor at either end of the central wing feature metal ramps that can be lowered into place over the stair treads. They were originally used to help with the moving of soils and dairy materials between floors. The ramps are still functional and exist in good commemorative condition. Figure 27 shows the ramps in the upright position.

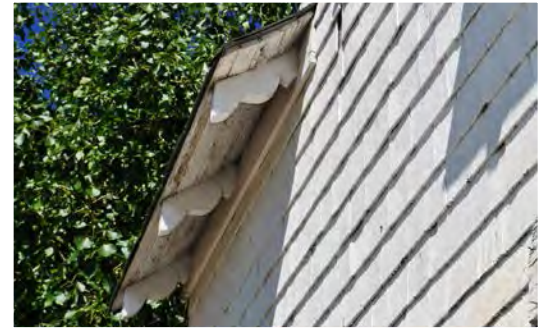
Figure 3. Exposed, profiled wooden rafter ends.

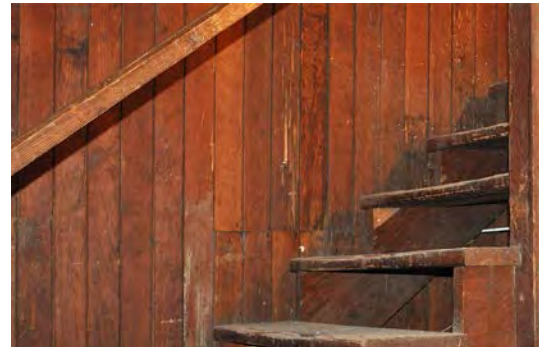
Figure 4. Douglas fir interior walls and stairs.

The interior of the building is also characterized by wooden materials: Douglas fir walls, floors, stairwells, columns, beams and partitions. Figure 4 shows the Douglas fir stair treads and wall paneling. The fir is generally unpainted and in good condition. Some of the interior wooden walls and columns have been painted. Some of the wood, especially in the hayloft, shows signs of minor water damage (Figure 5). Unpainted fir is a character-defining element.

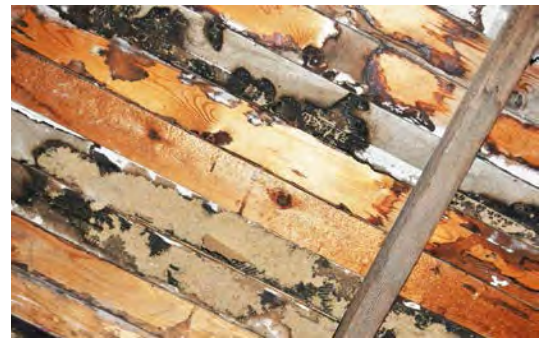
Figure 5. Fir roof decking showing signs of water ingress.

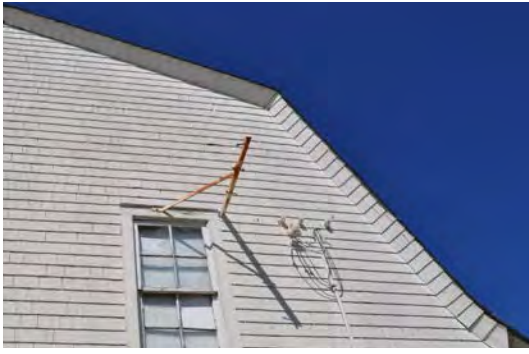
Figure 7. The distinctive slope of the Gambrel style roof.

The Seed Barn is typical of North American dairy and livestock barns of the early twentieth century. Gambrel roofs, roof ventilators and dormers, and multiple windows are the distinctive features of this style of barn, which became popular in the United States and Canada around 1850. Gambrel roofs have a shallow slope near the peak of the roof and a steeper pitch near the eaves (Figure 7). This roof shape was developed to create more space in the loft. The gambrel roof form is seen also on the nearby [Stone Barn](#). The Seed Barn also features roof ventilators, visible in Figure 8, and dormer windows (Figure 9). A large set of loft doors permit the direct loading of hay into the loft from the exterior (Figure 9). Originally, these loft doors could be accessed from an earth ramp on the exterior, as illustrated in Figure 8. The gambrel style roof, roof ventilators, dormer windows and loft doors are character-defining elements of the Seed Barn.

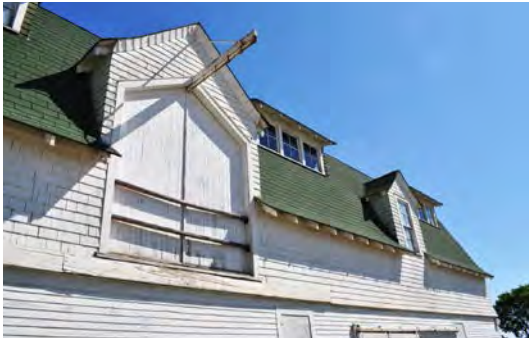
Figure 9. Dormer windows and Gambrel roof.

these doors were accessed from an earth ramp. Later, when the concrete ground floor walls were replaced, the ramp was removed, and a hoist system was added. The hoist arm is still in existence, and visible in Figure 9. Inside the loft, a rail and pulley system was installed to facilitate to movement of hay bales (Figure 16).

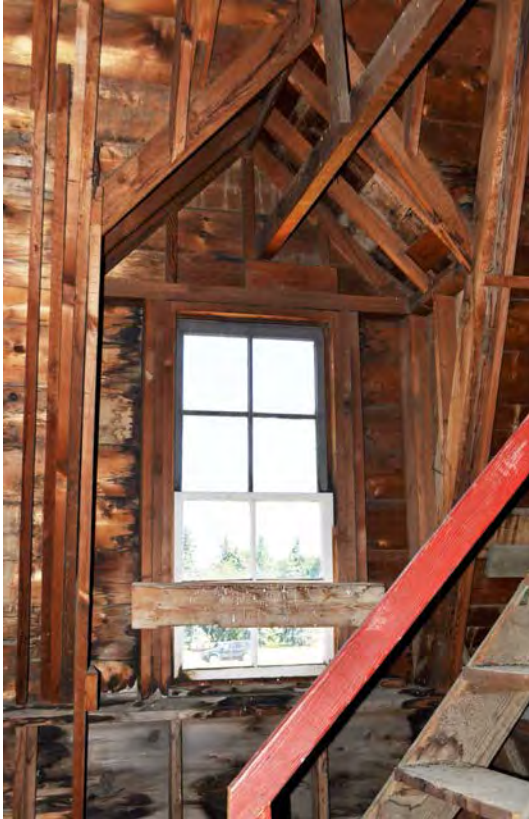
Figure 10. Interior view of peaked dormer.

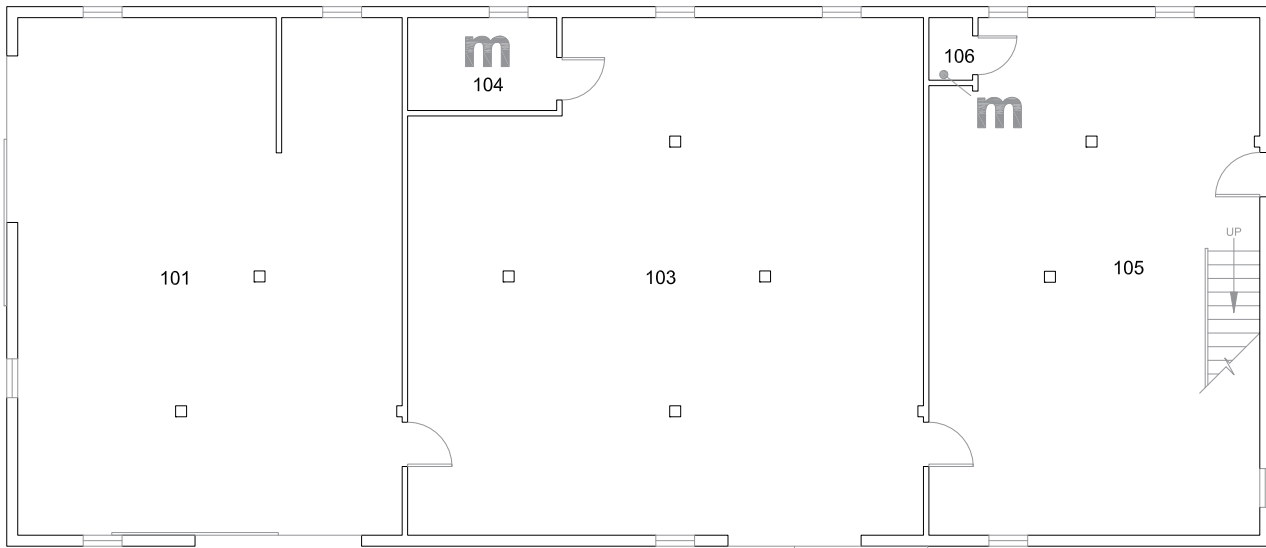
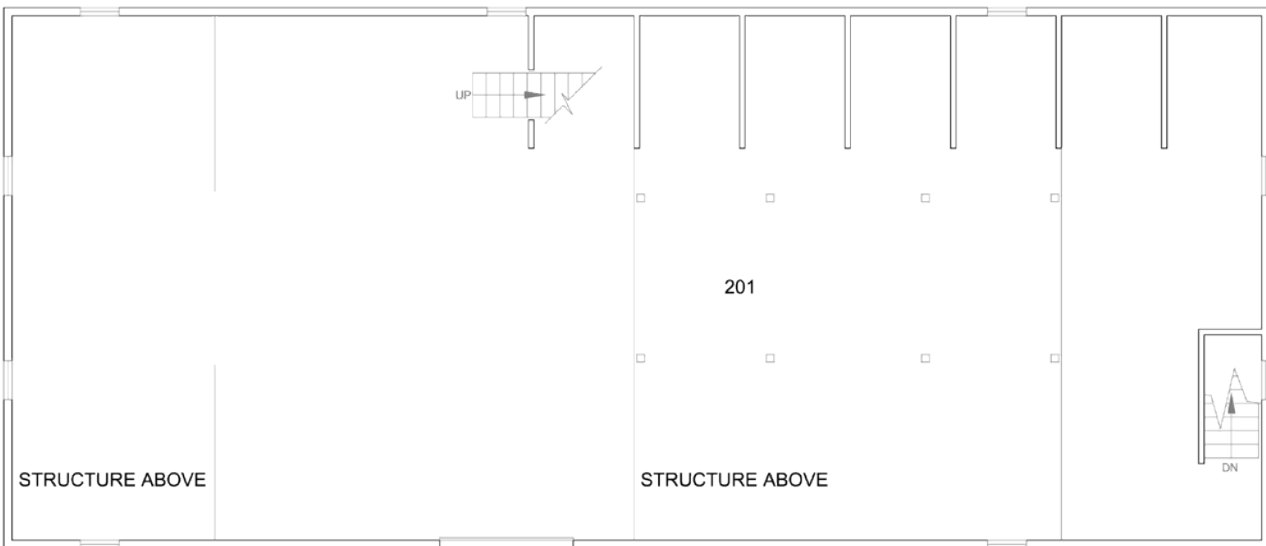
Figure 13. The 2012 configuration of the first and second floors of the Crop Science Seed Barn. FMD asset record system.

The Seed Barn is configured as a standard livestock barn, with the animal stalls located on the ground floor and a hayloft on the second floor. The original floor plans either never existed or have been lost. The ground level appears to have been completely replaced at some point, so the current configuration of partitions is likely not original. The early photograph in Figure 8 shows a regular arrangement of windows on the ground floor, which likely matched the arrangement of stalls inside. Figure 13 shows the layout as of 2012, before the building was moved to its current location. The second floor hayloft is original and has good commemorative integrity. This high, open space with its dormer windows and exposed rafters is a character-defining element (Figure 14).

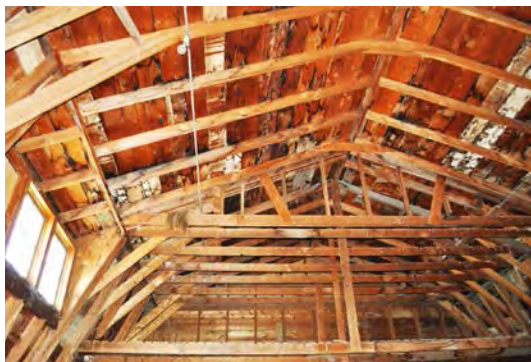
Figure 14. Exposed roof trusses.

The Seed Barn is a wood framed building with a cast-in-place concrete foundation. The roof system consists of a framework of arched wooden trusses, which are supported by the exterior walls. The walls are built of 2" x 6" Douglas fir studs at 24" centres, with wood sheathing on both the interior and exterior surfaces. The loft floor structure consists of 2" x 10" wood joists on 24" centres with a subfloor of 1" x 6" wooden planks. The floor is supported by the exterior walls, and on the interior of the building by a heavy timber structure of Douglas fir posts and beams. The exterior walls sit on a concrete foundation wall raised about 12" above the finished surface of the floor. The construction of the foundations is unknown. The ground floor is a poured concrete slab on grade. The exposed wooden roof trusses and timber posts and beams are character-defining elements.

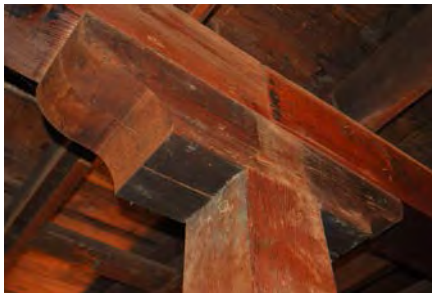
Figure 15. Dovetailed column detail.

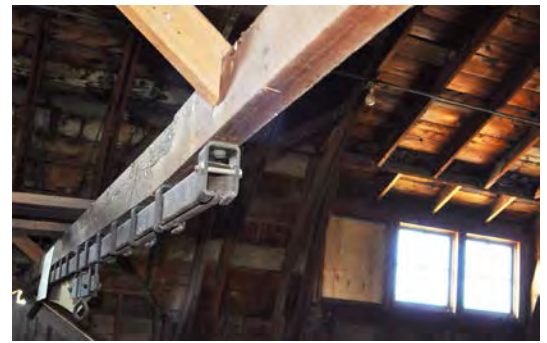
Figure 16. Steel rail & pulley system attached to wood beam.

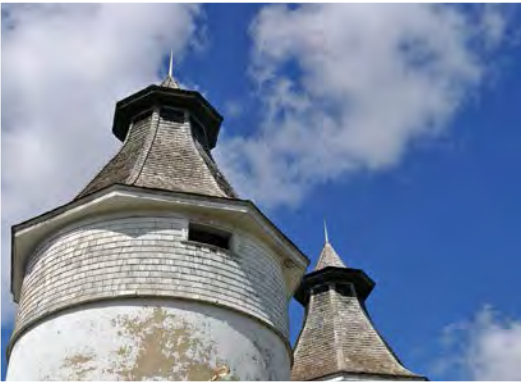
Figure 1. Concrete silos with cedar shingle roofs.

The silos are made out of cast-in-place concrete, with wooden roofs (Figure 9). Many of the original metal fixtures such as latches, hinges and pulley systems still exist in a good state of commemorative integrity. They are all either rusted or painted but remain functional.

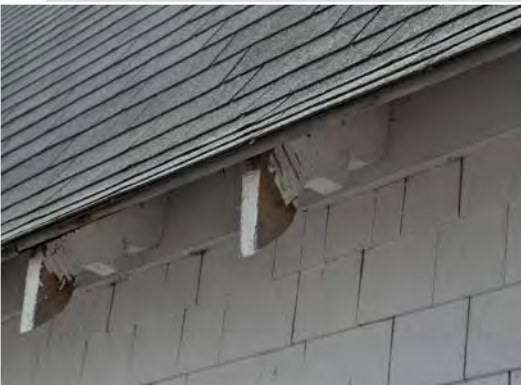
Figure 2. Top to bottom: Asphalt roof shingles have replaced the original cedar shingles, carved exposed wooden truss ends. The cedar shakes on the upper portion of the main barn have been painted white.

Despite its name, the Stone Barn is predominantly a wooden building; both its structure and cladding are built of wooden materials. Only the ground floor walls are built of stone. The upper portion of the exterior walls is clad in cedar shingles. The roof was initially also finished in cedar shingles, but these have since been replaced by asphalt shingles. The roofs of the silos are still shingled in cedar (Figure 1). The roofs of the barn, cupolas and silos all feature ornamental exposed wooden rafter ends, which are well preserved and are shown in Figure 2.

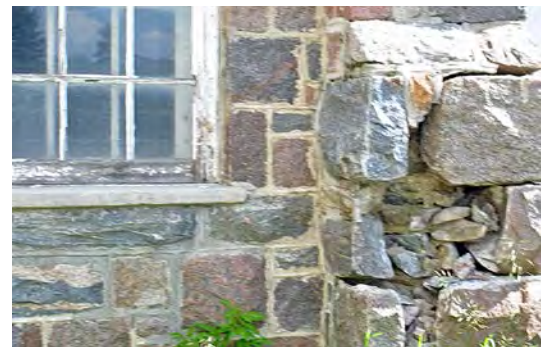
Figure 4. Ground floor walls are constructed of red and grey, rough-faced granite. Windows are framed in wood.

Windows are framed in wood and are single-glazed (Figure 4). In some places there are storm windows. Some exterior window sills feature concrete that has been replaced. A majority of the windows have retained their original glass; however, most are heavily weathered and are in poor physical condition. In a few instances the windows have been replaced or have been boarded up.

The ground floor walls and piers are constructed of rough granite of varying shades of grey and red (Figure 4).^{*} A stone paddock wall in the same rough granite was added at some time after the construction of the barn. The condition of the paddock walls is poor in many places. Parts of the stone wall have crumbled and have been replaced by a more temporary fence. The stone piers on the barn are failing in several instances and were the immediate cause of the building's recent closure. The stone walls of the barn have fared somewhat better but require re-pointing. The stone retaining wall that supports the remaining ramp is in good condition and maintains its commemorative integrity. Concrete has been used to refinish the top of this ramp.

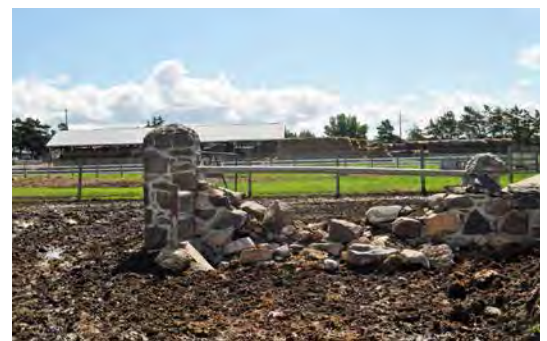
Figure 5. A portion of the stone fence which has fallen down.

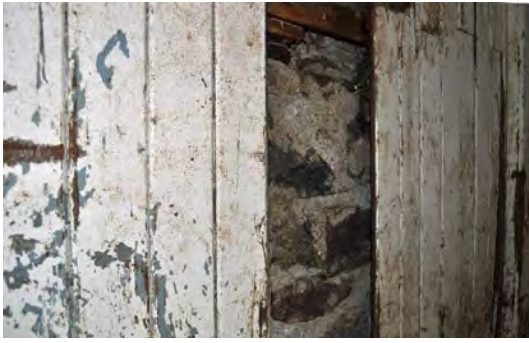
Figure 6. Interior walls clad in wooden planks.

On the interior of the building, the stone walls are clad with vertical wooden planking, painted white. Figure 6 shows this wooden sheathing covering the stone walls. Early elevations by Brown and Vallance Architects show that the building was originally conceived of as a wooden structure (Figure 7). The roof of the building is supported by a series of intricate trusses, made of Douglas fir. The trusses and decking are exposed and unpainted, and have been maintained to an excellent degree of commemorative integrity (Figure 8). These Douglas fir trusses and decking are important character-defining elements.

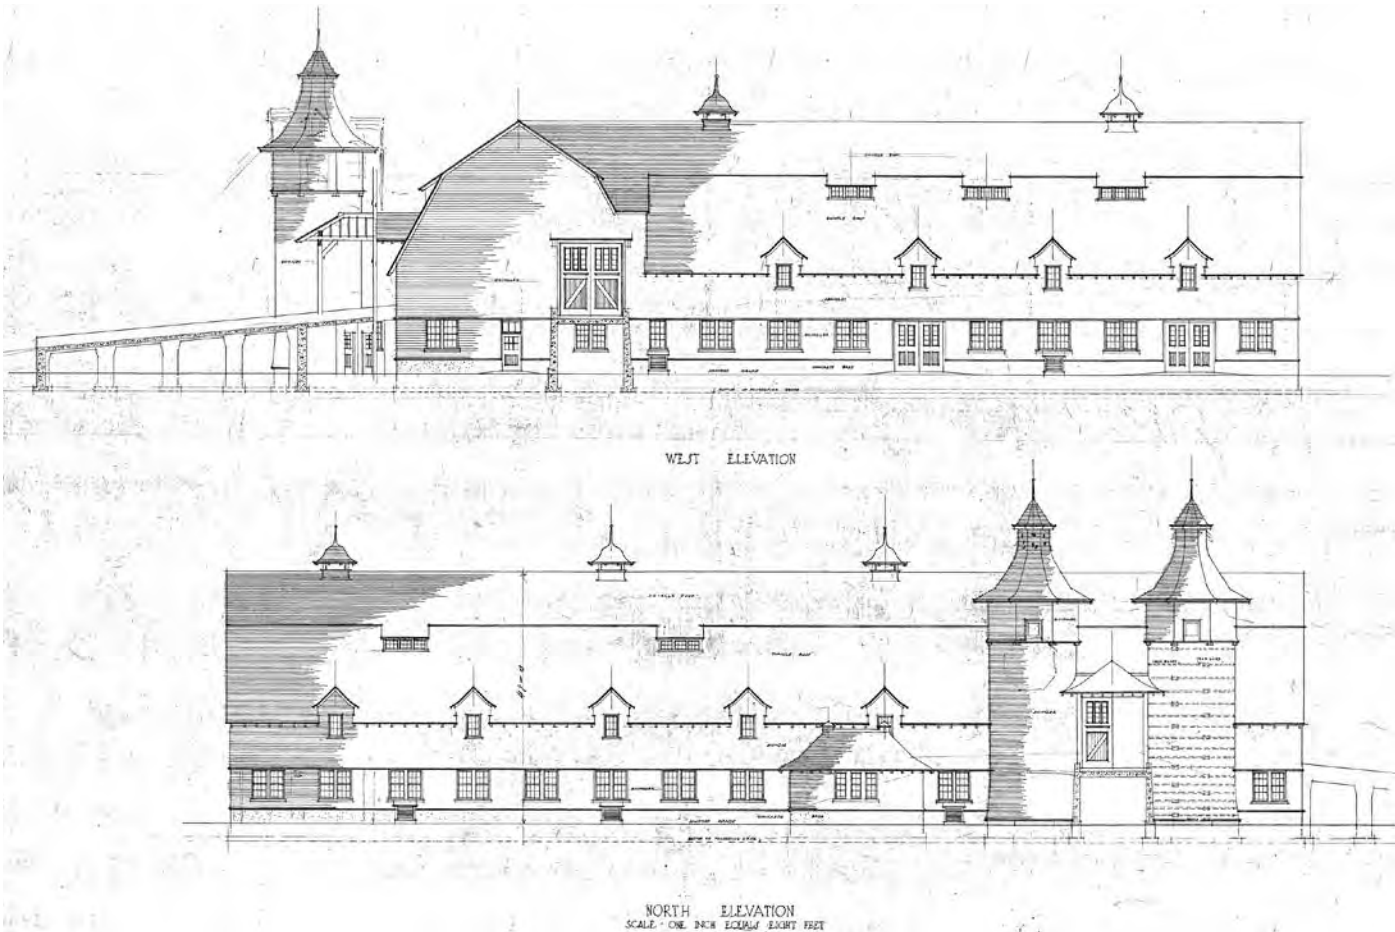
Figure 7. Elevations by Brown and Vallance Architects. In these drawings the lower walls of the barn are indicated to be wood rather than stone. The barn was not built exactly as shown. Retrieved from Facilities Management Division Asset Record system, File B-1-T.

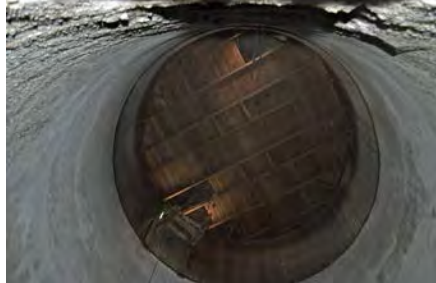
Figure 9. The interior of a silo constructed of concrete and Douglas fir
