University of Saskatchewan

Heritage Register

September 2013

Facilities Management
Division

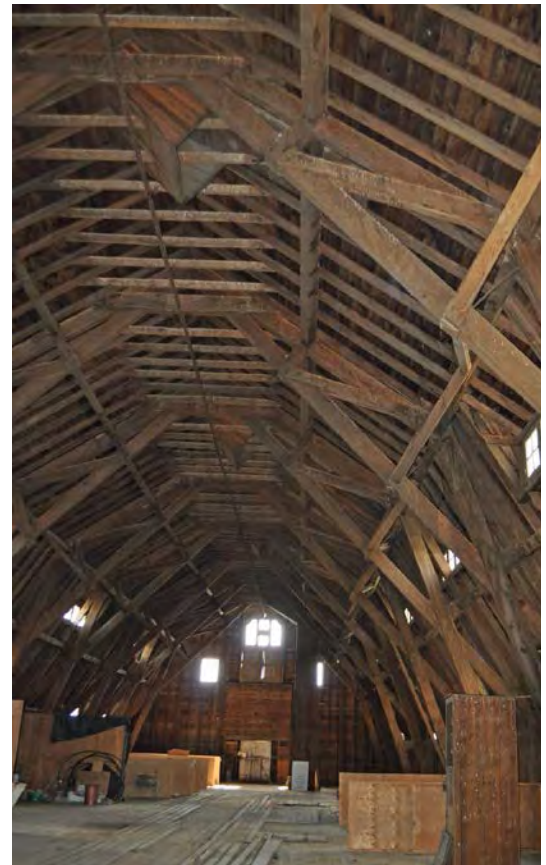
Figure 8. The loft features unfinished Douglas fir. The lower right corner shows a ventilation shaft that has been disconnected from a cupola. The opening for the cupola can be seen at the top left of the photograph.

On the interior of the building, the stone walls are clad with vertical wooden planking, painted white. Figure 6 shows this wooden sheathing covering the stone walls. Early elevations by Brown and Vallance Architects show that the building was originally conceived of as a wooden structure (Figure 7). The roof of the building is supported by a series of intricate trusses, made of Douglas fir. The trusses and decking are exposed and unpainted, and have been maintained to an excellent degree of commemorative integrity (Figure 8). These Douglas fir trusses and decking are important character-defining elements.

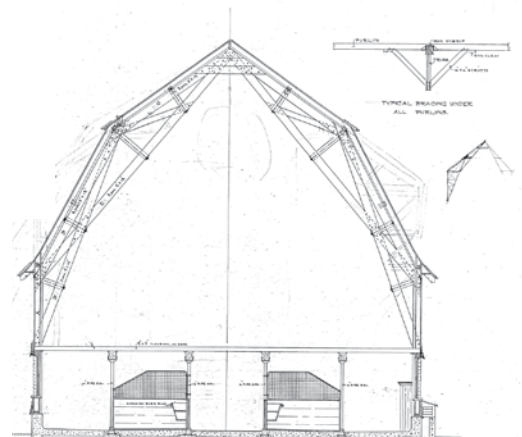
Figure 10. The Stone Barn’s Gambrel style roof. Retrieved from Facilities Management Division Asset Record System, File B-1-T.

The Stone Barn is different in style, form and material from other University of Saskatchewan buildings of its time. Rather than the limestone walls and characteristic forms of the Collegiate Gothic, the barn features a Gambrel style roof, and is built of wood and granite. In style, the Stone Barn is typical of North American dairy and livestock barns of the early twentieth century, although it is larger than most, and built to a very high standard of construction. Gambrel roofs, roof ventilators and dormers, and multiple windows are the distinctive features of this style of barn, which became popular in the United States and Canada around 1850. The Gambrel roof has a shallow slope near the peak of the roof and a steeper pitch near the eaves (Figure 10). This shape provides the Gambrel roof with more space in the loft. The roof is meant to overhang the walls.

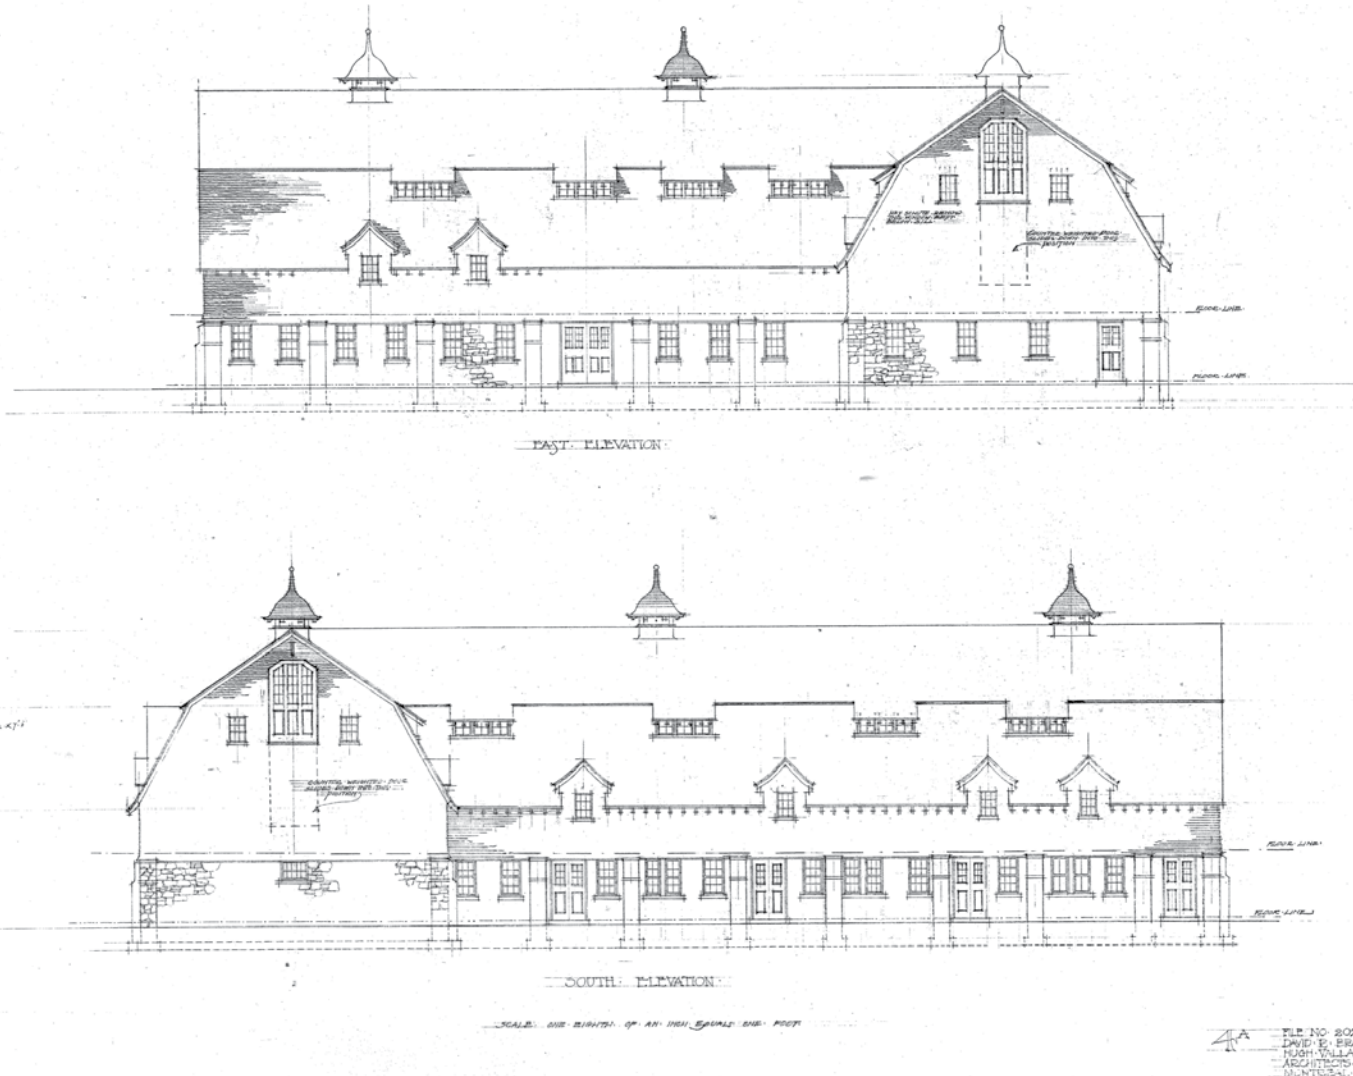
Figure 11. South and East elevations of the Stone Barn, by Brown and Vallance Architects. Here the lower walls are rendered as they were built, in stone. Note that the barn was not built exactly as shown. Retrieved from Facilities Management Division Asset Record System, File B-7-T.

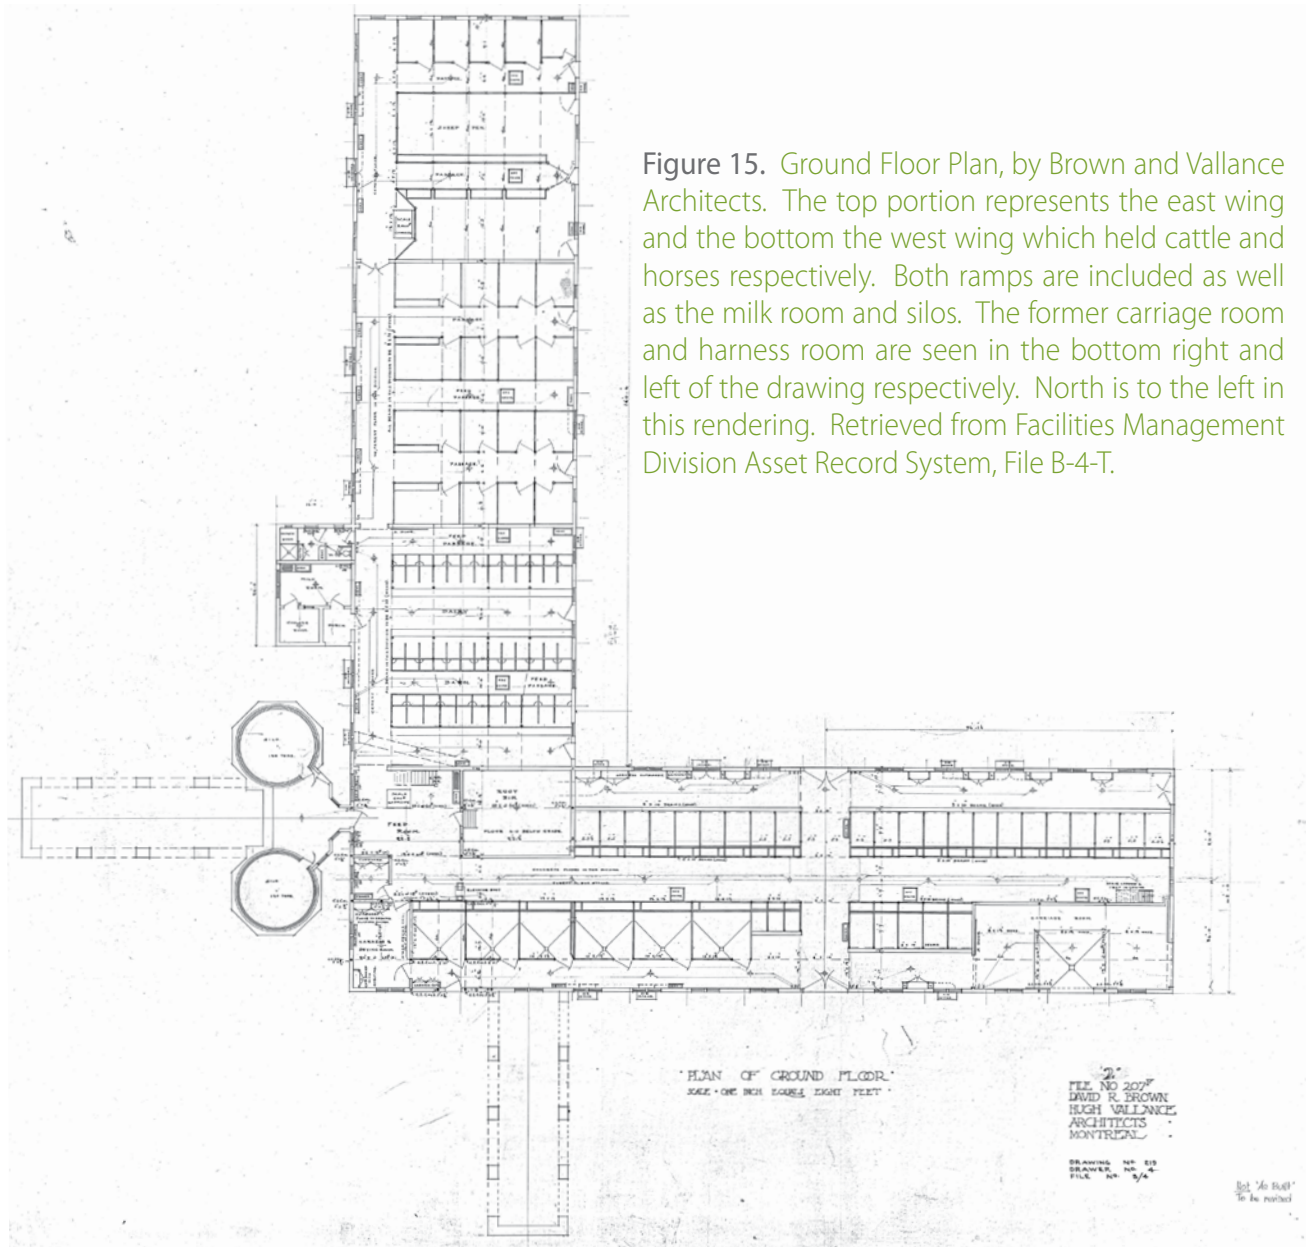
Figure 15. Ground Floor Plan, by Brown and Vallance Architects. The top portion represents the east wing and the bottom the west wing which held cattle and horses respectively. Both ramps are included as well as the milk room and silos. The former carriage room and harness room are seen in the bottom right and left of the drawing respectively. North is to the left in this rendering. Retrieved from Facilities Management Division Asset Record System, File B-4-T.

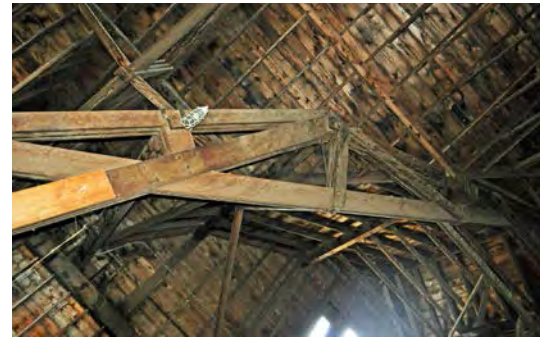
Figure 18. The structure of the barn roof.

The roof of the building is composed of Douglas Fir decking, supported by a series of intricate Gambrel style bolted girder trusses, also made of Douglas Fir, shown in Figures 18 and 19. The trusses span the full width of the building, and are supported by the exterior load-bearing stone walls and pilasters. The exterior walls of the Stone Barn are constructed of granite. Stone pilasters, which thicken as they reach the ground, pick up the roof trusses (Figure 20). Figure 21 illustrates the deterioration of the stone walls.

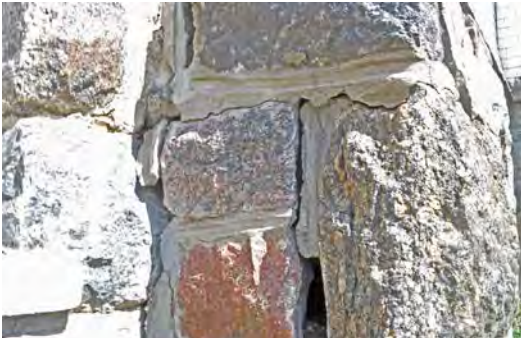
Figure 21. Deterioration of the walls of the Stone Barn.

In 2010, a structural analysis of the Stone barn was carried out, which determined that degradation of the stone piers had reached a critical state. As a result, the Stone Barn was closed in September 2010. The failing structure of the Stone Barn is obviously a threat to its heritage value.

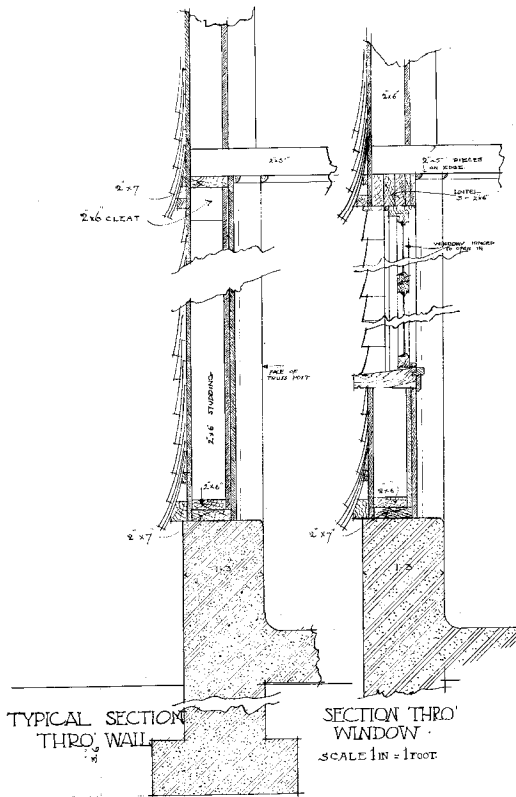
Figure 22. Early wall sections by Brown and Vallance architects showing a wall structure of 2x6 studs rather than load bearing stone.

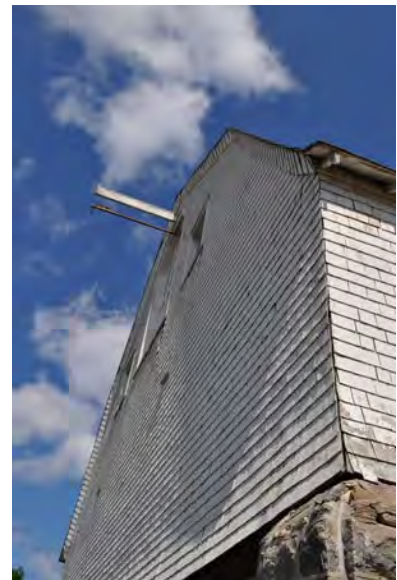
Figure 24. The loft trolley system extends from the barn.

The Stone Barn also features a noteworthy system for circulating feed. A steel rail runs along the roof line of the loft and extends outside either end. Figure 24 pictures the rail system extending out from the wall above the loft door. Figure 25 shows the curving rail drawn to serve the whole loft space. At the end of each wing of the building, a loft door still exists. With hooks and pulleys, bales and feed could be hoisted from the ground outside into the hay loft, and from there could be transported around the building and lowered to the ground floor through trap doors in the loft floor. Most of the trap doors have been fastened shut or covered over with wood. Figure 26 illustrates a trap door that has not been decommissioned. The rail system remains in an excellent state of commemorative integrity.

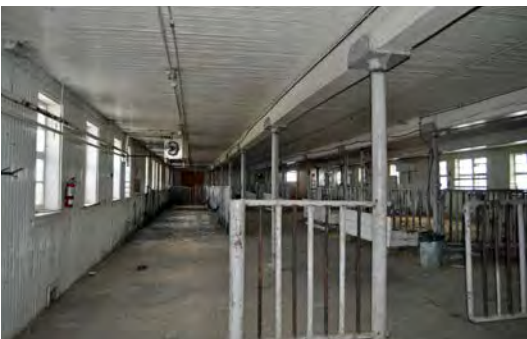
Figure 23. Steel posts support wooden beams.

of 2" x 5" fir planks laid on edge. This floor is supported by the exterior walls, as well as by two 10" x 16" fir beams running the length of the building, which are in turn supported by steel posts (Figure 23.) In the west wing, two wooden posts can also be found.

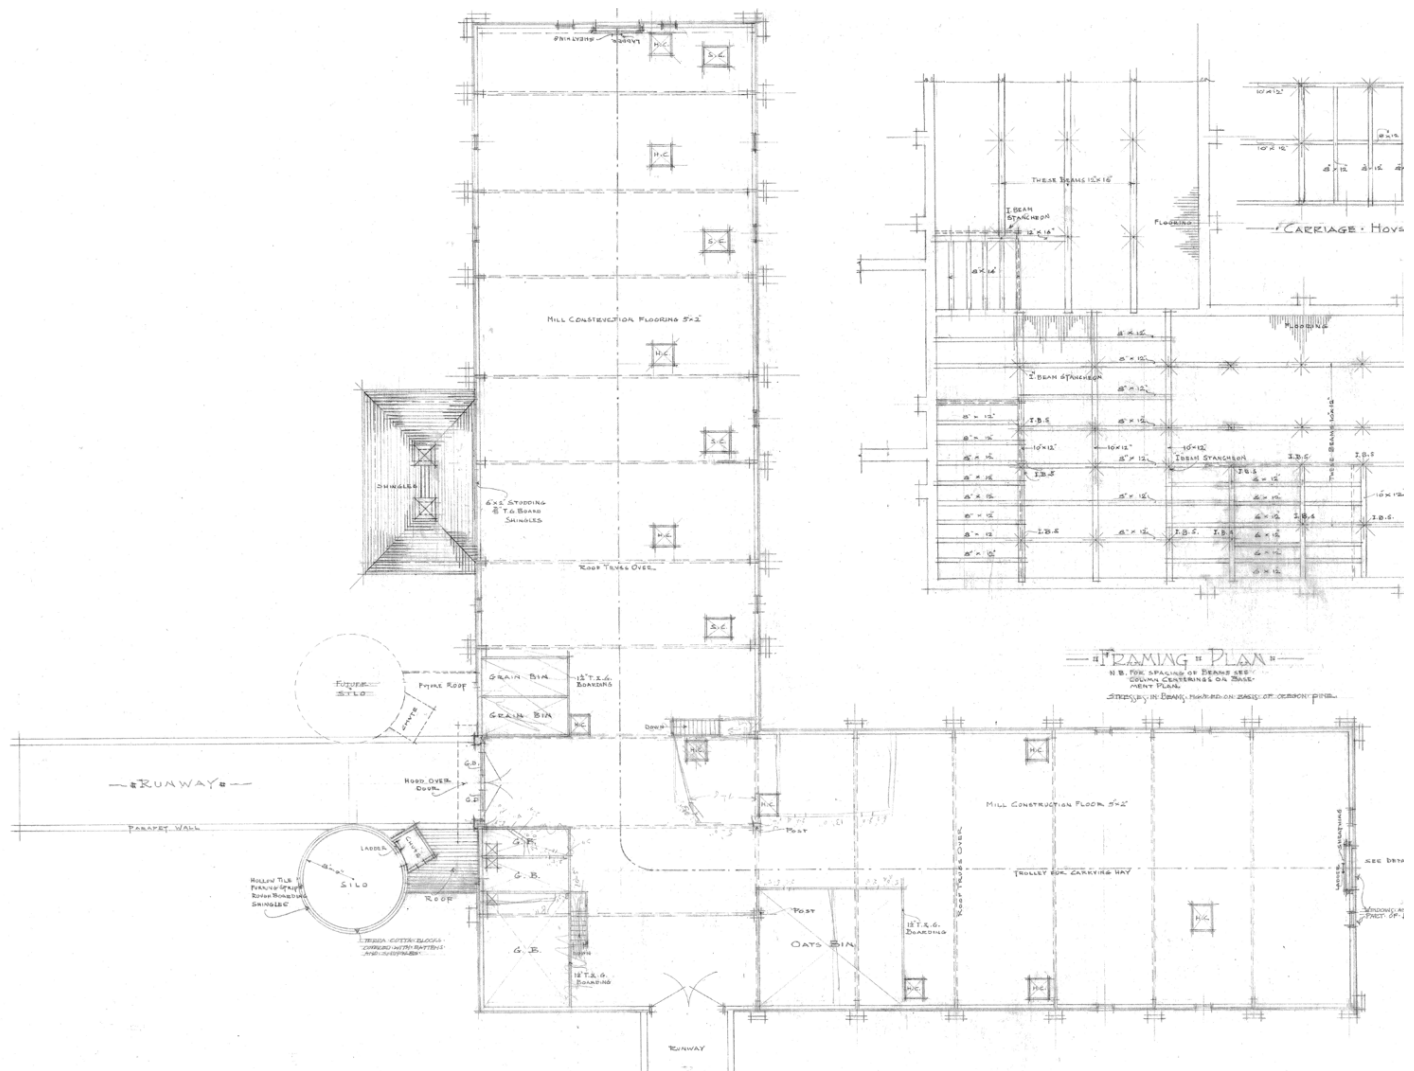
Figure 25. A plan view of the loft. Retrieved from Facilities Management Division Asset Record System, File B-8-T.

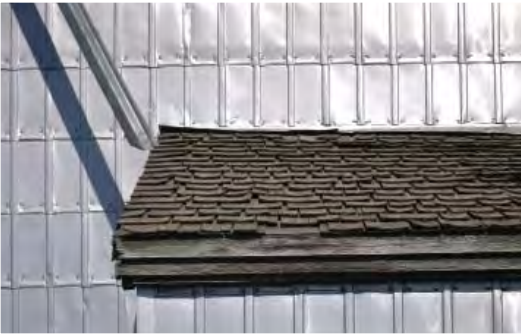
Figure 1. Aluminum cladding, cedar shingles.

The Feed Elevator is a wooden structure, clad in shingled aluminum tiles (Figure 1). The cladding is in good commemorative condition. Metal cladding is characteristic of grain elevators, having come into use just before the First World War. The elevator has painted wood doors and single-glazed wood framed sash windows, both of which are in poor condition (Figure 2). The roofs are clad in cedar shingles, which are also in poor condition (Figure 1). All of the original exterior materials – aluminum tiles, wood doors and windows and cedar roofing shingles – are character-defining elements.

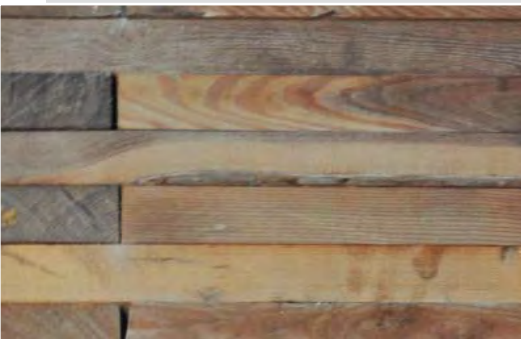
Figure 3. Cribbed cedar wall.

The interior of the elevator is constructed predominantly of cedar. The cedar walls require cleaning, but are otherwise generally in good condition. The floors of the elevator are also wooden; however, the species of wood is indiscernible due to the condition of the floors. Other materials found on both the interior and exterior include steel which was used in the manufacture of much of the grain processing equipment inside the elevator.

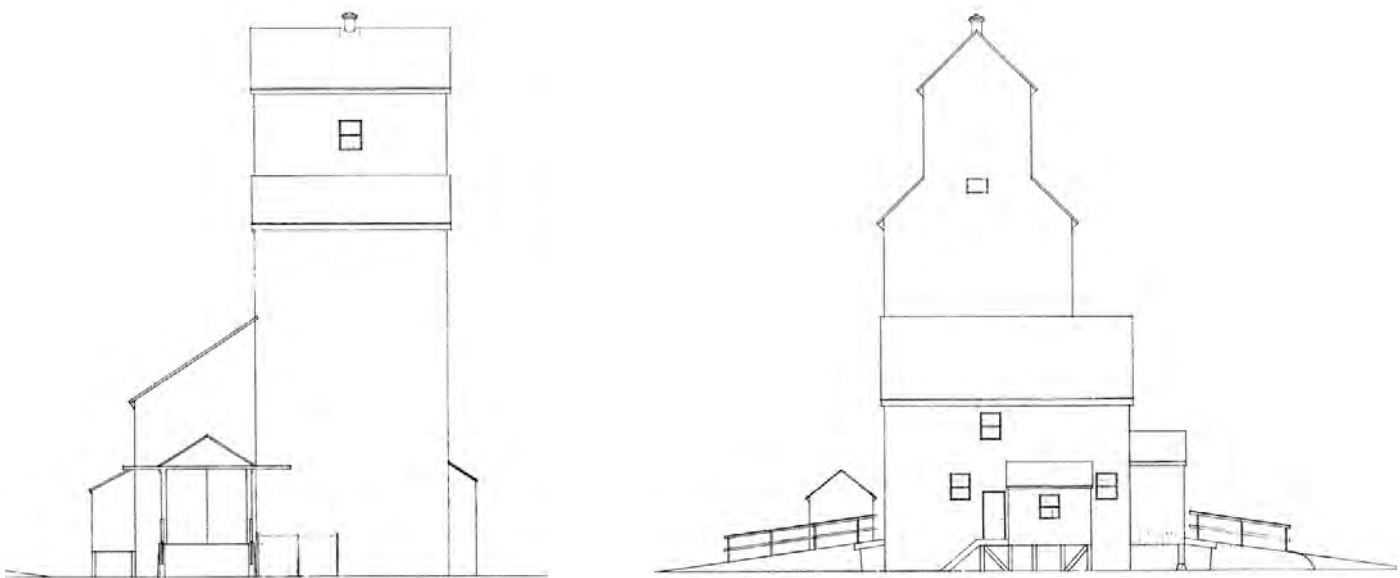
Figure 6. L to R: North and East elevations of the Feed Elevator. Retrieved from Facilities Management Division Asset Record System, File GE-7-T.

The term ‘Primary Elevator’ distinguishes grain elevators located in smaller farming communities from the larger ‘Terminal Elevators,’ built in terminal cities like Vancouver and Thunder Bay, where grain was collected and stored before being transferred to ships. Primary elevators received grain directly from farmers. The shape and height of the primary elevator derived from its function, which was to store grain and load it onto railway cars. As utilitarian agricultural structures, they were built without much regard for ornament or architectural style. Grain was received from farm trucks in a ‘drive shed’ and dumped into the ‘front pit.’ From the front pit, a conveyor system called a ‘leg,’ which consisted of a long belt with grain cups, would lift the grain to the top of the elevator. There, grain was channeled by a ‘distributor’ (also known by the trade name ‘Gerber’) into one of several vertical bins for storage. Loading onto a railway car occurred by gravity feed, through the ‘loading spout.’ The tower portion of the elevator enclosed the leg and grain storage bins. Secondary functions like motors and weigh scales were enclosed in lean-to structures off the side of the central, vertical volume. The university’s Feed Elevator has all of these elements except for the loading spout, since it was not used to load railcars. However, it does have a drive shed and engine room built in the form of a lean-to, in keeping with the typology (Figure 6).

The Feed Elevator also has the standard office/engine shed appended to its east side in the form of a lean-to. Early elevators (pre-1920) featured an engine room with an office located above. With the advent of safer engines, the office and engine room were moved to the same level. As no room exists above the office in the Feed Elevator, it is presumed that it was configured in the latter fashion. Figure 12 shows the configuration of the work floor, including the drive shed. The office is not shown as part of the work floor but is depicted in the elevations provided in Figure 6.

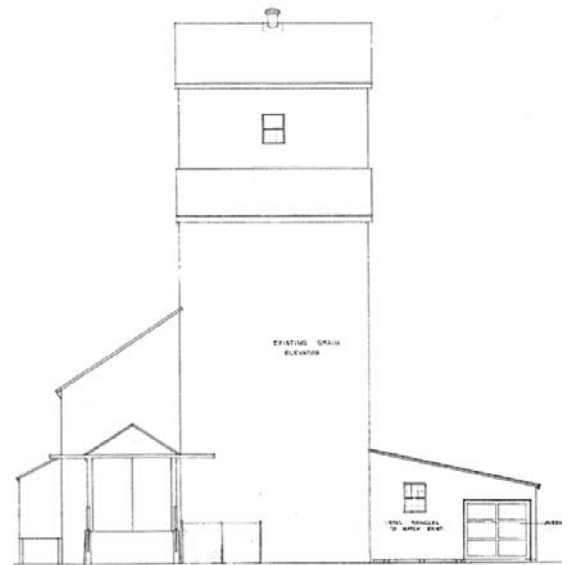
Figure 7. North Elevation of the Feed Elevator with addition. Retrieved from Facilities Management Division Asset Record System, File GE-12-T.

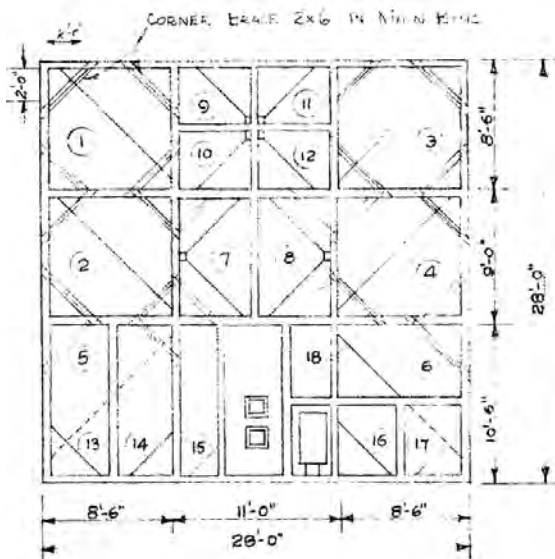
Figure 9. Plan of the grain bins. Retrieved from Facilities Management Division Asset Record System, File GE-1-T.

The granary is located in the tower portion of the building, and consists of elevated storage bins in the form of 18 vertical shafts. The plan layout of the storage bins inside the university Feed Elevator is shown in Figure 9, and they are shown in section in Figure 10.

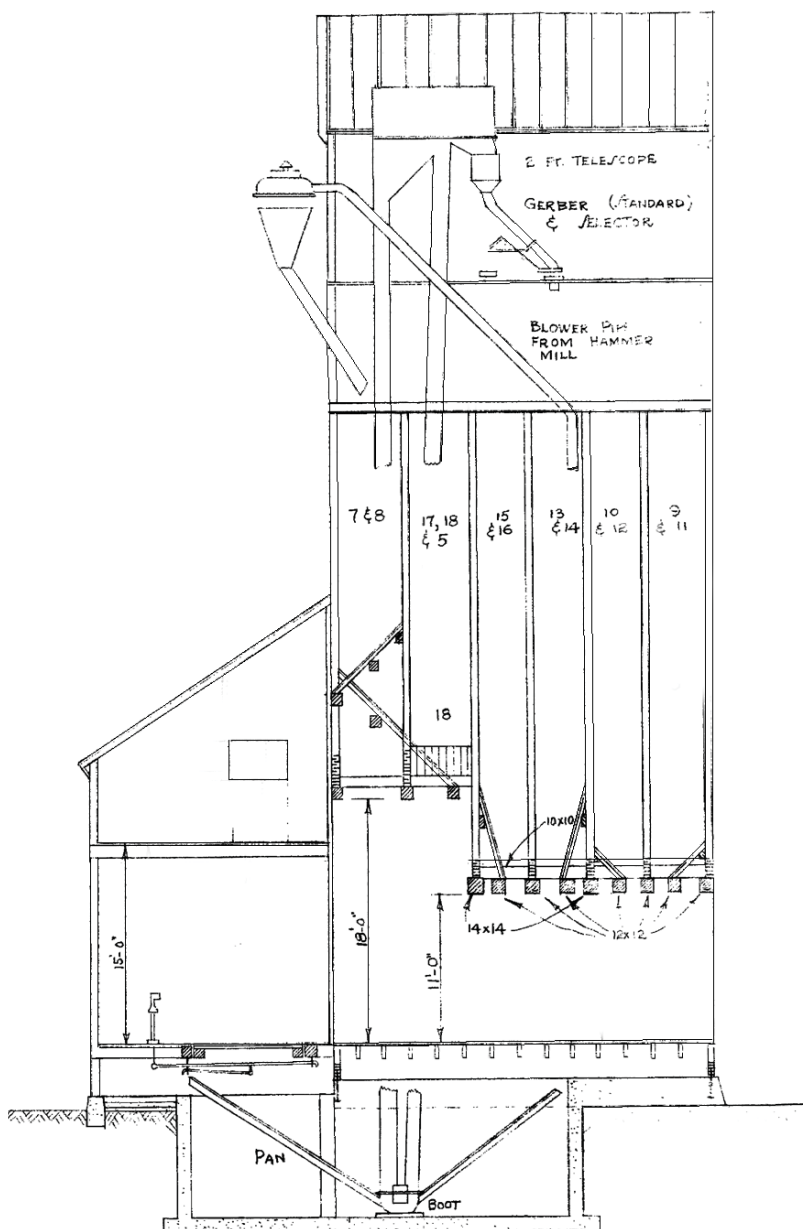
Figure 10. A section through the Feed Elevator. Retrieved from Facilities Management Division Asset Record System, File GE-5-T.

The existence and state of commemorative integrity of the internal systems such as the leg, or grain belt, the pan below the drive shed and the 'spouts' which delivered grain to the bins is unknown. Figure 10 shows the design of the grain delivery system including the pan, grain belt, bins and spouts.

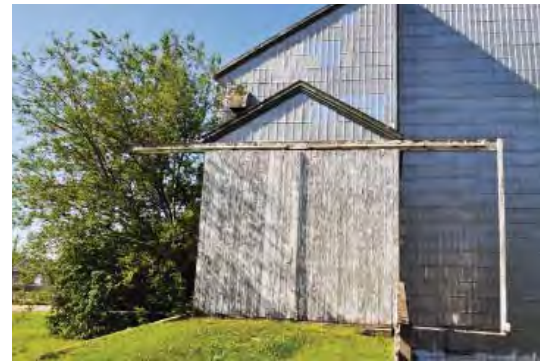
Figure 11. Ramp and doors to the drive shed.

The drive shed, or scale shed, was typically a lean-to structure. It had two openings to permit a wagon or truck to drive through. Trucks were weighed before and after unloading on a scale located in this space, to determine the quantity of grain delivered. The drive shed of the Feed Elevator is shown in Figure 11.

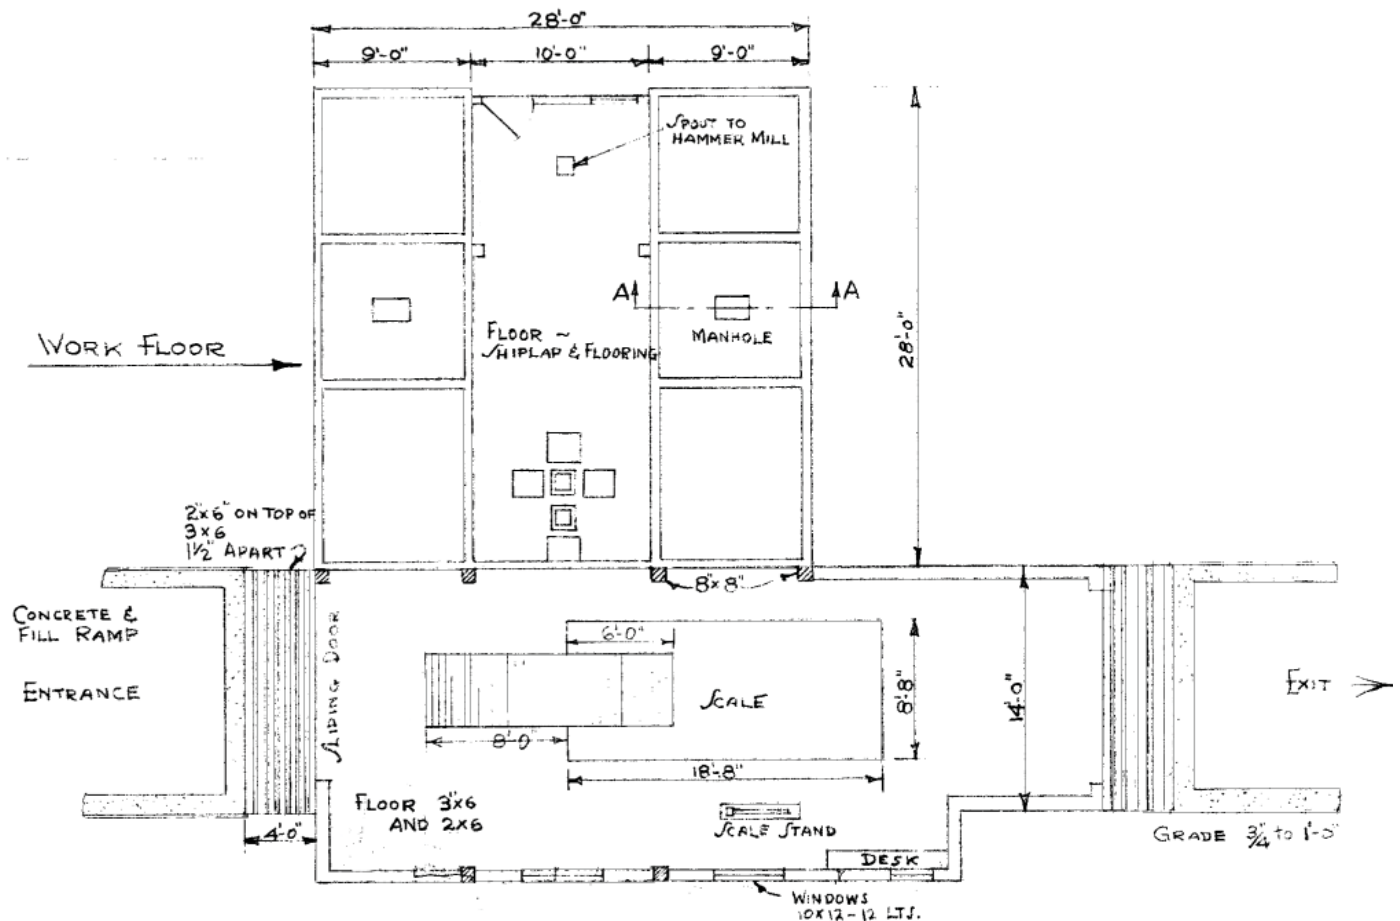
Figure 12. Original floor plan of the 'work floor.' The office and engine room are not included. Retrieved from Facilities Management Division Asset Record System, File GE-1-T.

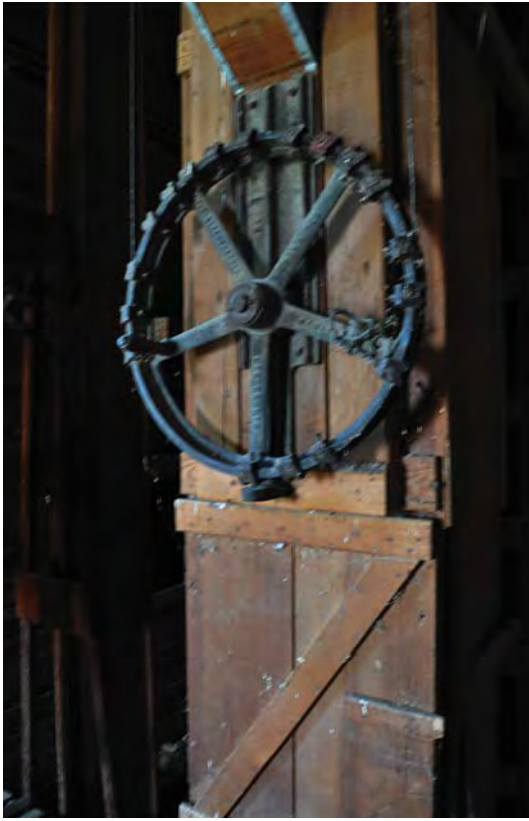
Figure 13. Crank controlling delivery of grain to bins.

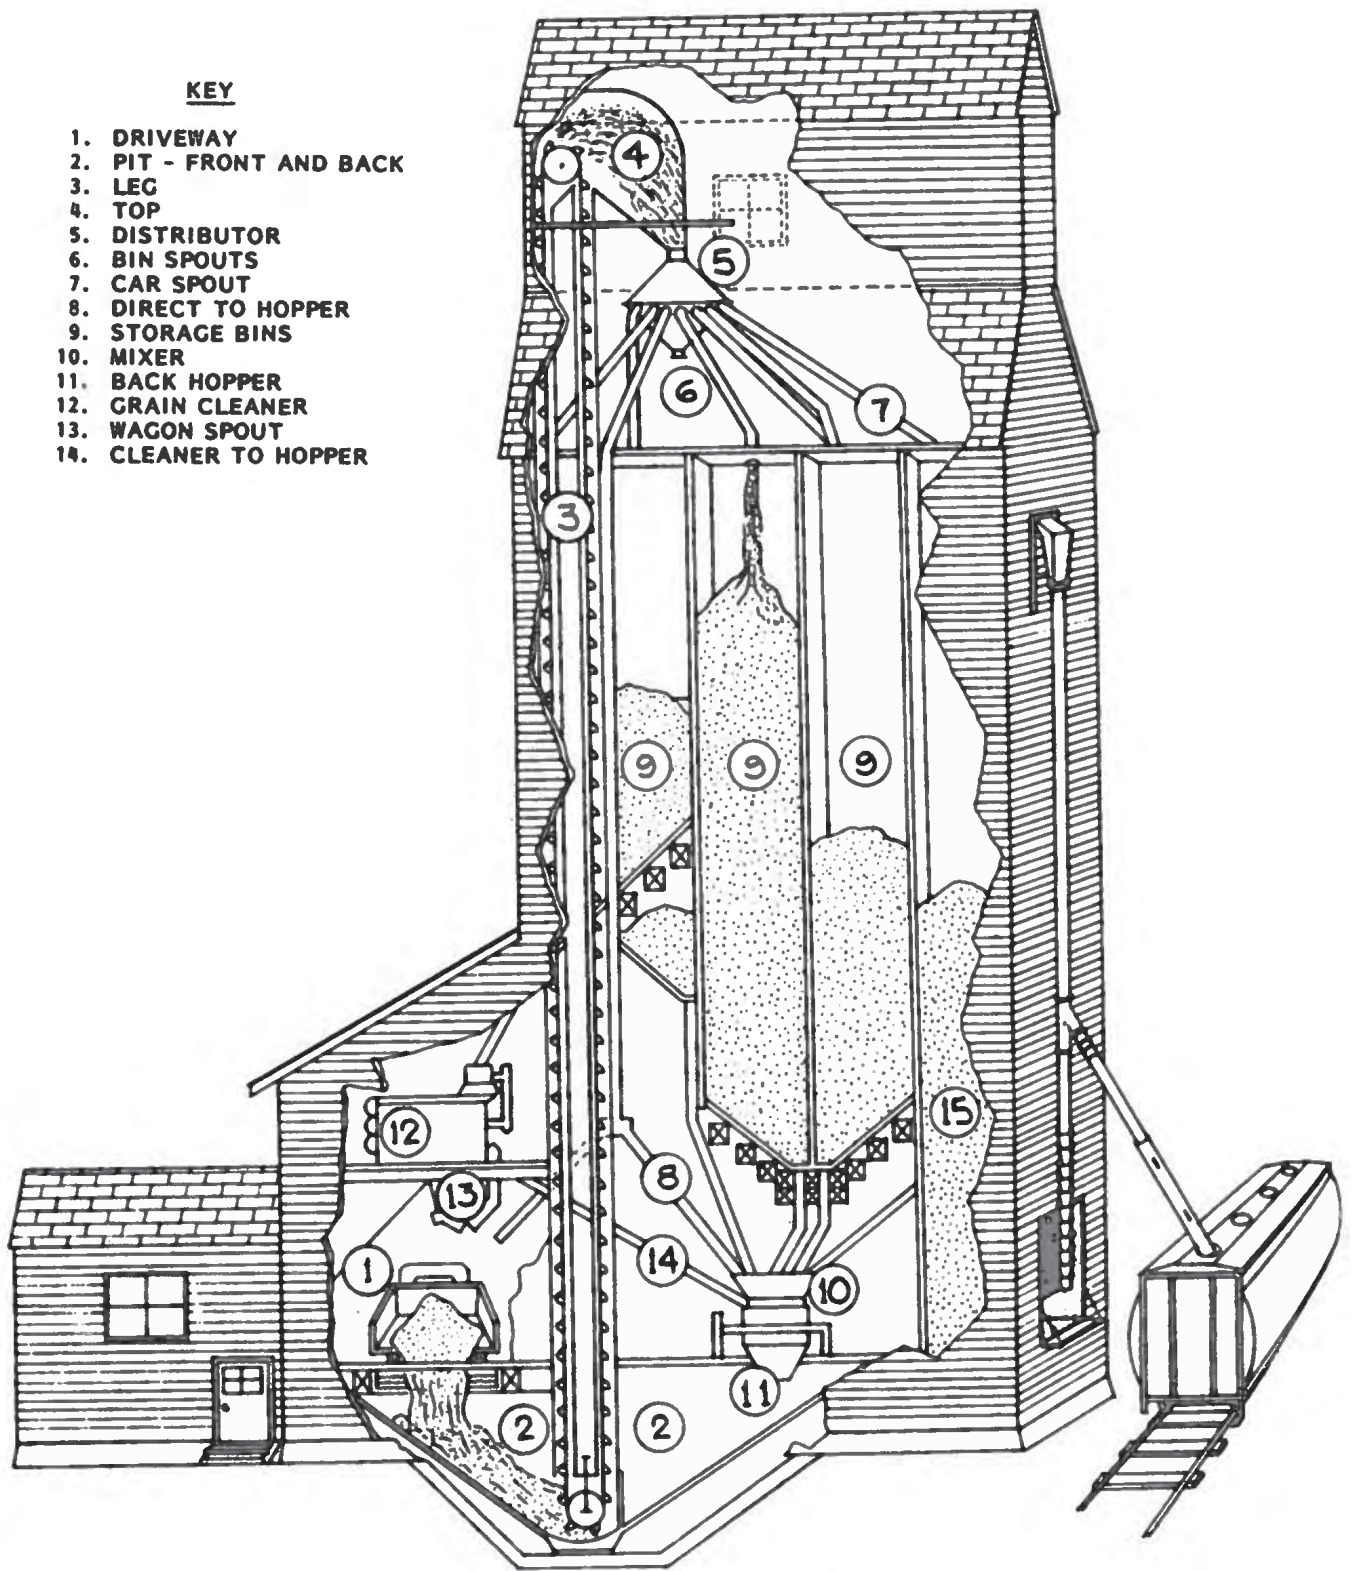
Figure 14. An annotated diagram of the operation of a typical grain elevator. Retrieved from Silversides, B.V., (1997) *Prairie Sentinel: The Story of the Canadian Grain Elevator*.

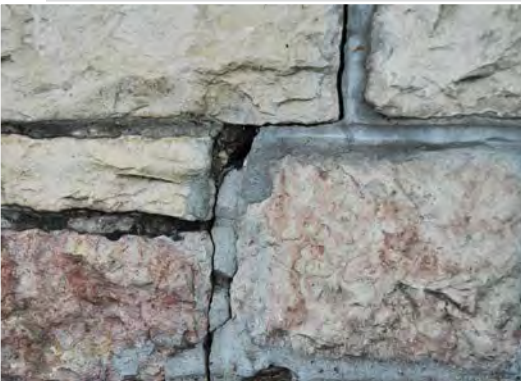
Figure 1. Greystone showing signs of deterioration in the mortar joints. The right half of the photograph shows an attempted repair using inappropriate material.

The Memorial Gates are built of materials common to the University of Saskatchewan campus. The walls and piers are built primarily with local 'greystone' (Figure 1). Indiana limestone is used for cut stone trim and decoration (Figures 3 and 4). (For further information on building stones used at the U of S, refer to ['Appendix: Stone'](#).) The cenotaph panels, which list the names of the deceased soldiers, are also made of Indiana limestone. The carved names were originally to be filled with lead, but this specification was never carried out. The gates themselves are constructed of bronze, and are suspended from four stone piers (Figure 5). The gates were manufactured in Cheltenham, England and were shipped to Canada. They each measure roughly 4.5 x 2.9 metres, and weigh over a thousand kilograms. Although weathered, the bronze components are in excellent condition. A base and a set of bollards are made of grey granite (Figure 6).

The physical condition of the Memorial Gates was recently assessed by the Facilities Management Division. This assessment noted that a combination of differential settlement and water ingress has caused cracking and spalling in many of the Indiana limestone elements (Figure 3). Surface staining and corrosion as a result of pollution and the build-up of organic materials is evident (Figure 4). Mortar joints are substantially deteriorated and require repointing. Attempts at repair have been undertaken with inappropriate materials (Figure 1). Cleaning and repairs were undertaken in 2013 to address these concerns.

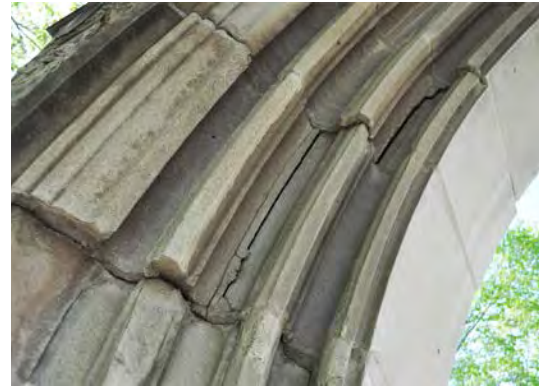
Figure 3. Indiana limestone showing signs of deterioration.

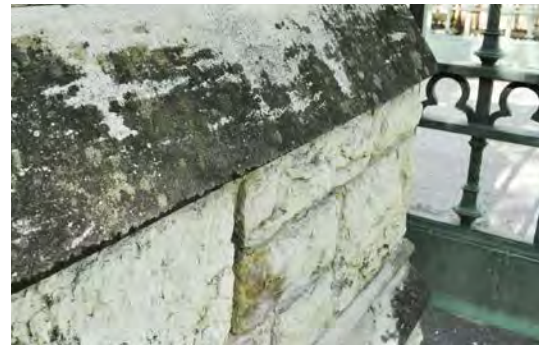
Figure 4. Limestone showing surface staining and corrosion.

The Memorial Gates are Collegiate Gothic in style. This is most clearly apparent in the verticality of the stone piers and in the pointed arches marking the pedestrian walkways (Figure 8). Gothic motifs such as shields, buttresses, keyhole and pointed arches are all referenced in the form of the monument and in its carved stone decoration (Figure 9 & 10). Much of the cut stone decoration features flora such as cereal plants and flowers (Figure 11). Stone string courses and quoining are also characteristic features of the Gothic style (Figure 4).

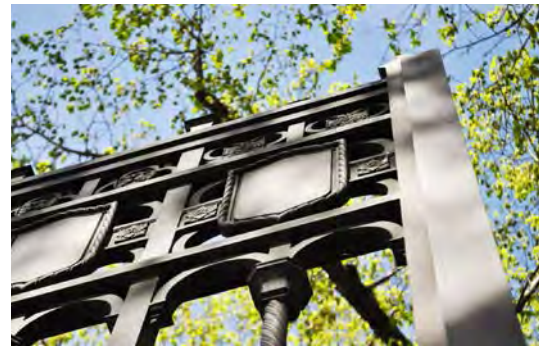
Figure 5. Bronze gates.

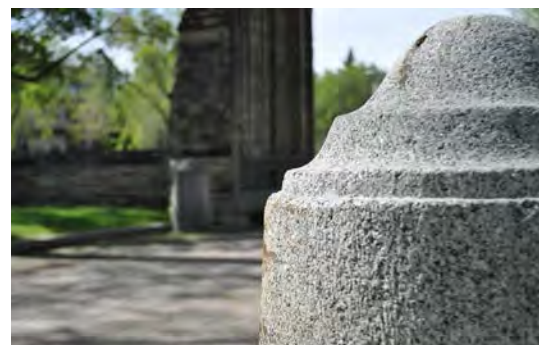
Figure 6. Granite bollard.

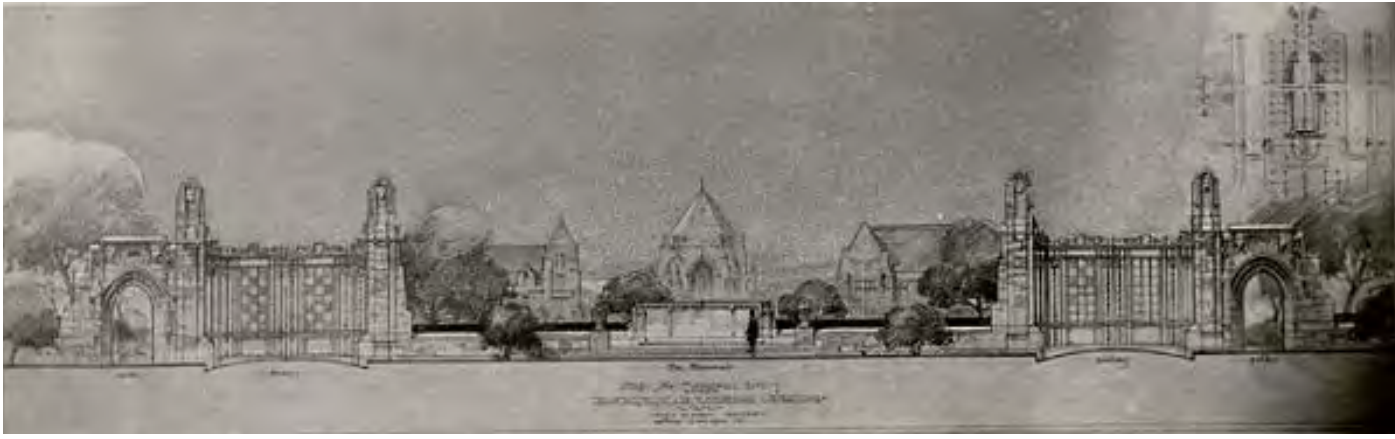
Figure 7. Sketch by University Architect David Brown showing the symmetry of the design. Photo A-8523. retrieved from http://scaa.sk.ca/gallery/uofs_buildings/

The Memorial Gates consist of a pair of ornate bronze gates in a low stone wall. Each gate is flanked by a pair of stone piers, about 6.4 metres tall. Each pair of gates defines an opening 5.5 metres wide, which originally formed a vehicular entrance to the university grounds. A slightly raised tablet forms the central feature of the composition, a cenotaph on which are inscribed the names of soldiers from the university killed during the war. The two outermost piers are each buttressed by a pointed arch marking a pedestrian path. The symmetrical composition of the Memorial Gates is a character-defining element (Figure 7).

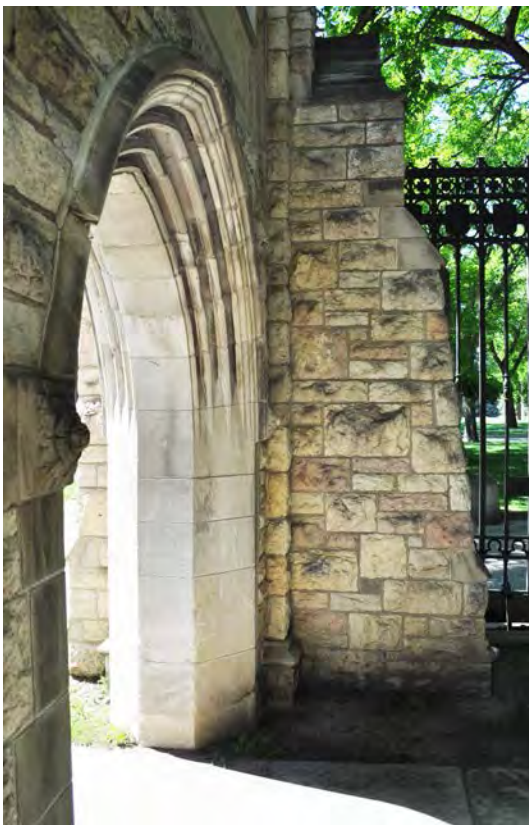
Figure 8. Gothic arch marking a pedestrian pathway.

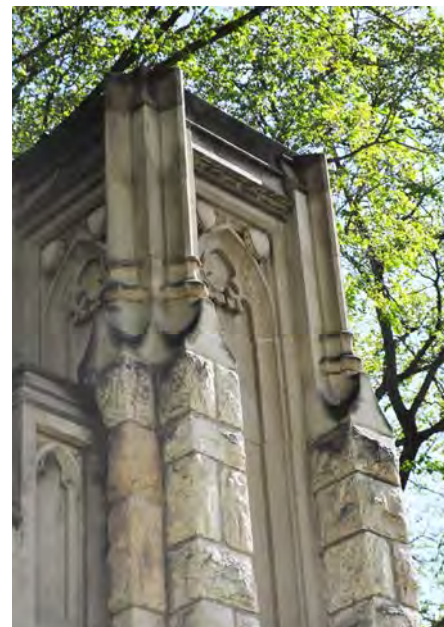
Figure 9. Stone pier, decorated with carved stone references to statuary niches, keyhole and gothic arches.

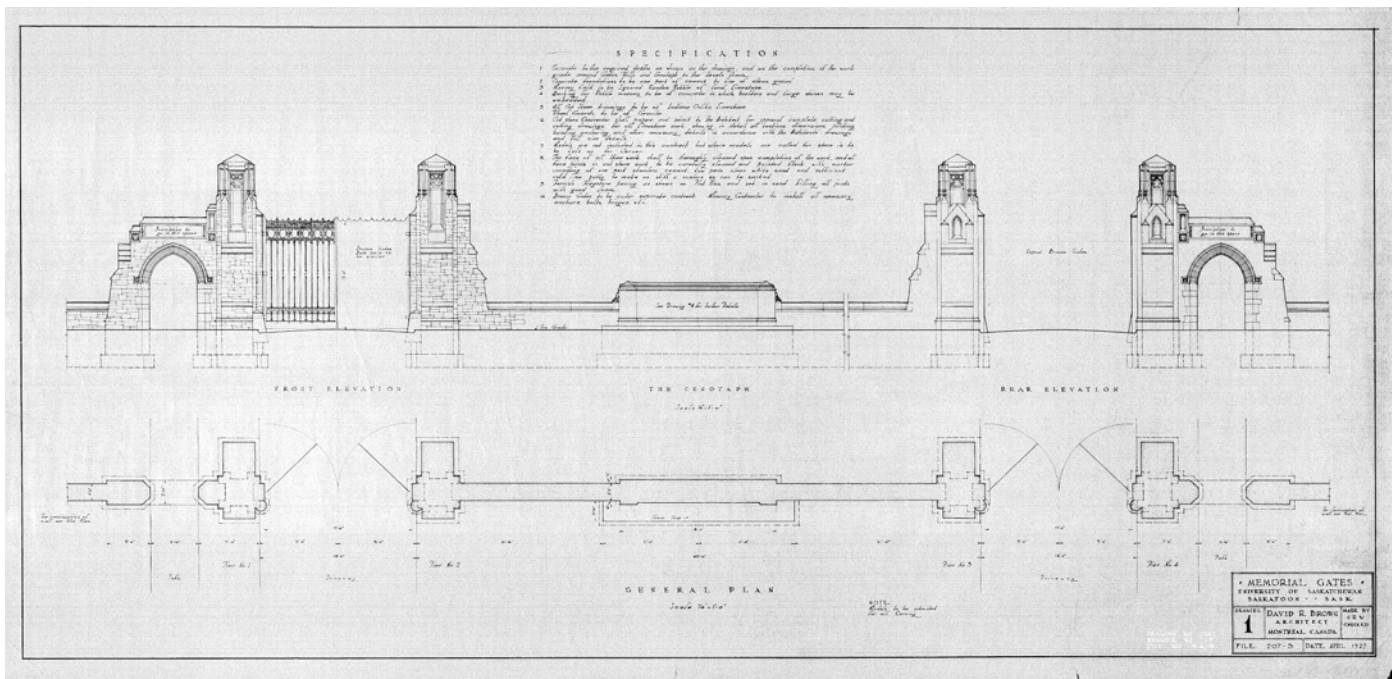
Figure 14. Front elevation and plan drawing, dated 1927. Retrieved from Facilities Management Division Asset Record System, File MG-4-T.

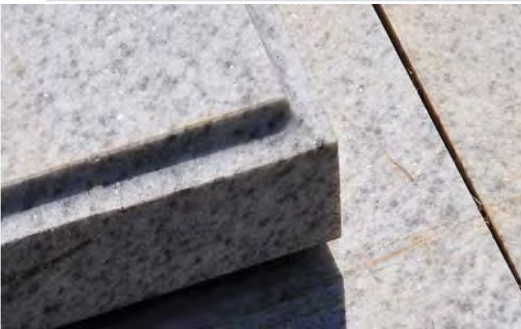
Figure 1. Granite grave stone.

The grave marker is a low stone tablet made of granite (Figure 1). The granite gravestone is in excellent commemorative condition. A bronze plaque commemorating both Diefenbaker and the 125th anniversary of Confederation was added in 1992. Both the gravestone and the bronze plaque are character-defining elements.

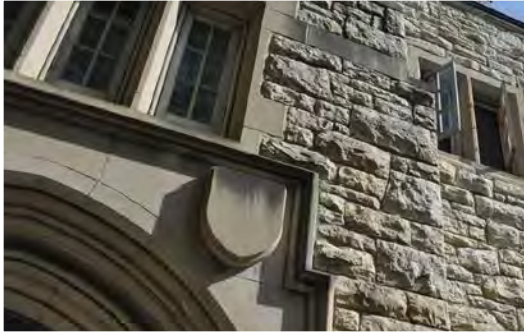
Figure 1. Greystone walls with Indiana limestone trim and decoration.

St. Andrew's College is built of the traditional materials that characterize the University of Saskatchewan campus. The exterior walls are primarily built of 'greystone', with cut Indiana limestone trim, a granite base course and granite steps (Figure 1 & 2). The roofs are clad in slate, and flashing, downspouts and gutters are in copper (Figure 3 & 5).

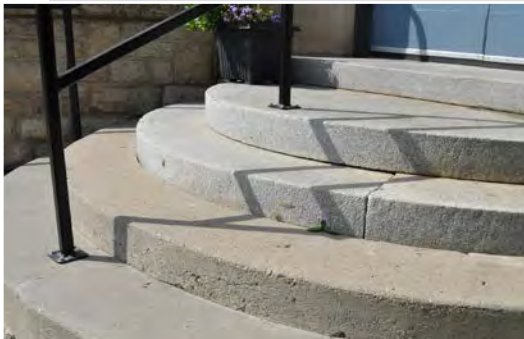
Figure 2. Granite steps.

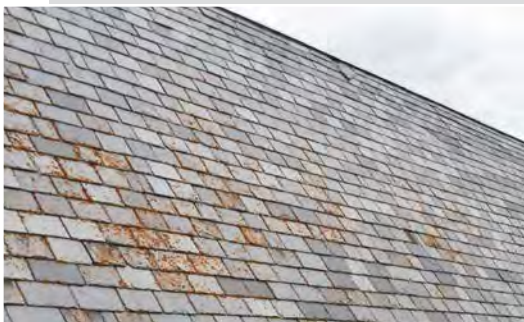
Figure 3. Slate tile roofing.

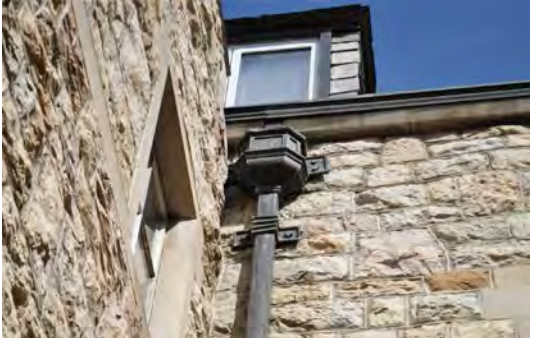
Figure 5. Copper downspout.

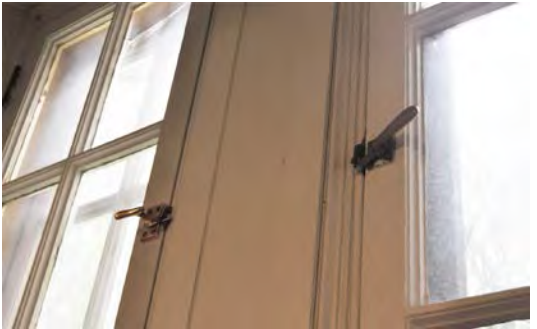
Figure 6. Interior and exterior wood-framed casement windows with brass hardware.

The windows are framed in wood on the 1922 portion of the building, and in steel on the 1959 portion (Figures 6 & 7). The windows are single-paned, but are arranged in two layers, with an interior and exterior set for each opening. On the 1922 portion of the building, the window frames were originally specified to be painted 'bottle

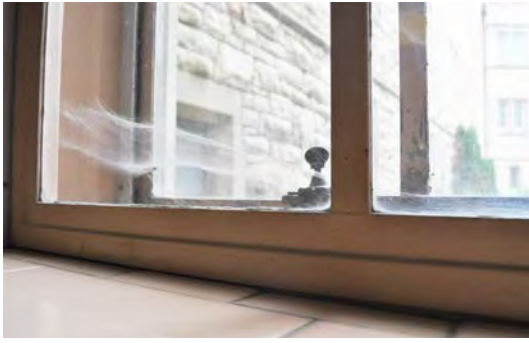
Figure 7. Steel framed windows.

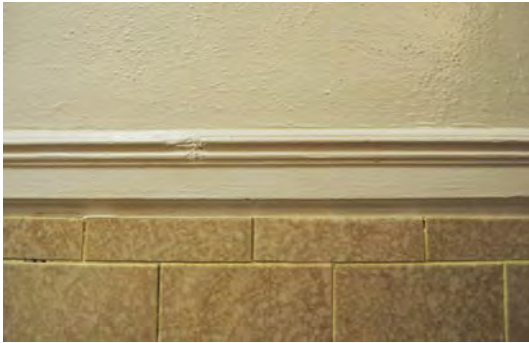
Figure 8. Plaster wall with painted wooden dado and glazed tile wainscoting.

The original interior finishes exist in varying states of commemorative integrity. Walls are finished in a painted textured plaster, with wood baseboards and trim. In the older portion of the building, most of the wood trim is intact, but its original dark oak finish is covered by layers of paint (Figure 8). The textured plaster walls are generally intact. In the basement, one wall features a buff glazed tile wainscot (Figure 8). In some rooms, the walls have been covered in carpet but original materials may still exist beneath. A yellow glazed tile was used for wainscoting and backsplashes in the washrooms and still exists in excellent condition. In the 1959 wing, blue and off-white glazed tile was used liberally as wainscoting and window sill finishes, as well as in washrooms. The off-white tile in the 1959 portion of the building is shown in Figure 9. The original plaster, wood trim and ceramic wall tile are character-defining elements.

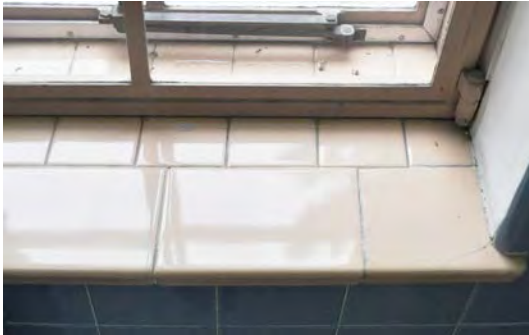
Figure 9. Buff and blue ceramic tile under a steel casement window in the 1959 wing.

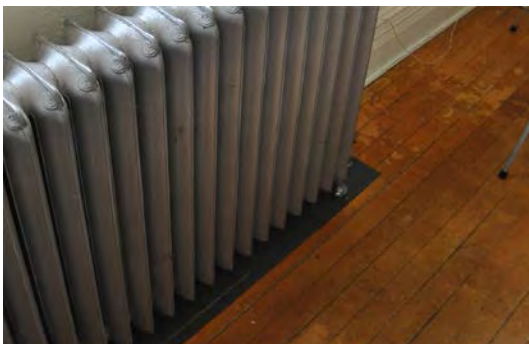
Figure 10. Original maple flooring and cast iron radiator.

The floors of the original wing were originally finished in maple, and are still intact in some places. On the ground floor, an office and meeting rooms still feature maple hardwood flooring, which is in fair condition but showing some wear (Figure 10). On the second and third floors, the original hardwood can still be found in the dormitory rooms that are now used as offices.
