University of Saskatchewan

Heritage Register

September 2013

Facilities Management
Division

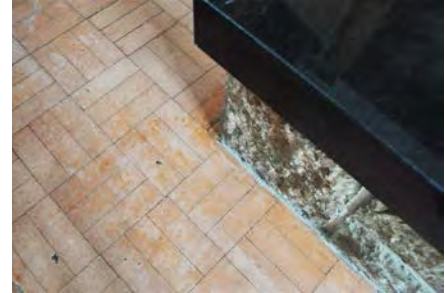
Figure 11. Red concrete tile and polished dark granite hearth.

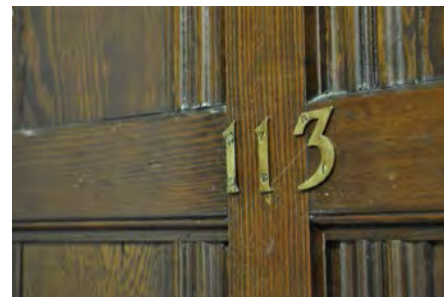
Figure 12. Oak door with brass numbering.

In the 1922 portion of the building, the original paneled doors were in oak, finished with a dark stain. In the basement, most of the original doors and frames have been retained. The brass doorknobs, numbers and hinges appear to be original (Figures 12 & 13). The upper floors of the 1922 wing contain a few original doors; however, most have been replaced. In the 1959 wing, doors are of a lighter oak finish, and their hardware matches the 1922 wing (Figure 14). Door frames in the newer wing are in painted wood or steel. The original doors are character-defining elements.

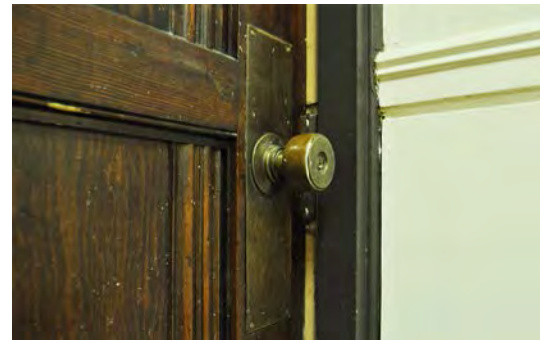
Figure 13. Oak door with brass hardware.

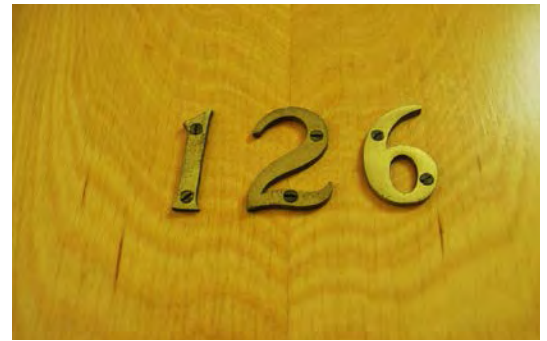
Figure 14. Door materials in the 1959 wing.

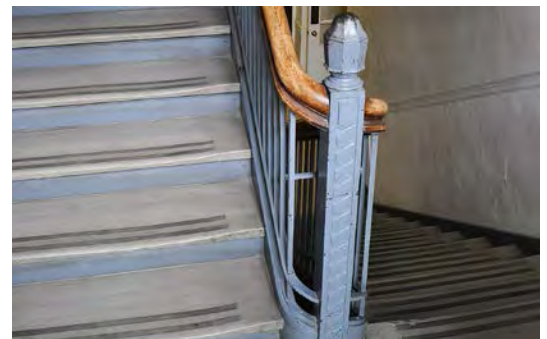
Figure 15. Steel stair and balustrade with oak banister and marble treads.

The stairwells in the building have excellent commemorative integrity, although only one dates from the original construction; the rest date from the 1959 addition and renovations. The original stairwell, shown in Figure 15, has treads, landings and thresholds in marble, which is intact and in fair condition. Some of the marble treads and thresholds are worn from frequent use. This stair also features steel stringers, an iron balustrade and an oak banister. Cast iron newel posts are ornamented with details typical of the Collegiate Gothic style (Figures 15 & 25). The later staircases are composed of steel stringers and balustrades, but have treads of terrazzo as shown in Figure 16. The northern entrance and staircase has a wainscoting of buff marble (Figure 17). The staircases and their finish materials are character-defining.

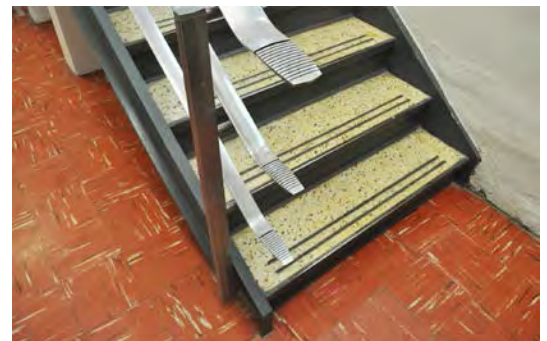
Figure 16. Aluminum balustrade and terrazzo treads.

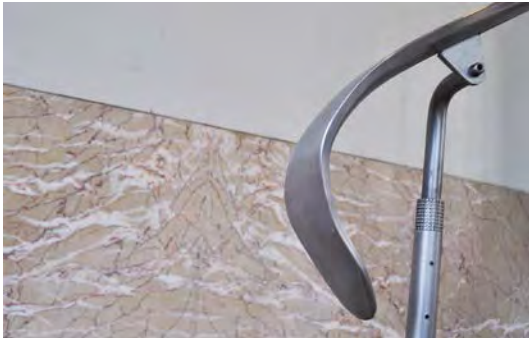
Figure 17. Marble wainscoting and aluminum balustrade.

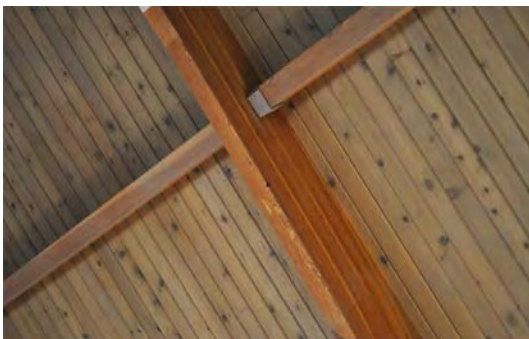
Figure 20. Glue-laminated wooden ribs and wooden decking.

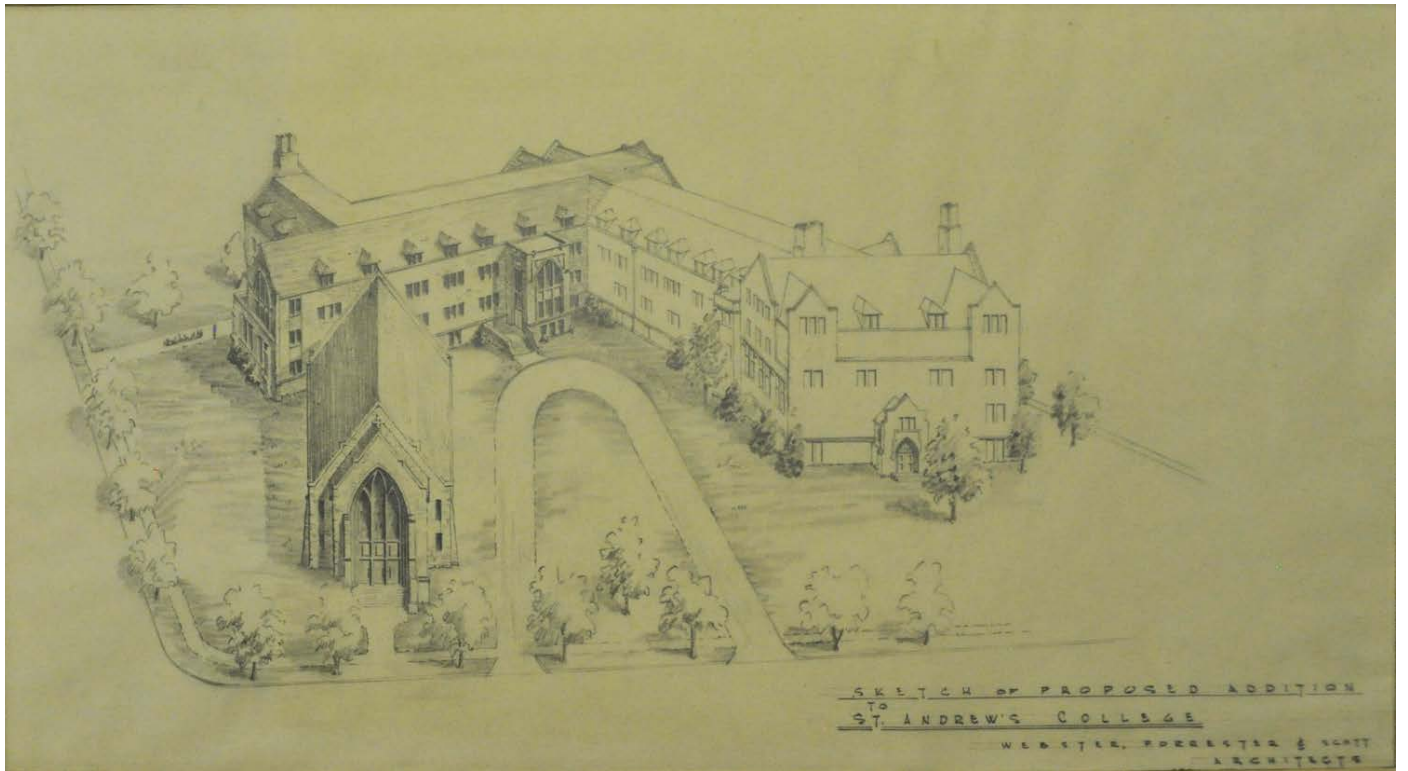
Figure 22. Architect's sketch of St. Andrew's College with the addition of the 1959 wing. Photo retrieved from St. Andrew's Archive, File STA.I.14.1.1.

The form of St. Andrew's College, created by the 1959 addition to the original 1922 structure, is a U-shaped building. The outdoor space enclosed by the U delineates an arrival court. The original wing built is shown in Figure 20. Figure 21 shows the building after the 1959 additions. St. Andrew's is composed formally of three connected volumes. The original building, now known as the west wing, is connected by the east wing to a chapel. The chapel sits at an angle to the rest of the building, which relates in its orientation to the rest of the university as defined by the 1909 Campus Plan. The east and west wings are oriented in relation to College Drive and the city. These two orientations are character-defining elements as they relate the building to the university and to the surrounding city.

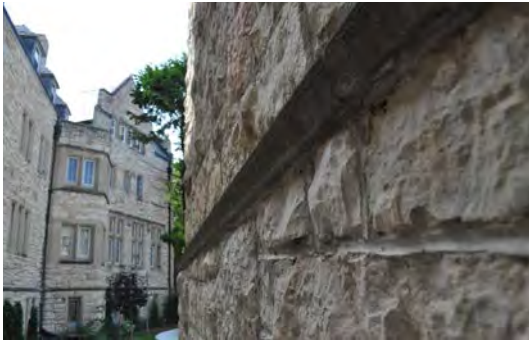
Figure 23. Stone string courses.

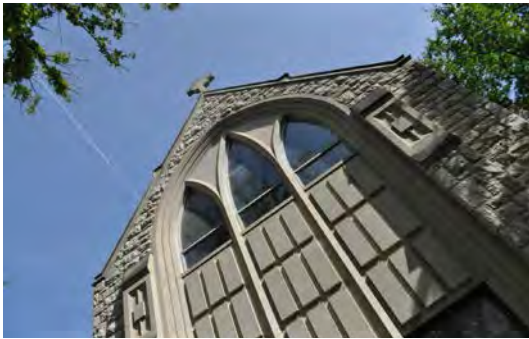
Figure 24. Gothic arch chapel windows, peaked roof and cut stone ornamentation featuring a cross.

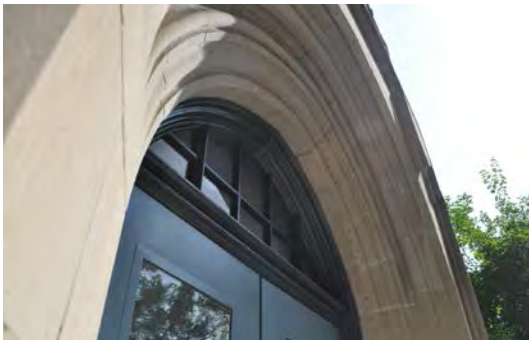
Figure 25. Gothic arch entrance and transom.

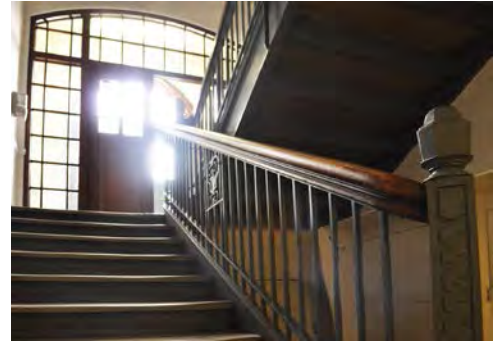
Figure 27. Arched transom and surround, decorative balustrade.

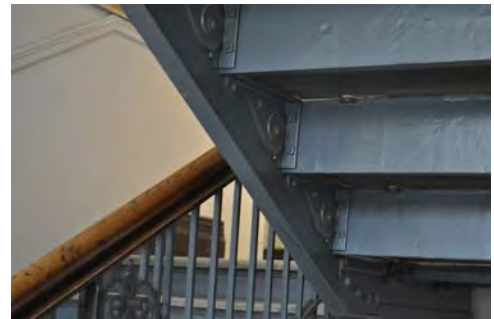
Figure 28. Ornamental iron work.

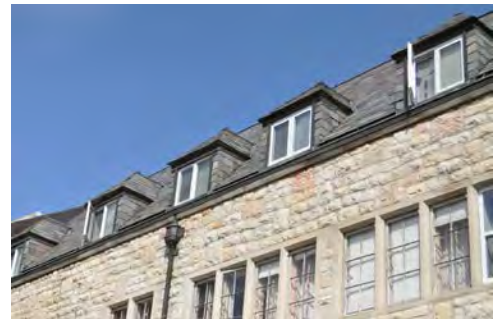
Figure 29. Dormer windows.

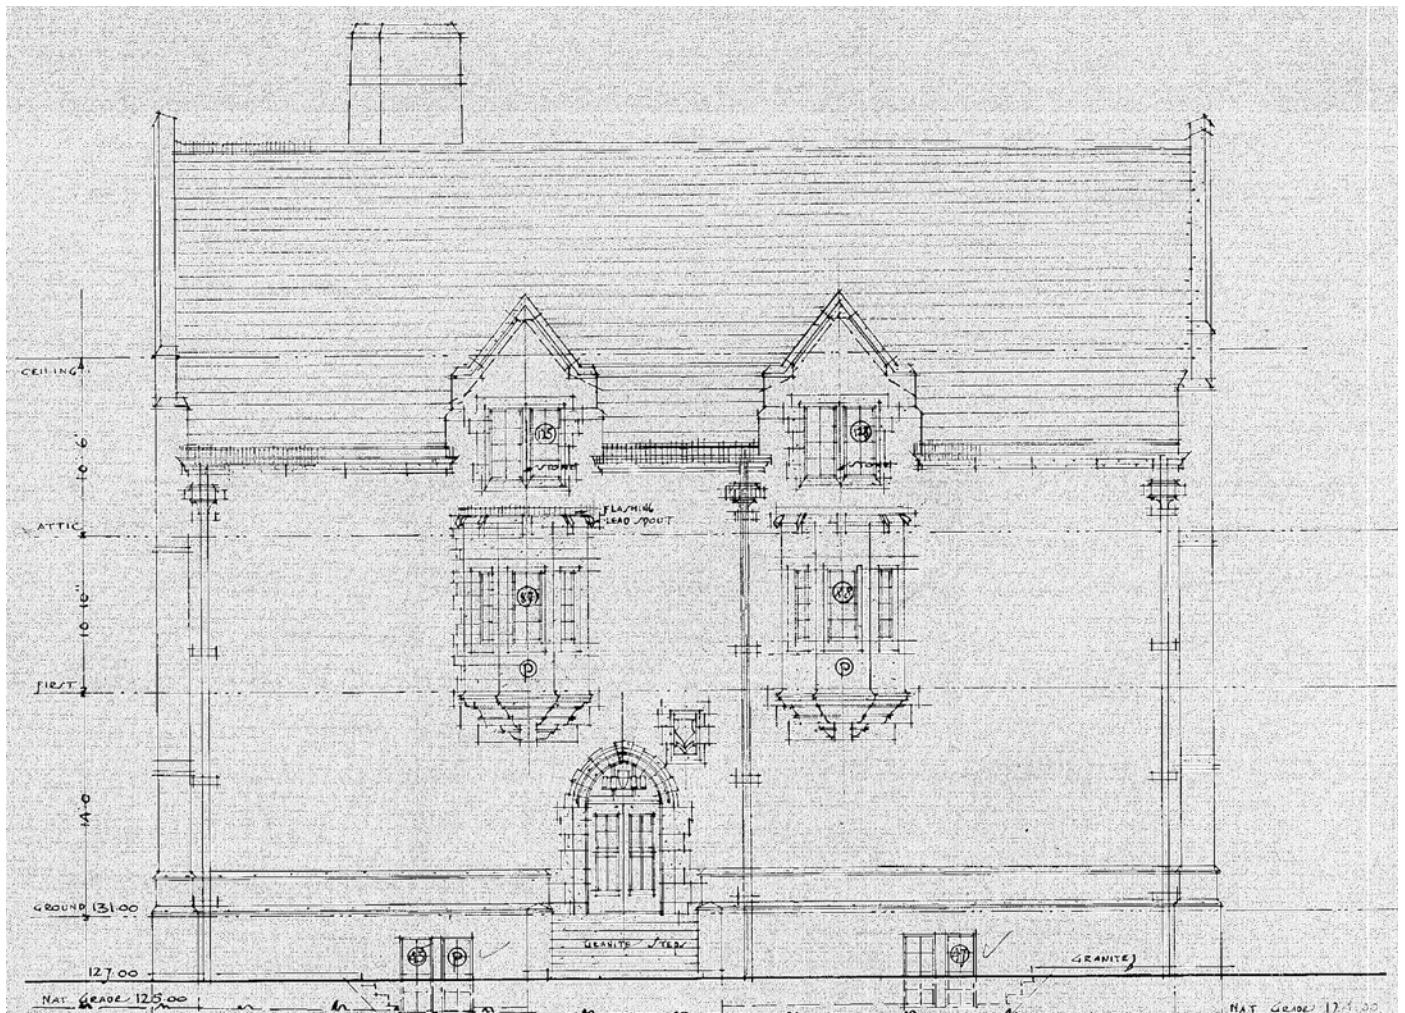
Figure 30. An unrealized elevation showing oriel windows flanking a gothic arched entry. Retrieved from Asset Record System, File SC-95-P.

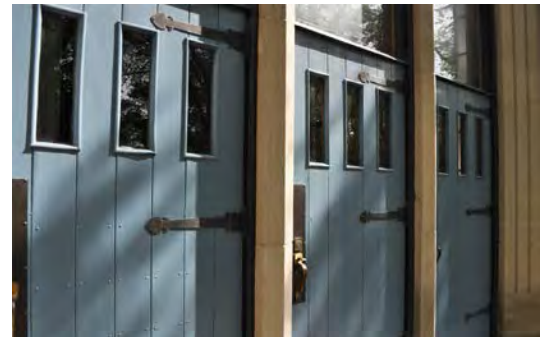
Figure 31. Chapel doors with slot windows.

The 1959 wings were designed to match the style of the original building, but are often simplified in their detailed execution. The doors of the chapel are low in proportion and quite plain, but have traditionally detailed iron hinges (Figure 31). The windows in the chapel, including the large east-facing stained glass panel, are set into pointed arched openings, but also feature plain stone spandrel panels (Figure 24). The north and south walls of the chapel are articulated by a row of simple stone buttresses (Figure 32).

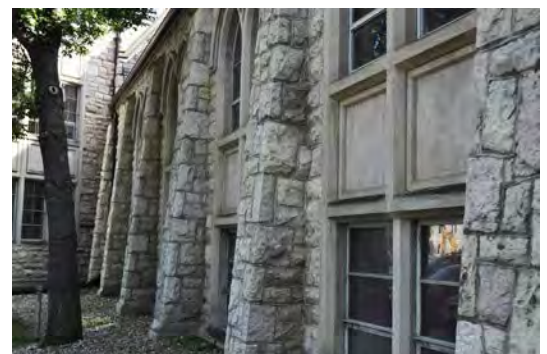
Figure 32. Stone buttresses.

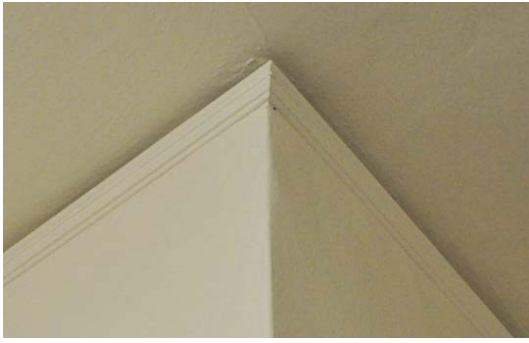
Figure 34. Picture mouldings.

A tall arch crowns the staircase at the west end of the original building (Figure 33). Hallways are adorned with wooden baseboards and moldings. Interior rooms have picture rails as shown in Figure 34. In one of the rooms in the 1922 wing, a decorative arch marks the place where a fireplace originally existed (Figure 35). The original drawings show the corridors once had vaulted ceilings, although currently the ceilings in the building are covered in suspended tile (Figure 36). The vaulted plaster ceilings may still exist above the ceiling tile. The same suspended ceilings also obscure the glazed transoms above interior doors; these have all been covered by an opaque material and are no longer operable (Figure 37).

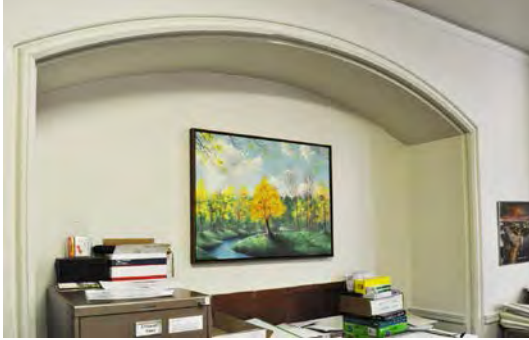
Figure 35. An arched recess over former hearth.

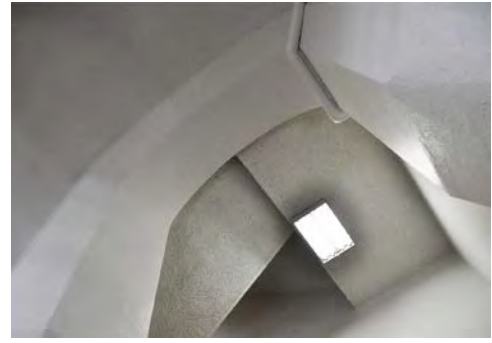
Figure 33. Interior arch.

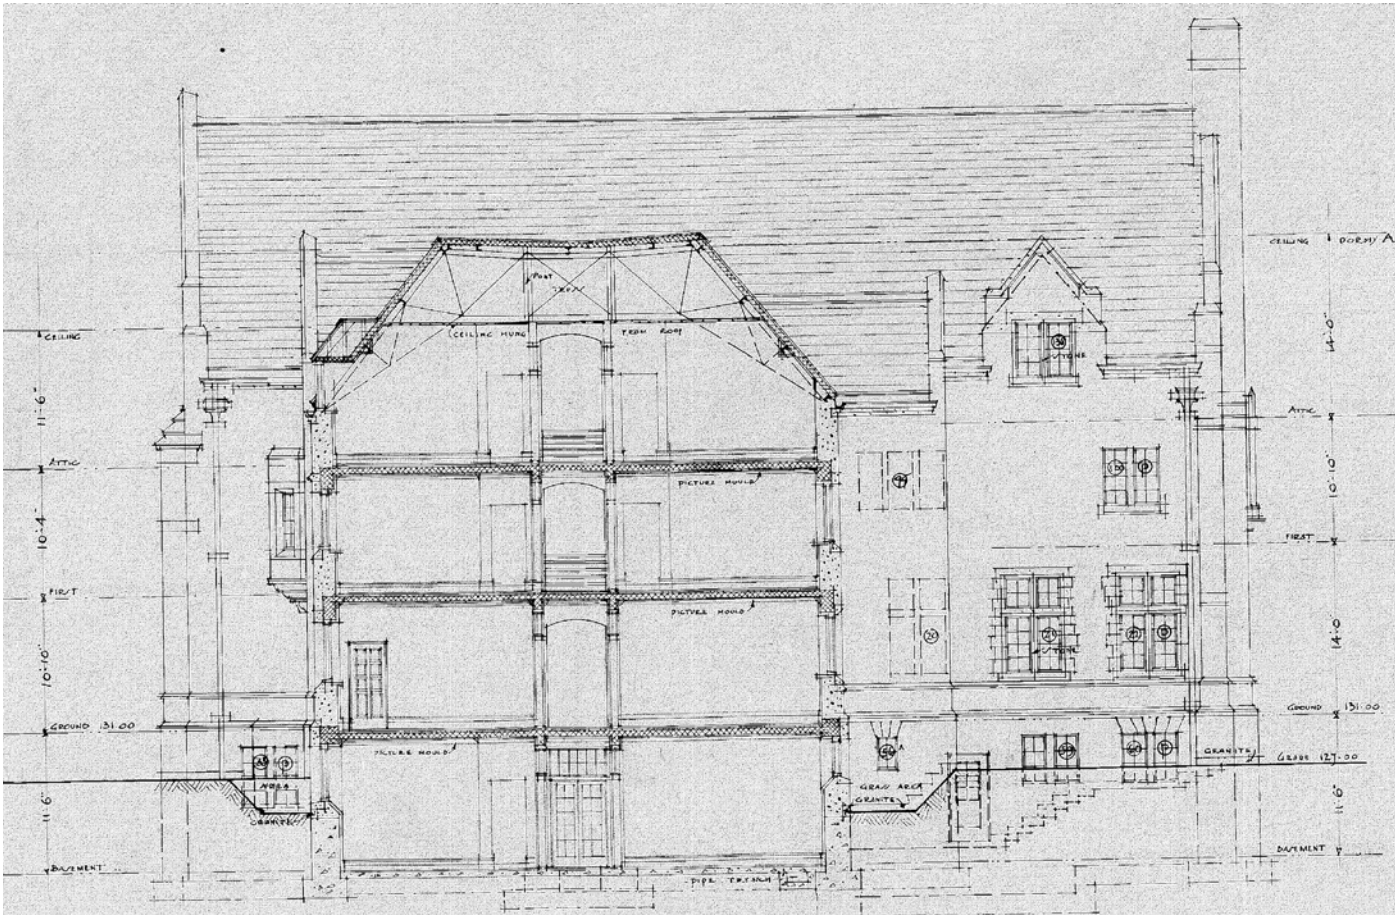
Figure 36. Section through the building showing vaulted ceilings in the corridors.. Retrieved from Asset Record System, File SC-96-P.

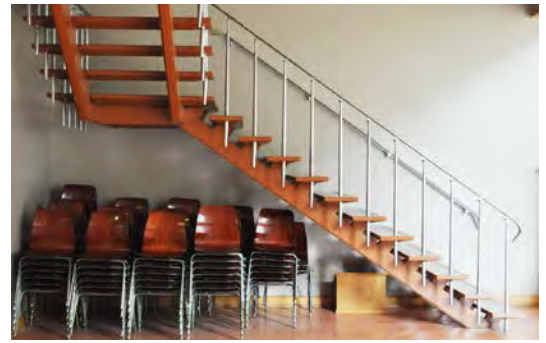
Figure 38. Modernist stair.

The newer portions of the building mix elements of the Collegiate Gothic and modernist styles. The staircases, for example, feature functionalist steel balustrades without decoration (Figure 38). The stair in the student lounge is a lovely minimalist design featuring open risers, shallow terrazzo treads and a light polished aluminum balustrade and handrail. The fireplace in the common room blends modern and traditional elements (Figure 39). It has an exposed greystone chimney that extends the full height of the room. The simplicity and continuity of the mantle shelf is modern, but it is formed of limestone, a traditional material. The carved limestone crest above the mantle is a more traditional flourish.

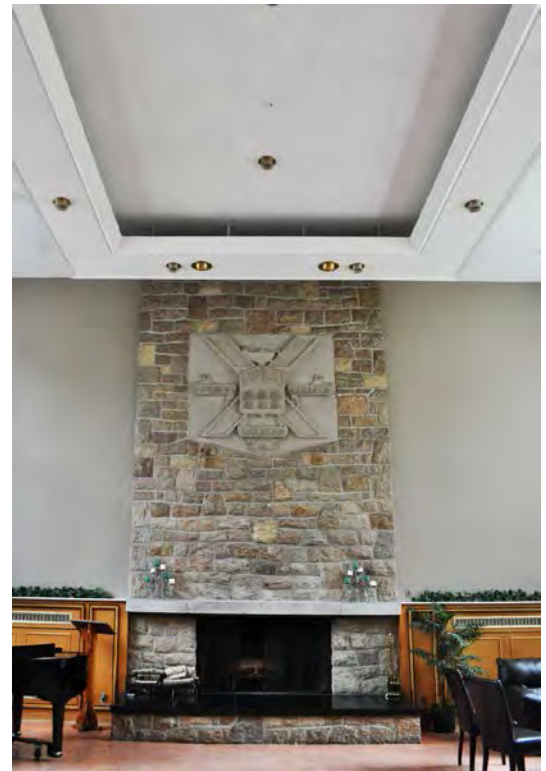
Figure 39. Fireplace with full height, modern mantle and decorative crest.

Across from the chapel is a double-height student lounge, which occupies the basement and first floor. The lounge is bathed in daylight owing to the tall windows on its north and south walls. The eastern wall is occupied by a grand fireplace (Figure 39). A set of stairs to the west allow access to a mezzanine level overlooking the lounge. The mezzanine, high ceiling, large hearth and the windows of the student lounge are character-defining.

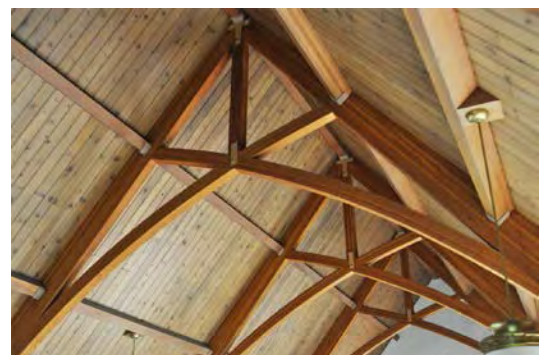
Figure 40. Glue-laminated trusses and wood decking in the chapel.

The interior details of the chapel also feature characteristics of both the Modern and Collegiate Gothic styles. The roof is supported by a series of glue-laminated wooden scissor trusses, whose lower chords are shaped in the form of a pointed arch, a modern reference to a traditional form (Figure 40). The wainscoting around the chapel walls and other carved oak millwork make reference to the tracery of gothic cathedrals (Figure 41). The windows of the chapel, including the large, east facing stained glass window, take the form of gothic arches (Figure 42).

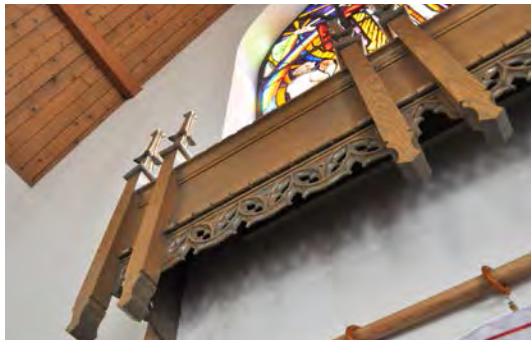
Figure 41. Gothic tracery in the chapel millwork.

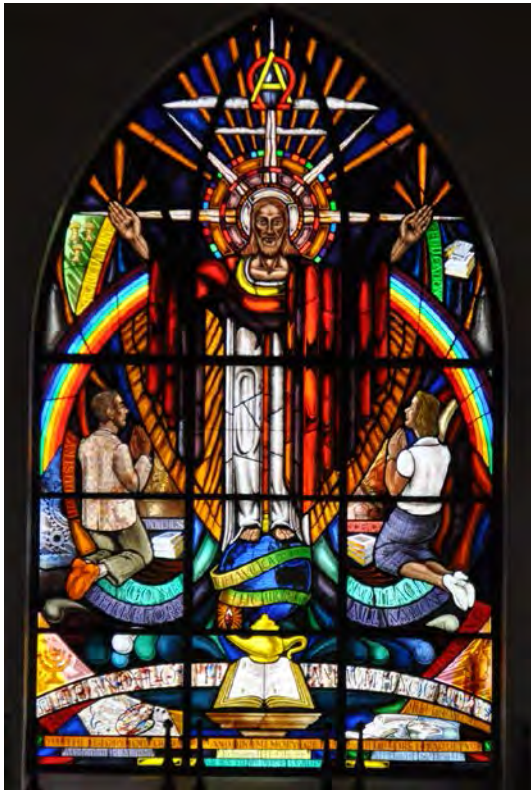
Figure 42. Stained glass window.

The large stained glass window in the chapel depicts a man and a woman, praying on their knees in front of Jesus (Figure 42). Jesus is standing on top of the world, his arms outstretched. The banner across the bottom reads, 'And lo I am with you always, I have overcome the world. Go ye therefore and teach all nations.' The names of several academic disciplines surround the mural including education, science, medicine, politics, agriculture and industry. The stained glass window is an important character-defining element, connecting the educational and religious objectives of the college.

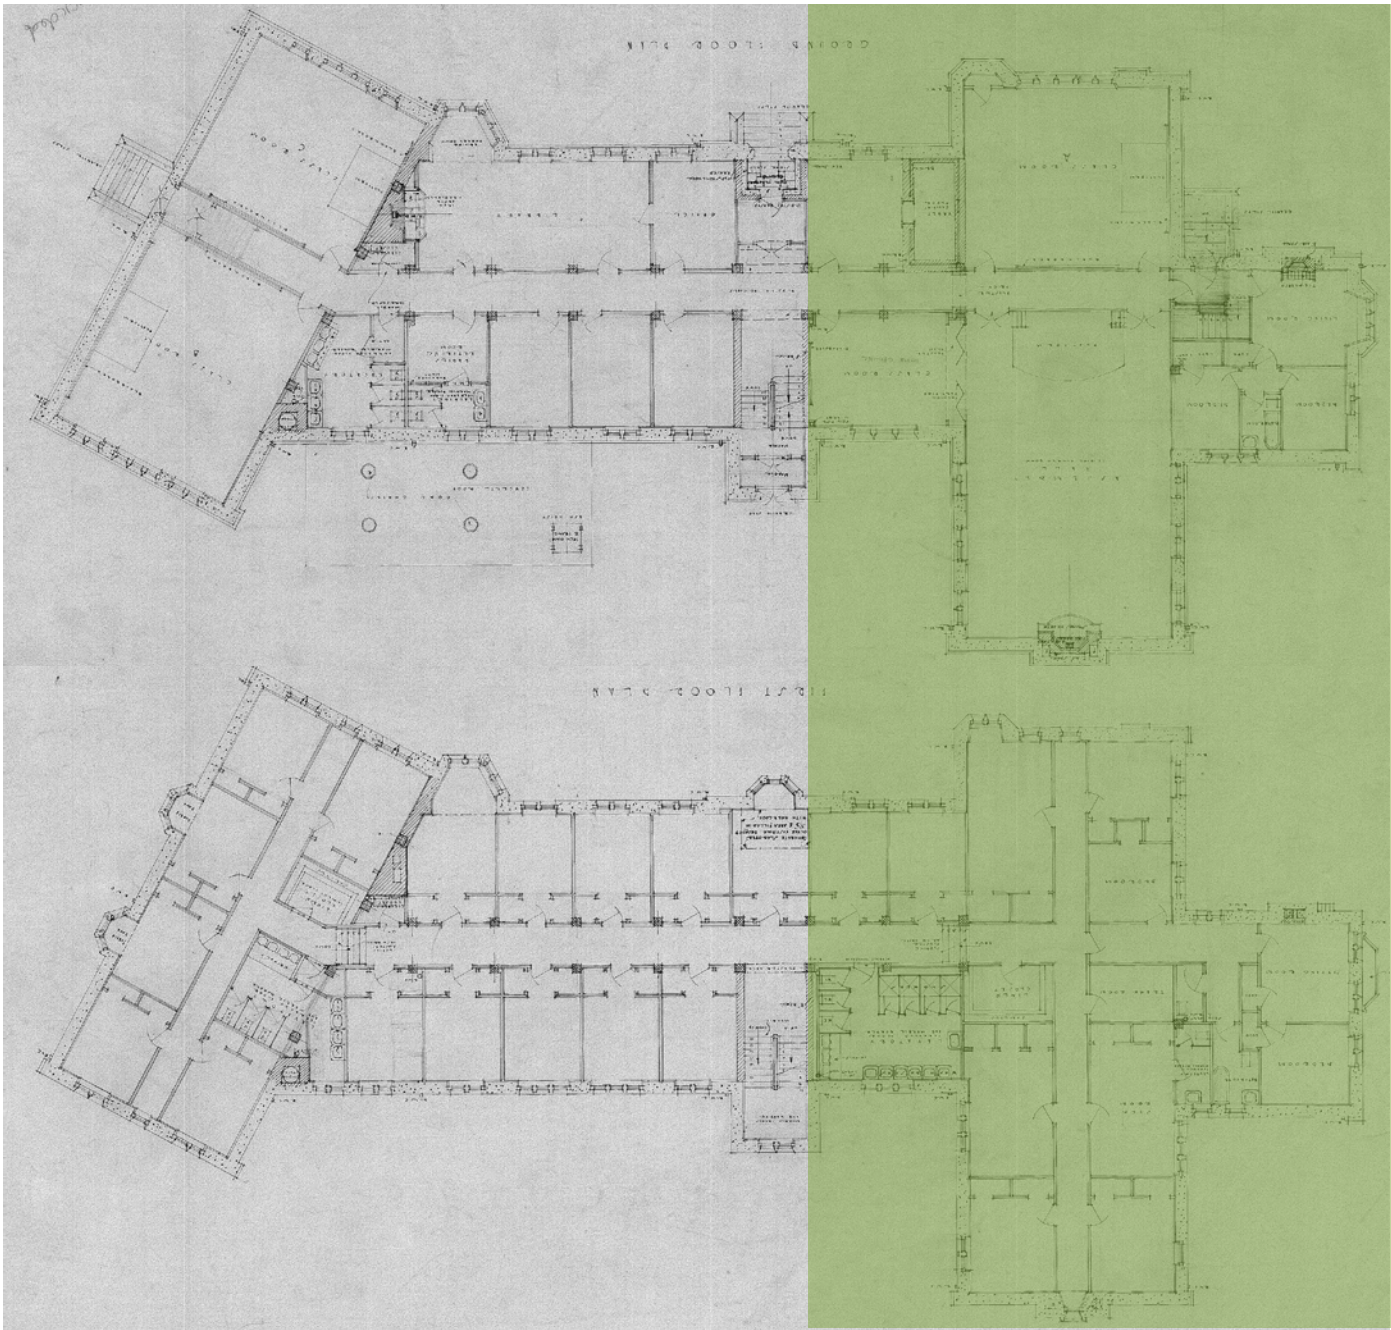
Figure 48. Top to bottom: preliminary ground and first floor plans of St. Andrew's College including many unrealized features. The areas shaded in green were never built, nor were the oriel windows. The rest of the plan is accurate. Retrieved from Facilities Management Asset Record System, File SC-93-P.

The spatial configuration of St. Andrew's College has been altered relatively little, and retains a high degree of heritage value. The building was built in two phases, the first beginning in 1922, the second in 1959. Notably, the initial structure was always anticipated to grow. Early plans show the 1922 building with an extra wing appended to its east side (Figure 48). However, this early proposed addition was not constructed; the 1959 addition was built to a new

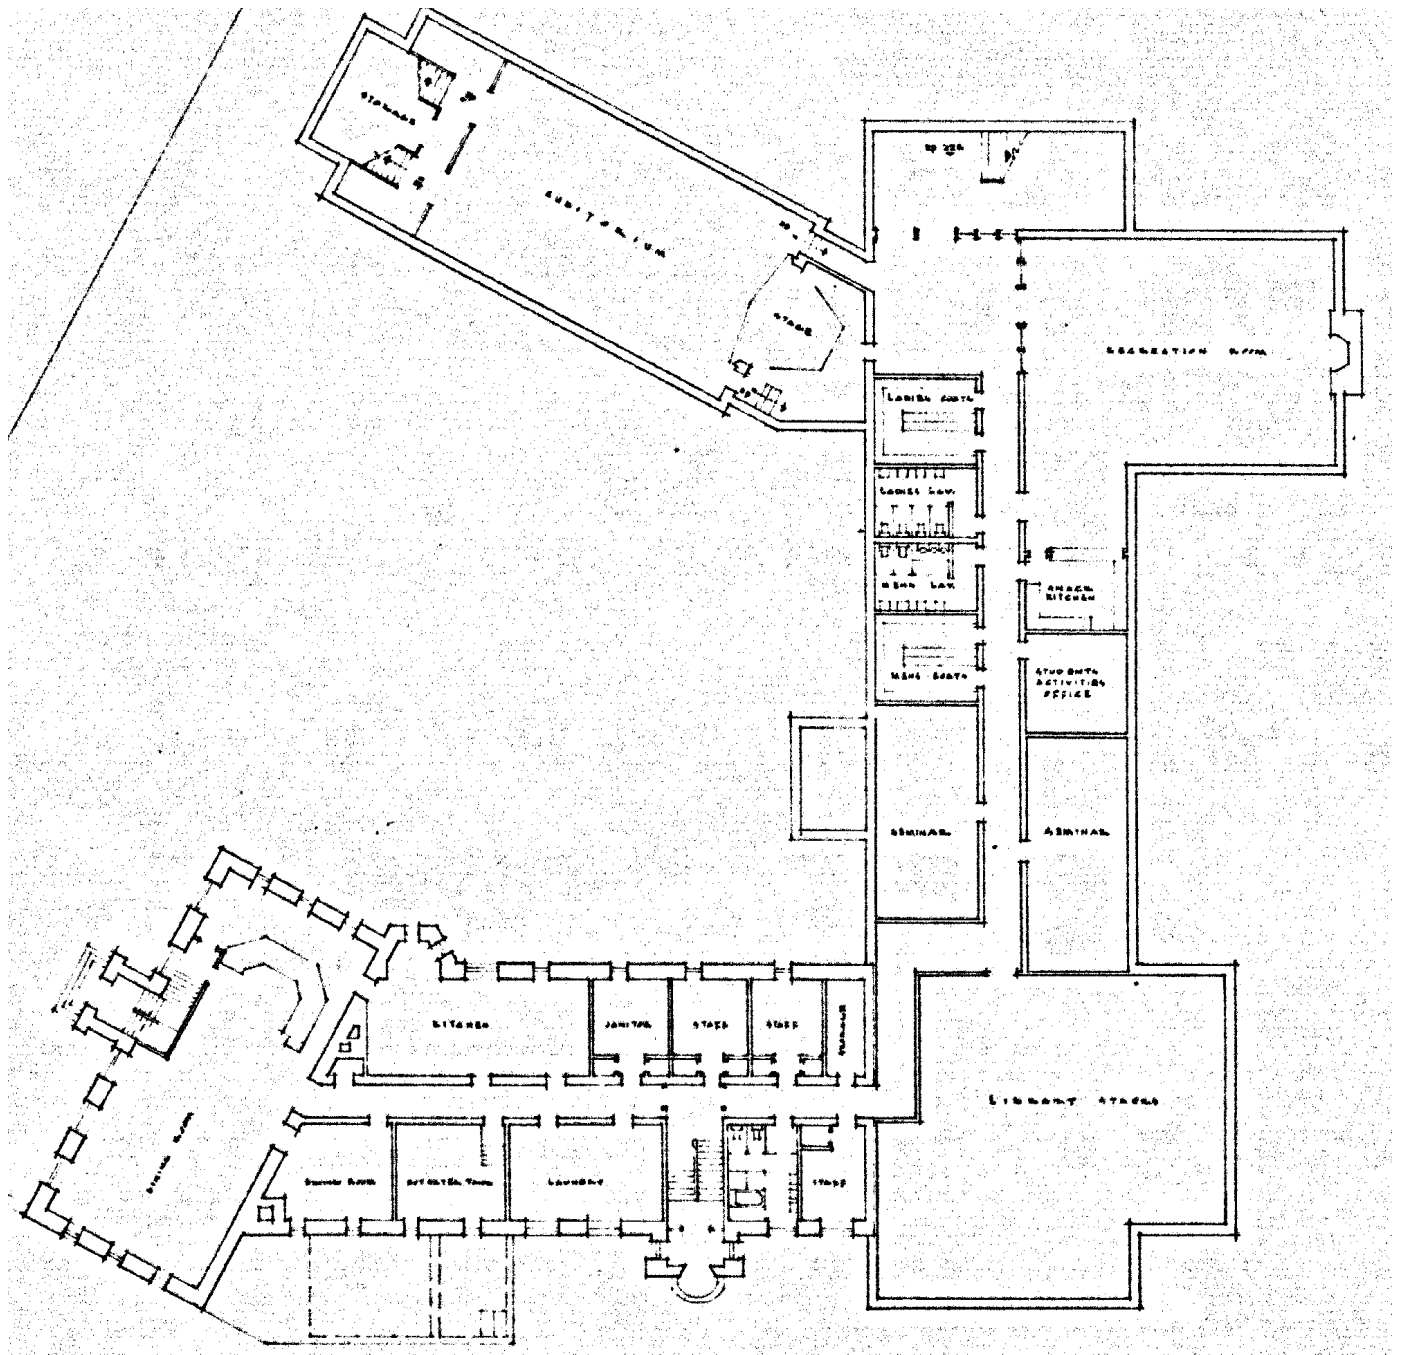
Figure 50. Basement floor plan of St. Andrew's College after completion. Retrieved from Asset Record System, File SC-41-T.

In general terms, the building is laid out with its larger feature spaces – a chapel, a library, a student lounge and a classroom – located at the extremities of the plan and connected by a series of double loaded corridors, with smaller rooms arrayed on either side. The plan of the basement provides an indication of the typical arrangement (Figure 50). Subtle changes have occurred, for example, dormitory rooms have been converted to offices, but the general arrangement of spaces remains intact.

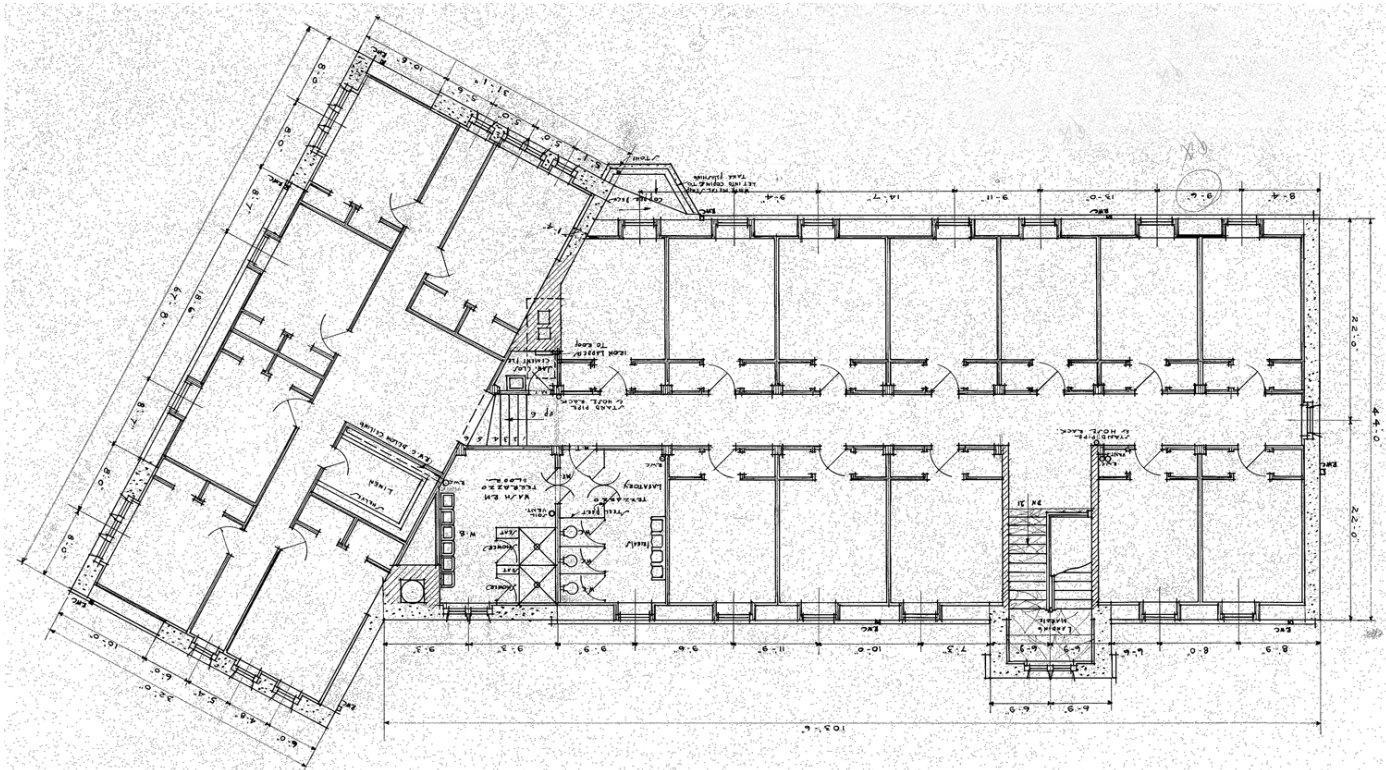
Figure 51. Attic plan of 1922 wing of St. Andrew's College. Retrieved from Facilities Management Division Asset Record System, File SC-14-T.

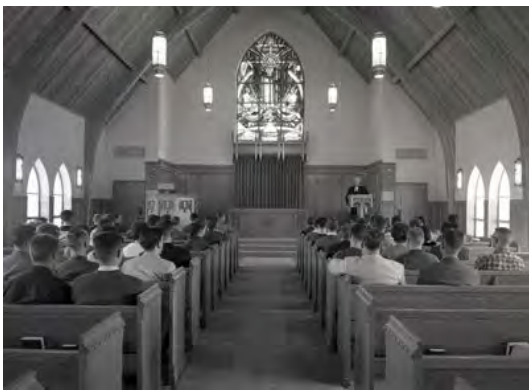
Figure 52. Chapel interior. Photo A-10767, retrieved from University of Saskatchewan Archives.

Some of the larger feature spaces merit special mention with respect to spatial configuration. The chapel adheres to gothic precedent as a high vaulted space with an open choir loft. Its east-facing nave is typical of Christian architecture and is character-defining. The orientation of the nave is determined by the configuration of the choir loft facing towards the stage at the east end of the chapel. Behind the low stage is the focal point of the room, a large stained glass window. The high vaulted ceiling of the chapel and the choir loft which faces the stained glass window and altar are character-defining elements. The spatial qualities of the chapel are visible in Figure 52.

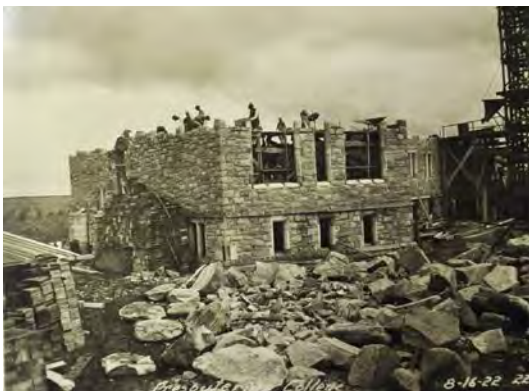
Figure 53. A 1922 construction photo. Photo retrieved from St. Andrew's Archives, File STA.J.3.1.1-18.

The 1922 and 1959 portions of the building differ in their structure. The exterior stone walls of the 1922 portion were built to be load-bearing. They are probably lined on the interior with hollow clay tile, although the original drawings do not show this detail. Concrete lintels span the window and door openings in the exterior walls. The exterior walls sit on cast-in-place concrete foundations and footings. The two interior corridor walls are constructed of load-bearing brick. Floors are cast-in-place concrete slabs on concrete joists. The roof is supported by a steel truss system which is concealed in the attic. Interior partition walls are constructed of clay tile. Terracotta tile was also used to fur down the ceiling in the attic. Figure 53 shows the construction of the exterior stone walls with a pile of clay tile visible.

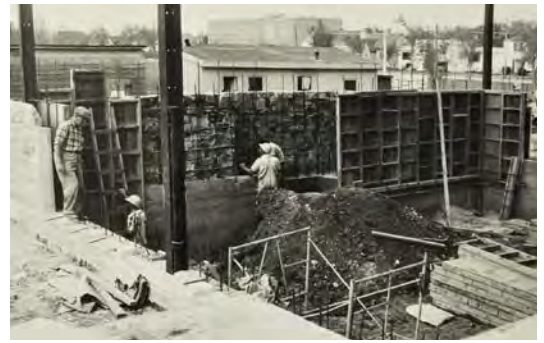
Figure 54. A 1959 construction photo. Photo retrieved from St. Andrew's Archives, File STA.J.21.10.1-43

The 1959 structural strategy differed greatly from that used in the early 1920's. The primary structural system is a steel frame, consisting of steel columns with open web steel floor joists supported on steel beams and girders. The exterior walls are a hybrid system; structural steel columns are embedded in cast-in-place concrete walls, which are faced on the exterior in greystone. The greystone exterior was used as formwork for the concrete. The photograph in Figure 54 shows the building under construction, with all the elements of this system clearly visible. The 1959 addition included the construction of a chapel, with a roof structure distinct from the rest of the building (Figure 40). The pitched roof is supported by a series of glue-laminated wooden scissor trusses and wooden purlins, with exposed wood decking exposed on its underside. The bottom chords of each truss take the form of a pointed arch, creating a vaulted space. The structure of the chapel is a character-defining element.

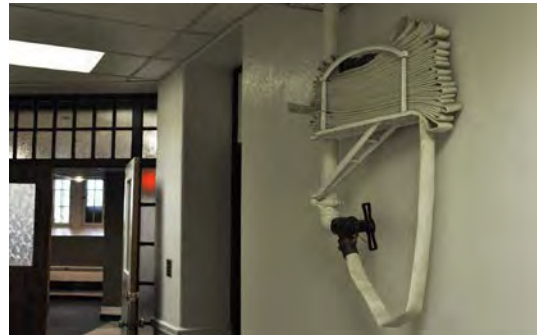
Figure 55. Fire hose apparatus.

The 1922 wing of the building still contains its original cast iron radiators (Figure 10) and the original fire hose apparatus. Some of the fire hoses appear to still be in use (Figure 55). The radiators and fire hose system are character-defining elements for their material and aesthetic value.

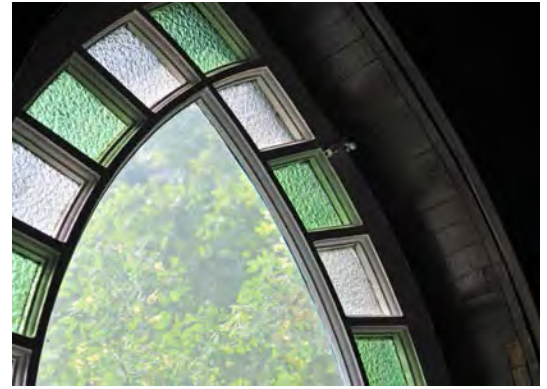
Figure 3. Wood-framed stained glass windows.

As a wooden building on a predominantly stone campus, Rugby Chapel distinguishes itself from its surroundings. Both the interior and exterior, shown in Figures 1 and 2, are finished in wood. Wood-framed stained glass windows (Figure 3) punctuate the building's façade and bring light into the nave and transept. The larger and more intricate stained glass of the Memorial Window is built as a steel-framed insert within a wooden framed opening. Inside the building, wooden roof trusses, ceilings and wainscoting create a continuous wooden interior. The original hardwood floors have been covered in carpet. The sanctuary features wooden wainscoting with plaster walls and ceiling (Figure 4). Fixtures and furnishings such as the pulpit and pews shown in Figure 5, the sanctuary balustrade and the altar are also wooden. The wood is in good commemorative condition save for some water damage that took place in 2012 causing some staining and warping.

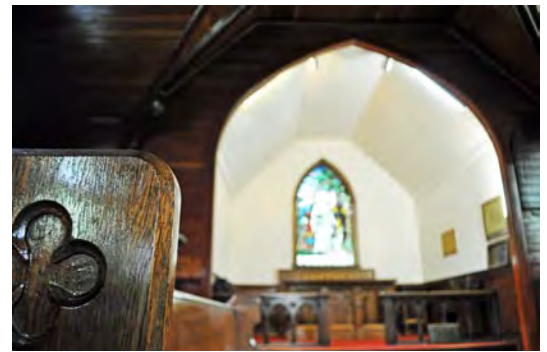
Figure 4. The sanctuary framed by a gothic arch.

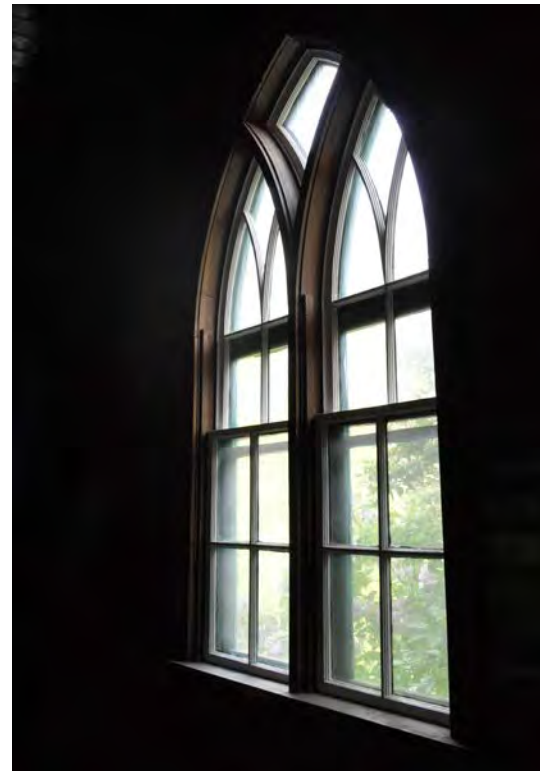
Figure 7. Pointed arch windows. The tracery is also in the shape of pointed arches.

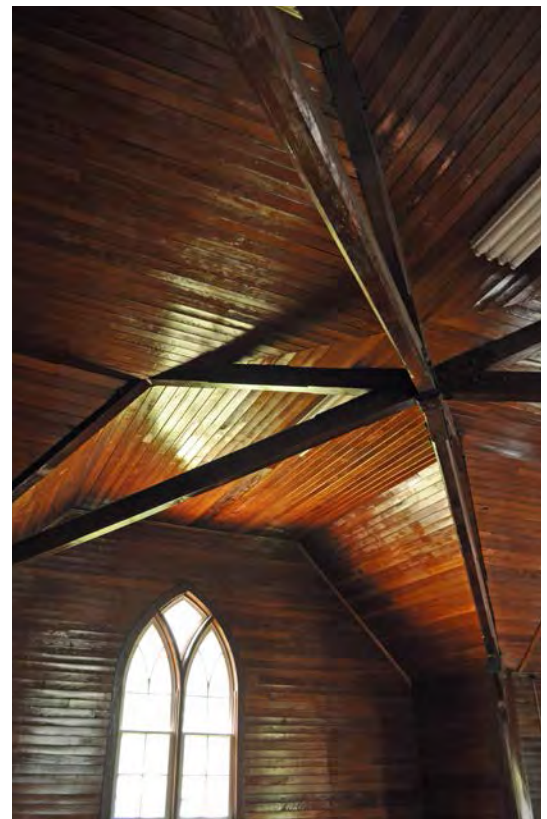
Figure 8. The ceiling is shaped to create a vault and dome effect on the church interior.

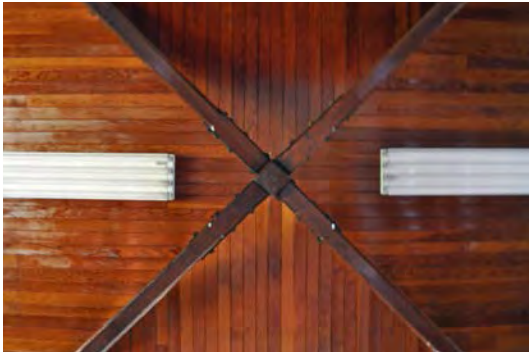
Figure 11. Fluorescent lighting has been added.

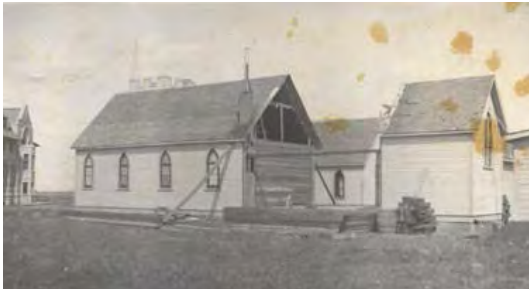
Figure 12. 1912. Rugby Chapel after its move to the University of Saskatchewan with the chancel cut off. Emmanuel College is visible to the left. Photo A-332, retrieved from <http://sain.scaa.sk.ca/items/index.php/emmanuel-college-rugby-chapel;rad>

The current configuration of the chapel is the result of an addition carried out when the building was moved from Prince Albert to Saskatoon in 1913. At that time, the chapel was expanded to seat 200 people rather than 150. The ceiling was raised and the walls decorated in 1922. Also in 1922, a furnace replaced the three heating stoves that had previously served the church. The stained glass 'Memorial Window' (Figure 14), commemorating veterans of the First World War, was added in 1926.

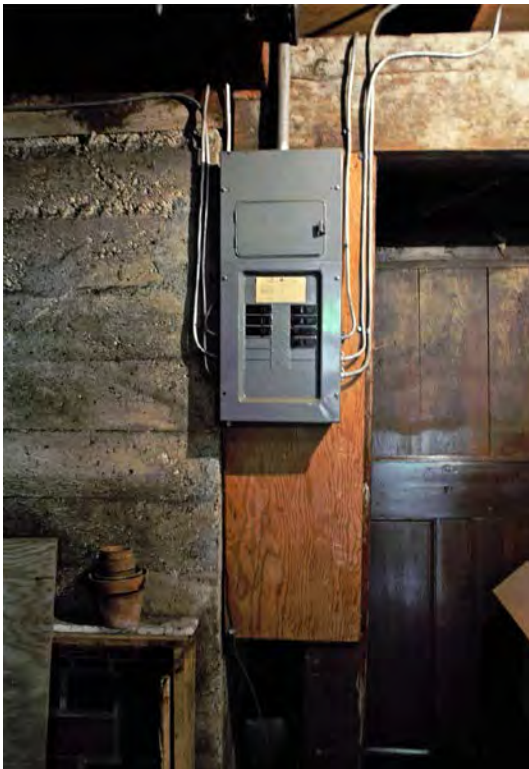
Figure 13. Concrete foundation walls and a wooden post and beam system.

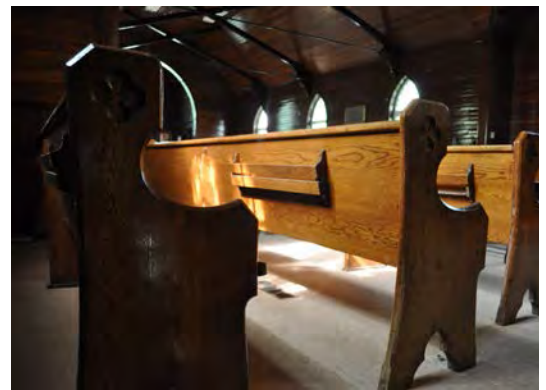
Figure 22. The Chapel's pews have pointed arches carved to form their feet and carved ornamentation on the exterior of the armrests.

The original pipe organ no longer exists; however, the chapel contains two organs and a piano. Although not original to the church, the older of the two organs has candleholders which suggest its advanced age (Figure 21). Several oak church pews are still arranged in the transept. Figure 22 shows the pews with their pointed arch bases. The oak altar, also intricately carved with trefoil gothic arches, still holds its place in the sanctuary (Figure 23).

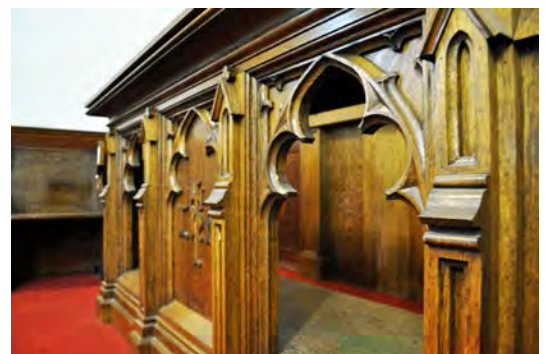
Figure 23. The altar is carved with openings in the form of a trefoil pointed arch.

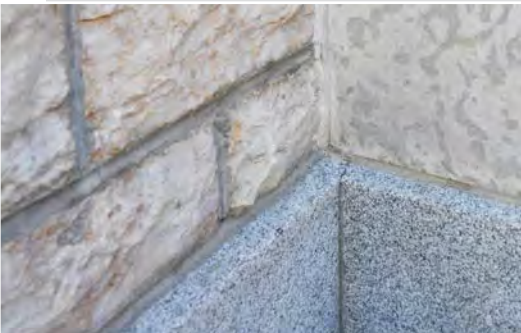
Figure 1. Greystone, Tyndall stone and granite base.

The exterior of STM is constructed of 'greystone' walls, with cut Tyndall stone trim, on a granite base course (Figure 1). The greystone, a stone native to the South Saskatchewan River valley, defines much of the campus, and was a choice of materials intended to associate St. Thomas More College with the larger university. (For further information on the stone materials used in this building, refer to [Appendix: Stone.](#)) Other exterior materials include slate tile roofing, copper downspouts, and steel exterior light fixtures (Figures 2 & 3). The oldest parts

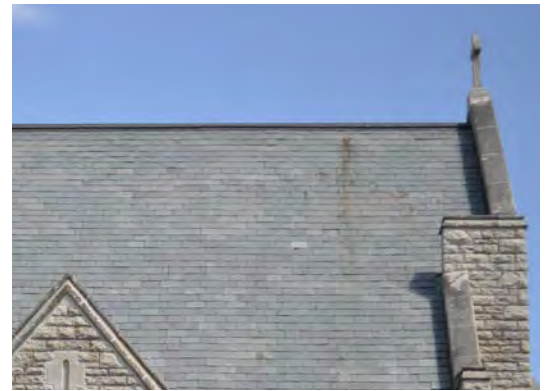
Figure 2. Slate tile roofing.

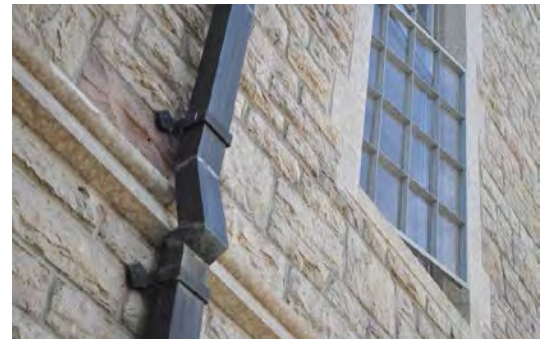
Figure 3. Copper downspout and painted steel window sash.

of the building have painted steel sash windows with multiple divisions (Figure 3). The newer portions of the building have aluminum framed glazing (Figure 4). In these cases the glazing is not divided into smaller lites, but rather larger panes of glass are used. The original exterior materials are character-defining elements.

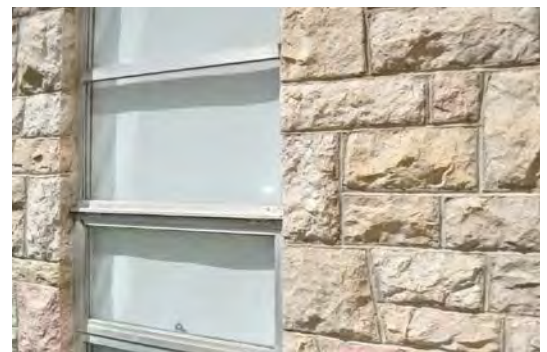
Figure 4. Aluminum framed windows set into a field of greystone.

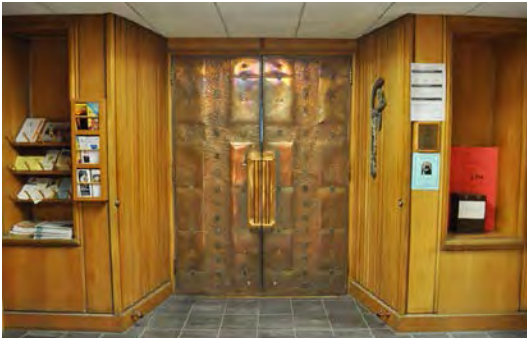
Figure 6. Copper doors set into oak panelled walls.

The interior of the 1954 section of the building has retained most of its original character-defining materials. Four sets of copper doors were a gift of the Emmett Hall family and were designed and constructed by the Vancouver artist, Lionel Thomas. The doors are fabricated from kiln-dried fir and covered with sheets of copper. The copper doors feature various designs including the crests of St. Thomas More and John Henry Newman (Figure 6).

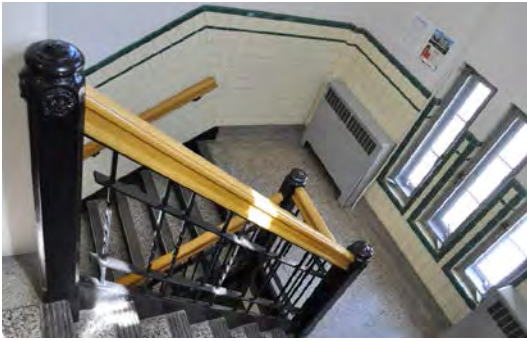
Figure 7. Character-defining stairwell materials.

In the 1954 wing, the main stair has an oak banister and painted steel balustrade (Figure 7). The steel newel posts feature the flower motif found commonly in other early University of Saskatchewan buildings. Terrazzo treads have been retained on the upper floors and landings. Glazed ceramic tile wainscoting is used on the upper portion of the staircase (Figure 8). Oak wainscoting has been applied to many of the walls in the 1954 wing, but is not original to the building. Recent renovation work has shown that in at least some places, the original glazed tile wainscoting exists beneath the oak paneling. Original red terra cotta tile flooring has also been exposed in the original 1954 building (Figure 9). The corridors of the upper floors still have their original maple doors with stainless steel fixtures (Figure 11). Some of the brass door numbers remain.

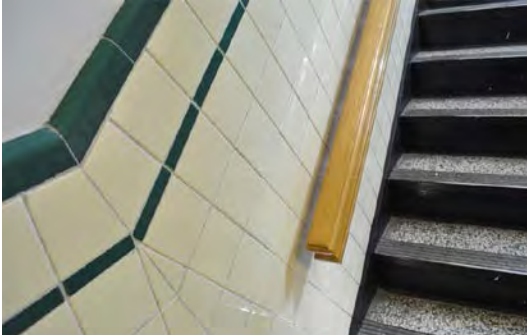
Figure 8. Glazed ceramic tile wainscoting, oak banister, steel stair and terrazzo treads.
