University of Saskatchewan

Heritage Register

September 2013

Facilities Management
Division

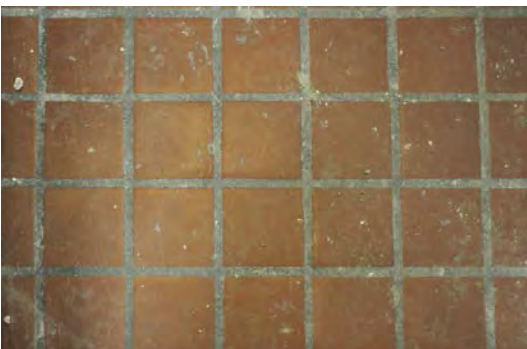
Figure 9. Red clay tile flooring.

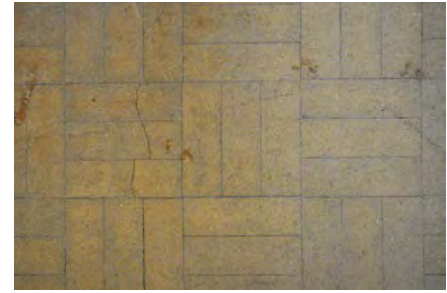
Figure 10. Patterned concrete tile.

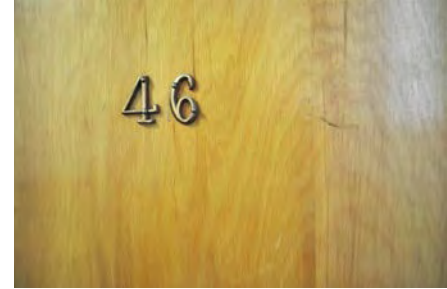
Figure 11. Maple door with brass numbers.

In the 1954 wing, the main stair has an oak banister and painted steel balustrade (Figure 7). The steel newel posts feature the flower motif found commonly in other early University of Saskatchewan buildings. Terrazzo treads have been retained on the upper floors and landings. Glazed ceramic tile wainscoting is used on the upper portion of the staircase (Figure 8). Oak wainscoting has been applied to many of the walls in the 1954 wing, but is not original to the building. Recent renovation work has shown that in at least some places, the original glazed tile wainscoting exists beneath the oak paneling. Original red terra cotta tile flooring has also been exposed in the original 1954 building (Figure 9). The corridors of the upper floors still have their original maple doors with stainless steel fixtures (Figure 11). Some of the brass door numbers remain.

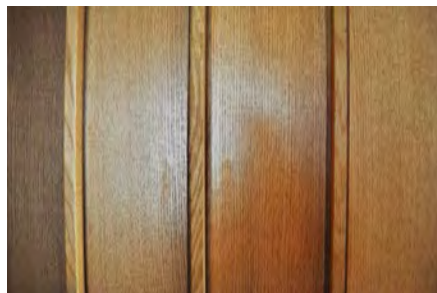
Figure 16. Oak wall paneling in the Chelsea Commons.

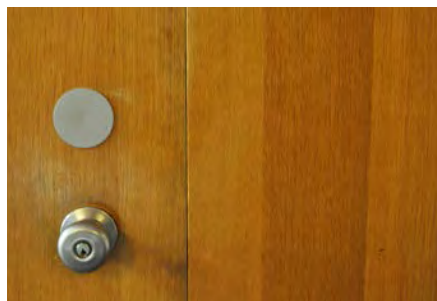
Figure 17. Oak door and wall panel with rabbitted frame and stainless steel knob.

surface of the wall continuous (Figure 17). Throughout, materials are characterized by a lack of embellishment. The lecture room in the 1969 addition features the cedar panel roof, oak doors and window surrounds found in earlier portions of the building. The student lounge features a terrazzo floor. A greystone wall, formerly on the exterior of the building, has been enclosed as an interior element in the lounge space.

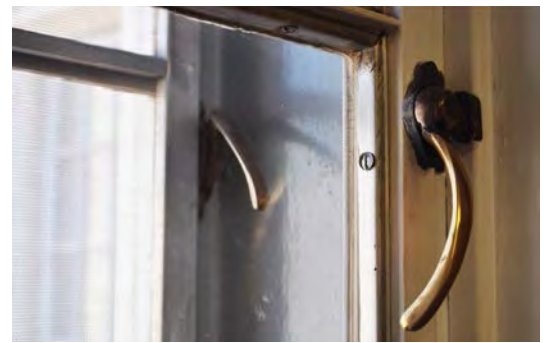
Figure 12. Brass window fixtures.

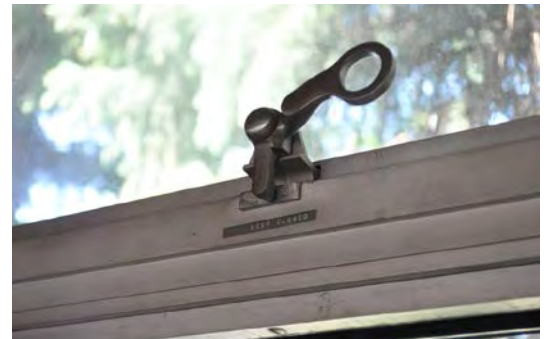
Figure 13. Aluminum window frame and steel handle.

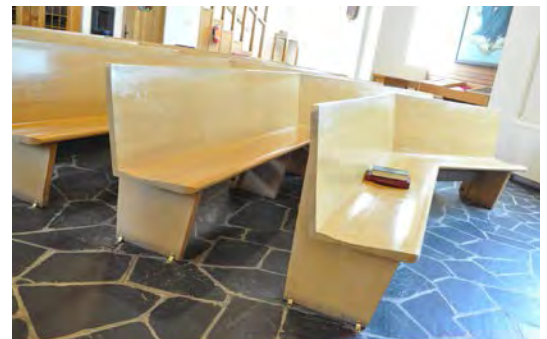
Figure 14. Black slate flooring, oak pews.

The chapel has walls of white plaster contrasted with exposed glue-laminated wood arches, and cedar paneling (Figures 15 & 30). The ceiling is also finished in cedar paneling (Figure 15). Stained glass windows, designed by Robert Rambusch of New York, are the focal point of the south wall. Vancouver artist Lionel Thomas was commissioned to design a mural, painted on oak panels, in the cantilevered recess at the north end of the chapel. The same artist designed the black granite altar. The black granite of the altar is sandblasted to give it texture and several wall mounted fixtures are made of the same material. The pews in the chapel are made of a light stained oak (Figure 14). The floors of the chapel are finished in black slate flagstones (Figure 14).

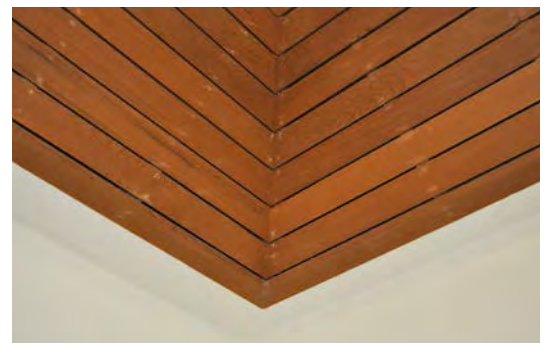
Figure 15. Cedar paneling on ceiling.

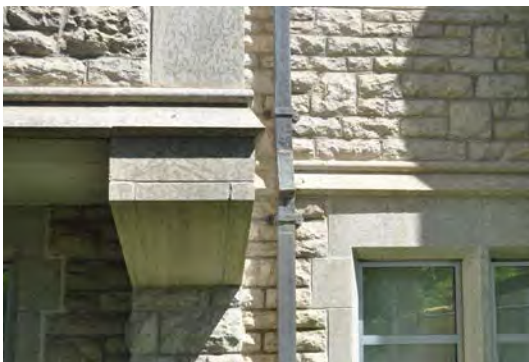
Figure 19. Tyndall stone corbels and string courses.

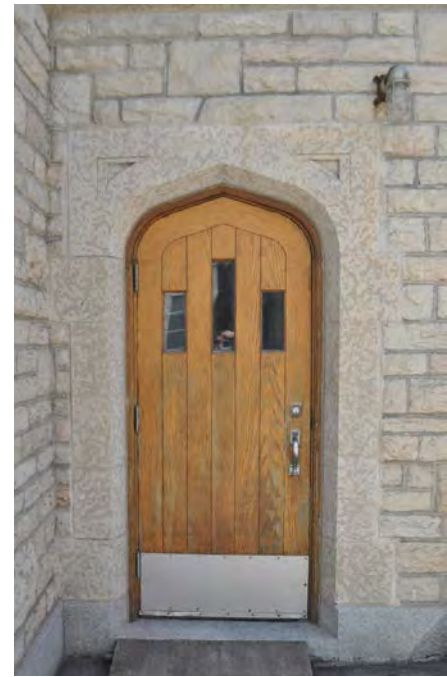
Figure 20. Arched door.

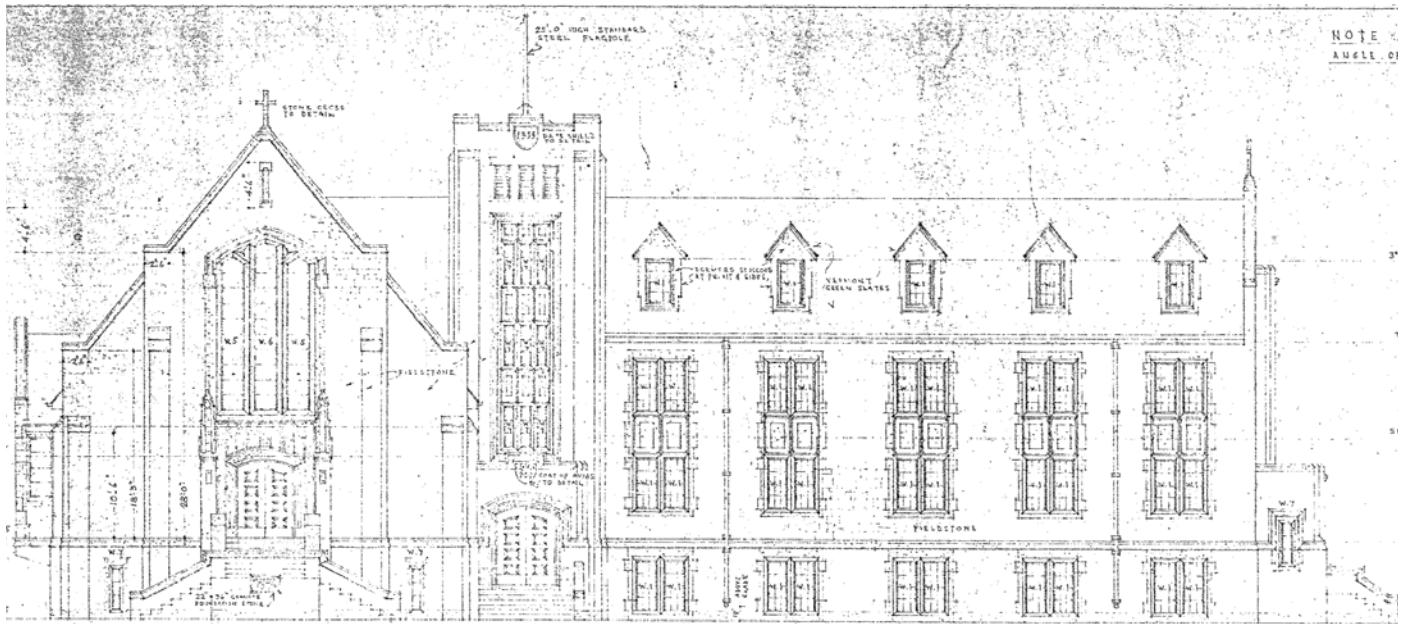
Figure 21. South elevation of the 1954 portion of the STM building depicting numerous character-defining elements of the Collegiate Gothic style. Retrieved from Facilities Management Division Asset Record system, File 934-241-T.

The exterior of the 1954 portion of the building is Collegiate Gothic in its style, although the expression of the style, particularly in the design of the chapel, is restrained and simplified in comparison to earlier examples. The front elevation of the chapel places an emphasis on its vertical elements, with its slender buttresses and tall, narrow lancet windows with stained glass. The doors to the chapel are clad in copper and set into an arched opening. The west elevation has an almost Modern expression of a series of cantilevered stone bays. The rest of the 1954 wing is more conventional, featuring typical Collegiate Gothic elements. A 'Norman' tower rises to the east of the chapel, and marks the main entrance. The roof is gabled, with a flattened top, and peaked dormer windows. The walls are in rough-faced greystone, with Tyndall stone string courses, windows surrounds, quoins and archer slots (Figures 21 & 22).

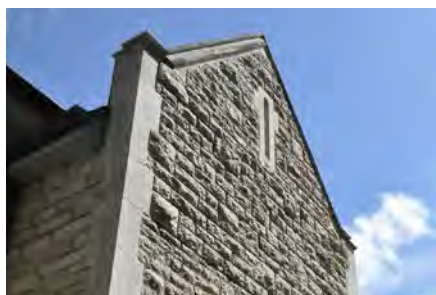
Figure 22. Tyndall stone quoins and arched slots adorn a peaked parapet.

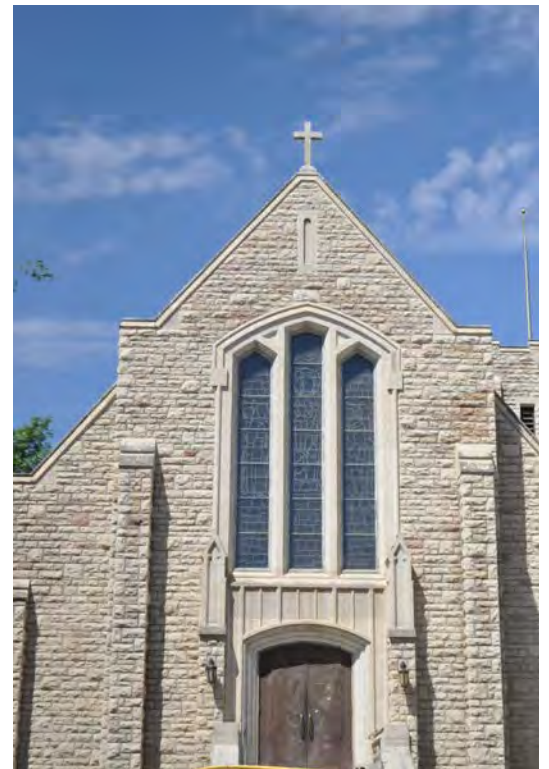
Figure 23. Lancet windows set into a gothic arch formed in stone. Stone piers and references to statuary niches flank the arched entry.

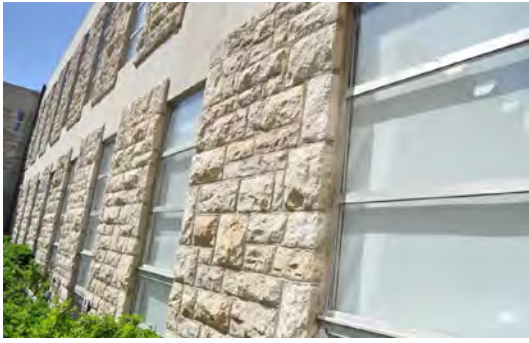
Figure 24. Typical arrangement of windows on the modern portions of the building.

Tyndall stone (Figure 24). Vertical windows separate the greystone panels. The northern stair tower is detailed in a modernist way, as a series of slender Tyndal stone columns separated by narrow windows stretched over the full height of the tower (Figure 27). The 1969 addition follows the same principles and is largely indiscernible from the 1963 portion.

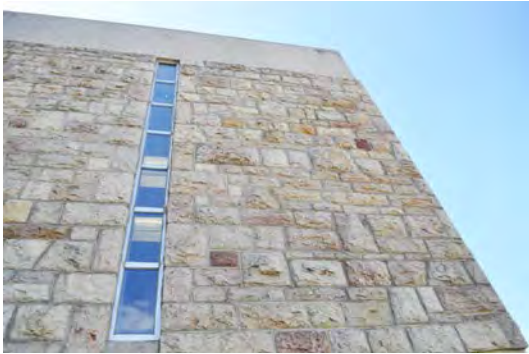
Figure 25. Narrow windows make reference to historical archer slots.

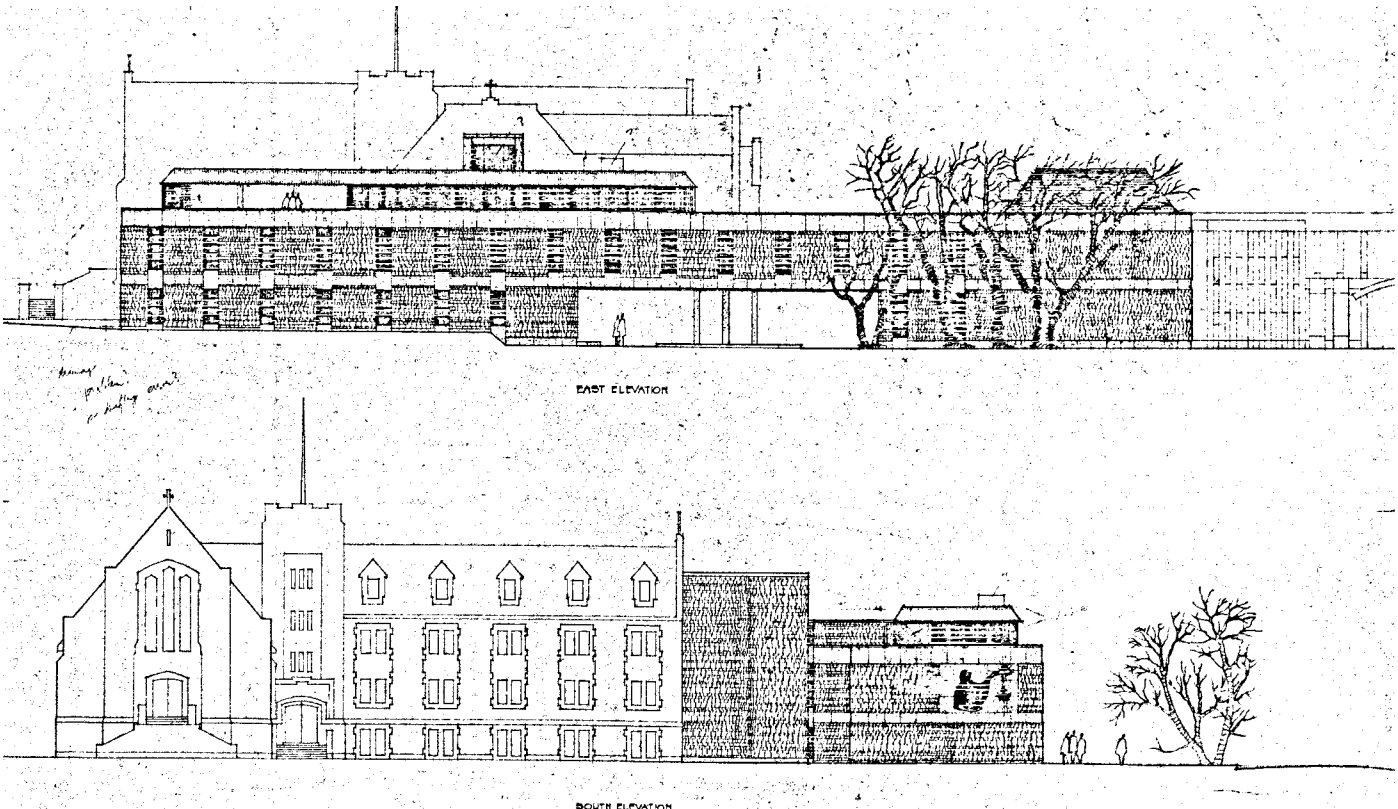
Figure 26. Elevations of STM College after the completion of the 1960's addition. Retrieved from Facilities Management Division Asset Record system, File ST-81-T.

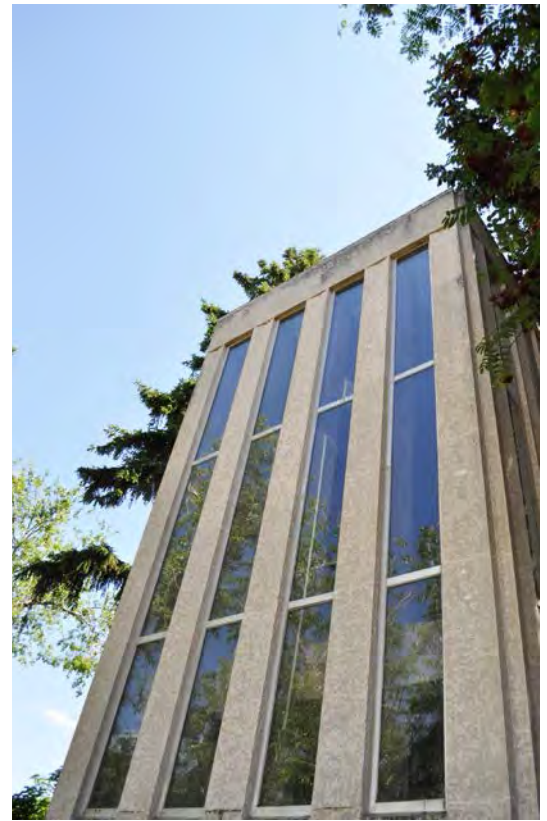
Figure 27. Stair tower.

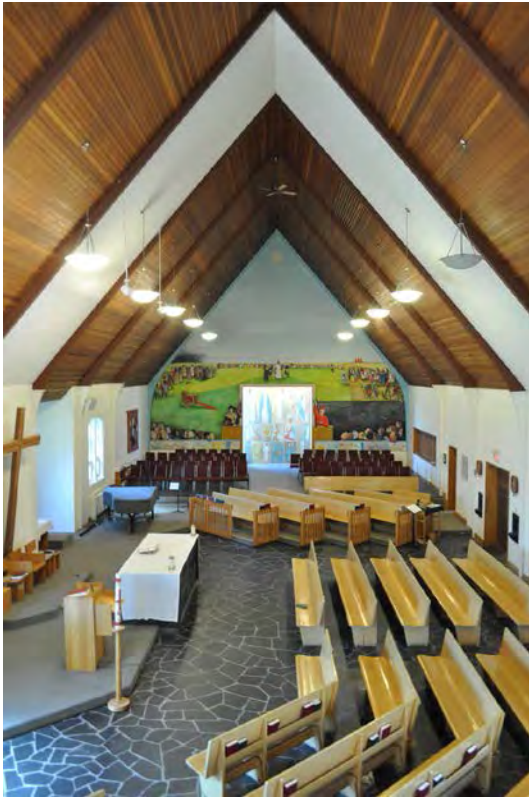
Figure 30. The current configuration of the chapel with the pews facing west. The high ceiling is a character-defining element.

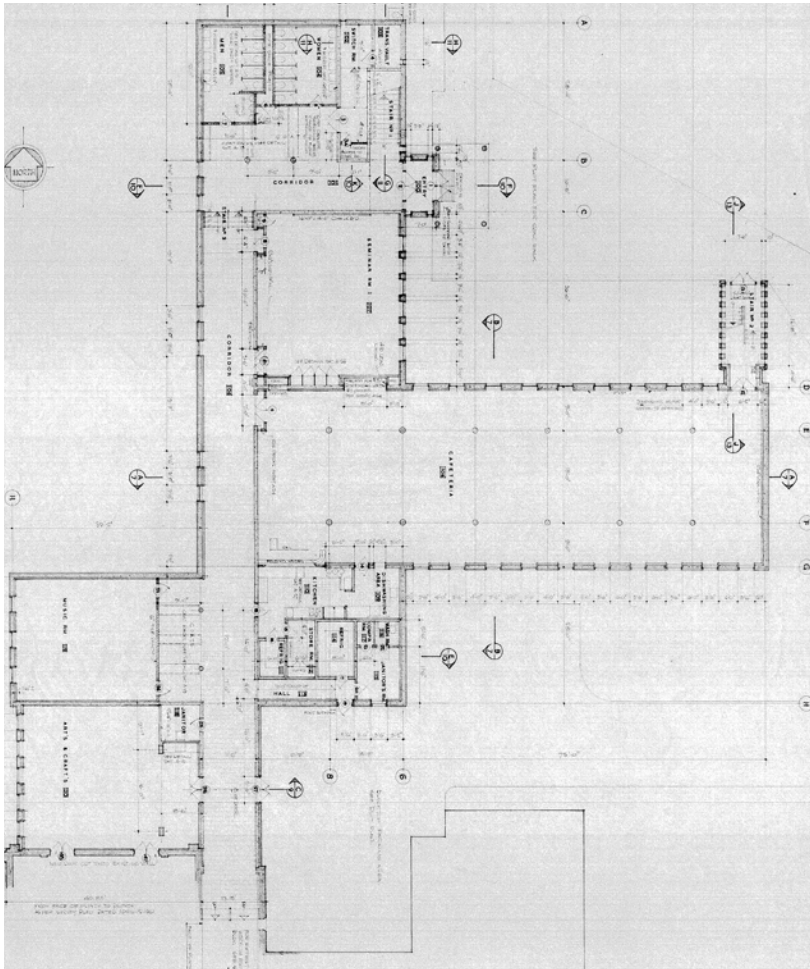
Figure 32. The first floor plan of the 1963 addition. Retrieved from Facilities Management Division Asset Record system, File ST-51-T.

The 1963 addition is located to the north of the original wing, and connects at the north side of the main entrance vestibule, just east of the chapel. On the basement level, it contains a large cafeteria, associated service spaces and a seminar room. On the 1st floor, the 1963 addition houses a library above the cafeteria, a seminar room, offices, and a 'walk-through' art gallery. Funding for the addition came partly from grants provided by the Canada Council for the Arts. In order to be eligible for more funding, the architect was challenged to designate as much of the building as possible to education in the social sciences and humanities. The walk through art gallery was conceived as a way of increasing the floor area in the building devoted to the arts, thereby increasing the value of the grant. By designating what would otherwise be considered a hallway as an art gallery, STM was able to secure more funding.

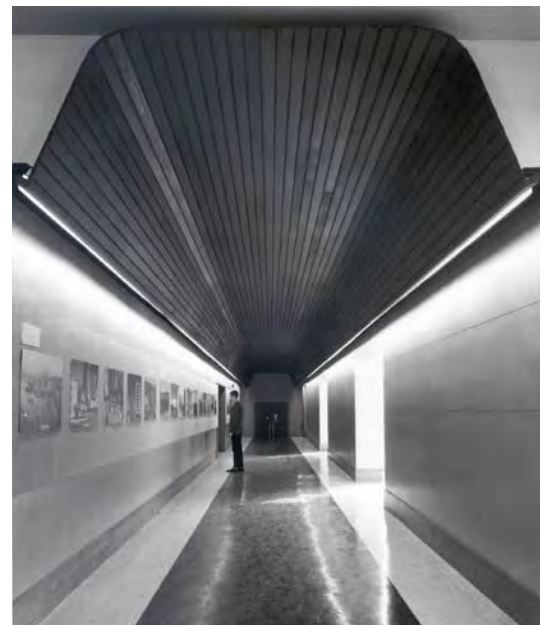
Figure 34. A 1963 photo of the gallery hallway. Light shed from the cantilevered lightwells is visible in the right half of the photograph. Photo A.31, retrieved from St. Thomas More College Archives.

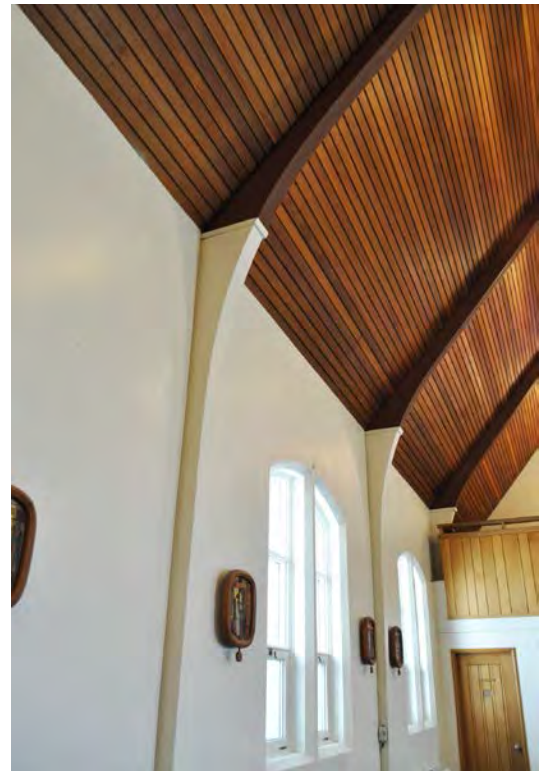
Figure 36. Exposed glue-laminated ribs in the chapel.

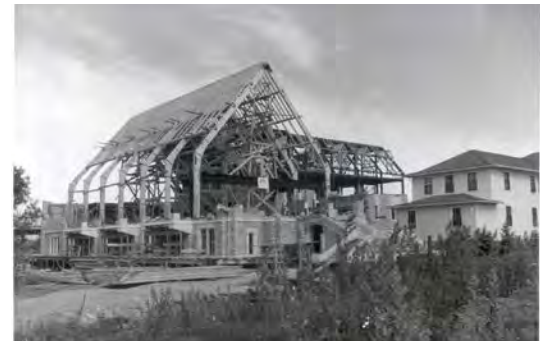
Figure 37. STM under construction, 1953-1956. Photo B.05, retrieved from St. Thomas More College Archives.

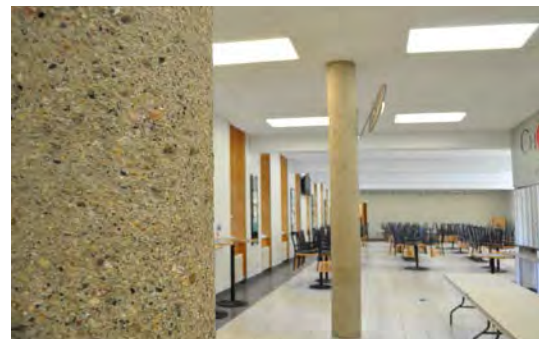
Figure 38. Exposed aggregate finish on concrete columns.

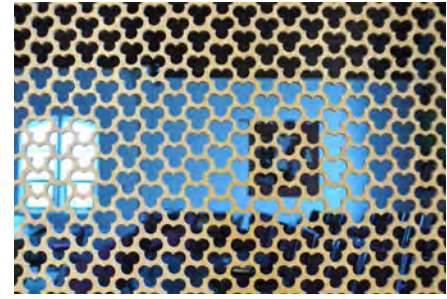
Figure 39. Wooden ventilation grille.

The building features several intricate wooden grilles where ventilation and cooling are delivered. The chapel has a wooden screen in a geometric pattern (Figure 39). This operable screen can be opened or closed to control ventilation. Above the library door is a grille made from walnut. The cafeteria features a large oak grille. Many windows feature wooden radiator covers. The cafeteria has retained its original radiators, which are still in use. One can be found beneath each window. The radiators are character-defining as a visible system indicative of the time of construction.

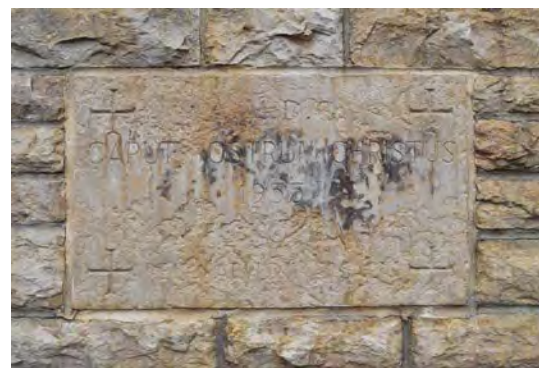
Figure 50. The cornerstone, showing signs of weathering.

The cornerstone of the building is located on the stone wall of the exterior chapel stair. The stone is weathered and much of the text is no longer discernible (Figure 50).

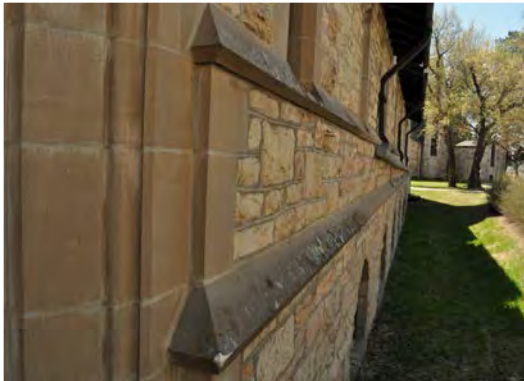
Figure 1. L to R: Sandstone accents, greystone wall.

The materials used to construct the College of Emmanuel and St. Chad are characteristic of and harmonize with the rest of the University of Saskatchewan campus. 'Greystone' makes up the exterior of the building. Sandstone was used for accents and the exterior steps and base were constructed of granite. Figure 1 shows sandstone string courses on a field of greystone. (For further information on building stones used at the U of S, refer to [Appendix: Stone](#).) The roof of the College of Emmanuel and St. Chad is clad in slate tile and is supported by wooden rafters. The rafter ends were extended as decorative elements on the exterior of the building, as shown in Figure 2. Also visible in Figure 2 are the copper eaves troughs. Copper downspouts carry rainwater to the ground.

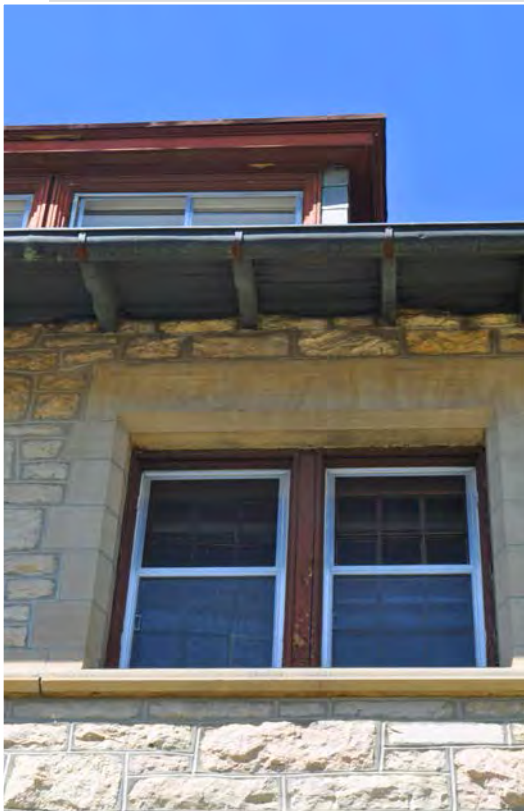
Figure 2. Carved wooden rafter ends.

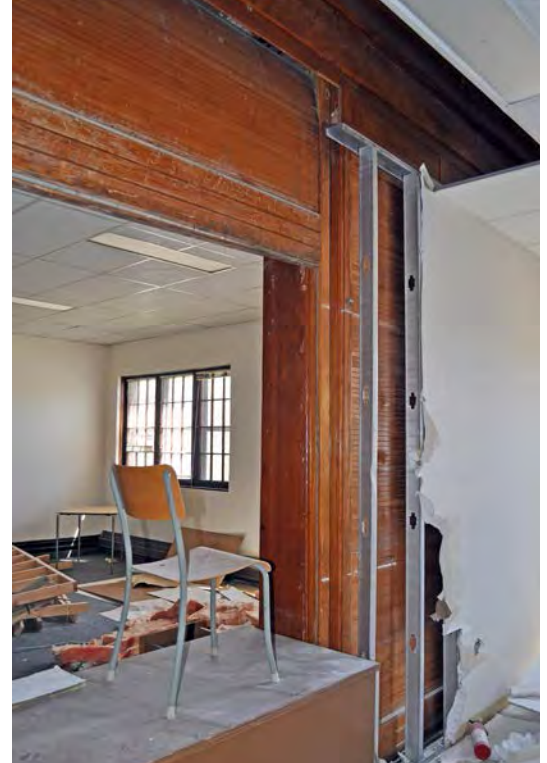
Figure 5. This coiling partition made of Douglas Fir was covered by gypsum board in 1992.

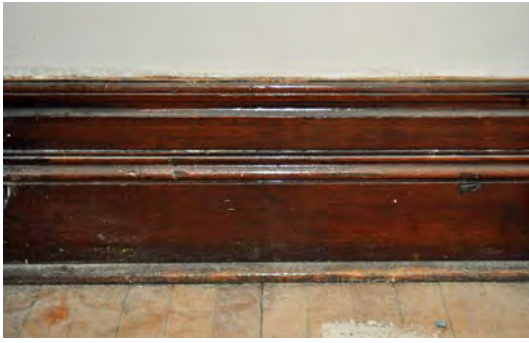
Figure 6. Top to bottom: Plaster wall, oak baseboards, original hardwood flooring.

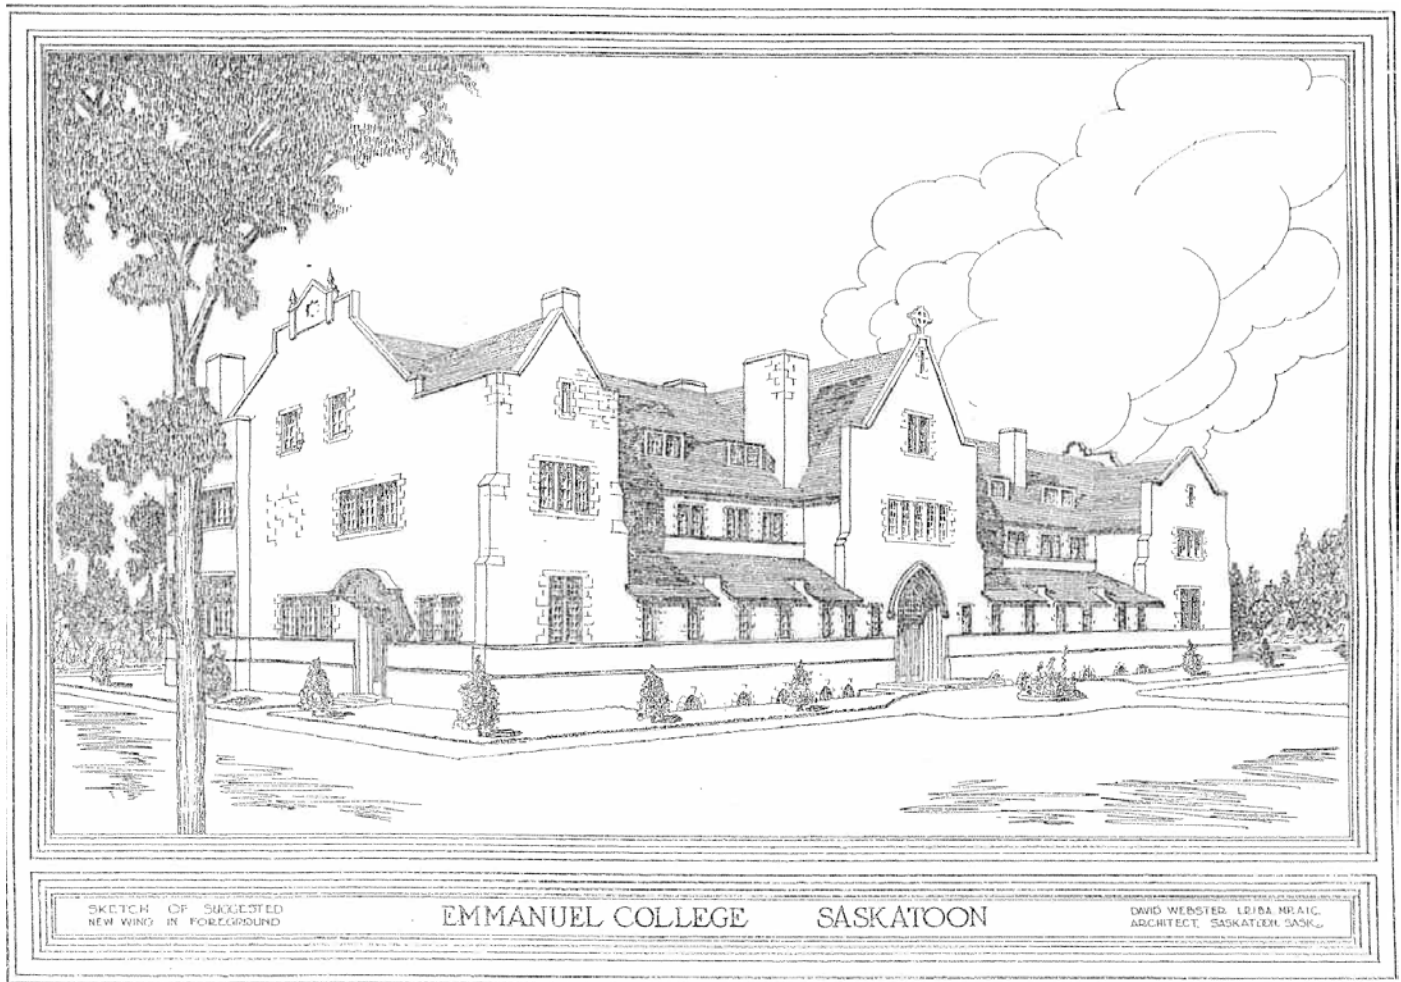
Figure 9. The College of Emmanuel and St. Chad building as originally intended. Call no. B124A, retrieved from Saskatchewan Archives Board.

The form of the College of Emmanuel and St. Chad, shown in Figures 8 and 9, is in keeping with the context of the University of Saskatchewan. The building consists of one three-storey volume. The floor plan is relatively narrow. The original design, shown in Figure 9, intended for the building to be larger than it was eventually built. A central house for the president was intended to be flanked by two wings. The original building was planned to accommodate 60 students. The First World War and the Great Depression intervened such that construction was never completed. Thus, the College of Emmanuel and St. Chad building, as an incomplete work of architecture, reflects its historical context and the events of its time.

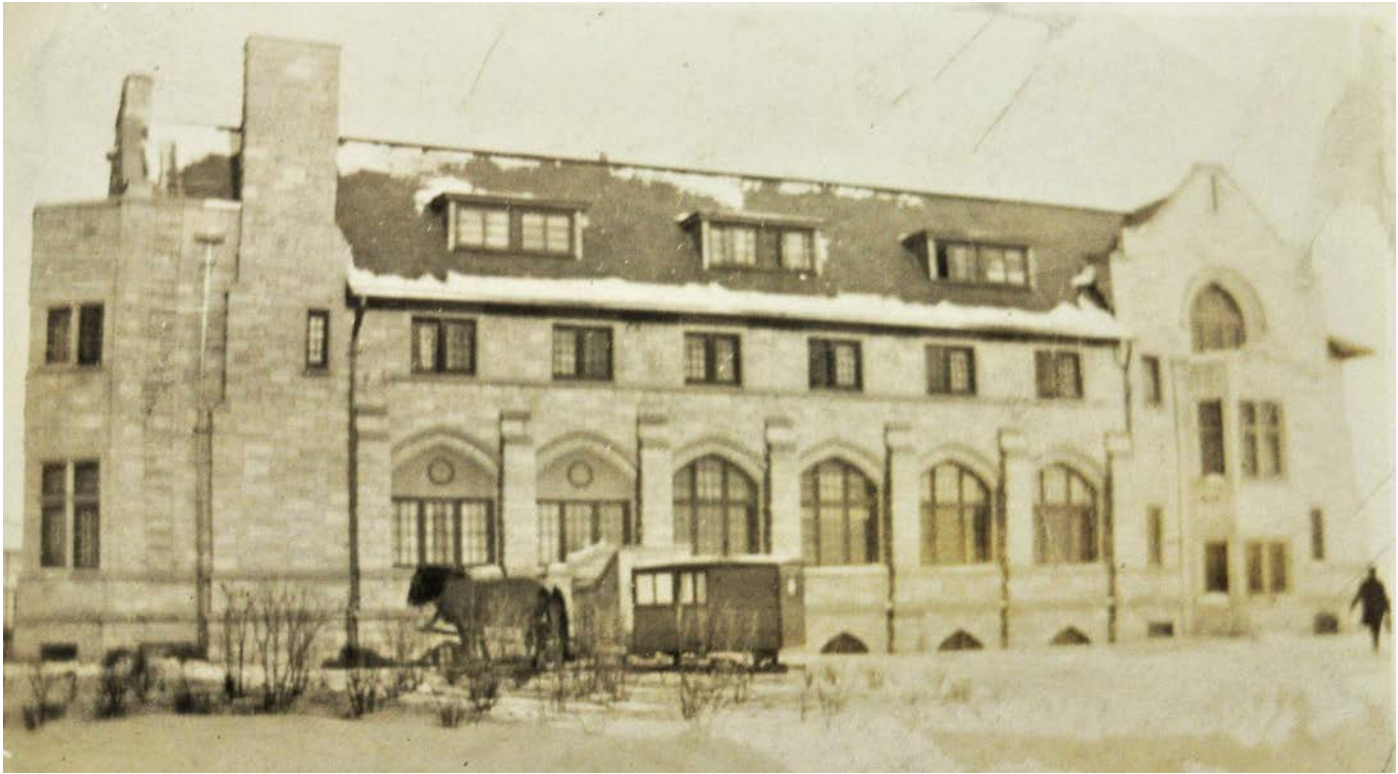
Figure 11. A photograph of the College of Emmanuel in 1925 shows elements of the Collegiate Gothic style: dormer windows, pointed arches, bay windows, and archer slots. To the left, two ground floor windows already feature a stucco treatment covering their arched transoms. Call no. B124.A.II.SB6715, retrieved from Saskatchewan Archives Board.

This style is manifested in the use of dormer and bay windows, gothic arched windows and doorways. Statuary niches and narrow false windows are used as decoration. Openings are surrounded by cut sandstone surrounds. Sandstone quoins adorn corners. Figure 11 shows some of the Collegiate Gothic elements that decorate the facade of this building. Figure 12 shows a bay window decorated with sandstone quoins. The principle entry is located prominently in an archway, pictured in Figure 13. Some slabs of stone were left blank, presumably intended as locations for future ornamentation.

Figure 11 shows an interesting asymmetry on the building's southern facade. Two of the six ground floor windows have had their arched transoms replaced by stucco panels. Today all six windows feature this treatment.

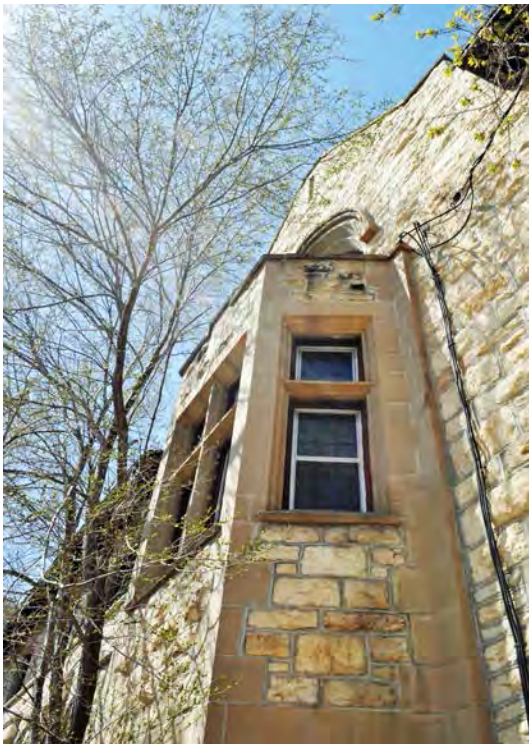
Figure 12. A bay window located on the south east corner of the College of Emmanuel and St. Chad. Sandstone quoins surround the window.

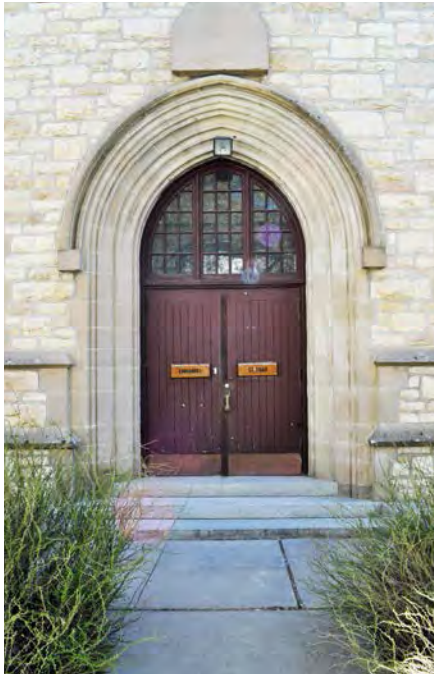
Figure 13. The principal entrance of the College of Emmanuel and St. Chad featuring a gothic arch and transom with stone blanks.

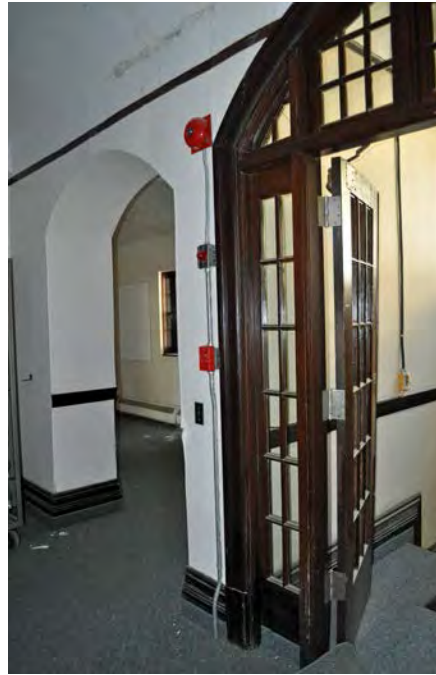
Figure 14. Arched entryways, hallways and doorways with arched transoms characterize the interior of the building as Collegiate Gothic.

The interior of this building is in an intermediate state of commemorative integrity. Figure 14 shows an example of an interior element that harmonizes with the gothic exterior. A ground floor corridor featuring a vaulted plaster ceiling, arched entries and transoms contributes to this effect. However, in many places these character-defining elements have been altered such that they no longer contribute to the heritage value of the building. (Refer to Figure 15.)

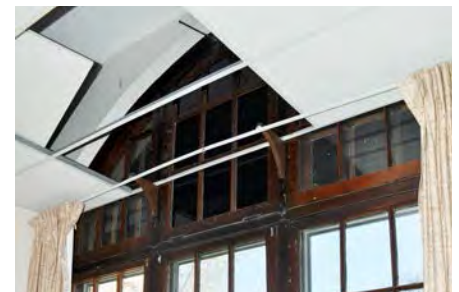
Figure 15. A gothic arch window. The arched transom has been hidden from view on the interior by a dropped ceiling. Stucco on obscures the window on the exterior.

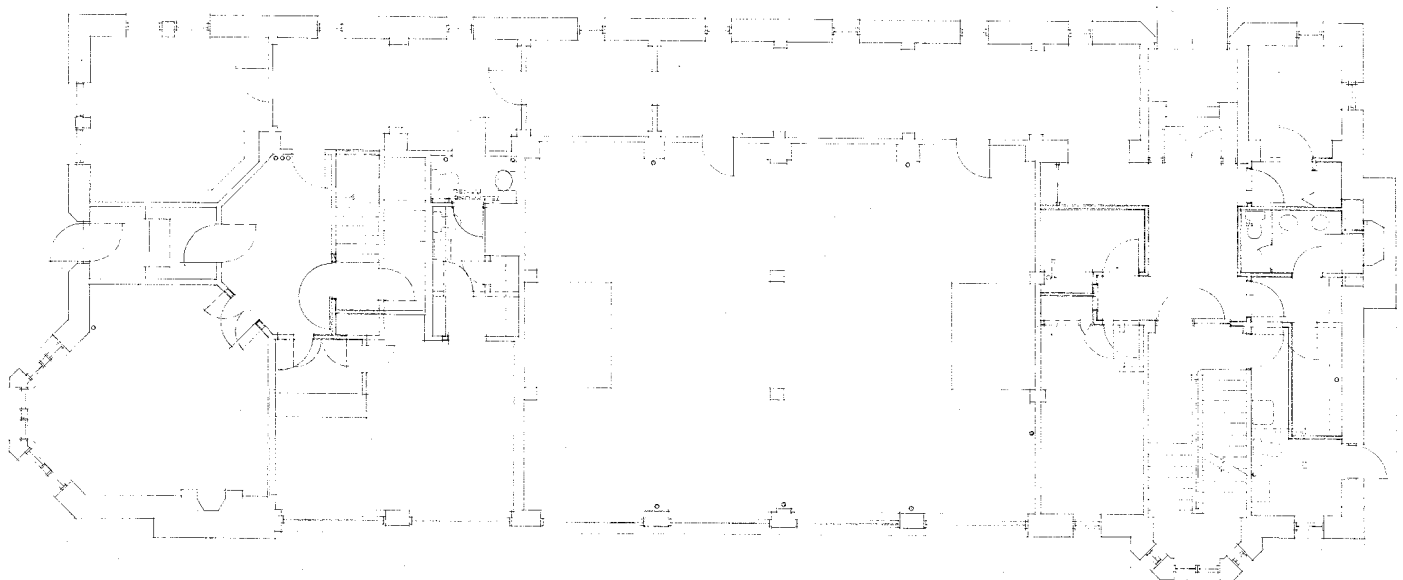
Figure 18. The ground floor plan of the College of Emmanuel and St. Chad. Retrieved from Facilities Management Division Asset Resource System, File EC-94-T

The College of Emmanuel and St. Chad has three above ground storeys, and a basement. Aside from the basement, all floors consist of rooms organized linearly and connected by a corridor. As Figure 18 shows, the ground floor contains, in general, larger rooms and more common spaces. The ground floor is accessed by a single-loaded corridor with a vaulted plaster ceiling running along the north-west side of the building. The basement, shown in Figure 19, also originally featured larger rooms and common spaces. Today the basement exists as one large open space. Only the mechanical room and interior storage room from the original layout remain. Figure 20 shows the coal chute still existing in the mechanical room. This is a character-defining element as it associates the building with the time it was built, when coal was a common source of heat.

Figure 25, a photograph of a Deacon's class in progress, illustrates the main purpose of the building. As Figure 18 shows, the floor plan of the first floor of the building was planned to accommodate educational uses with larger lecture spaces. The basement originally housed a refectory or dining hall as pictured in Figure 26. In later years, uses were rearranged and classrooms were built in the basement. Figure 19 shows this rearrangement. As Figure 27 illustrates, a library was also housed within the building during its early years.

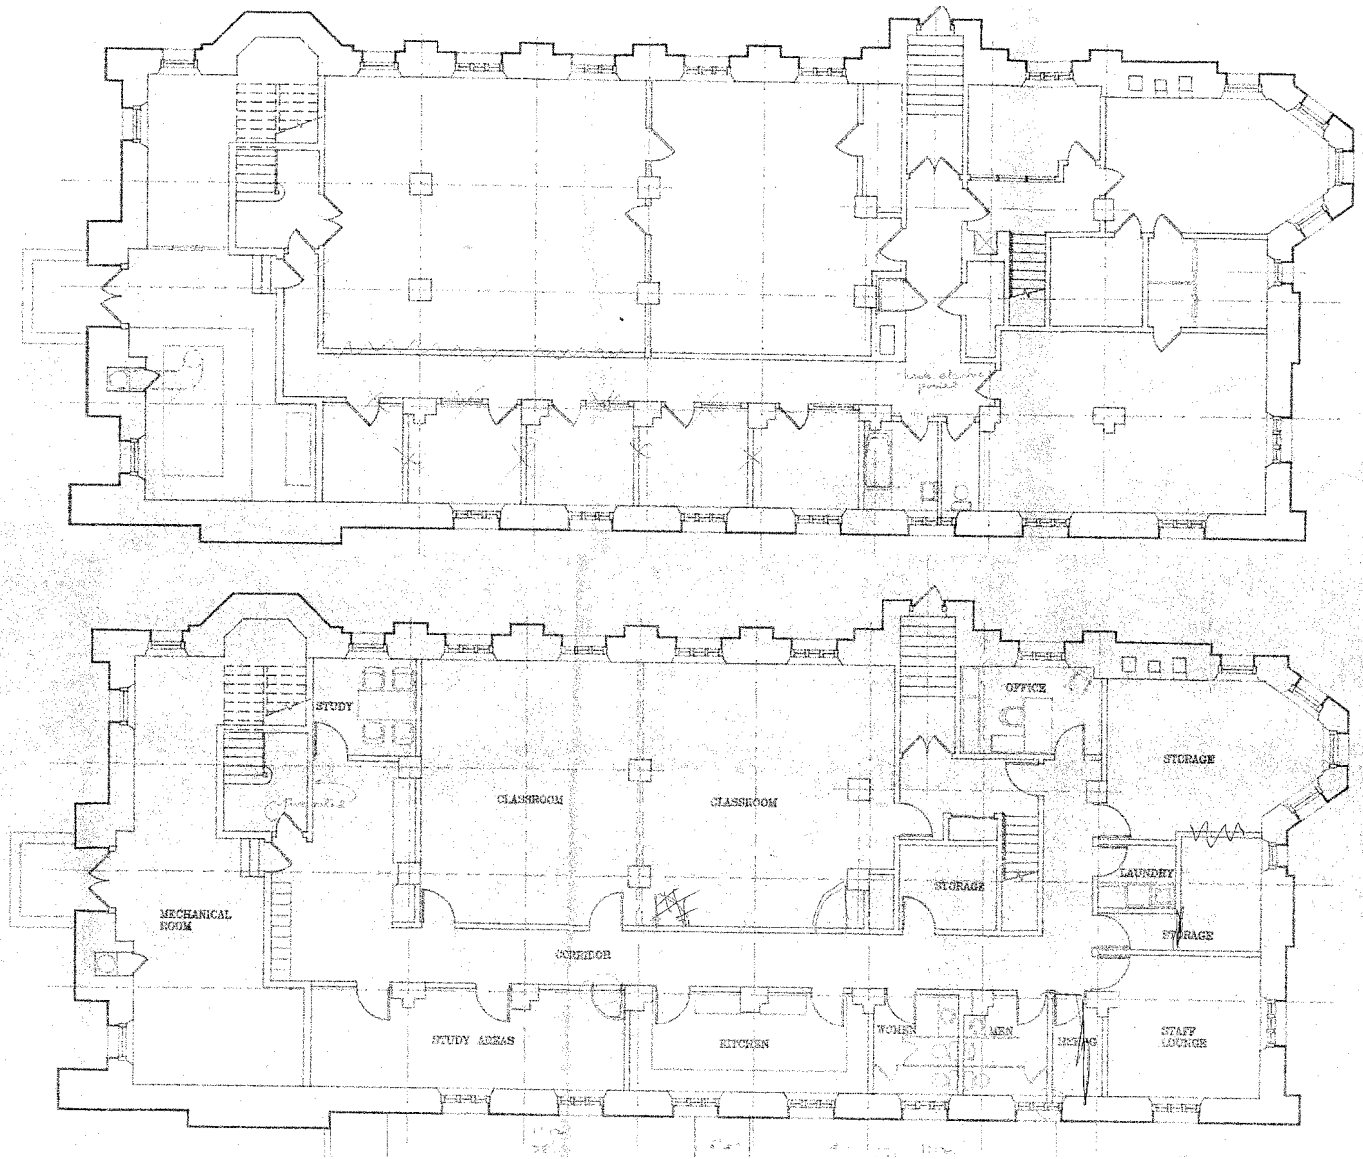
Figure 19. Top to bottom: original basement layout, basement layout after renovations. Retrieved from Facilities Management Division Asset Record System, File EC-91-P.

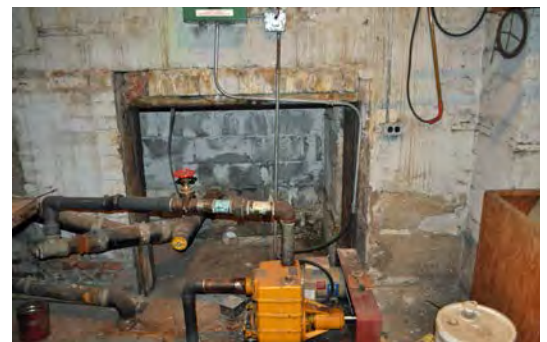
Figure 20. Coal chute.

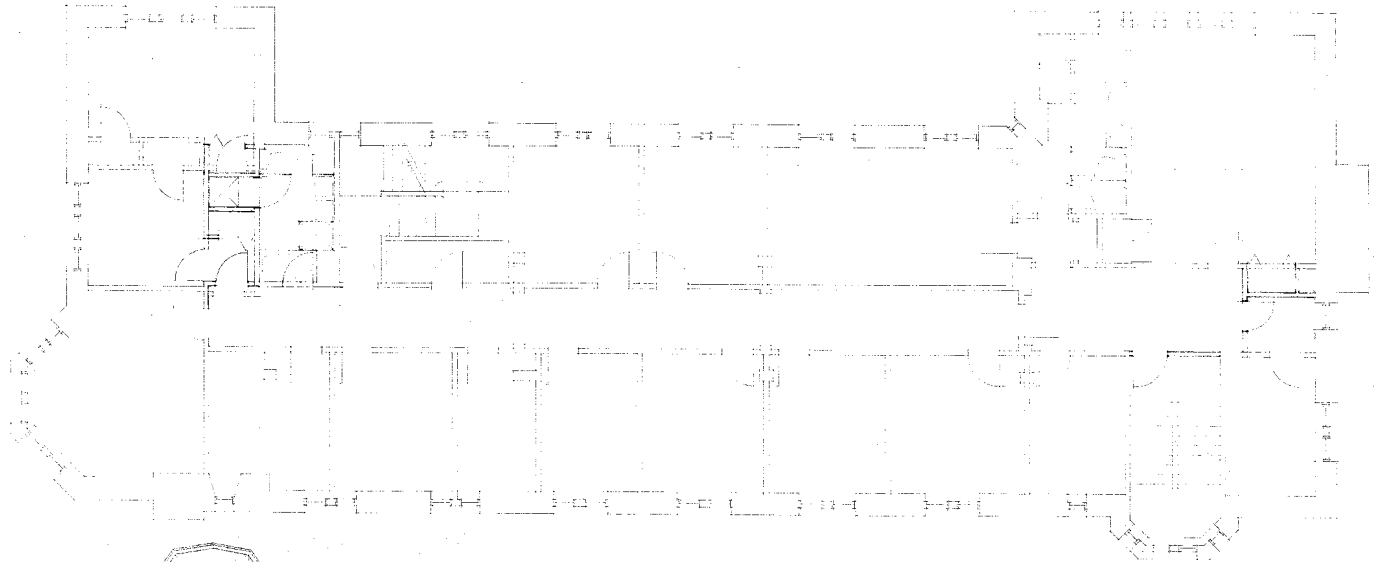
Figure 21. Second Floor Plan. Double loaded corridor serving linear rows of small rooms. Retrieved from Facilities Management Division Asset Record System, File EC-95-T .

The upper storeys all consist of double-loaded corridors lined with dormitory rooms. Figure 21 shows a floor plan of the second floor. As Figure 22 indicates, the rooms on the upper floor are characterized by sloped ceilings, due to their location directly underneath the gabled roof.

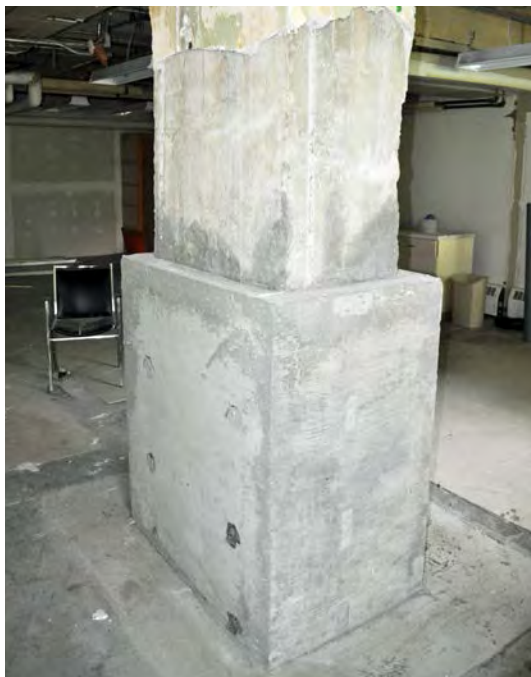
Figure 23. Concrete columns in the basement have been underpinned to address structural degradation.

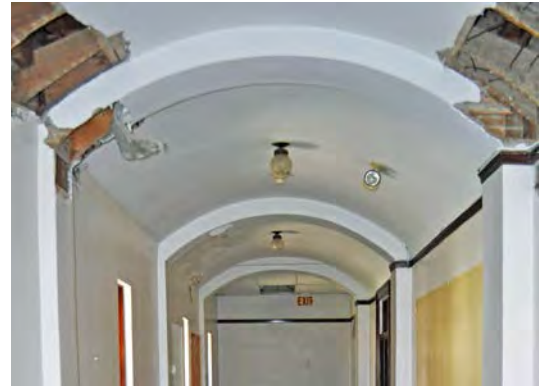
Figure 24. Arched ceiling in the first floor corridor.

The structure of the College of Emmanuel and St. Chad is hierarchical. This is apparent on the building facade as the exterior walls thicken discernibly towards the base of the building. The building's foundation is made of concrete and concrete columns are visible in the basement; as Figure 23 shows, these columns have been underpinned to repair concrete degradation. The exterior walls of the building are load bearing and are made of stone. The interior structure consists of a wooden post and beam system which supports the floor joists. An exception to this interior system is a load-bearing brick wall in the ground floor corridor. Figure 24 shows a vaulted ceiling formed of plaster on wooden lath.

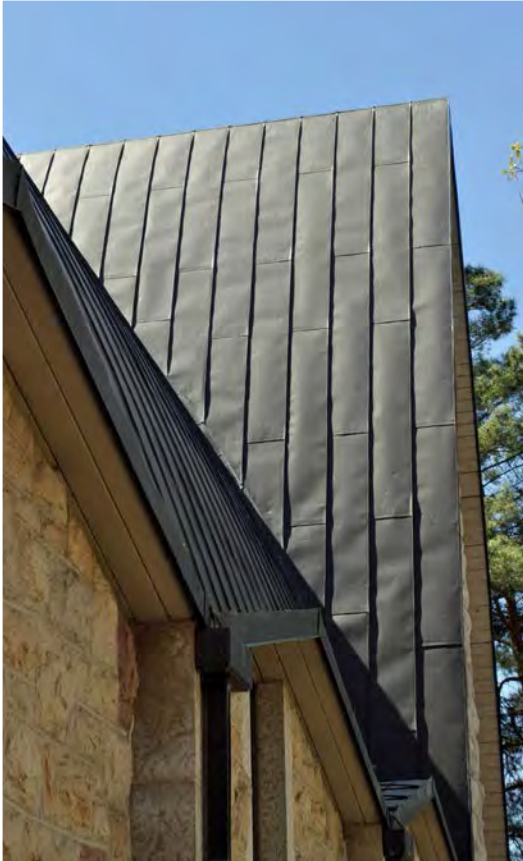
Figure 1. Copper roofing.

The defining material feature on the exterior of the College of Emmanuel and St. Chad Chapel is the standing seam copper roof of the nave. This roof takes the form of two intersecting pointed vaults, which reach 40 feet in height, such that the copper roof is the building's most dominant architectural element. In Saskatoon, copper does not turn green as is typical in many other locations, but rather loses its sheen in the clean, dry prairie air and deepens to a dark brown patina. The copper roofing is shown in Figure 1.

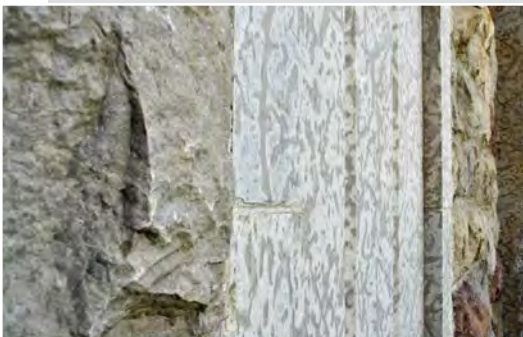
Figure 2. L to R: Greystone and Tyndall stone.

The primary material of the exterior walls is rough-faced 'greystone.' This stone is significant as it was chosen as the signature material for university buildings at the outset of campus construction. Cut Tyndall stone is used for window surrounds and accents. The ground floor and basement windows are grouped into a series of vertical slots framed by Tyndall stone. Tyndall stone detailing is also used around copper drainage spouts. The use of greystone on the Emmanuel and St. Chad Chapel signifies its affiliation with both the university and the other theological colleges. Tyndall stone is also considered a character-defining element of later university buildings as it was the accepted replacement for sandstone and Indiana limestone. Greystone and Tyndall stone are shown in Figure 2. (For further information on building stones used at the U of S, refer to ['Appendix: Stone.'](#))

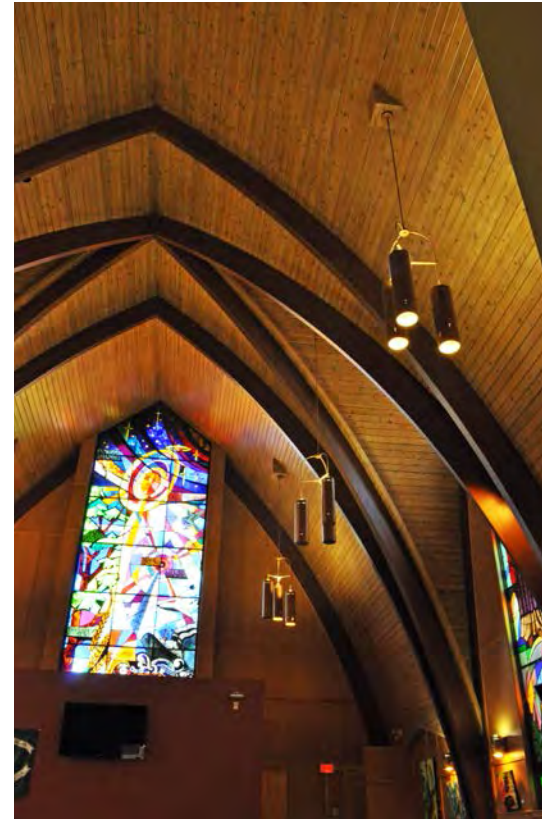
Figure 4. The chapel interior is defined by its fir ceiling and glue laminated arches.

Exposed fir glue-laminated arches extend from the floor to the roof of the nave. Between these ribs, fir roof decking is exposed, as shown in Figure 4.

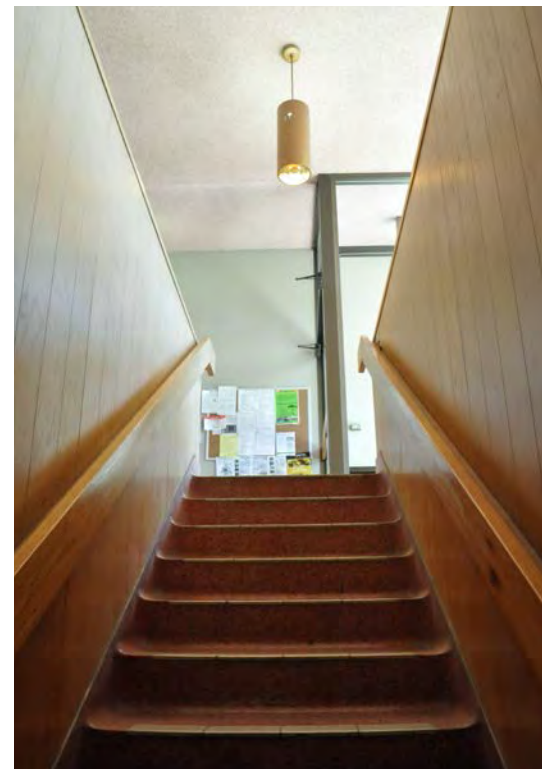
Figure 5. Terrazo stairs, wooden banister and balustrade.

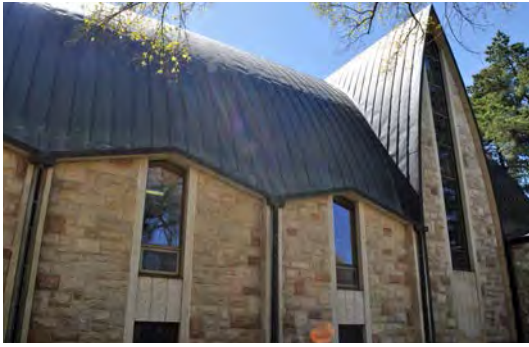
Figure 6. The forms used to compose the College of Emmanuel and St. Chad Chapel.
