University of Saskatchewan

Heritage Register

September 2013

Facilities Management
Division

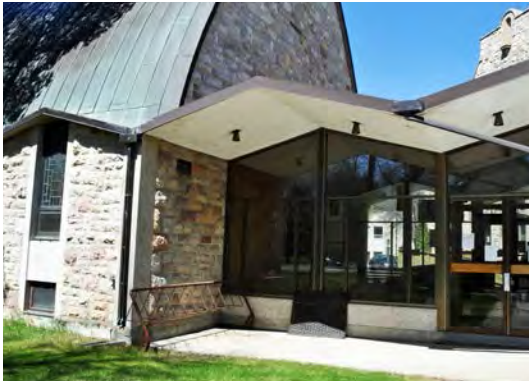
Figure 7. The zigzag roof bisects the arched form of the nave contrasting heavy stone with light glazing.

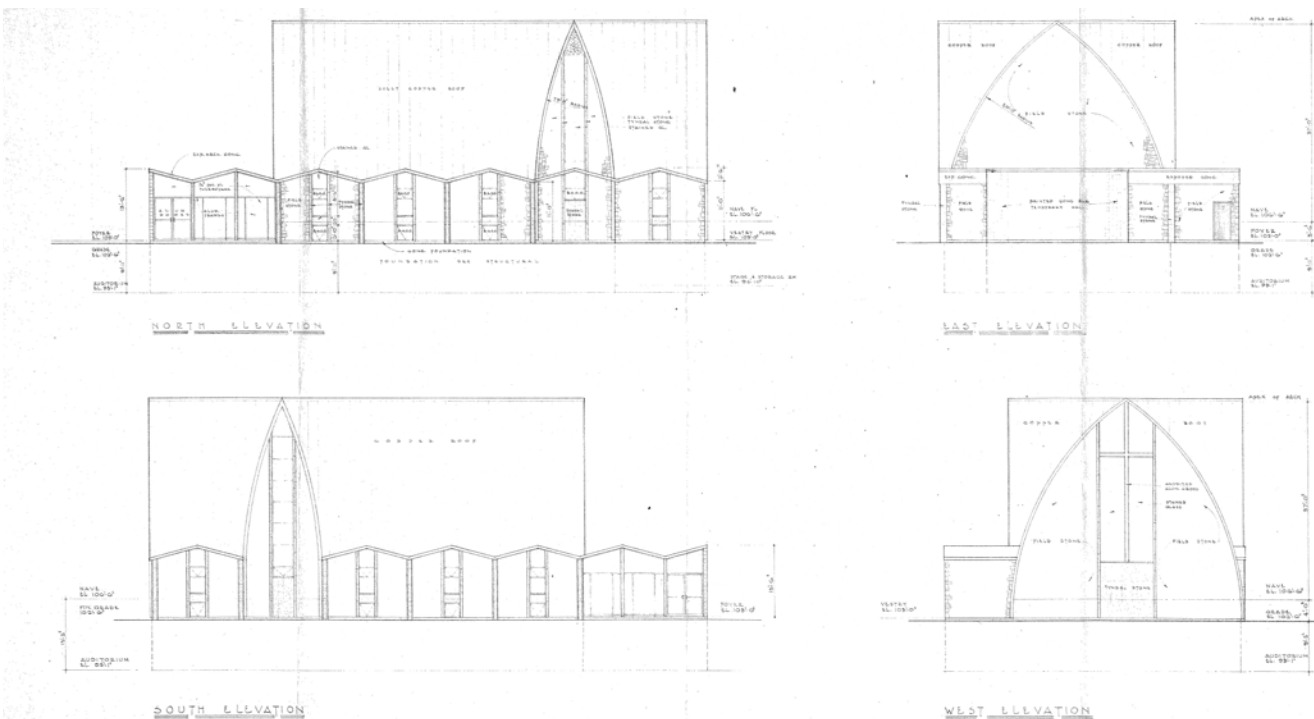
Figure 8. Building elevations. Retrieved from Facilities Management Division Asset Record System, File EC-24-T.

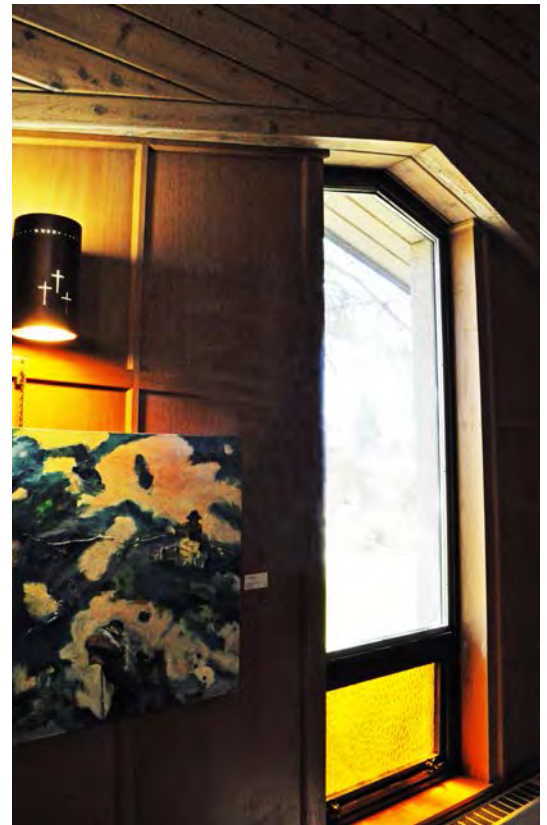
Figure 9. This window is modern in style but its peak pays tribute to the gothic style.

The chapel is characteristic of the modern period in its simplified ornamentation. In the case of this building, form is often used as ornament; the zigzag vestibule roof is an example. The building form itself consists of two exaggerated intersecting pointed vaults. The pointed arch is a Gothic element, but its application is Modern. Here, the traditional Gothic ribbed vault takes the Modern form of a series of glue-laminated wood arches. The vaults are punctuated only by windows and their structural ribs, and feature no decorative details. Notably, the windows of the nave feature triangular arches; a Modern interpretation of the Gothic arched window. These windows are shown in Figure 9.

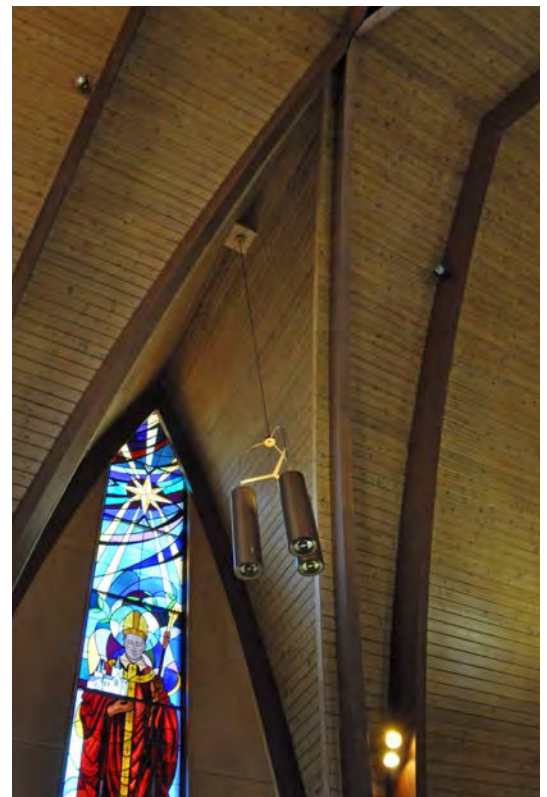
Figure 10. The nave features lancet windows and gothic arches formed by exposed decorative ribs.

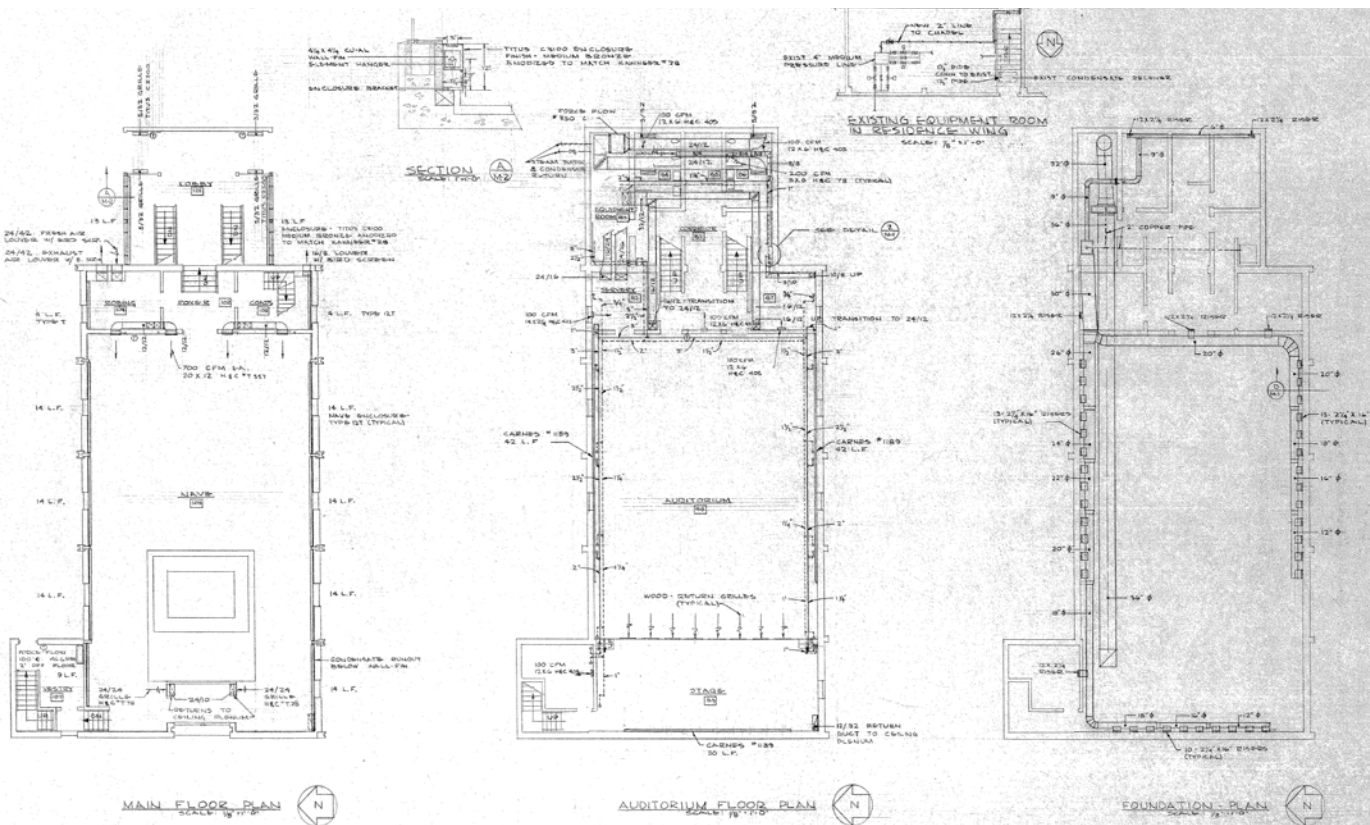
Figure 12. The floor plan of the College of Emmanuel and St. Chad Chapel. North is to the left. Retrieved from Facilities Management Division Asset Record System, File EC-32-T.

The spatial configuration of the chapel has been largely maintained. The layout is a character-defining element as the floor plan and defines the building's identity as a Christian chapel. Figure 12 shows the building's floor plan; the primary space on the ground floor is the nave. The high, arched ceiling allows the choir loft to overlook the open nave. The spacious nave has largely maintained its commemorative integrity through the maintenance of its vaulted ceiling.

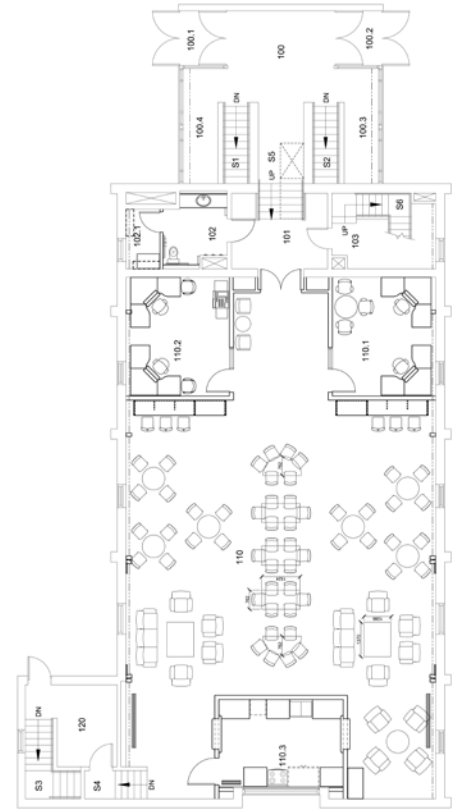
Figure 14. The current ground floor plan of Emmanuel Chapel. North is to the left. Retrieved from Facilities Management Division Asset Record System, File EC-936-130-T.

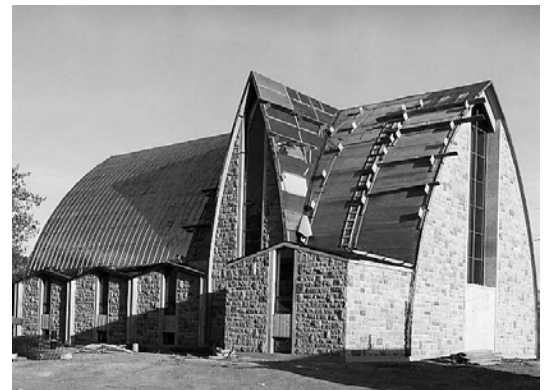
Figure 15. Emmanuel and St. Chad Chapel under construction in 1966. Photo A-346, retrieved from http://scaa.sk.ca/gallery/uofs_buildings/

The exterior walls of the chapel consist of cast in place concrete faced in stone. The vaulted roof of the chapel, seen under construction in Figure 15, is supported by large wooden glue-laminated arched beams which are exposed on the interior. These arched beams support fir roof decking which is similarly exposed on the interior. The glue laminated arches carry the load of the building down to its concrete foundation walls. The structural system holds heritage and architectural value because of the vaulted form it creates and because of the aesthetic qualities of its exposed materials.

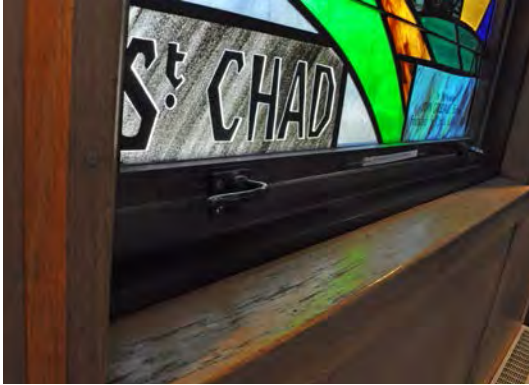
Figure 18. An association with St. Chad College built into the North facing glass.

The chapel still carries association with the Colleges of Emmanuel and St. Chad despite their discontinued use of the building. The stained glass windows in particular are character-defining elements associating the building with the theological colleges (Figures 17-20). The windows have heritage value and commemorative integrity. The two large stained glass windows on either side of the nave display the names of the Colleges, shown in Figures 18 and 19.

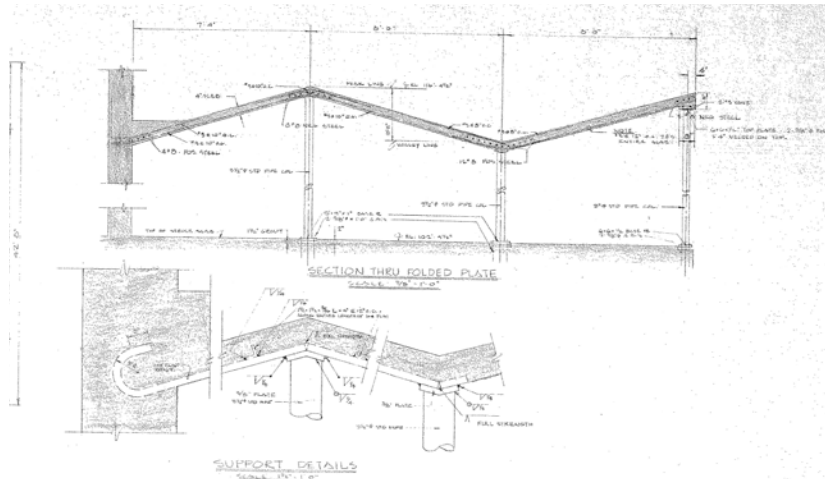
Figure 16. Roof details. Retrieved from Facilities Management Division Asset Record System, File EC-35-T.

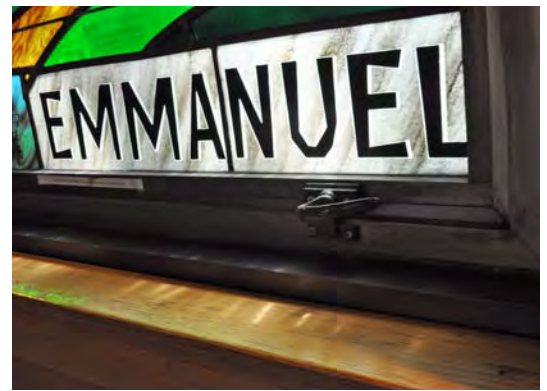
Figure 19. Emmanuel College is commemorated in the south facing window.

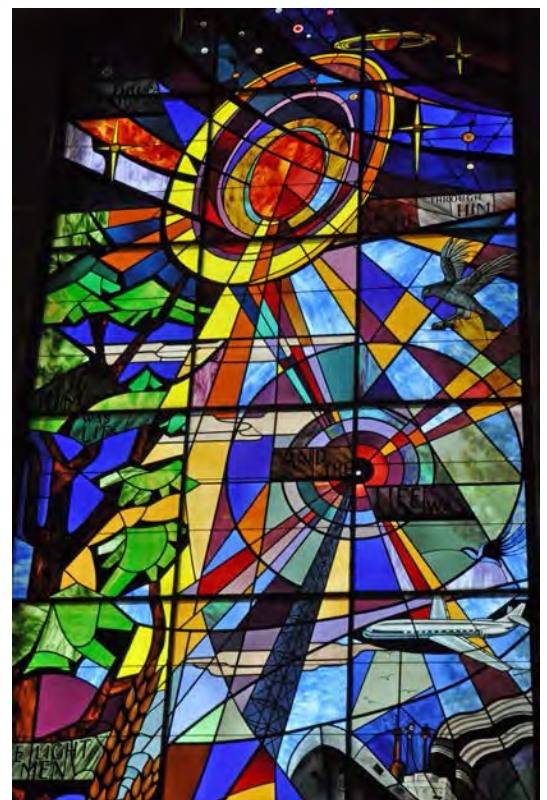
Figure 20. The central stained glass window depicts the creative works of man and God.

The central stained glass window overlooking the nave from the head of the space chronologically associates the building with the Modern era. The principle window depicts steamships and airplanes as well as wheat being harvested by scythe. The construction of the servery at the head of the nave has obscured some of this imagery. Figure 20 shows the largest stained glass panel located above the former location of the altar.

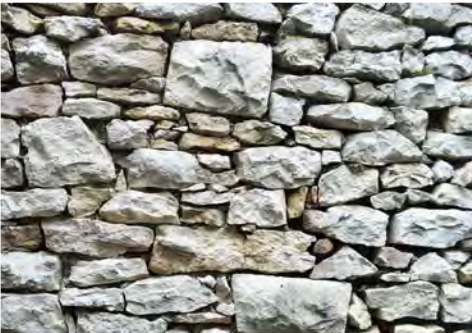
Figure 1. 'Dry stone wall' composed of greystone.

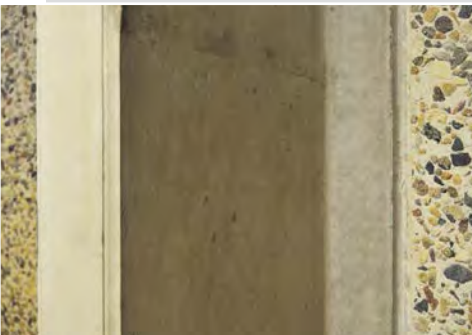
Figure 2. Smooth and exposed aggregate concrete finishes.

The walls of the library are constructed of precast concrete T-section panels, oriented vertically. The concrete panels have an exposed aggregate finish, except for their vertical fins, which are smooth (Figure 2). The repetition of the fins across the elevation and the alternating pattern of smooth and exposed-aggregate concrete, gives the impression of a colonnade. On the Dean's residence and student dormitories, walls are in greystone, smooth concrete is used to express horizontal floor and roof plates, while the exposed-aggregate concrete forms spandrel panels. The Dean's residence and student dormitories both feature exaggerated roof projections in the form of smooth-finished precast concrete beams and slabs.

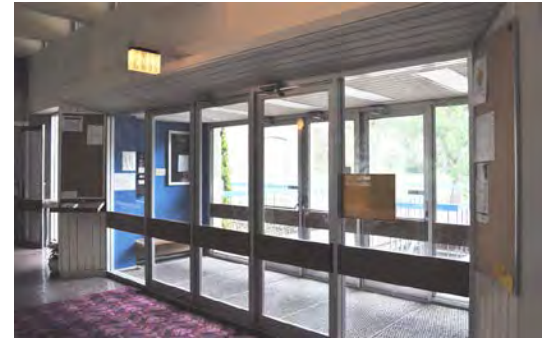
Figure 3. Glazing in the foyer of the Academic College Building.

Aluminum and steel-framed glazing is another character-defining material. Floor-to-ceiling glazing is used to distinguish entries, circulation and common spaces in the Academic College Building (Figure 3). Skylights illuminate the chapel, library and central stair.

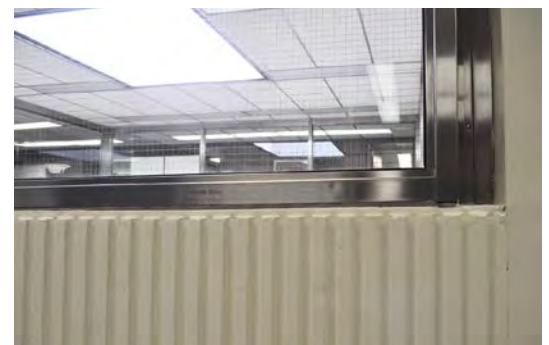
Figure 4. Stainless steel framed clerestory glazing on a painted, ribbed concrete wall.

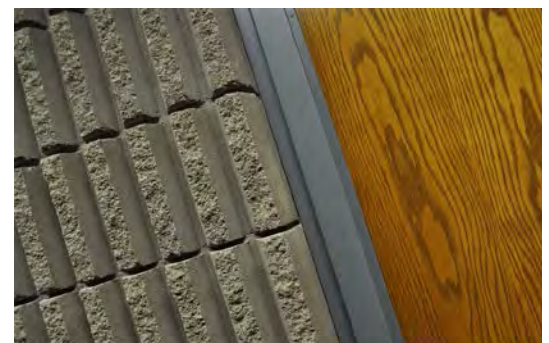
Figure 5. L to R: Split-faced, ribbed concrete block, oak door.

Millwork, doors, baseboards, wall cladding, window frames and surrounds are typically in oak, which is generally in good condition (Figures 5 & 9). Some of the oak doors of the student residence rooms have been resurfaced due to damage. The student residence rooms still retain their oak desks; the chapel has an oak altar, lectern and pews.

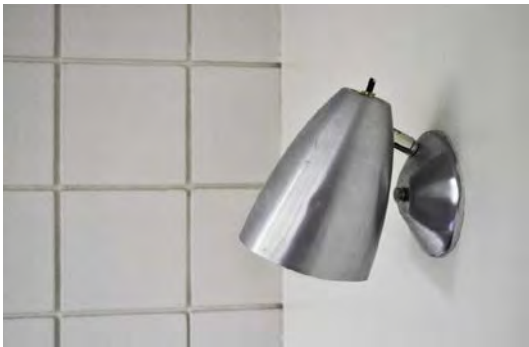
Figure 8. Stainless steel light fixture in front of painted concrete block wall.

Steel is a commonly-used secondary material. Brushed stainless steel is used for light fixtures (Figure 8), edging along window surrounds (Figure 9), door hardware, and as the framing material for the glazed entrance doors and the door to the chapel. The library features a steel and oak balustrade. Painted steel balustrades and staircases are found on both the interior and exterior. The interior of the library features steel staircases, painted steel balustrades and a raised walkway. The painted and stainless steel fixtures are in excellent commemorative condition and are character-defining elements.

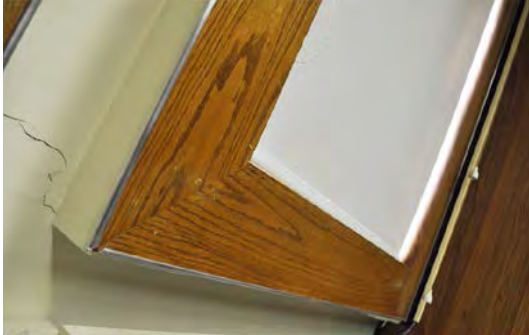
Figure 9. Oak window frame, edged in steel and detailed as a discrete entity.

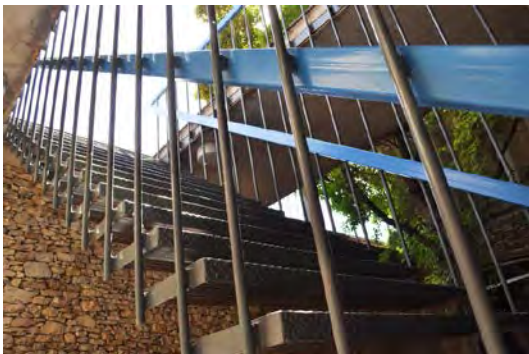
Figure 10. Steel balustrade.

Architect John Holliday-Scott often accentuated his designs with bright accent colours. In the case of the Lutheran Seminary, the architect chose to highlight certain details in blue (Figure 10). The colour blue appears in numerous places throughout the complex, most commonly on balustrades and furnishings, and is a character-defining element.

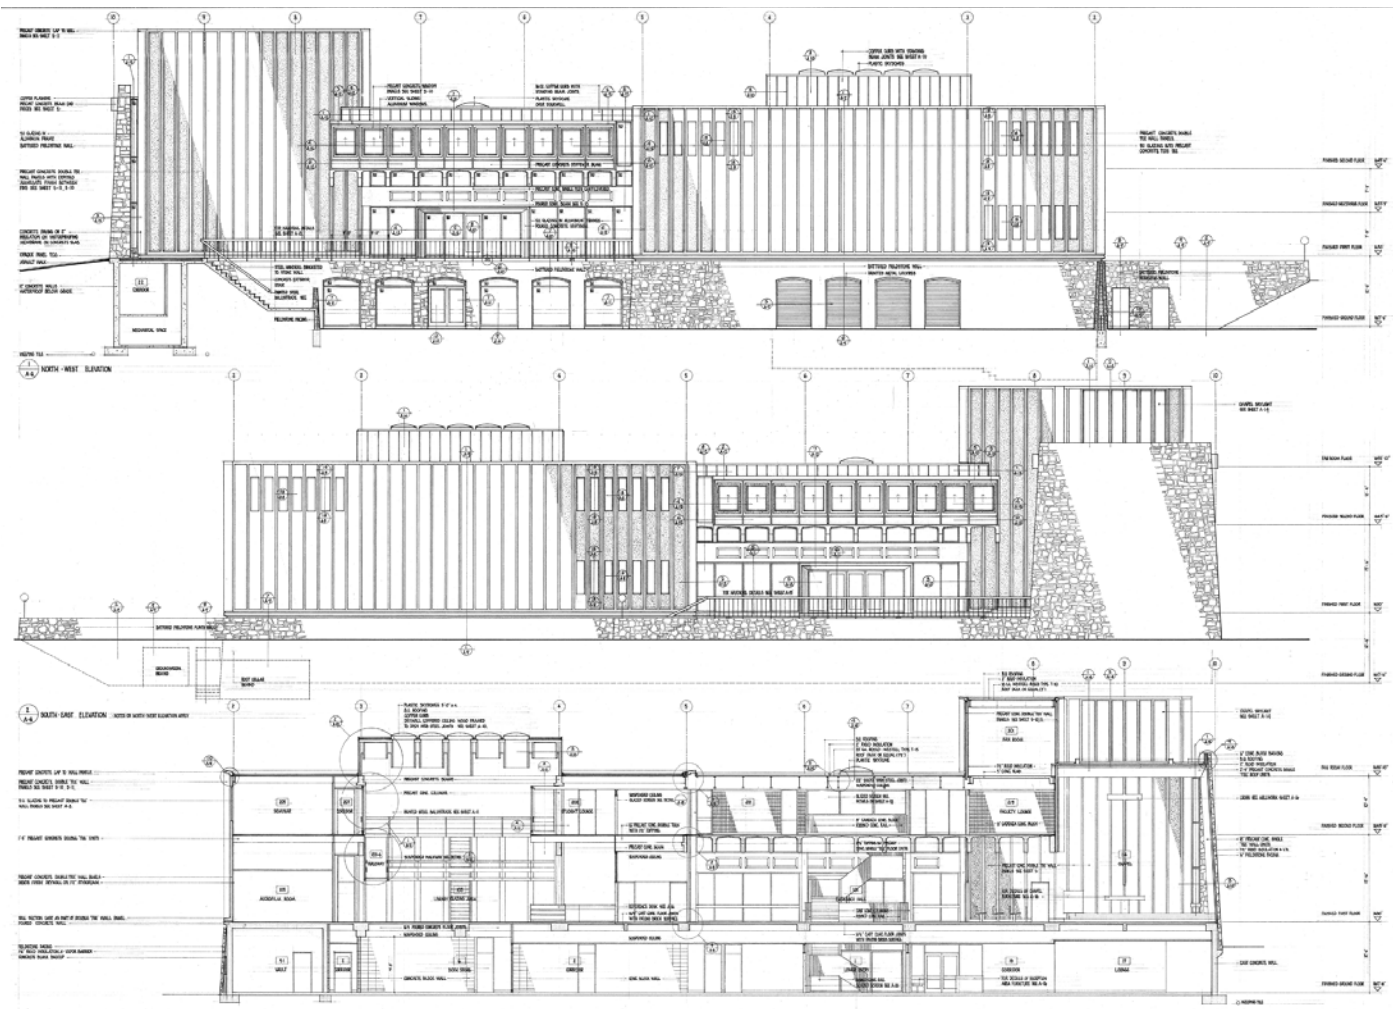
Figure 11. Elevations and section of the Academic College Building at the Lutheran Seminary. Retrieved from Facilities Management Division Asset Record System File 938-143-T.

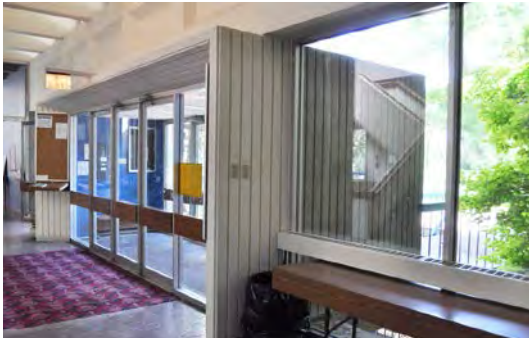
Figure 13. The cast concrete walls of the entrance vestibule penetrate an envelope of glass. The glazing lightly intersects with the concrete.

Just as the courtyard form of the Lutheran Seminary was drawn from an ancient tradition but rendered in a modern idiom, Holliday-Scott seamlessly blends modernist and traditional architectural expressions throughout the building. The various functions of the functional program - a chapel, library, Dean's residence and student dormitories - are expressed in the modernist manner as distinct parts. That expression of function is reinforced by Holliday-Scott's use of materials. For example, the traditional material of greystone is used in the cladding of the chapel in a modern way, to define that function as its own discreet form, separate from the other parts of the building (Figure 12). The characteristics of materials are used to reinforce this expression of separate elements; glazing is detailed so as to 'disappear' into the surrounding stone giving the impression of two materials intersecting. Interior oak window frames project from the plane of the wall to look like discrete volumes (Figure 9). At the main entrance, the vestibule is expressed as a concrete box, which appears to intersect the plane of the glazed wall (Figure 13).

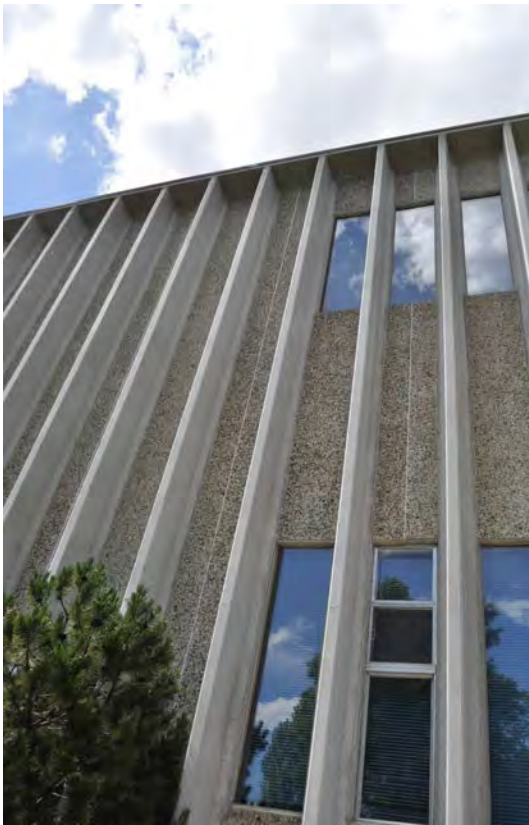
Figure 14. Precast concrete wall panels on the library.

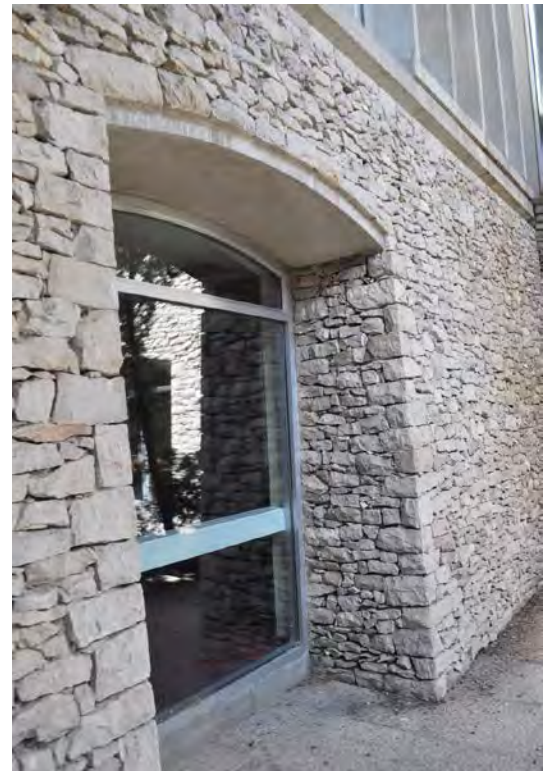
Figure 15. Canted stone wall with arched window openings.

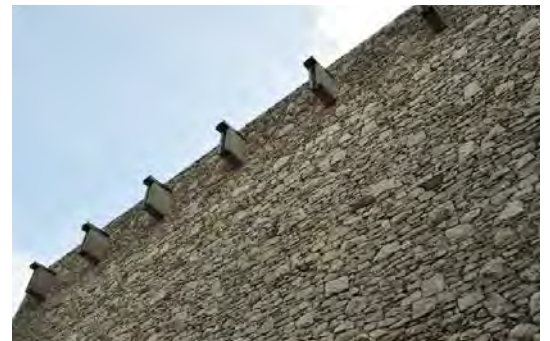
Figure 17. Concrete beam ends on the chapel walls.

On the east and west sides of the chapel, a row of concrete beam ends project along the top of the stone walls. These projections express on the exterior of the chapel the precast concrete beams that form its roof structure. However, they also make reference to triglyphs, a decorative device from the classical architecture of ancient Greece and Rome. In the architecture of the Greek temple, triglyphs were the stone expression of wooden beam ends that would have supported the temple roof. Figures 17 and 18 compare the concrete details of the Lutheran Seminary with their ancient Greek precedent.

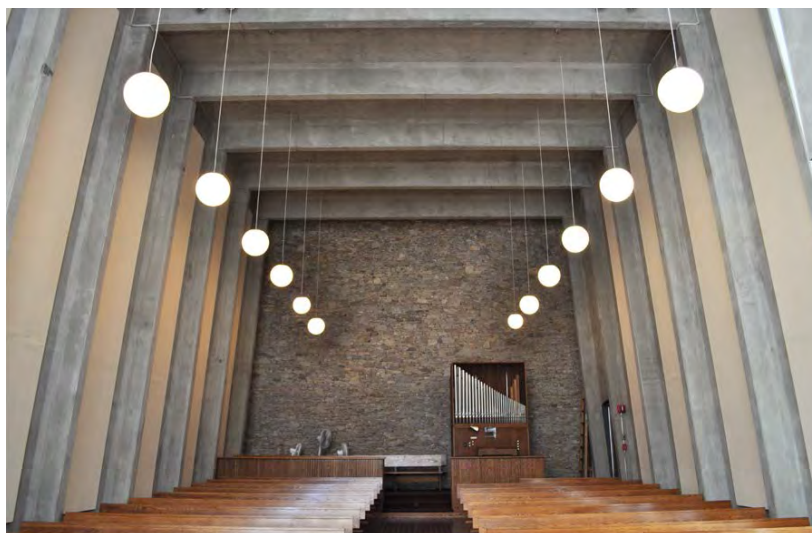
Figure 16. The nave of the chapel: exposed concrete structure and canted walls recall ribbed vaulting.

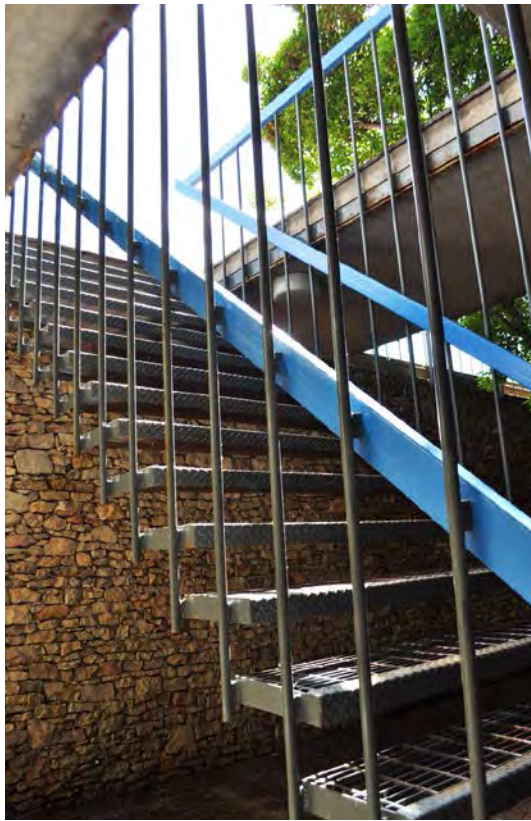
Figure 20. A stair pierces the bridge to the first floor entrance.

Other expressions of structural elements are unequivocally modern. On both the exterior and interior, precast concrete beams and roof slabs are cantilevered to form overhangs and to support projecting spaces (Figures 19 & 20). Precast concrete T's

forming the floor structures of the building are exposed as finished ceilings in the entrance lobby, the chapel and the library. At the main entrance, the front doors are reached over a concrete bridge spanning a light well (Figure 20). The centre of the bridge is punctured by an open staircase that offers access to the level below. The open treads of the stair are suspended from the concrete bridge deck by steel tension rods, with a detail similar to that used by Holliday-Scott in both the [Law](#) and [Dentistry](#) buildings. The stair recalls the earlier modernist precedent of the suspended stair in Eero Saarinen's General Motors Technical Center in Detroit (1949-55) (Figure 21).

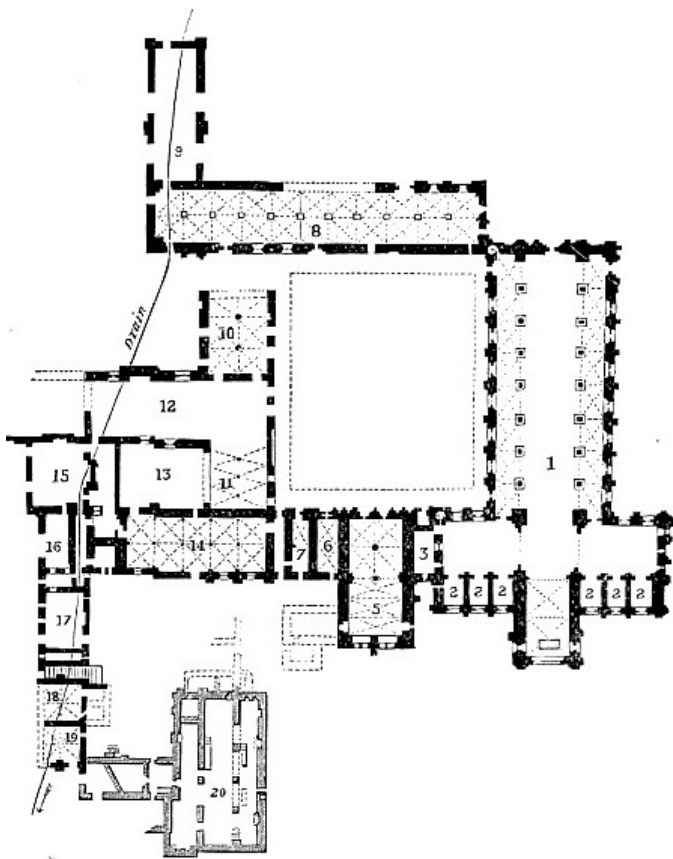
Figure 23. Site plan of Kirkstall Abbey, Yorkshire. This Cistercian abbey consists of: 1. Church 2. Chapels 3. Sacristy 4. Cloister 5. Chapter House 6. Parlour 7. Punishment Cell 8. Cellars with Dormitories for Conversi over 9. Guest House 10. Common Room 11. Old Refectory 12. New Refectory 13. Kitchen Court 14. Day Room 15. Kitchen and Offices 16-19. Uncertain 20. Infirmary or Abbot's House. Retrieved from <http://www.1902encyclopedia.com/A/ABB/abbey-13.html>

As discussed earlier, the Lutheran Seminary is designed as a modern interpretation of a cloister. The cloister of the middle ages included a church and a dormitory, arranged to enclose a courtyard with an arcaded periphery (Kostof, 1985). Kirkstall Abbey in Yorkshire is a useful precedent for comparison (Figure 23). Although the site plan of the Lutheran Seminary is more open than that of Kirkstall, a shared courtyard unifies both designs in a similar way. Many of the functions of the buildings of the Lutheran Seminary descend directly from those of its predecessors; a church and dormitories are still important components of the plan. Whereas the traditional cloister was generally enclosed on all four sides, the courtyard of the Lutheran Seminary is enclosed on three sides, but left open towards the river.

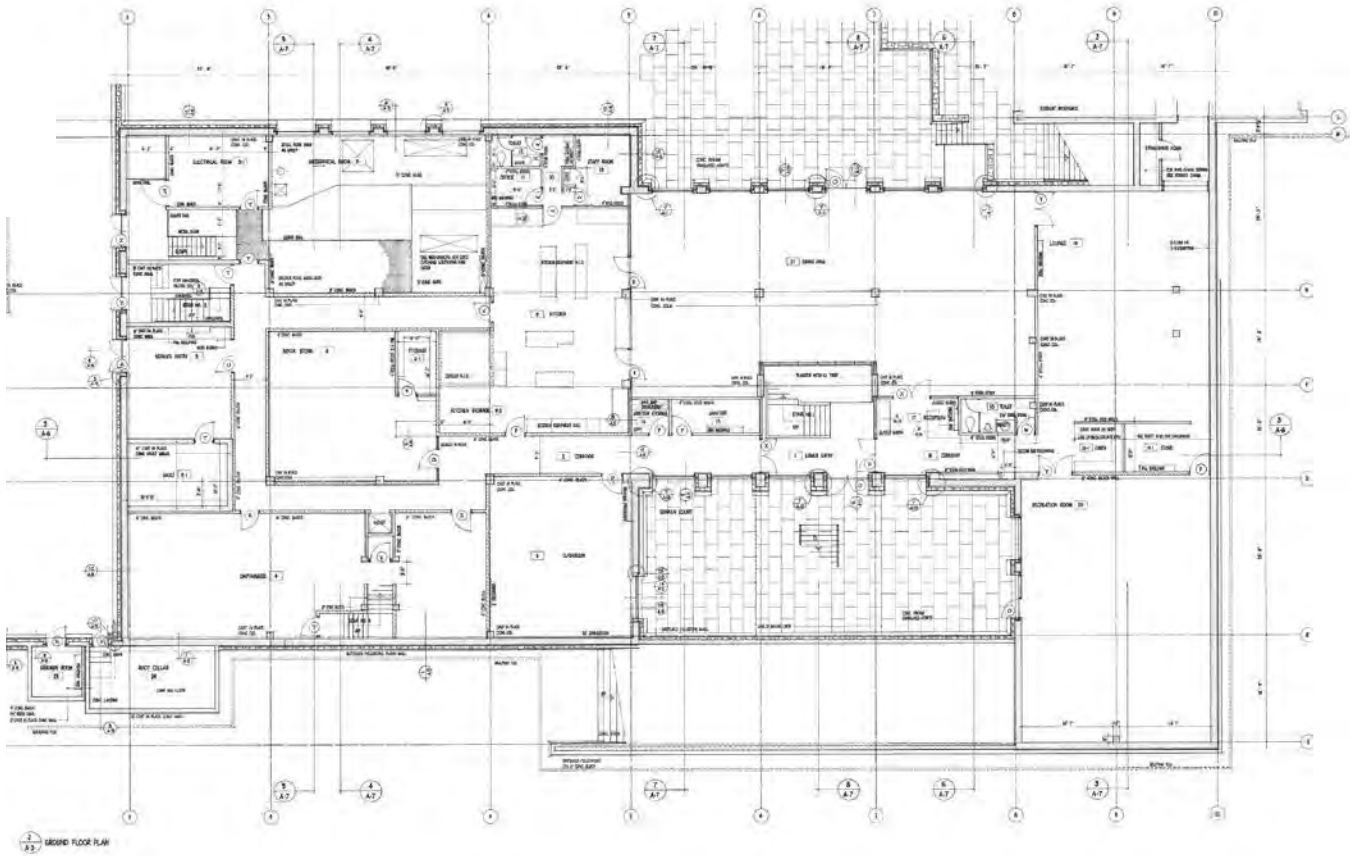
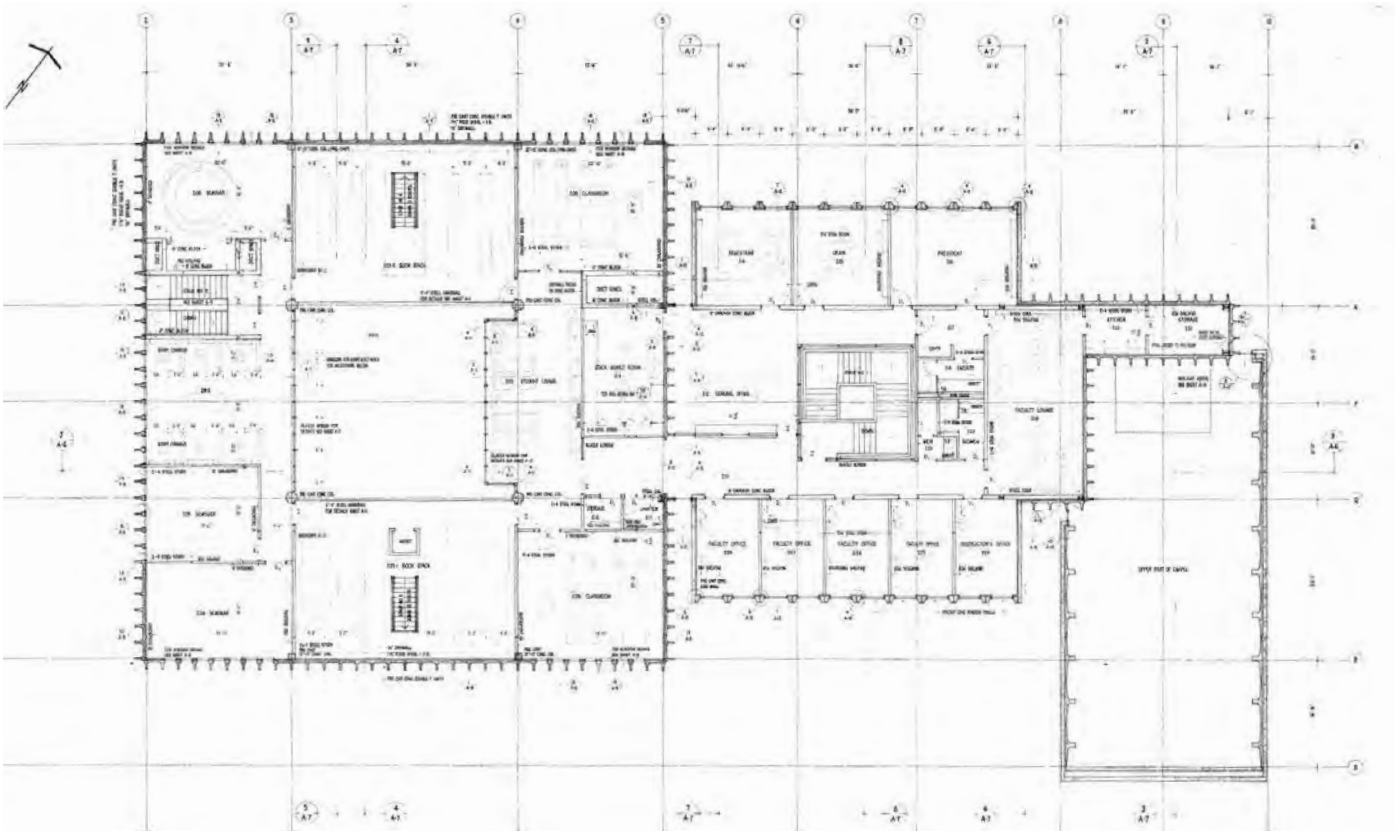
Figure 25. Top to Bottom: Ground and second floor plans of the Academic College Building. Retrieved from Facilities Management Division Asset Record System, Files 983-146-T, 938-144-T.

The Academic College Building in the Lutheran Seminary is composed of three major functional spaces: a chapel, a library and a central foyer and administrative area. The entrance and administrative wing serves to connect the larger volumes of the library and chapel.

The chapel is an austere but beautiful space. It is laid out in the traditional manner, with a nave, a central aisle, an apse and a choir, except that the entrance is incorporated into a transept on the west side. The chapel is a tall space, about 26 feet in height, and the floor is slightly raked. The wall and roof structures of the chapel are formed from a series of precast concrete T-shaped panels. The walls are slightly inclined, and their precast panels are exposed on the inside surface of the room, such that the fins of the panels form a row of vertical elements, like a row of columns. At the north end of the central aisle, the apse is bathed in natural light from a skylight (Figure 26). The skylight washes the adjacent wall, highlighting the contrasting textures of the rough exposed aggregate of the wall panels and the smooth concrete of their vertical fins. Aside from the skylight, very little natural light enters the space. The acoustic quality of the space is particularly striking – small sounds are amplified by the echo in the room, very much like a stone church of the middle ages. The chapel is well-suited to musical performance and is often used by music students. The height of the space, the skylight and the configuration of its nave, transept and apse are all character-defining elements.

A hallmark of the work of John Holliday-Scott was to incorporate a soaring central space as a focal point, around which the rest of the building was organised. The main reading room fulfills this function in the library of the Lutheran Seminary. The library is square in plan, 80 x 80 feet in dimension. A double-height central reading room on the first floor forms its core. Classrooms, seminar rooms, study carrels and support services are arranged around the perimeter of the first floor reading room and on the second floor, overlooking the main reading room. A second floor seating area projects out into the space of the library atrium (Figure 27). Book stacks are arranged on three levels, compressed into the vertical dimension of the two adjacent floors. Open steel staircases provide access between the book stack levels, and a bridge spans the open space between the two book stack mezzanines. In the ceiling of the reading room, a series of acrylic dome skylights and light wells illuminate the space. The only change to the spatial configuration of the library has been the addition of a second elevator shaft.

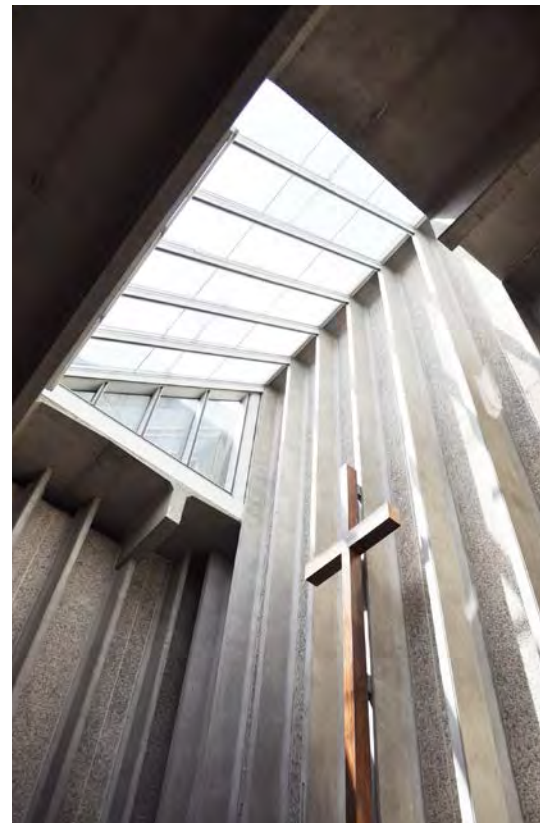
Figure 26. Chapel skylight.

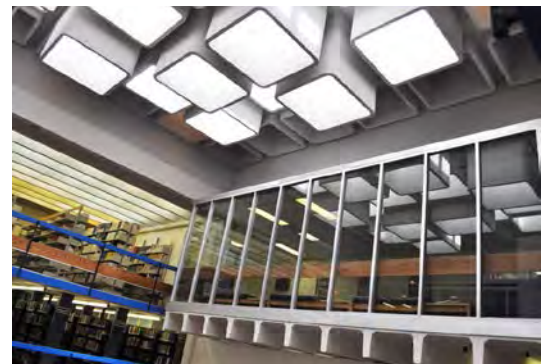
Figure 27. Skylights above a glazed seating area into the Lutheran Seminary library.

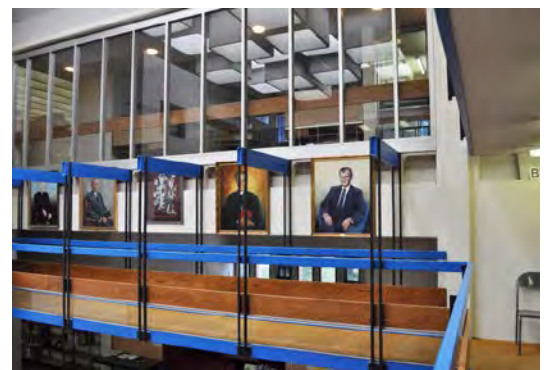
Figure 28. Raised walkway in the Lutheran Seminary library.

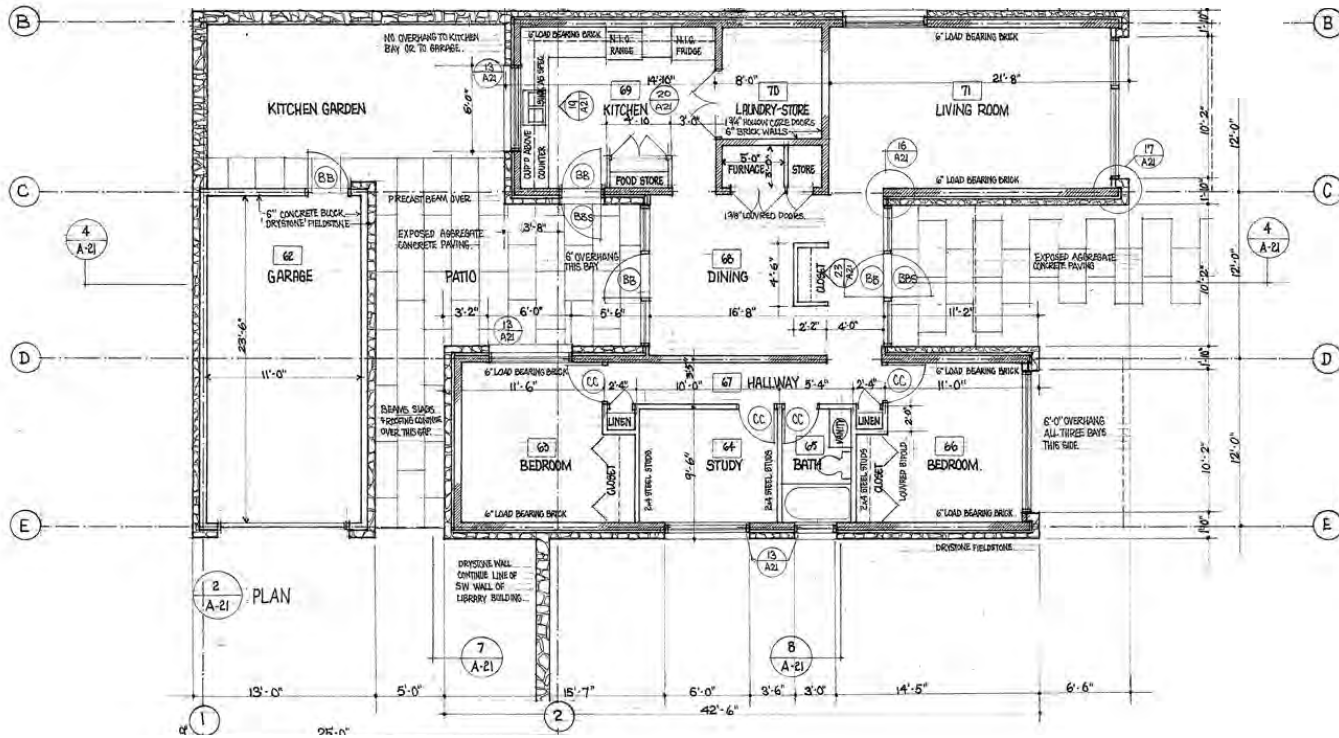
Figure 29. Floor plans for the Dean's Residence. Retrieved from Facilities Management Division Asset Record System, File 983-128-T.

The Dean's Residence, originally a private house for the Dean of the seminary, has been converted into residence accommodation for multiple students. Originally, this was a simple single-story dwelling in the modernist style. The house was arranged in plan as three connected wings. The north wing consisted of a kitchen, laundry room and living room. The south wing contained two bedrooms and a small study. The north and south wings were connected by a central wing consisting of an entrance foyer and a dining room. A covered outdoor patio led off the dining room to the west, and connected to a garage. A small courtyard, enclosed by stone walls, provided a private outdoor space adjacent to the kitchen. Formally, the north and south wings of the Dean's residence are conceived of as discrete volumes, wrapped by stone walls. The central entrance and dining wing is predominantly glazed, and forms a lighter connective element between the living and sleeping wings (Figure 29).

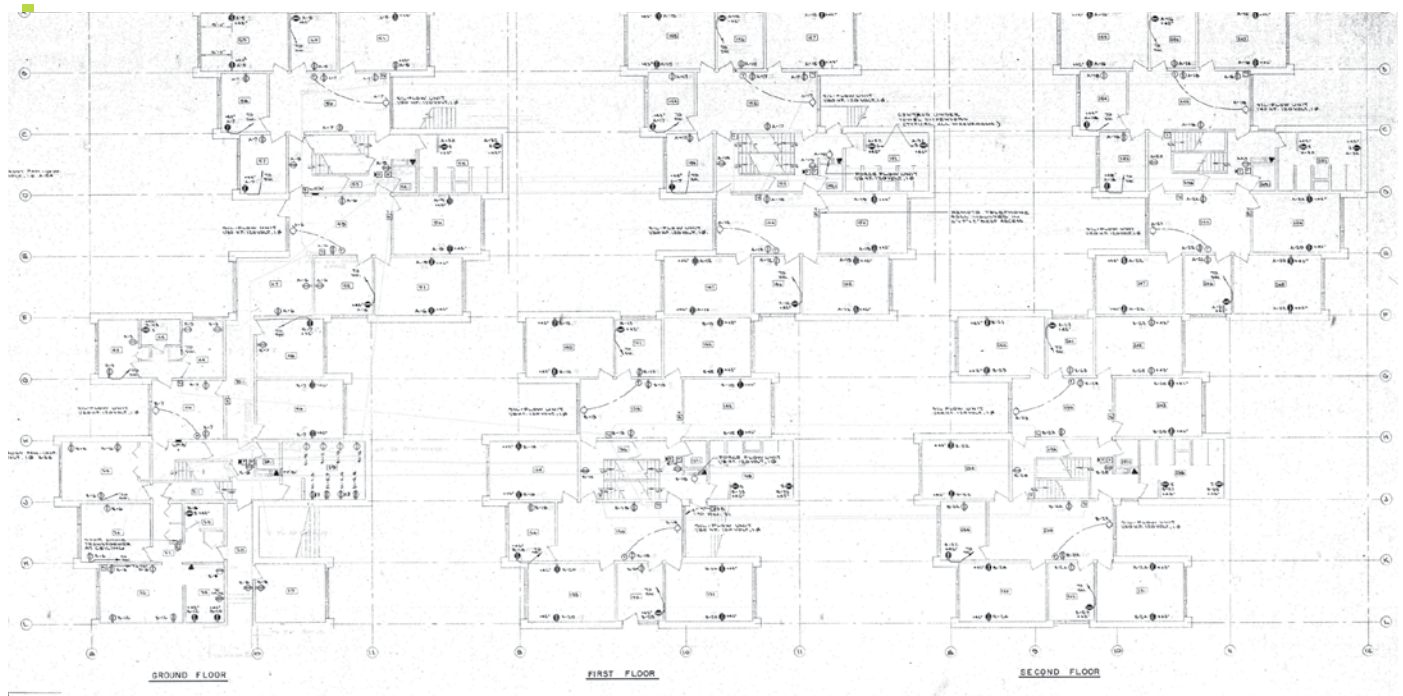
Figure 31. Floor plans for the Student Residence Building. Retrieved from Facilities Management Division Asset Record System, File 983-83-T.

The Student Residence Building is configured on each of its three floors as two clusters of dormitory rooms, each arranged around a central stair and two common lounges spaces. The lounges unify the residence rooms much as the courtyard unifies the separate buildings of the larger seminary. The result is a series of ‘houses.’ The grammar school that architect John Holliday-Scott attended in England was divided into ‘houses,’ which influenced his thinking on the most effective arrangement of spaces to support collegiate life. It was this conviction that led him to arrange the rooms in groups or ‘families’ rather than in a linear fashion along corridors.

The dormitory rooms have large windows and the common lounges are glazed from floor to ceiling. Figure 31 shows the staggered arrangement of the rooms in plan, which allows for varying degrees of privacy. Those familiar with the Lutheran Seminary have come to refer to the southern half of the Student Residence Building as ‘Tower One’ and the northern half as ‘Tower Two.’ The two ‘halves’ of the building are connected only by the hallway on the ground floor. The central staircases in each cluster offer the only means of accessing the rooms above. The uppermost floor of the Residence Building features the high ceiling and clerestory windows that are also found in the Dean’s Building (Figure 32).

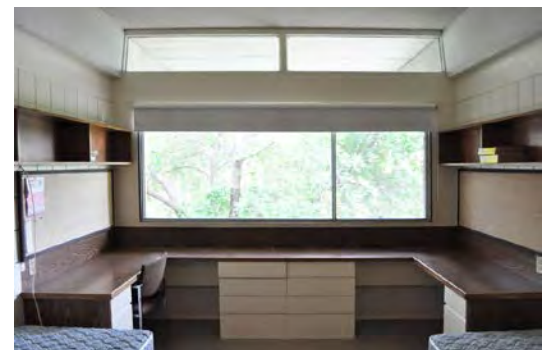
Figure 32. A residence room on the top floor.

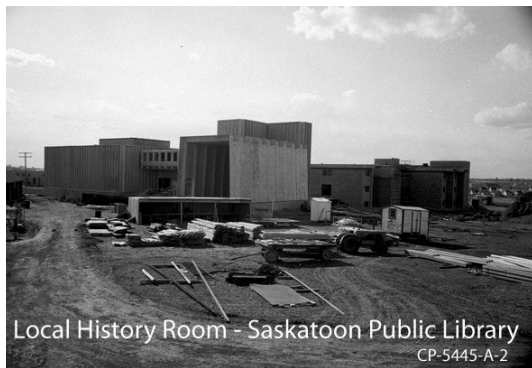
Figure 33. The Lutheran Seminary under construction, April 18, 1968. Photo CP-5925-A-2, retrieved from <http://spldatabase.saskatoonlibrary.ca/csdata/images/lhr/web/cp/5000/cp-5925-A-2.jpg>

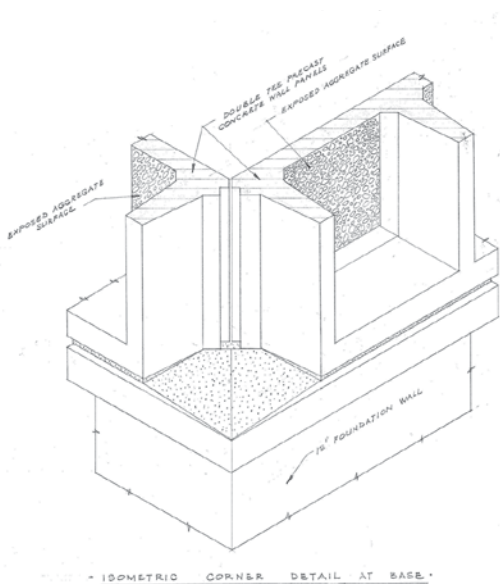
Figure 34. Concrete detailing. Retrieved from Facilities Management Division Asset Record System, File 938-114-T.

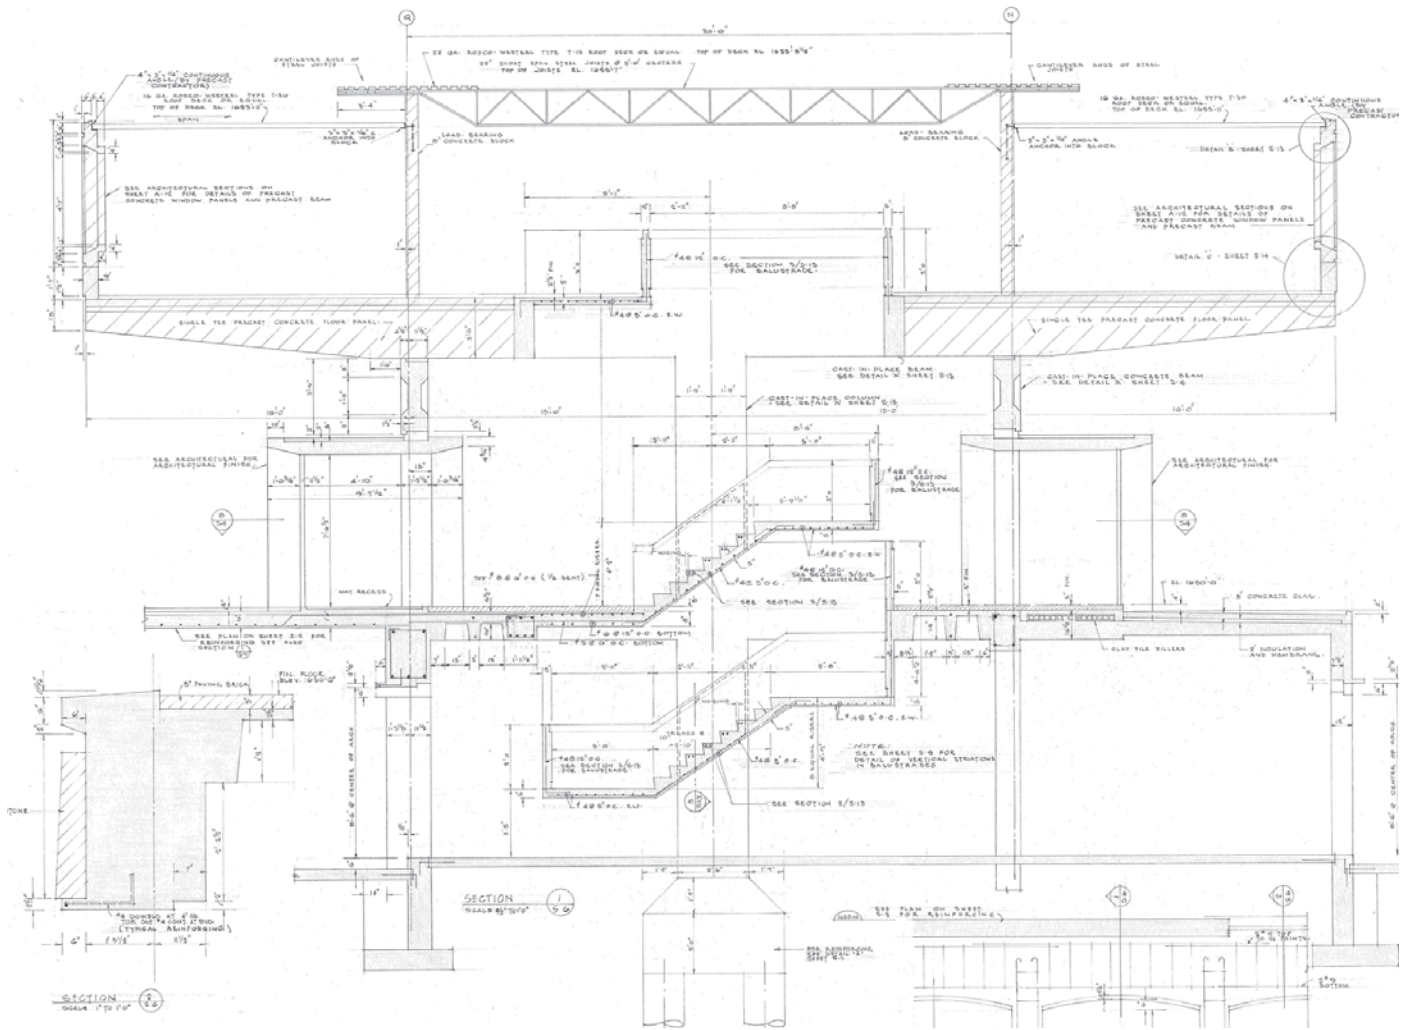
Figure 35. A section through the Academic College Building. Retrieved from Facilities Management Division Asset Record System, File 938-119-T.
