University of Saskatchewan

Heritage Register

September 2013

Facilities Management
Division

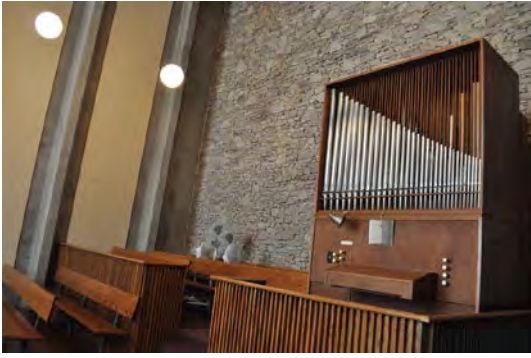
Figure 37. The organ situated in the choir at the rear of the Chapel.

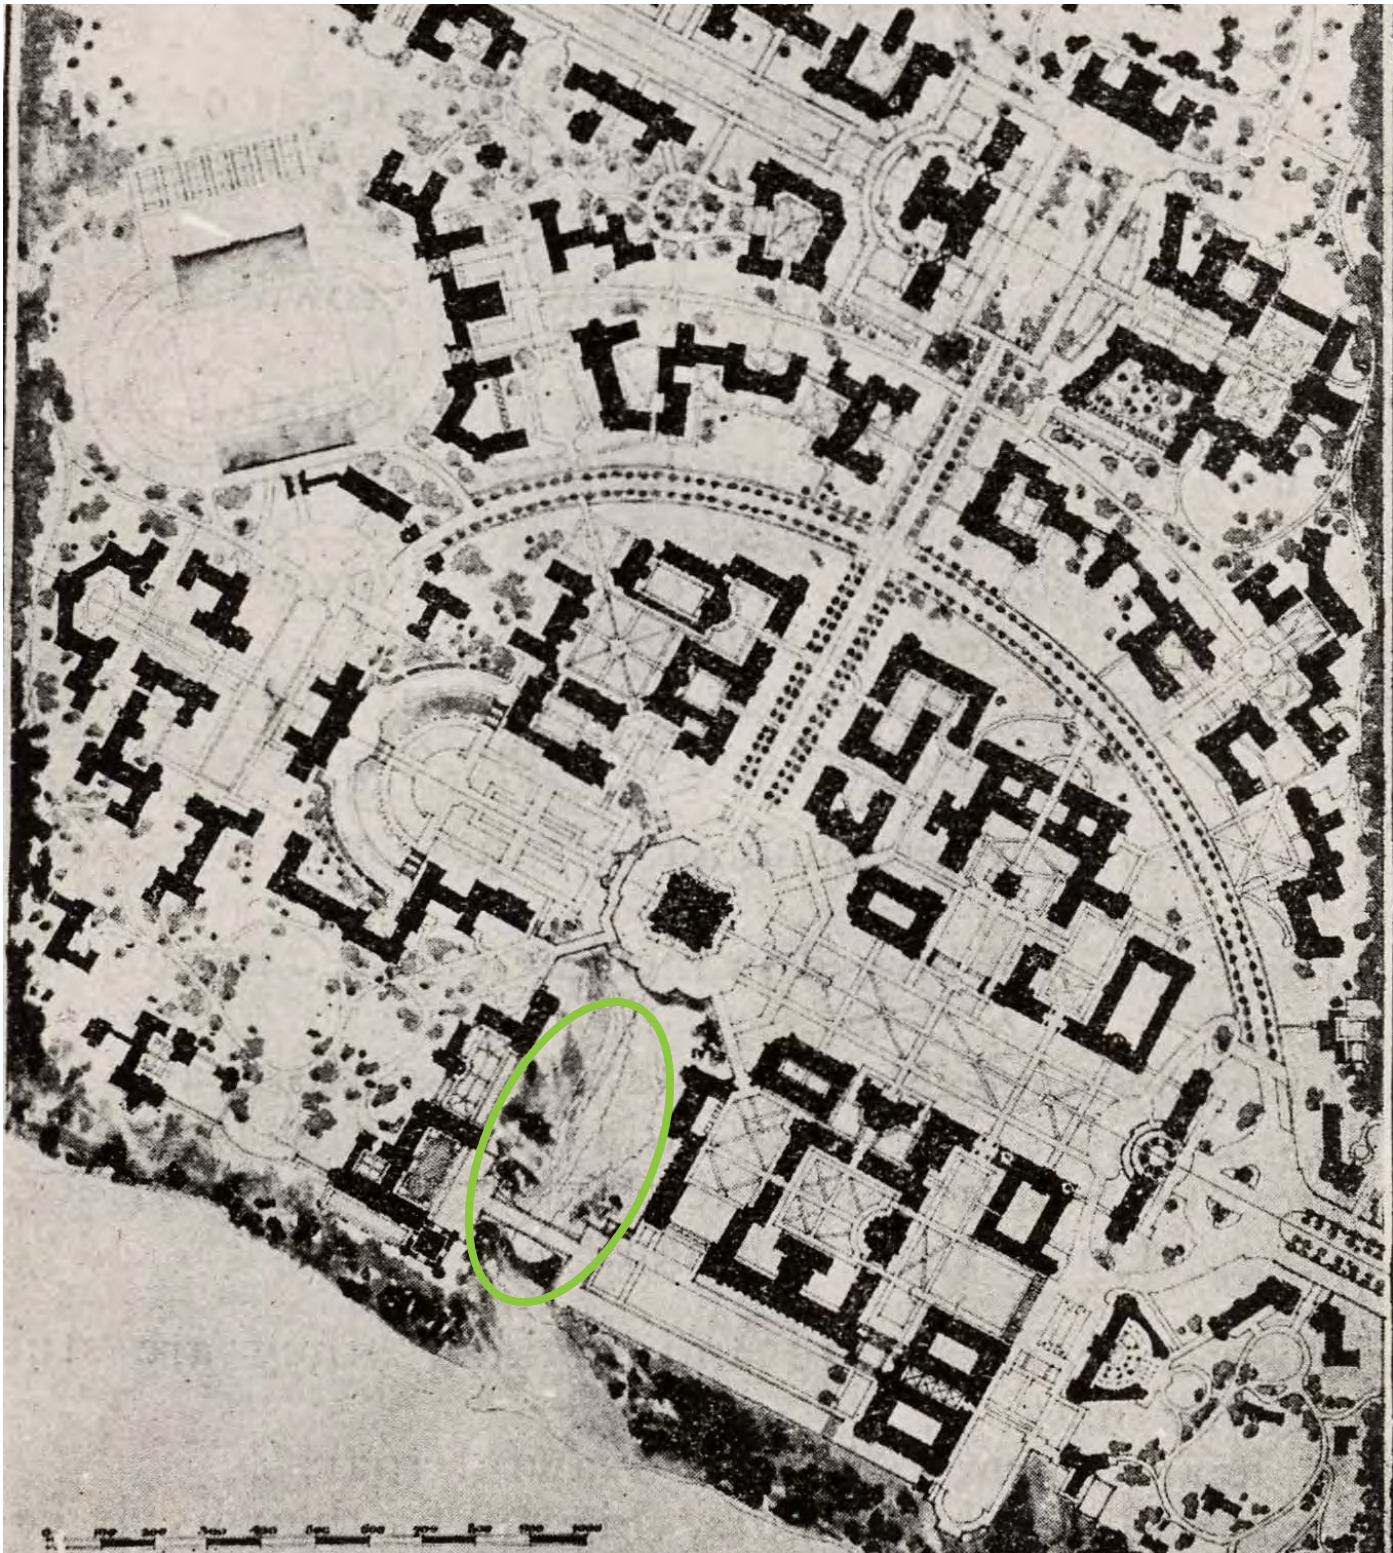
Figure 7. A portion of the 1909 Campus Plan by Brown and Vallance. Devil's Dip is circled in green. North is oriented to the left.

Devil's Dip is also of significance due to the important role it played in the formal layout of the University of Saskatchewan. The first university architects, David Brown and Hugh Vallance, aligned the primary axis of the 1909 Campus Plan with Devil's Dip. The axis, oriented 28.5 degrees south of due east, is apparent when the campus is viewed in plan (Figure 7). From Devil's Dip, a grand boulevard would radiate towards a central courtyard (now ['The Bowl'](#)), around which academic buildings would be placed. The buildings shown in the 1909 plan indicate a constructed

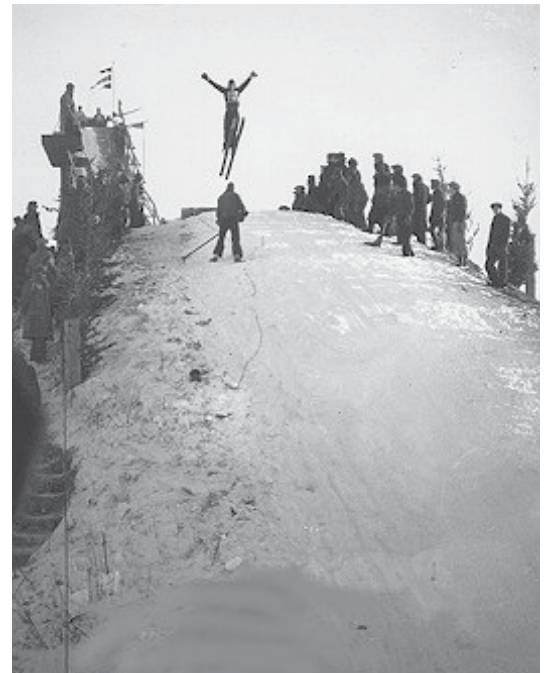
Figure 8. The ski jump in this photograph, may be the one that existed at Devil's Dip. Devil's Dip Ski Jump was the first on the banks of the Saskatchewan River and was constructed in 1929. This photograph is dated 1925, but that date may be in error. Retrieved from <http://www.skisprungschanzen.com/EN/Ski+Jumps/CAN-Canada/SK-Saskatchewan/Saskatoon/0117/>

The Devil's Dip ski jump had a K point or critical point of 80 meters, indicating that the target jumping distance was 80 meters from the jump and that is where most skiers would land. The first club championship of the Saskatoon Ski Club was held there in 1930. A skier broke his leg during the competition, and the ski jump was closed. Later, a second jump was built north of Devil's Dip, at a site now called 'Ski Jump Coulee.'

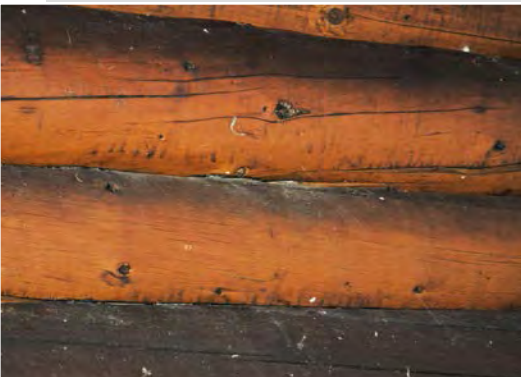
Figure 1. Logs showing gaps in need of re-chinking.

Lindner's Studio is a log cabin, made primarily of spruce logs harvested from the island. The logs are supported by a combination of concrete foundations, spruce logs and stones. On the interior of the cabin, the spruce logs are finished with linseed oil (Figure 1), and on the exterior they have been painted (Figures 2 & 3). The windows and shutters are also made of wood. The spruce logs that form the walls of the cabin have retained good commemorative integrity. The interior of the cabin has maintained its oiled finish beautifully. However, the spruce log walls are in need of re-thinking. Figure 1 illustrates one of the many spots where gaps in the log walls might allow air and water to penetrate.

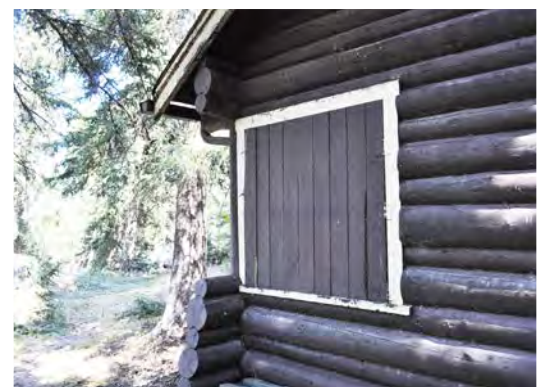
Figure 3. Lindner's studio window with painted shutters nailed shut.

The wooden window frames and shutters have also been painted on the exterior (Figure 3). Some original shutters have been retained and some new counterparts have been added. In recent years, the building has experienced repeated acts of vandalism, including having all of its windows broken more than once. To protect the building from further damage the windows have had their shutters nailed closed. This necessary provision, while protecting the cabin from further degradation of its heritage value, represents a loss to its commemorative integrity and a change in its character. Figure 3 shows one of Lindner's corner studio windows with its shutters painted and nailed shut. Lindner's portrayals of the cabin in his artwork suggest that the trim of the building has always been painted (Figure 4). Figure 5

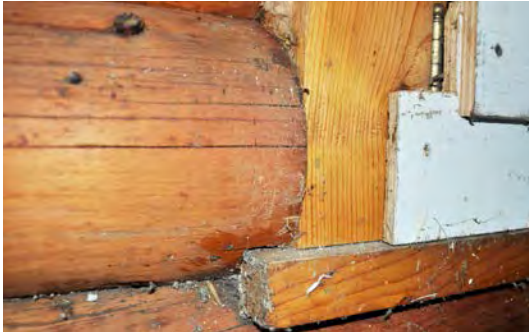
Figure 5. Spruce logs, fir trim and brass hardware.

shows the wooden window frames without paint on the interior.

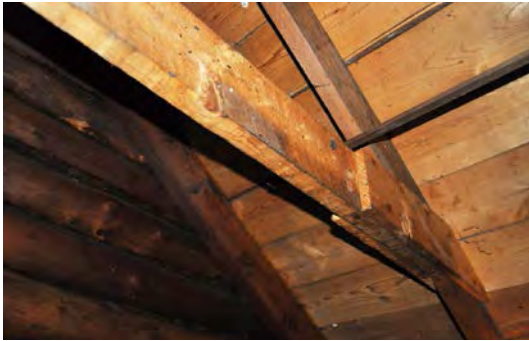
Figure 6. Wooden trussed rafters.

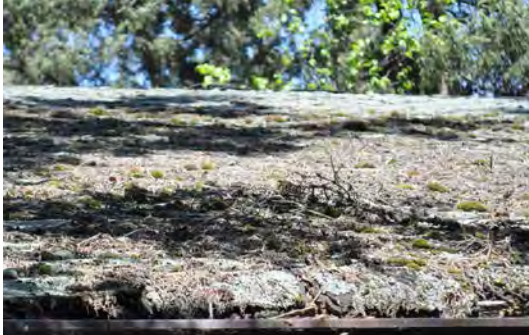
Figure 7. State of roofing material.

Figure 7 shows that the roof of the studio is in disrepair. The shingles are severely deteriorated. On the interior, the roof decking shows signs of water damage in places. The wood of the roof is still in excellent condition; however, the condition of the shingles is a threat to its commemorative integrity.

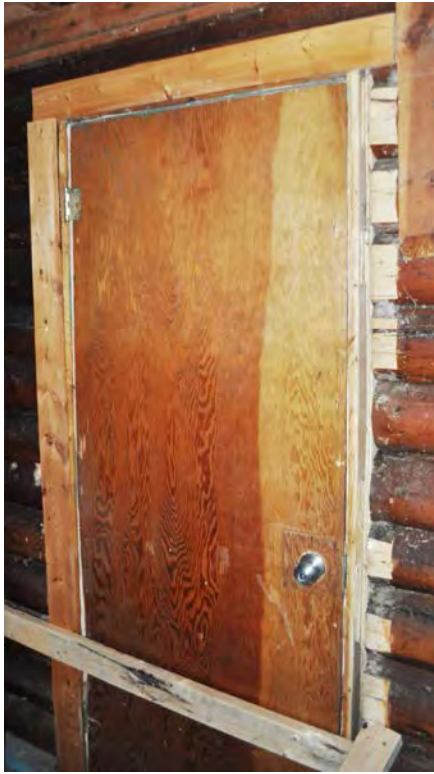
Figure 8. Damage due to vandalism.

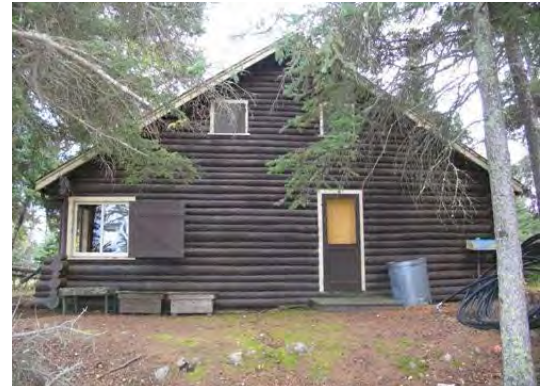
The form of the cabin is character-defining in its simplicity and scale. The cabin is rectangular, 1.5 storeys high, with a pitched roof (Figure 9). The simplicity of the design, its pitched roof and log walls are important character-defining elements classifying the studio as a cabin.

Figure 9. A 2007 photograph of the rear of Linder's Studio. Retrieved from <http://www.historicplaces.ca/en/rep-reg/image-image.aspx?id=10429#i1>

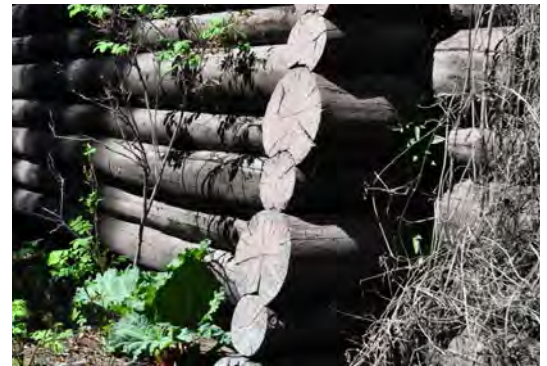
Figure 10. Saddlenotched logs.

The primary structural system of the cabin consists of its log walls, with saddle-notched corners. The foundations of the Lindner cabin are a combination of concrete, stones, and logs. A concrete strip foundation supports the walls on the east and west sides. On the north and south, rocks and logs can be seen supporting the cabin walls. This ad hoc system of support is a product of the undeveloped nature of the site; the cabin was built from what was available on the island. Figure 15 shows a rock supporting the cabin.

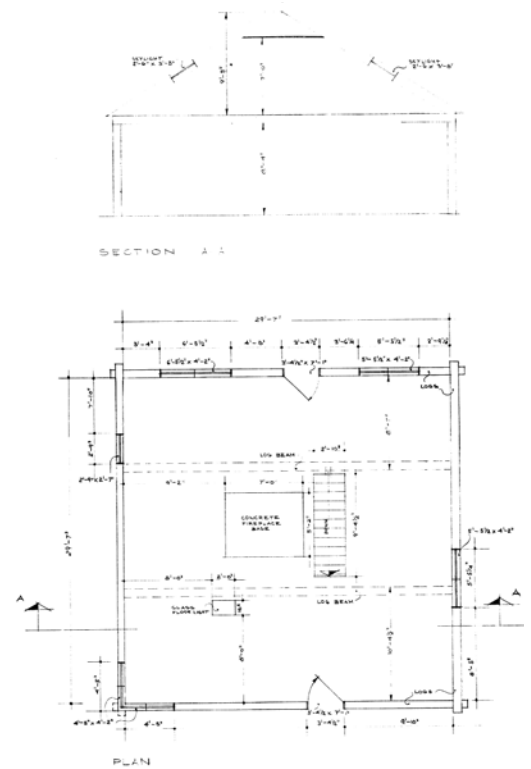
Originally, the cabin consisted of one floor with a basement. The ground floor was entirely open, as shown in Figure 14. When the cabin was acquired by the university, it was partitioned and a second floor was added. The ground floor was divided into four rooms and the new second floor was built with two rooms. The original layout of the cabins has therefore been compromised. The open plan and double height vaulted ceiling were character-defining elements. The same can be said for the windows; without glazing the character of the interior space has been substantially changed. Figure 14 shows that originally the cabin featured skylights and a floorlight. These character-defining elements are now gone.

Figure 14. The layout of Lindner's Studio in 1961. Retrieved from Facilities Management Division Asset Record System, File E-49-T.

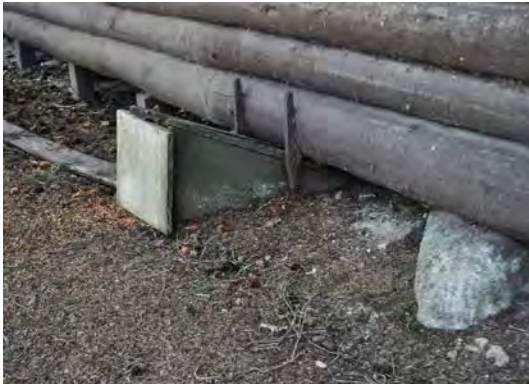
Figure 15. L to R: coal chute and a rock supporting the cabin's base.

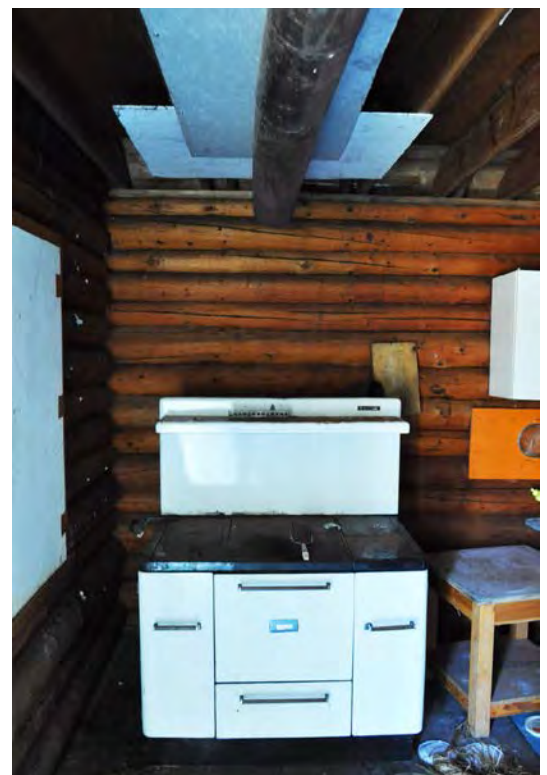
The white stove in the Lindner cabin is original to the building (Figure 17). Unfortunately, this piece of memorabilia has been vandalized; the stove pipe has been disconnected and the finish of the stove has been marred by pellet gun shots.

Figure 17. Original wood-burning stove.

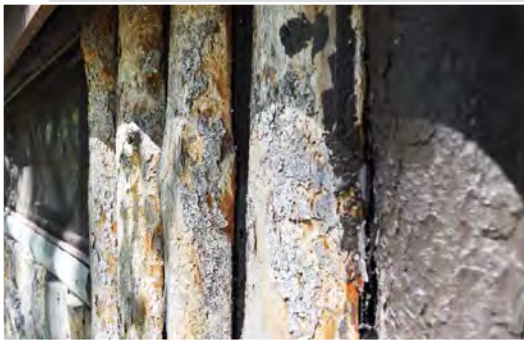
Figure 1. Exterior log siding.

Gus Kenderdine's studio at Emma Lake is built of spruce lumber procured from sawmills local to the site at Emma Lake. The lumber is in the form of both cut wood and log siding (Figures 1 & 2). The cut wood has been painted, but the log siding remains unfinished, with the exception of the upright logs on either side of the door. A 1936 photo shows the cabin with painted wood trim and unfinished log siding, so the exterior appears to have retained its commemorative integrity. A materials order quotes paint for the cabin as being 'extra optional.' The original porch decking has been replaced by plywood. The roofing is currently asphalt, however, it was originally specified to be 'native shingles,' presumably spruce.

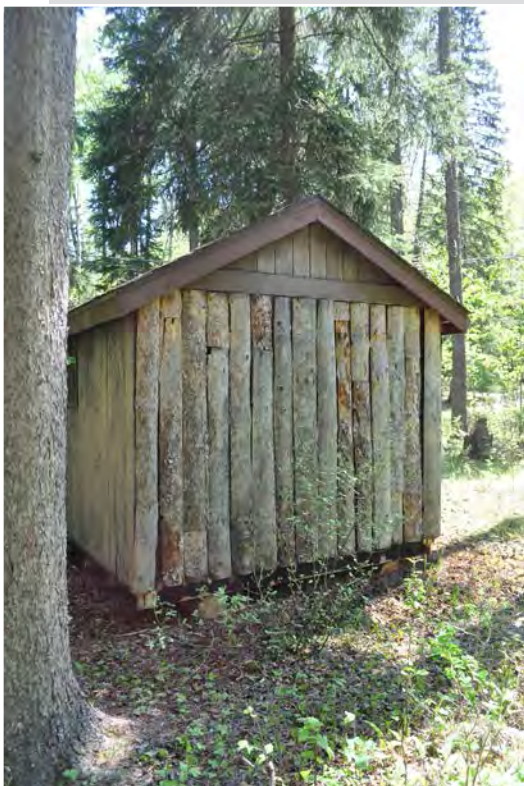
Figure 2. Exterior log siding and painted wood trim.

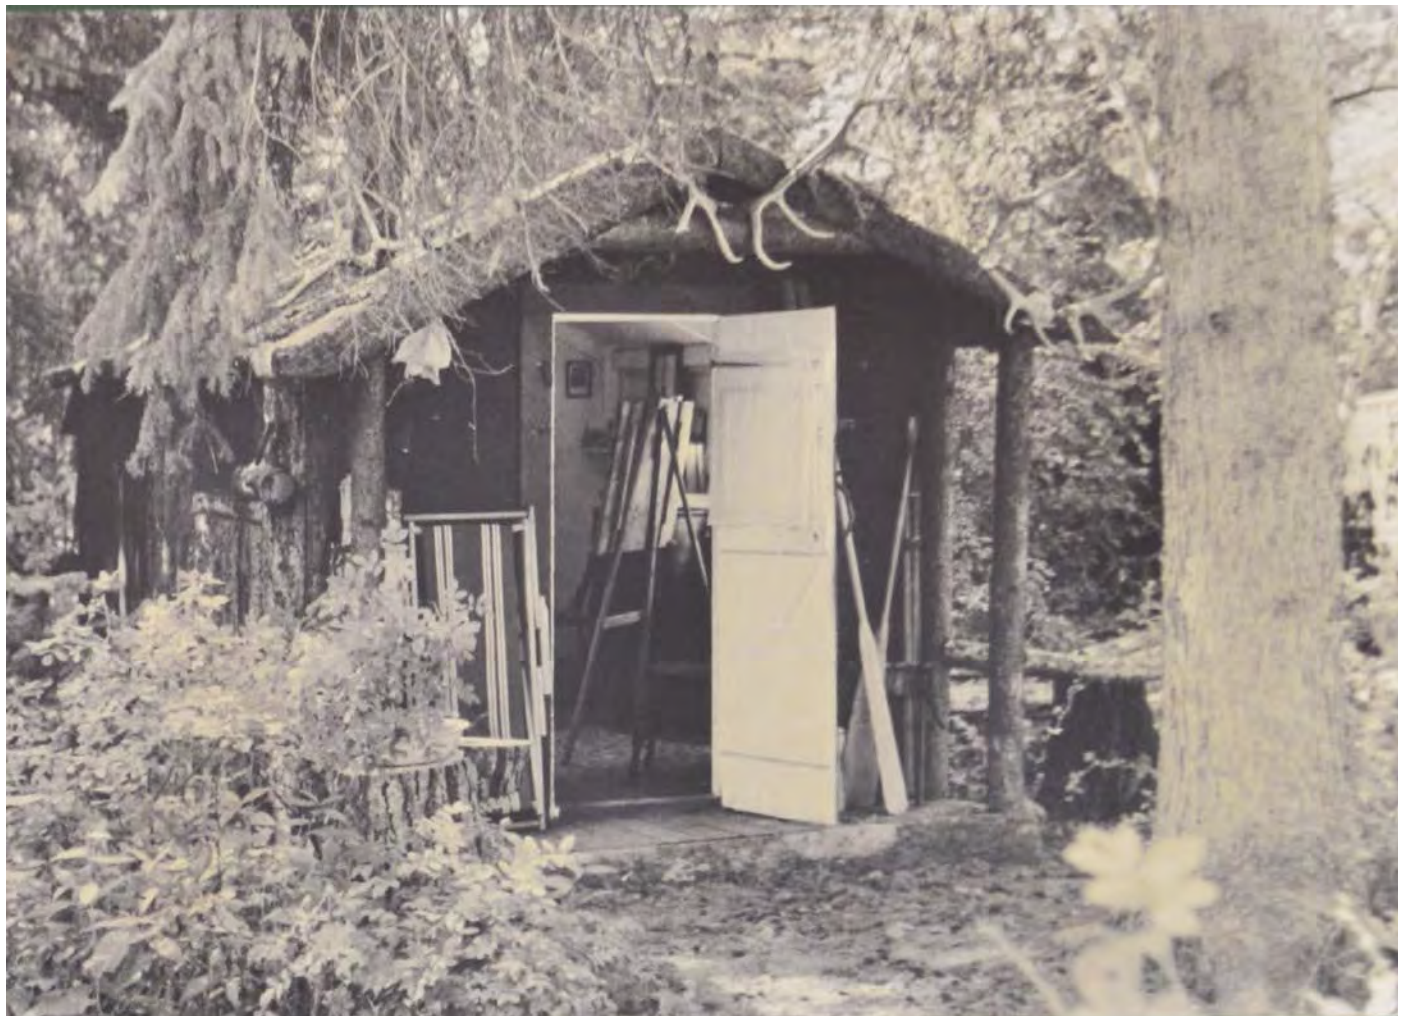
Figure 3. A 1936 photo of Kenderdine's Studio. Photo by E.N. Davis. Retrieved from Kenderdine Campus Dining Hall.

The interior of the cabin consists of painted cedar tongue & groove boards, visible in a 1936 photo (Figure 3). This finish material largely remains in place, except for the addition of several sheets of painted particle board, shown in Figure 4. The flooring in the cabin was originally spruce, which remains in existence. In the bedroom it is exposed, but painted, and in the larger room it is covered by a layer of linoleum (Figure 5).

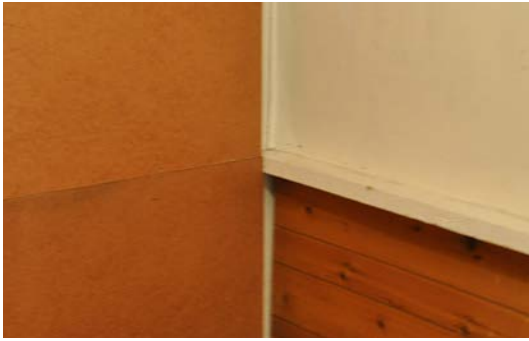
Figure 4. Interior bedroom materials.

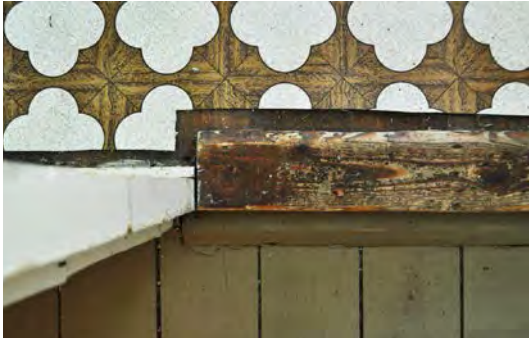
Figure 5. Flooring materials.

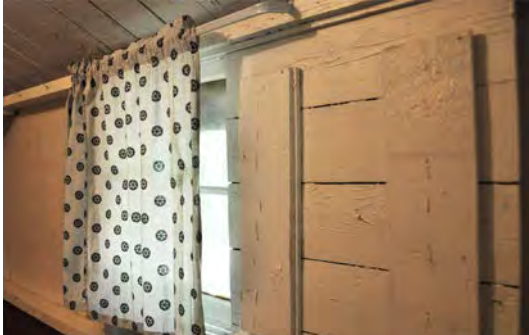
Figure 6. Bedroom window with sliding wooden shutter.

The windows have lost some commemorative integrity. The glass in the north window in the large room has been replaced with a sheet of clear plastic. The southern window appears to have been maintained, as has the bedroom window. The bedroom window is shown in Figure 6. A painted interior wooden shutter can still slide over this window. Both original windows are wood-framed with single-paned glazing. The other two windows have wooden brackets for sliding shutters, but the shutters are missing. A modern aluminum-framed window has been installed in the original wooden door. A built-in pantry is also constructed of wood. Records show that the curtains in the cabin have been replaced and the current ones are not original.

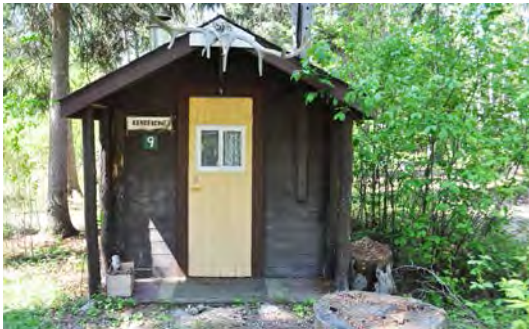
Figure 7. The form of the studio.

The cabin is very small, measuring approximately six feet by 15 feet and is one reduced storey in height. This diminutive scale is a character-defining element. The rectangular shape and pitched roof of the cabin are also character-defining elements (Figure 7).

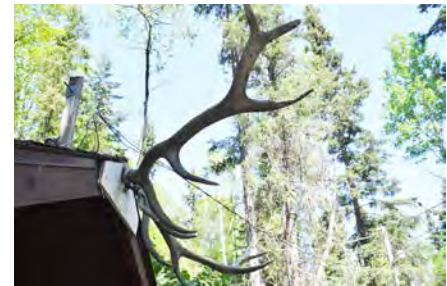
Figure 8. Pitched roof and antlers.

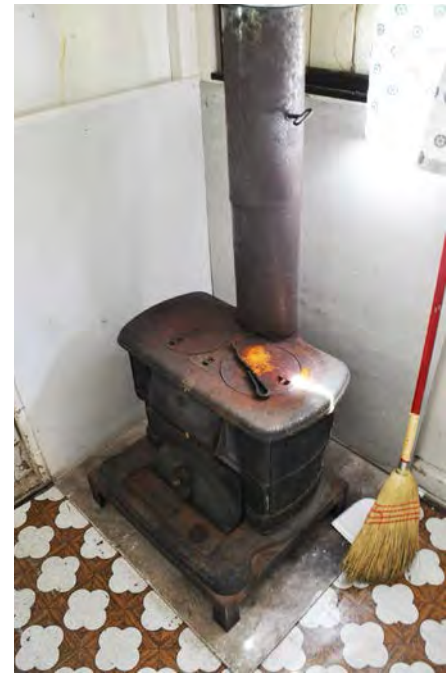
A wood-burning stove, still in existence, provided heat (Figure 12). The stove appears to have been moved. Photographs show a stove pipe in the north-west corner of the large studio space. It is now installed in the south-east corner. The original stove pipe was replaced in 1953.

Figure 12. Original cookstove.

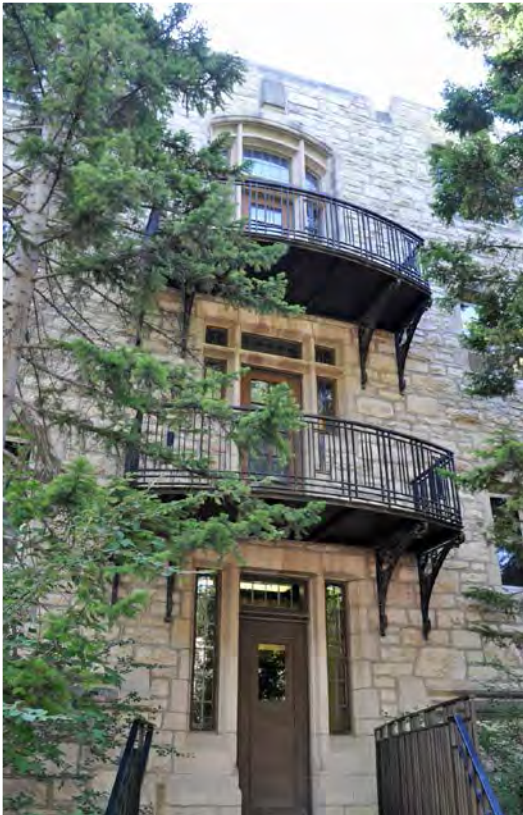
Figure 1. Materials defining the character of Palliser Garden: the greystone facade of Qu'Appelle Hall, steel balustrades, oak doors, pine and spruce trees.

The landscape features of the garden were designed by landscape architects Clive Justice and Harry Webb, who aimed for the garden to have an 'alpine' feel with lots of smaller plants. Character-defining plants include the spruce and pine trees shown in Figure 1. The use of trees without heavy foliage at eye level is another character-defining element allowing for visibility within the garden. Figure 3 depicts one of the trees chosen and planted in the middle of the space for this characteristic.

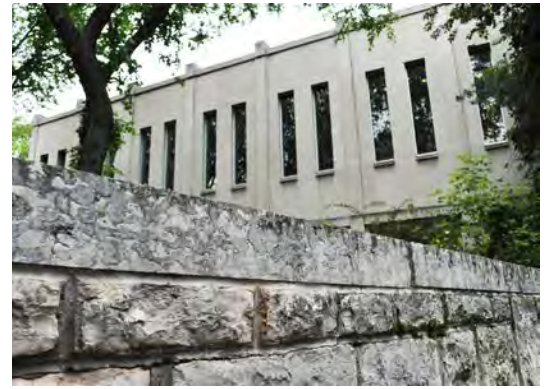
Figure 2. Top to bottom: Tyndall stone facade of Marquis Hall, Tyndall stone coping and greystone wall.

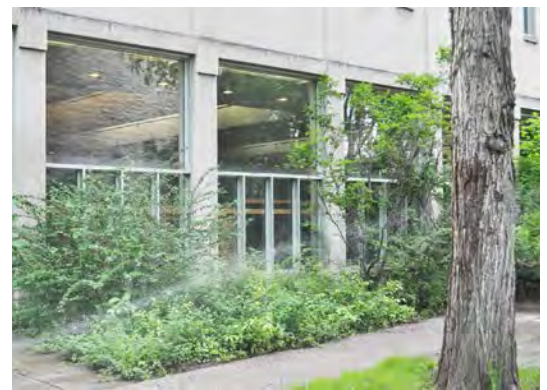
Figure 3. Materials defining the character of Palliser Garden: the Tyndall stone and the glazed facade of Marquis Hall, trees with trunks allowing visibility.

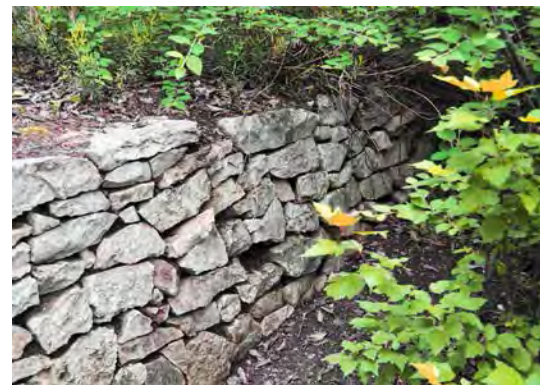
Figure 4. Materials defining the character of Palliser Garden: L to R: greystone retaining wall, foliage.

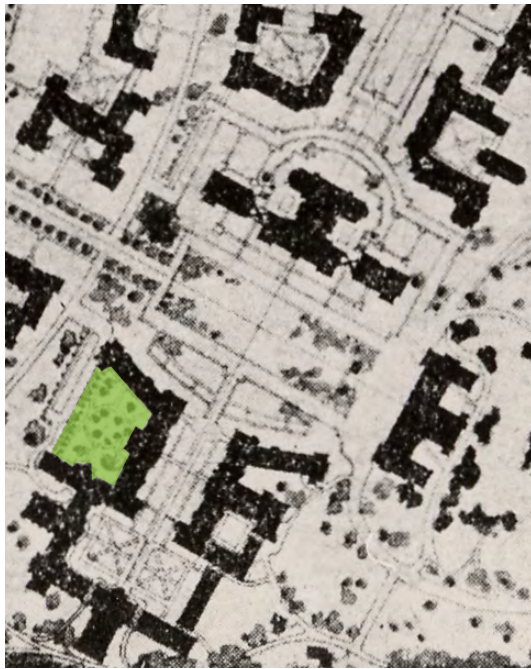
Figure 6. The location and form for the outdoor courtyard as intended by Brown and Vallance is indicated in green on the 1909 Campus Plan.

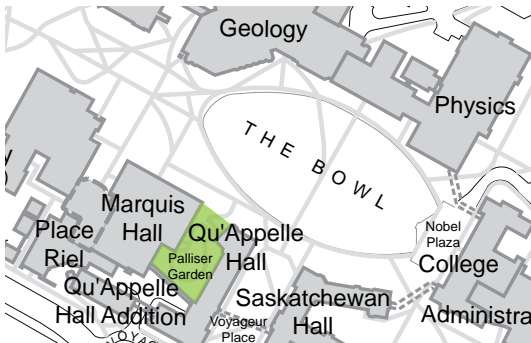
Figure 7. The existing location and configuration of Palliser Garden is indicated in green on this contemporary campus map.

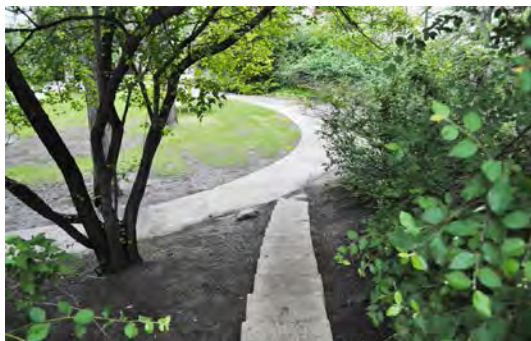
Figure 8. Concrete steps and path surrounded by foliage intended to screen surrounding uses.

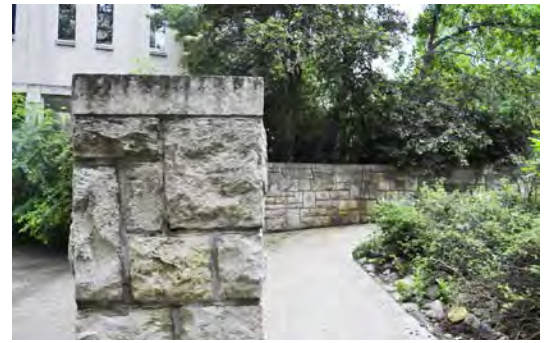
Figure 9. Greystone wall and ramp.

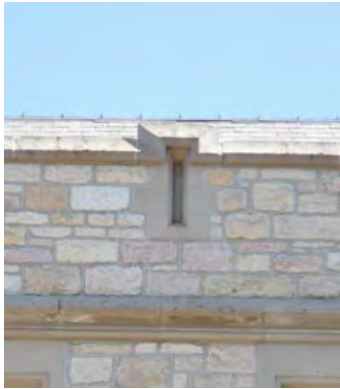
Figure 1. Archer slot.

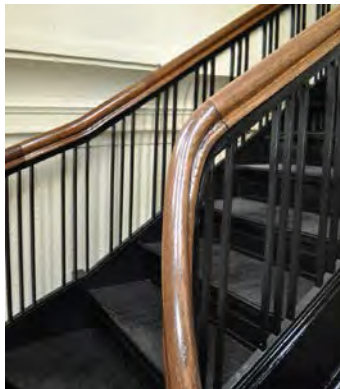
Figure 2. Balustrade.

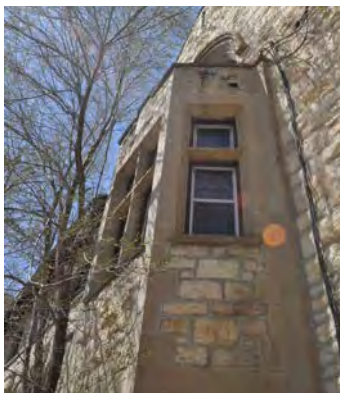
Figure 3. Bay window.

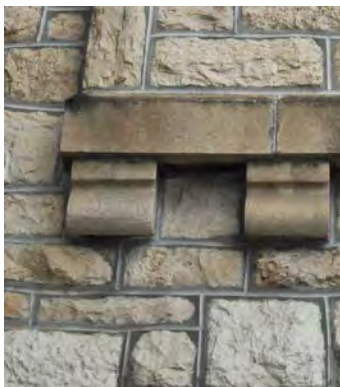
Figure 4. Brackets.

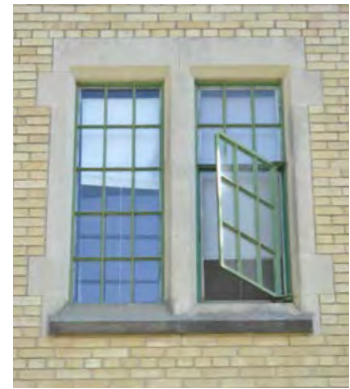
Figure 5. Casement window.

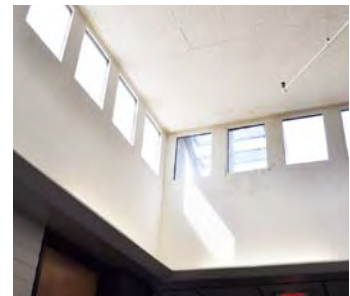
Figure 6. Clerestory windows.

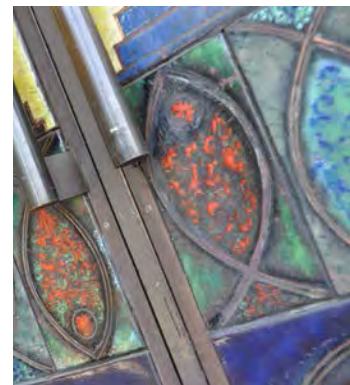
Figure 7. Doors featuring the cloisonne enameling process.

- **Cloisonne:** An enameling process in which strips of metal (cloisons) are soldered to a base, forming compartments into which enamel is poured and fused (Figure 7).

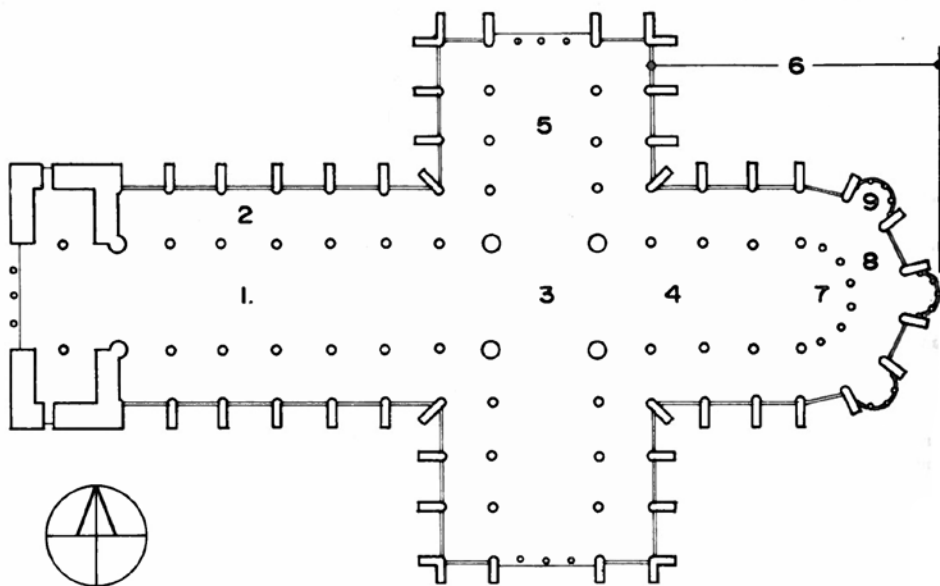
Figure 8. Common characteristics of the Christian church. Retrieved from, Kostof, S. (1985). *A History of Architecture: Settings and Rituals*. Oxford University Press: Oxford.

1. Nave
2. Aisle
3. Crossing
4. Choir
5. Transept
6. Chancel
7. Apse
8. Ambulatory
9. Radiating Chapel

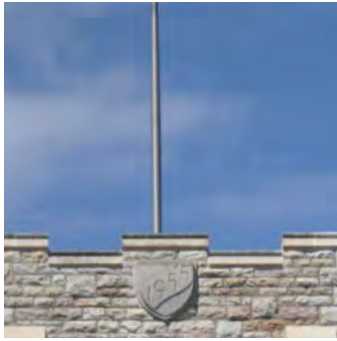
Figure 9. Crenellation or battlement.

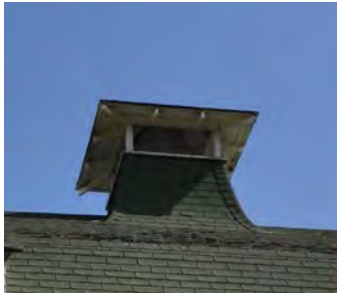
Figure 10. Cupola.

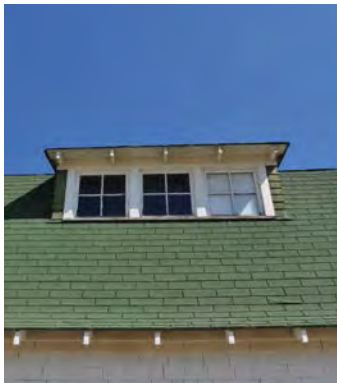
Figure 11. Dormer window.

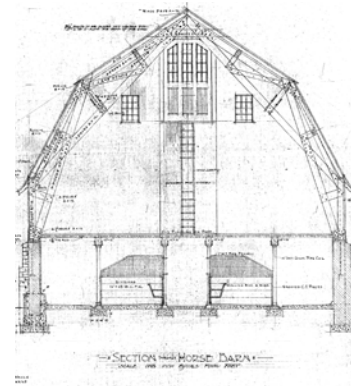
Figure 13. Gambrel roof shape.

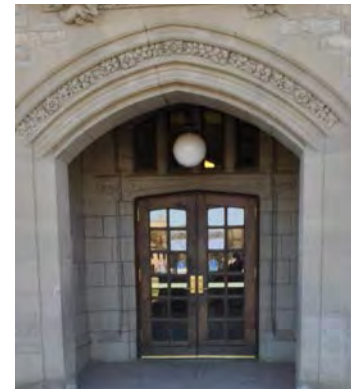
Figure 14. Gothic arch.

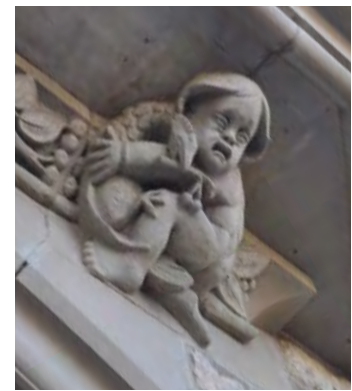
Figure 15. Grotesque.

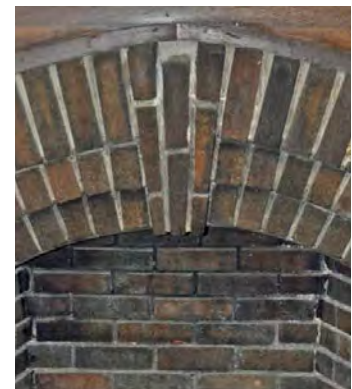
Figure 16. Keystone.

- **Keystone:** The central wedge-shaped stone in an arch, sometimes decorated. As a structural member, used to stabilize the other stones in an arch. In contemporary times, keystones are sometimes used for ornamentation rather than structural purposes and can be found as the central stone in a series of horizontal stones (Figure 16).

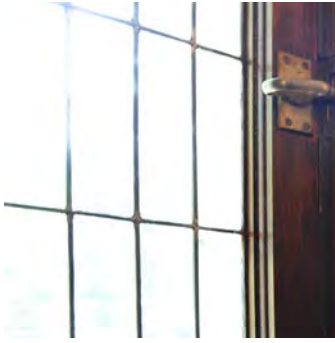
Figure 17. A leaded glass window; lites separated by lead glazing bars.

- **Leaded Glass Windows:** Windows in which separate glass lites have been soldered together with lead glazing bars (Figure 17).
- **Lintel:** A horizontal beam or stone that spans an opening.

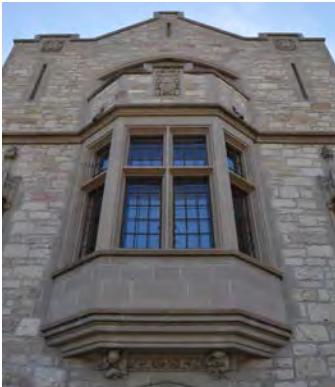
Figure 18. Oriel window.

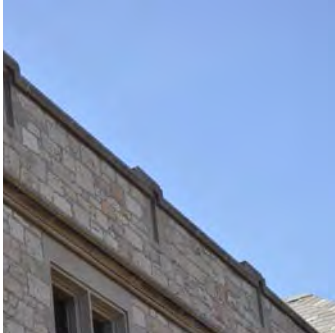
Figure 19. Parapet with archer slots and crenellation.

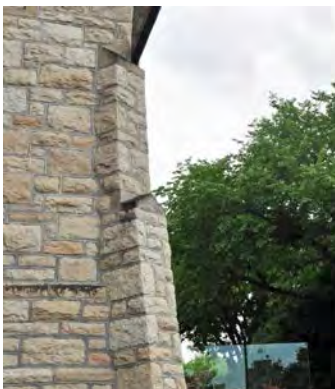
Figure 20. Pier.

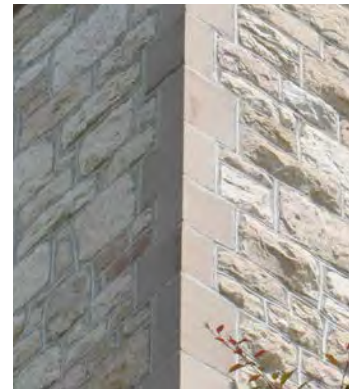
Figure 21. Quoining.

- **Quatrefoil:** Four lobed, leaf-shaped, indented spaces which are found especially in the tracery of gothic windows.
- **Quoin:** One of a series of stones or bricks used to mark the corners of a building, often through a contrast of size, shape or color (Figure 21).

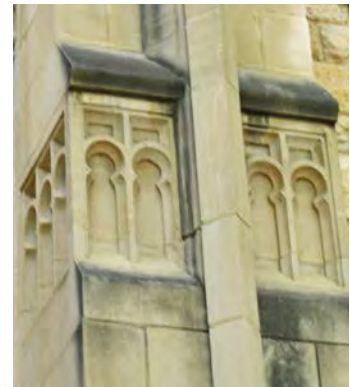
Figure 22. Relief carving with a motif of horsehoe arches.

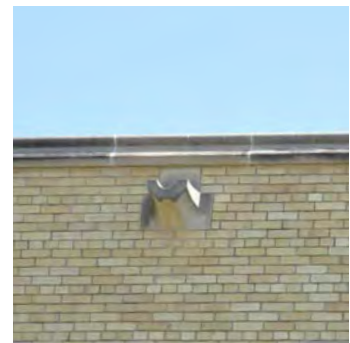
Figure 23. Scupper.

- **Sash Window:** A window that opens by sliding up or down.
- **Scupper:** An opening for draining off water, as from a floor or the roof of a building (Figure 23).

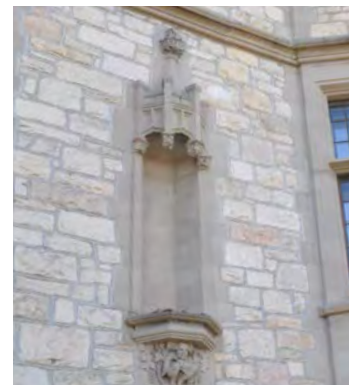
Figure 24. Statuary niche.

- **Spandrel:** The area between the sill of a window and the head of the window below it.
- **Statuary Niche:** An ornamental recess in a wall or the like, usually semicircular in plan and arched, as for statue or other decorative object (Figure 24).

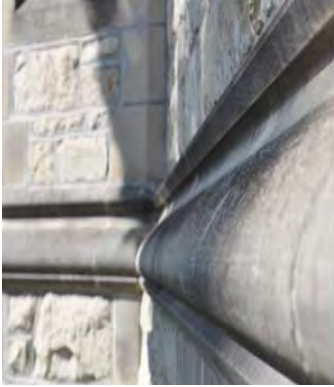
Figure 25. String course.

- **String Course:** A projecting horizontal band across an exterior wall of a building (Figure 25).
- **Terracotta:** Hard, molded, and fired clay used for ornamental wall covering, or roof or floor tile.

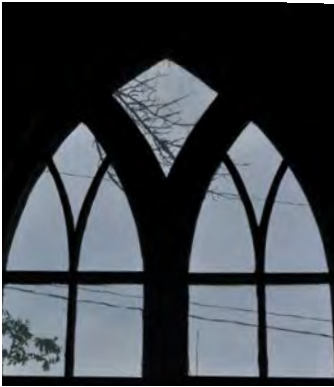
Figure 26. Tracery.

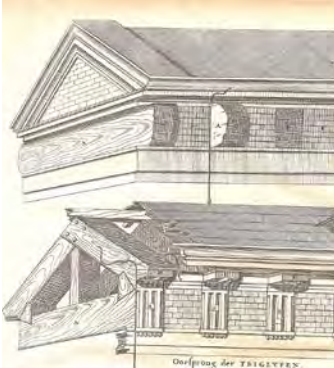
Figure 27. Triglyphs.

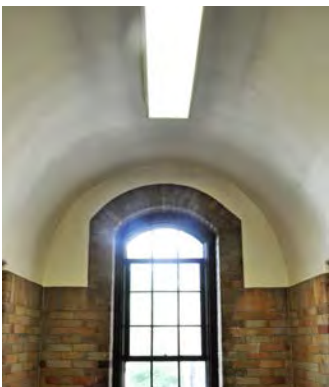
Figure 28. Ceiling vault.

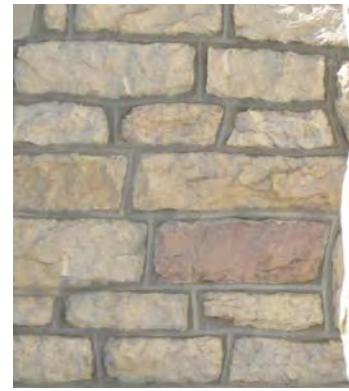
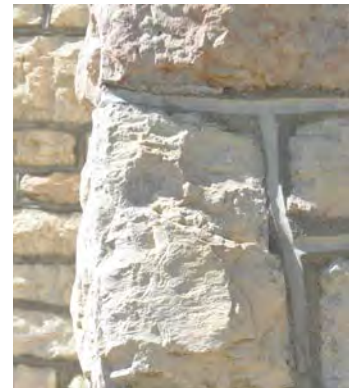
Figure 1. Greystone.

▪ **Greystone:** ‘Greystone,’ a type of dolomitic limestone, is the most common building stone in Saskatoon (Mysyk & Kulyk, 2006). Greystone is common to the area around Saskatoon and through the South Saskatchewan River valley. It was originally found and gathered on or near the surface of the soil, and is therefore often referred to locally as ‘fieldstone,’ although it is now more frequently quarried. Greystone formed 450 million years ago during the Ordovician period, but was deposited in the South Saskatchewan River valley when the glaciers of the last ice age retreated 10,000 years ago. Although it is a type of limestone, greystone is characterized by an absence of fossils, due to its formation in deep cool waters that were devoid of marine life. The term greystone is a colloquialism that refers to its colour, although it is in fact predominantly a buff colour, with some shades of yellow, pink and purple.

Greystone is a significant character-defining element of many buildings at the University of Saskatchewan, and of the campus as a whole. Its significance lies in the consistency of its use through one hundred years of building, and due to the fact that the material is local. In *Saskatchewan: The Making of a University* (1959) Arthur Morton, describes how the university Board of Directors came to choose greystone for Saskatchewan Hall and for the Agriculture Building, now the MacKinnon Building:

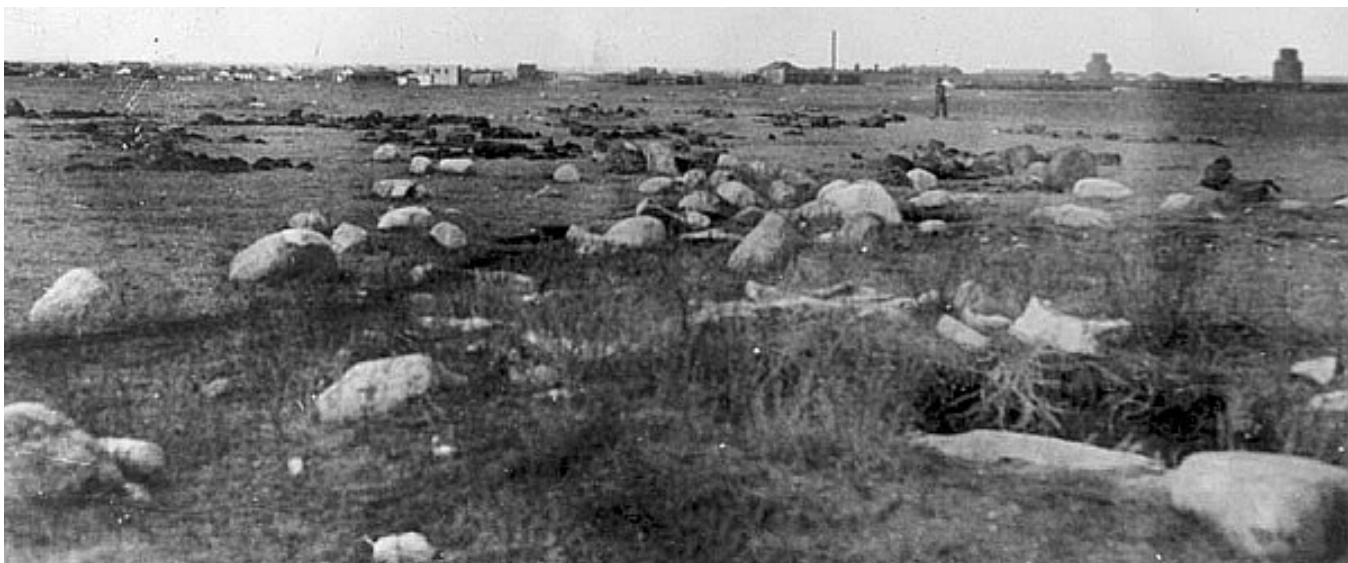
Figure 2. Fieldstone north of campus ca. 1910. Photo A-758, retrieved from http://scaa.usask.ca/gallery/uofs_buildings/

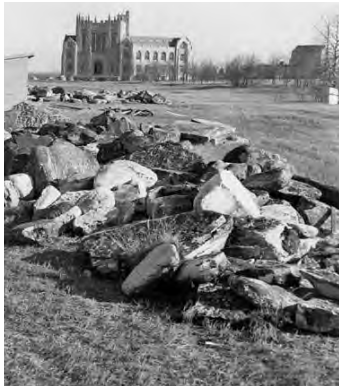
Figure 3. Stones used for the construction of University hospital. The Thorvaldson Building is in the background. Photo A-1067, retrieved from http://scaa.usask.ca/gallery/uofs_buildings/.

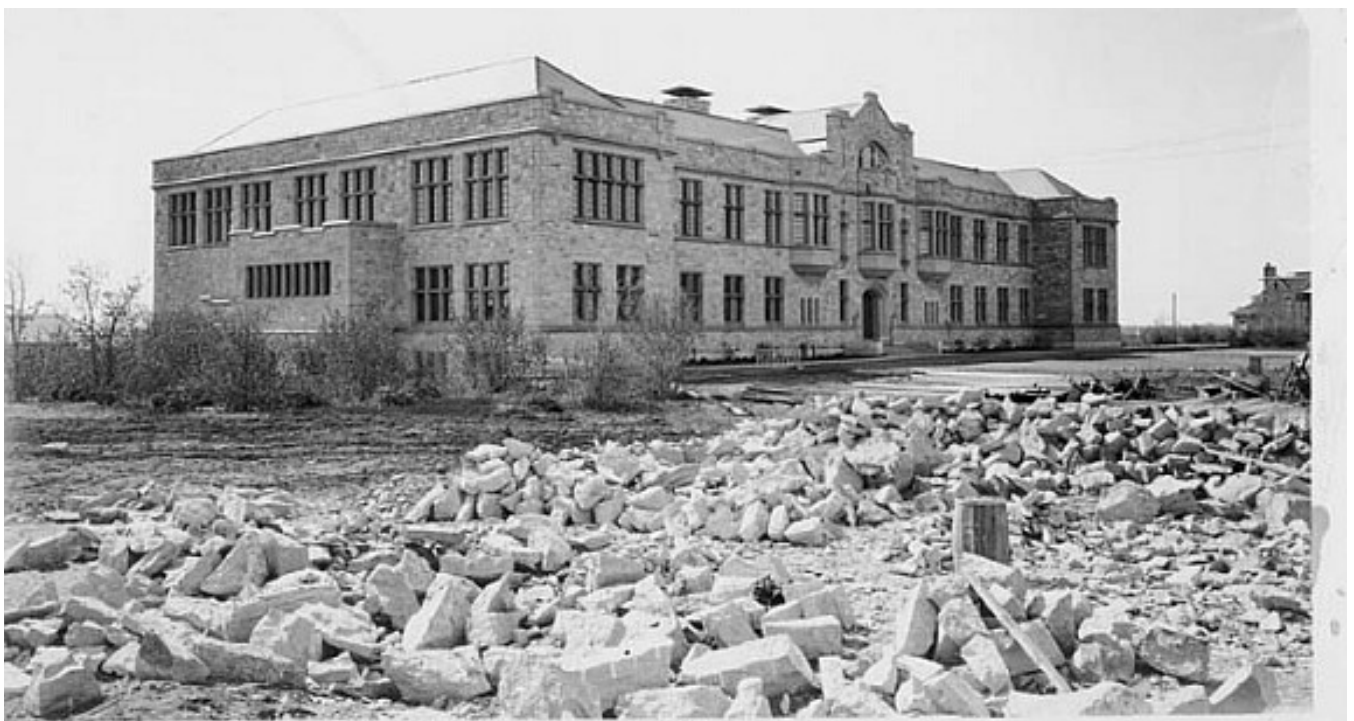
Figure 4. 1912, surplus greystone shortly after the completion of the MacKinnon Building. Photo A-758, retrieved from http://scaa.usask.ca/gallery/uofs_buildings/

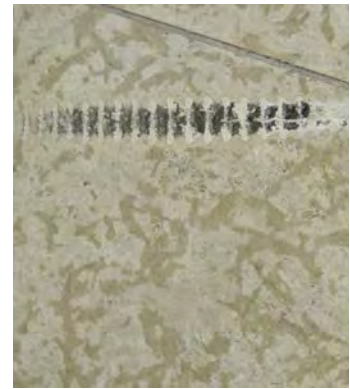
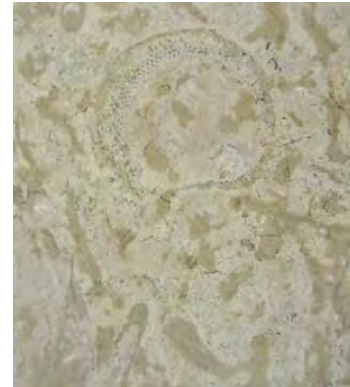
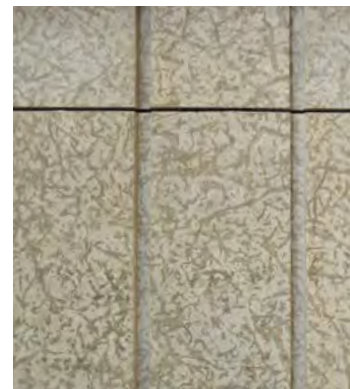
Figure 5. Tyndall stone showing fossil remains and characteristic mottling.

Tyndall stone is a dolomitic limestone characterized by its light grey colour, mottled appearance and visible fossils. The fossils in Tyndall stone are a result of the way in which the stone was formed. 450 million years ago, much of Saskatchewan and southern Manitoba was covered by a vast, shallow, inland sea. Marine animals, such as corals, sponges, molluscs, trilobites and stromatoporoids, lived on or above the soft, muddy sea floor. After they died, their remains settled into the mud, and became fossilized over time. The calcium carbonate in their skeletons and shells, mixed with silt, became limestone. The fossil remains of these animals are visible in Tyndall Stone. The channels formed by burrowing animals created the worm-like mottling which gives Tyndall Stone its characteristic mottled appearance. Tyndall stone is sometimes called ‘tapestry stone’ due to this patterning. Geologically, Tyndall stone is referred to as ‘Upper Mottled Limestone of the Red River Formation of the Ordovician System’.

At the University of Saskatchewan, Tyndall stone replaced Indiana Limestone as the most common stone used for cut and carved stone ornamentation after the Second World War. Its first use appears to have been on the Health Science building (now the Academic Health Sciences A Wing), which began construction in 1945. It was used more extensively, as a wall cladding material, on parts of the Murray Memorial Library in 1954. Tyndall stone was the material originally chosen for the exterior walls of the first buildings at the University of Saskatchewan in 1910; however, the local availability of greystone made it the preferred choice. (Refer to Greystone, above). The common use of Tyndall Stone at the University of Saskatchewan has made it an important character-defining element.

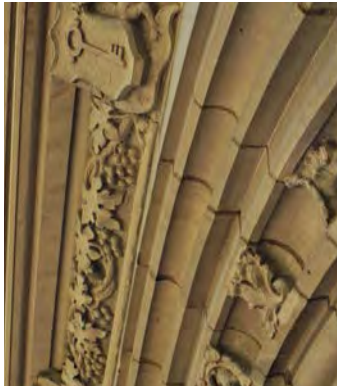
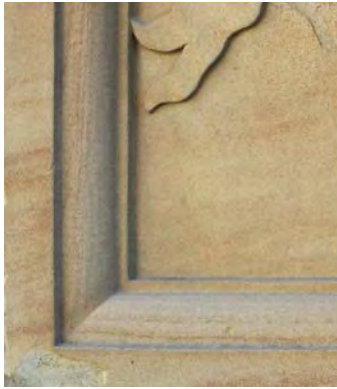
Figure 6. Sandstone.

■ **Sandstone:** Berea Sandstone is a sedimentary rock composed mainly of sand-sized grains of quartz and other minerals, bonded by silica and lime. Berea sandstone was formed during the Carboniferous period, between 360 to 300 million years ago. Berea Sandstone was used for cut and carved stone ornamentation on the earliest buildings at the University of Saskatchewan, such as the MacKinnon Building (1910-12), Saskatchewan Hall (1910-12), and the College of Emmanuel and St. Chad (1910-12). Beginning with Qu'Appelle Hall in 1914, Salem or Indiana limestone replaced the use of sandstone because it was found to be more durable and easier to carve (Mysyk & Kulyk, 2006).

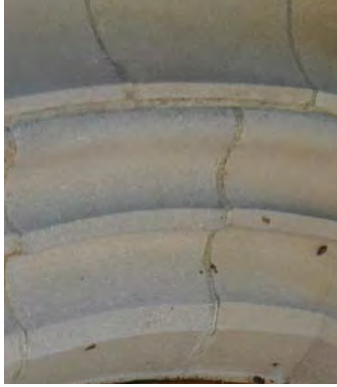
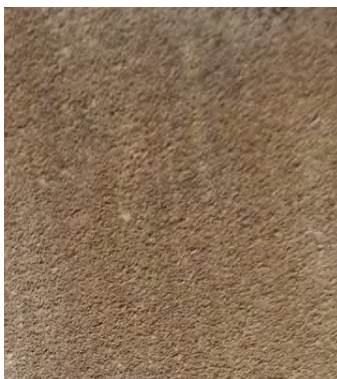
Figure 7. Indiana Limestone.

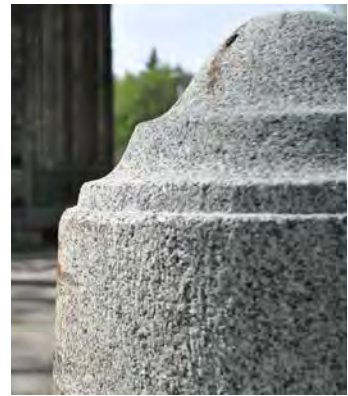
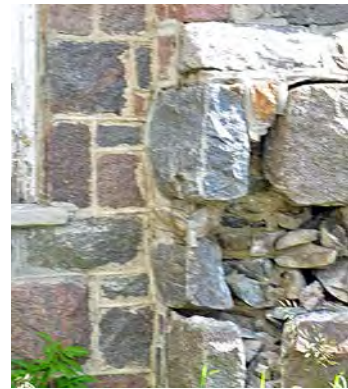
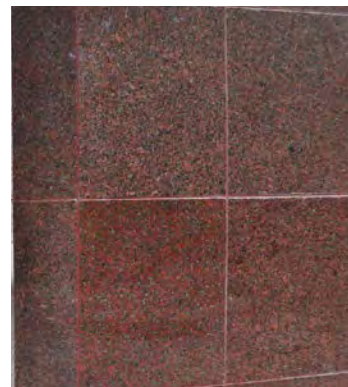
Figure 8. Top to Bottom : Grey dimension cut granite bollard, rough cut, dark granite wall, polished red granite.
