University of Saskatchewan

Heritage Register

September 2013

Facilities Management
Division

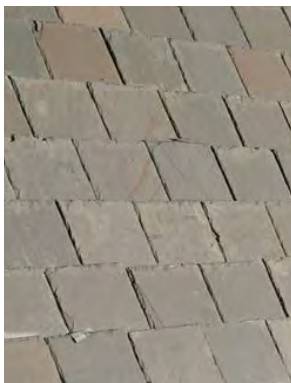
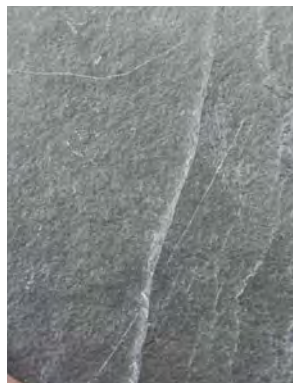
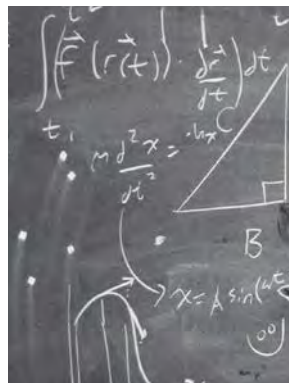
Figure 9. L to R: slate roof tiles, natural cleft slate surface, slate chalkboard.

▪ **Slate:** Slate is a fine-grained homogenous metamorphic rock formed from shale. With heat and compression, the clay in shale turns into mica which transforms the mineral from shale to slate. Slate is most commonly used for roofing tiles. The properties and formation of slate make it easy to cut into thin sheets for this application. In addition, slate is a water-shedding material and withstands contact with freezing water.

Slate tile roofing and slate stair treads were used on most University of Saskatchewan buildings during the first phase of construction from 1909-1929. The slate tile at the University of Saskatchewan is characteristically green in colour. Many of staircases on early university buildings, such as those in the MacKinnon Building (1910-12), feature original slate treads which show grooves from years of use. In some places, black slate is used. There are still some black slate chalkboards in use on campus; the lecture theatre in the Thorvaldson Building (1922-24) is one example.

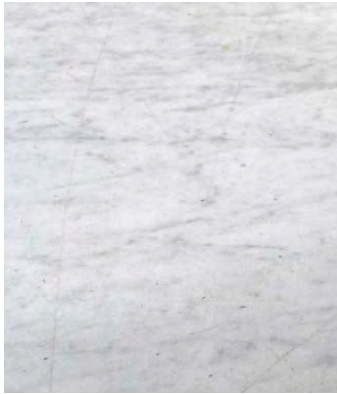
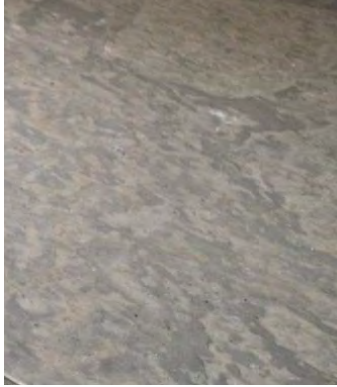
Figure 10. Top to Bottom:
White marble, green marble.

▪ **Marble:** Marble is a metamorphic rock composed of recrystallized carbonate minerals, most commonly calcium or dolomite. It is formed from the heat and compression of limestone. Marble will take a high polish, and is most often used as an interior finish material.

Marble is seen in its most abundant use in the first residence buildings at the university: Saskatchewan Hall and Qu'Appelle Hall. It is found in the washrooms of Saskatchewan Hall and in the bedrooms and corridors of Qu'Appelle Hall. The window sills, baseboards stair treads and landings in Qu'Appelle Hall are composed of white marble. Some of the original white marble has been replaced with a locally available, green variety. The swirls and veins of coloration found in marble are due to mineral impurities. The colour green is most often indicative of high magnesium limestone or dolostone with silica impurities.
